TREE ASSESSMENT REPORT

Consulting Arborist Report for Tree Health & Risk Management

Report Prepared By: John Madderom – Consulting Arborist – Diploma of Arboriculture
Report Commissioned By: Mossman Port Douglas Tree Lopping
Subject Site: Warner Street, Port Douglas
Date of Assessment: 25 April 2021
Date of Report: 26 April 2021

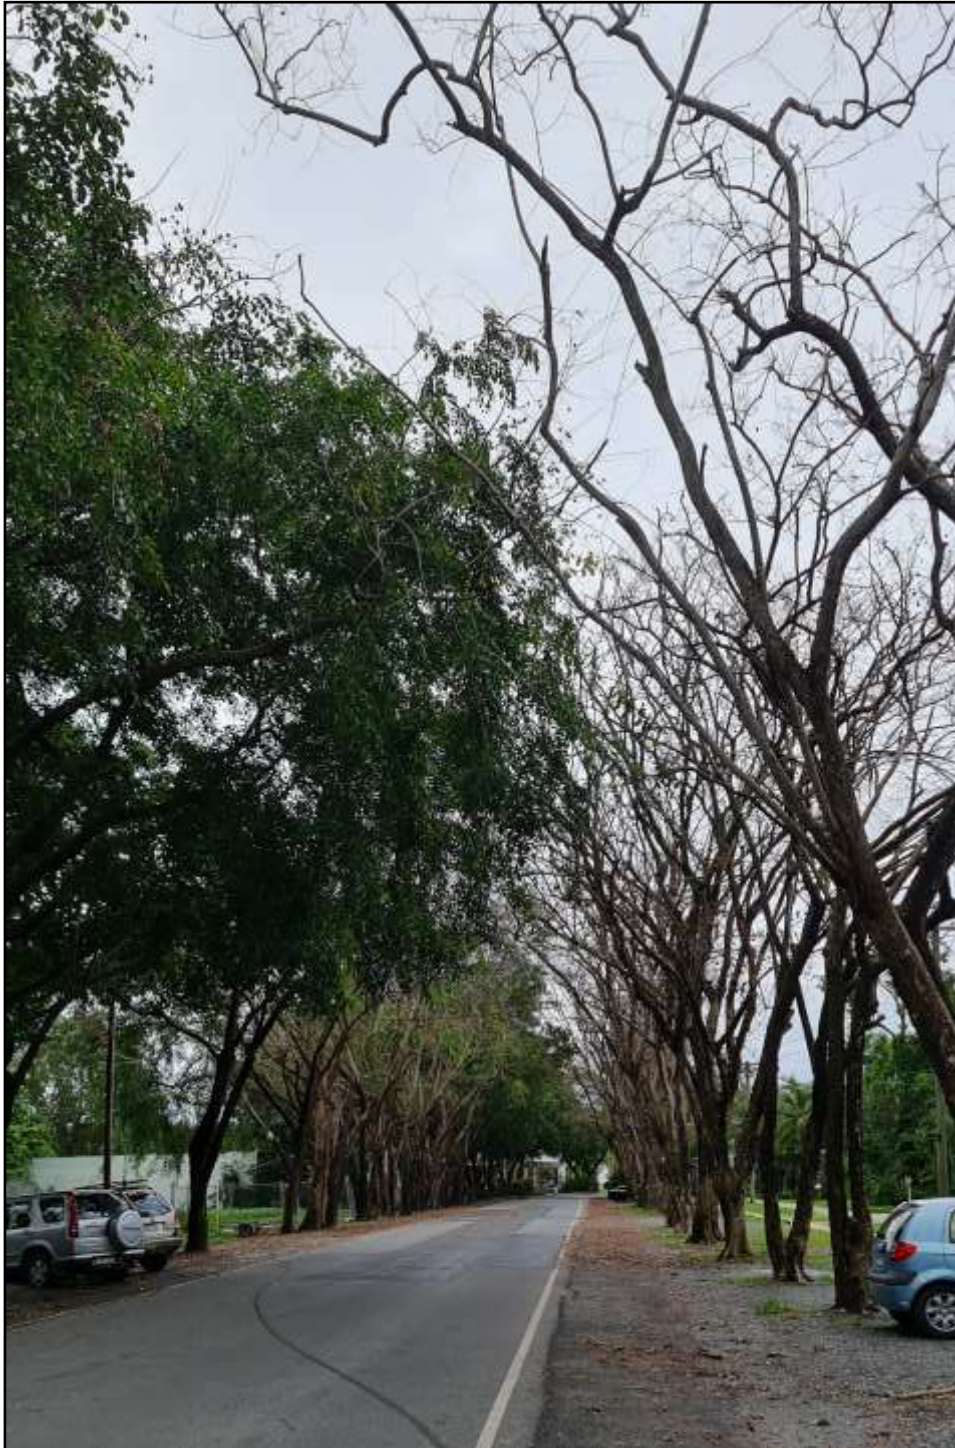
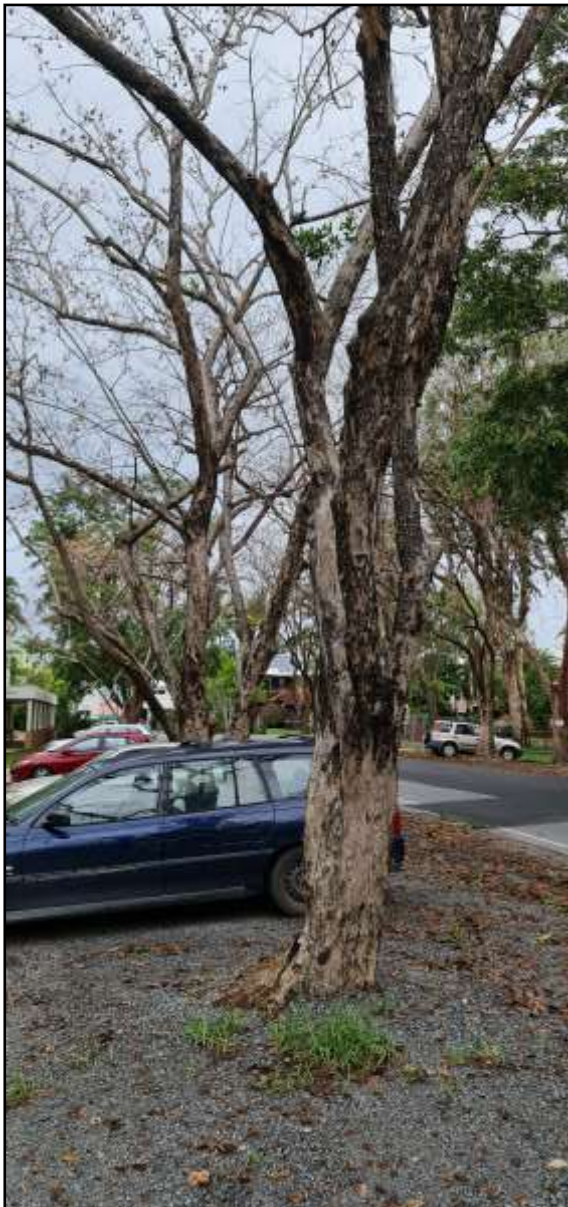
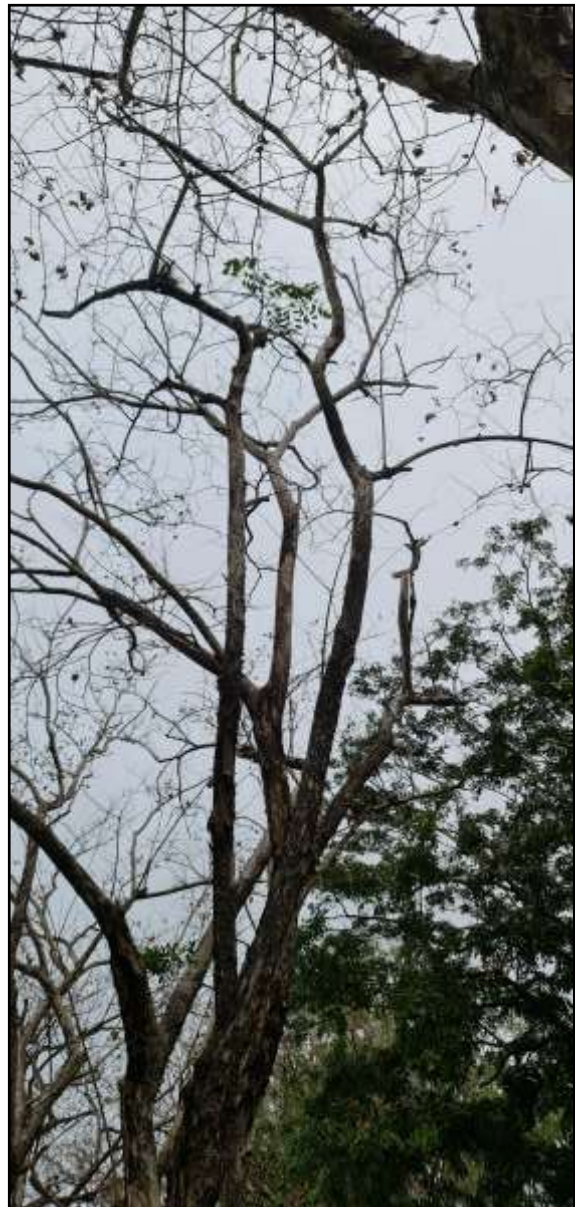
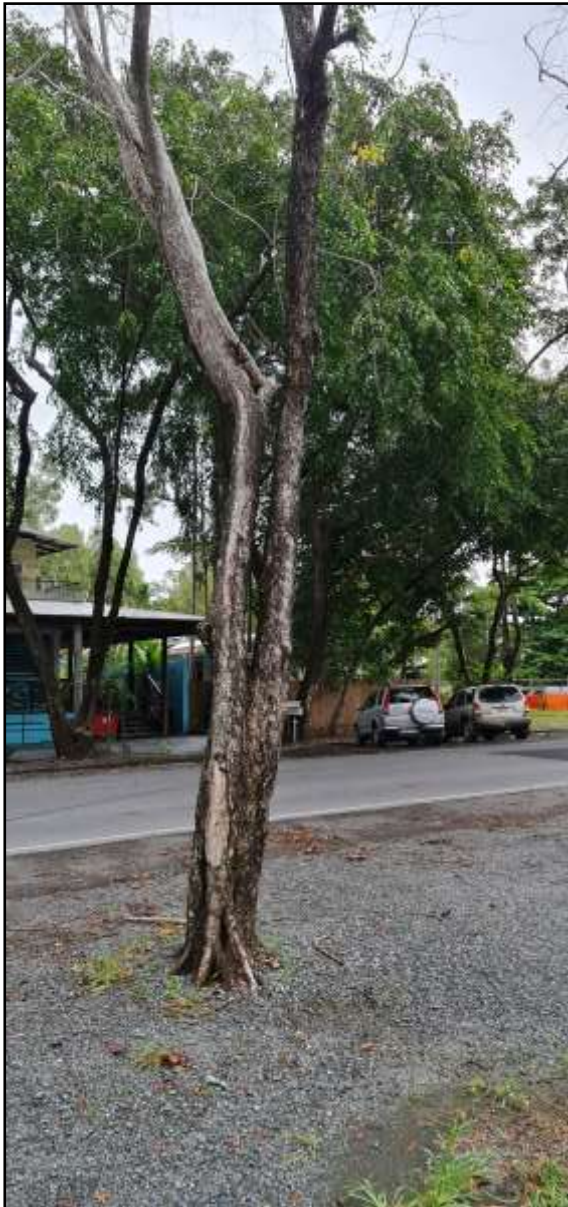
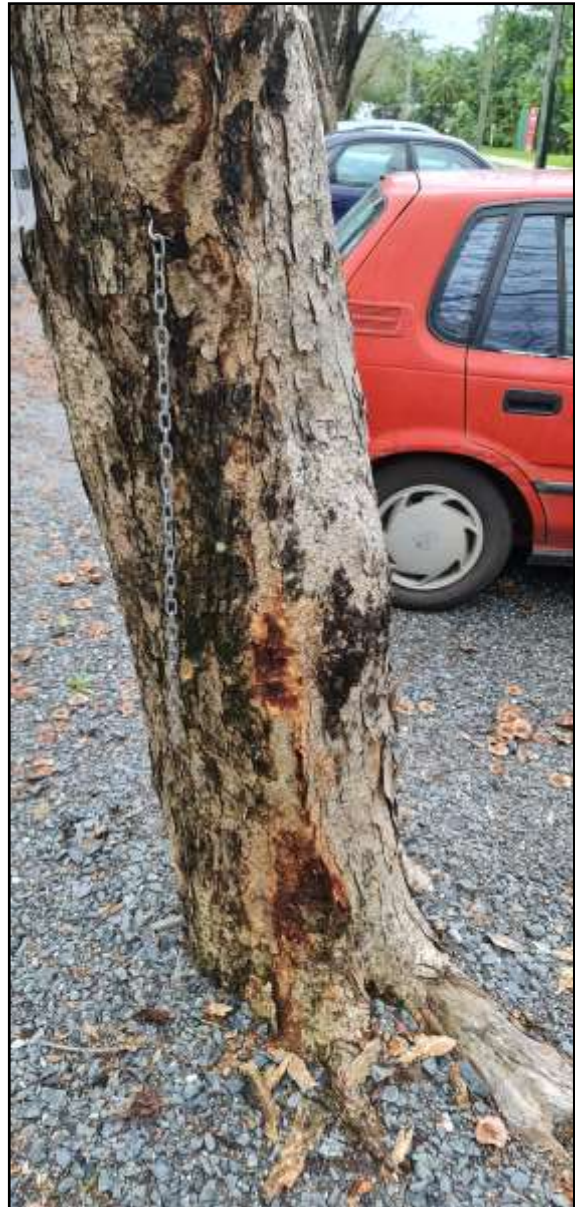
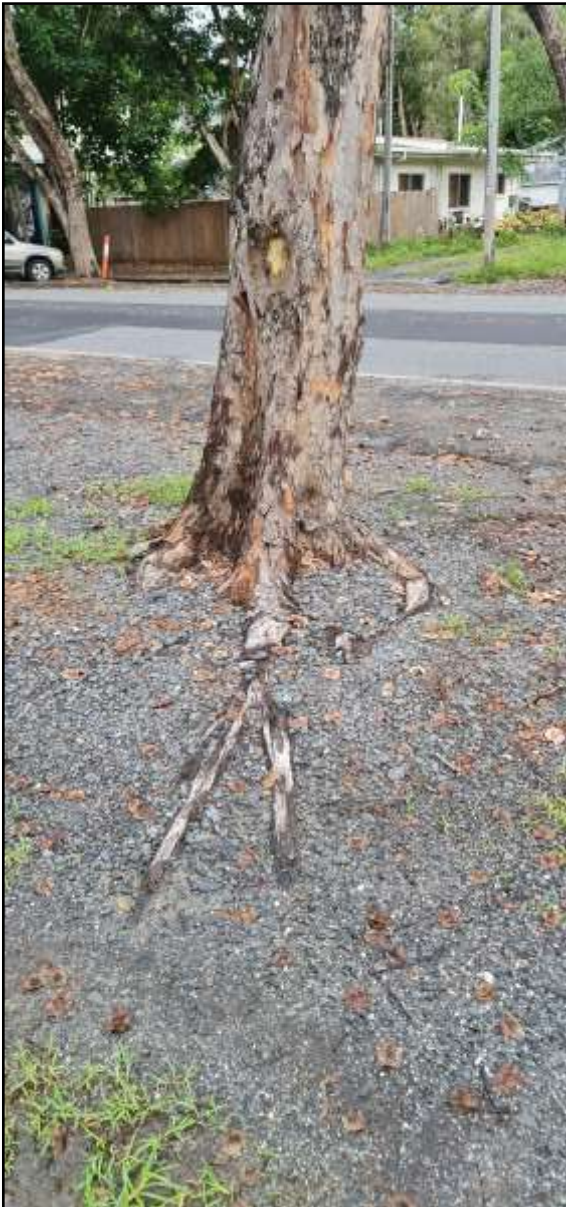
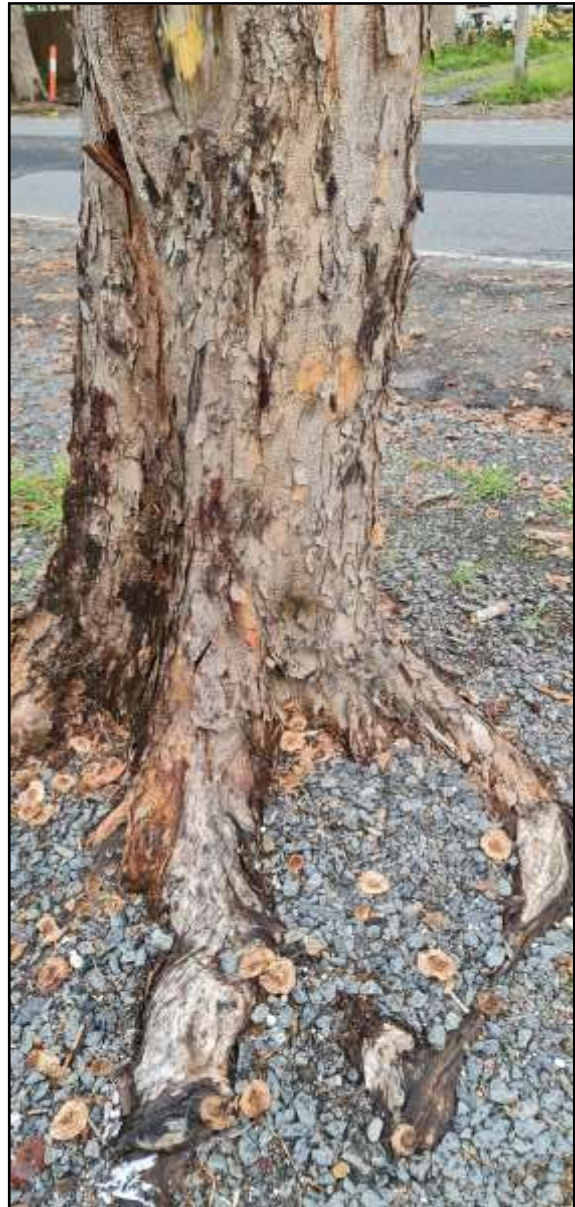
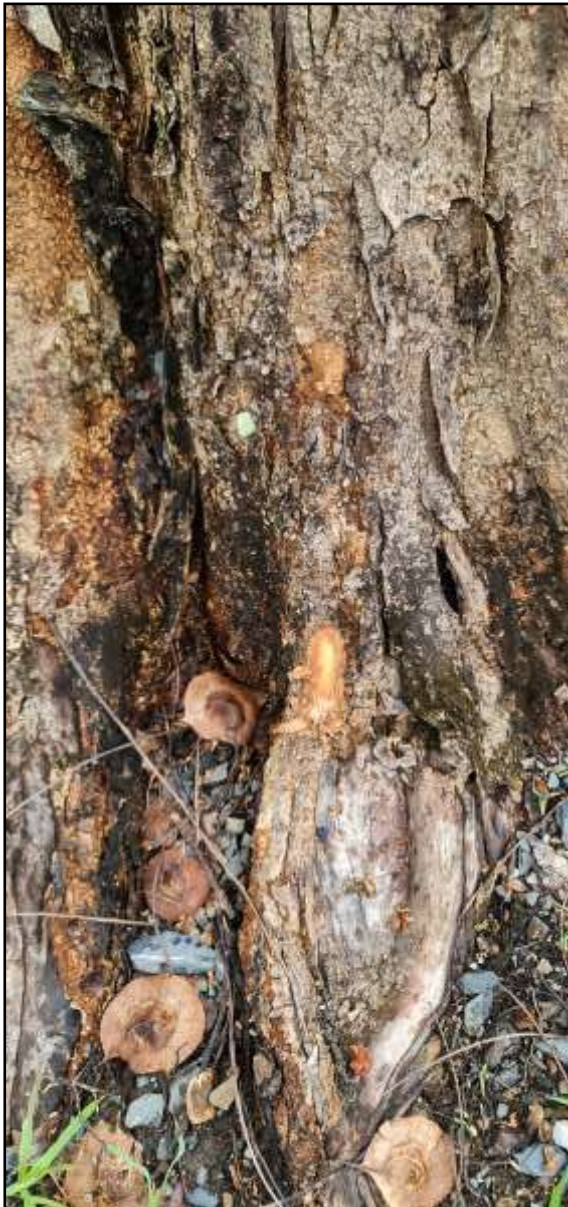
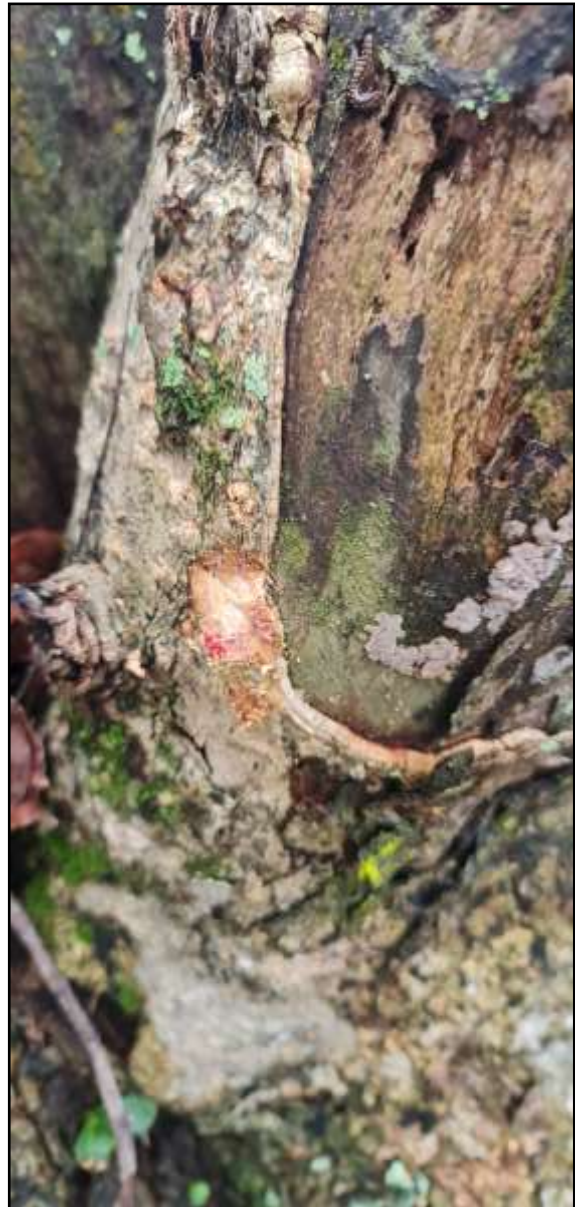
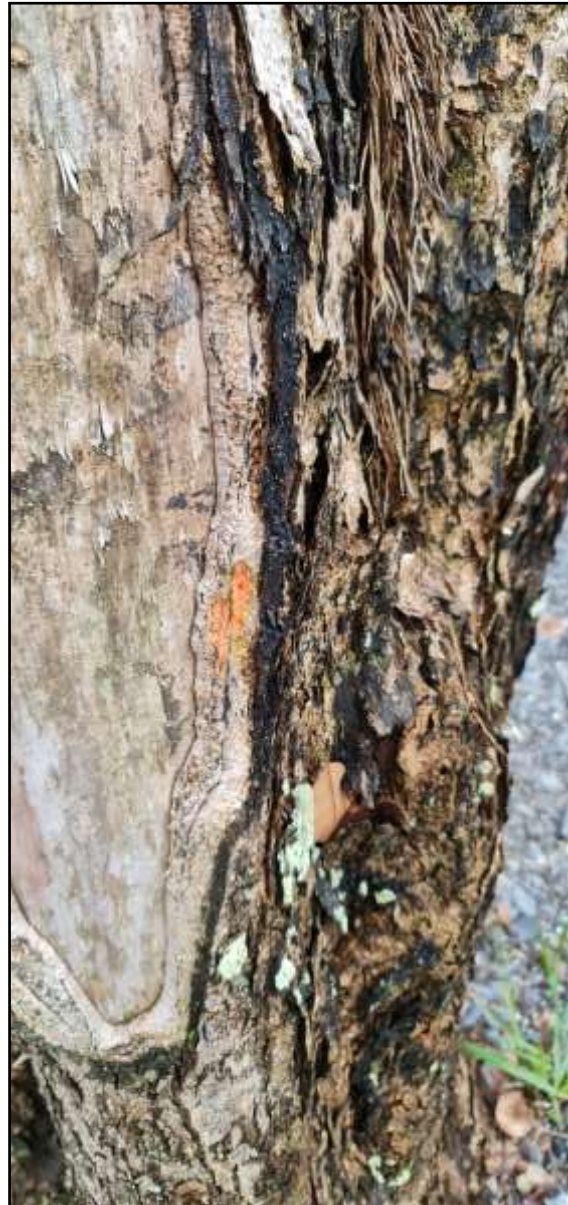
4.1 Photographic Evidence

These trees present typical for the species in form or structure for the location, many of the trees are in a state of stress and decline.

Some deadwood is falling from the canopies of the most advanced in stress.

Many of the root zones have exposed root structures. The tree root zones are unprotected and appear to have vehicle parking and transmission common producing root damage above and below ground, compaction is also severe.

Machinery or vehicle damage to trunk areas is also evident indicating the close proximity of compaction to root zone.

On inspection I chose six of these trees at random, trees that appeared negative in leaf count and very distressed, yet none of these trees have hydraulic failure and all presented well with good sap flow. (See attached photos)

We recommend deadwooding and cleaning crowns of all trees, during aerial activities take photo evidence of tip conditions and any sign of shoots.

Aeriate all root zones and treat with antifungal, apply a broad-spectrum fertilizer (Nitrophoska T.E)

Restrict traffic over root zones and monitor weekly branch tips for signs of recovery.
