Central Tree Services

Tree Health and Condition Report

Douglas Shire Council
Warner Street, Port Douglas
6th April 2021

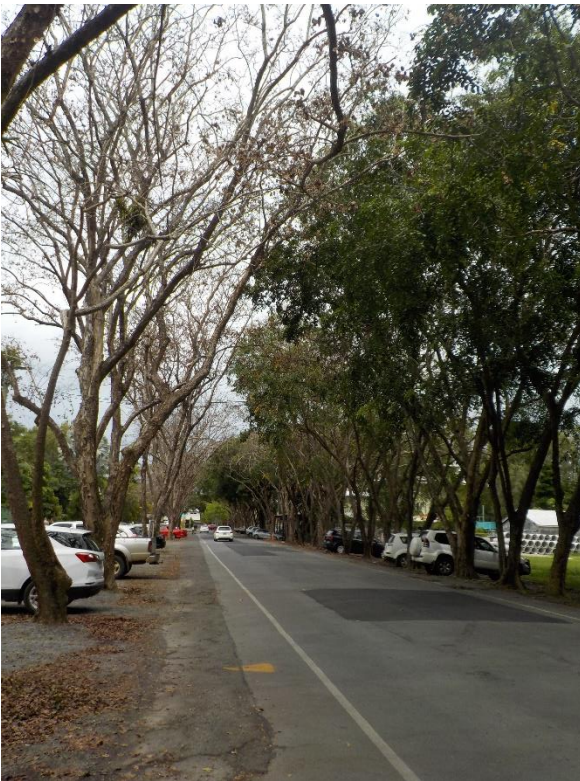
This assessment has confirmed that 22 trees along the eastern side of Warner Street are in a similar or more advanced state of decline (when compared to observations on 18th March), with a total of 12 trees on the western side now affected.

With the exception of a number of trees located within garden beds (corners of Grant and Owen Streets), the entirety of trees along the eastern side displayed advanced symptoms of rapid decline/death. Symptoms were uniform and consistent in nature, indicating an event which has impacted upon all of the affected trees within a short timeframe (see Image 1, below)

Image 1 – Warner Street (6th April). Eastern side of street with 22 trees either dead / in advanced decline, western side of street with 12 trees either dead / showing initial indications of decline

This assessment has confirmed that 22 trees along the eastern side of Warner Street have failed to show signs of recovery, with the number of affected trees along the western side now increasing to 12 in total.

As stated in the previous report, decline of the trees has been rapid and if it is the case that this is due to herbicide application, the observed affects are likely to be terminal. The precise details of herbicide used can only be accurately confirmed via laboratory analysis.

- Implement plans to remove trees which have been confirmed as being completely physiologically dead. As an example, trees located between 32-38 Warner Street would meet requirements for this category, having advanced (unstable) deadwood present.
- Closely monitor all trees for any further signs of decline.
- As before, once individual trees have been confirmed as being dead, prioritise removal. This is particularly important given species characteristics - Rosewood trees typically have highly unstable deadwood.
