Central Tree Services

Tree Health and Condition Report

**Douglas Shire Council
Warner Street, Port Douglas**

14th October 2021

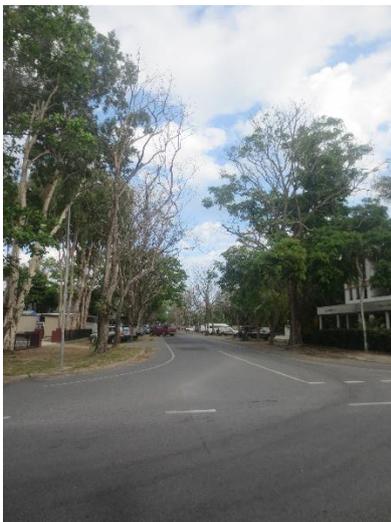
Recent rapid dieback of almost half the trees within the avenue has significantly reduced the current level of amenity – see Image 1, below.

Image 1 – Warner Street (corner Owen Street looking towards Grant Street)

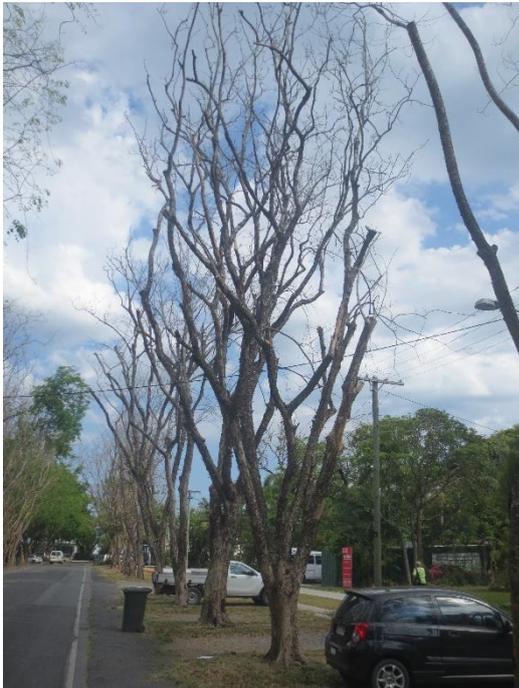
13	Poor form. In advanced decline. Recent removal of deadwood. Some marginal foliage present mid-crown.	Monitor and remove deadwood as appropriate.
14	In advanced decline, significant dieback and vascular dysfunction throughout. Recent heavy reduction and removal of deadwood.	Remove.
15	In advanced decline, significant dieback and vascular dysfunction throughout. Recent reduction and removal of deadwood.	Monitor and remove deadwood as appropriate. Unlikely to be suitable for longer term retention. Advise removal.
16	Poor form. In advanced decline, significant dieback throughout. Recent removal of deadwood.	Monitor and remove deadwood as appropriate. Unlikely to be suitable for longer term retention. Advise removal.

Image 2 – Tree 14 (14th October 2021). Extensive dieback, tree in advanced decline. A large section of the eastern side of Warner Street can also be seen, with trees displaying similar symptoms.

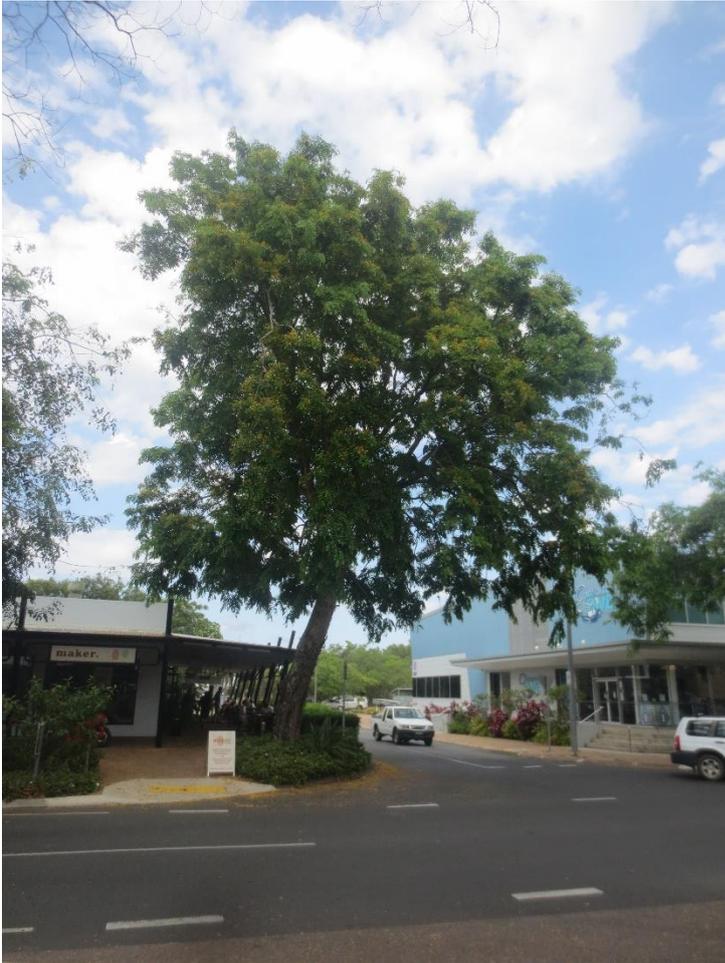
Image 3 – Tree 29 (14th October 2021). Tree is showing typical foliage and vigour for time of year, species, age and location. This typically healthy tree can be seen in stark contrast to the remainder of trees assessed along Warner Street.
