TREE ASSESSMENT REPORT

Consulting Arborist Report for Tree Health & Risk Management

Report Prepared By: John Madderom – Consulting Arborist – Diploma of Arboriculture
Report Commissioned By: Douglas Shire Council - Peter Logan
Subject Site: Warner Street, Port Douglas
Date of Assessment: 22 October 2021
Date of Report: 18 October 2021

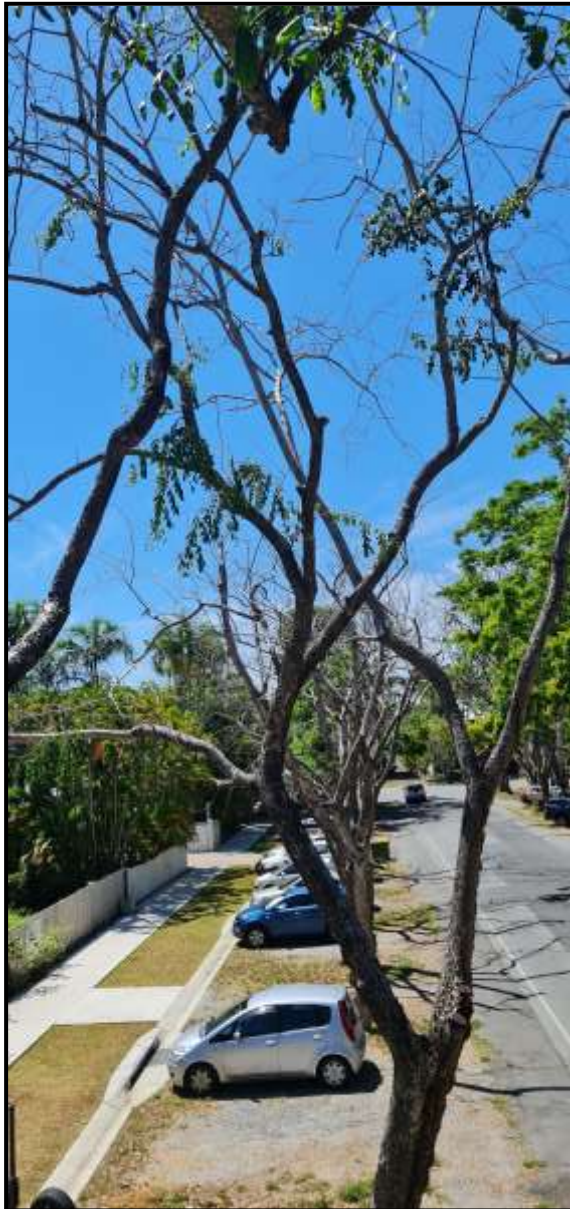
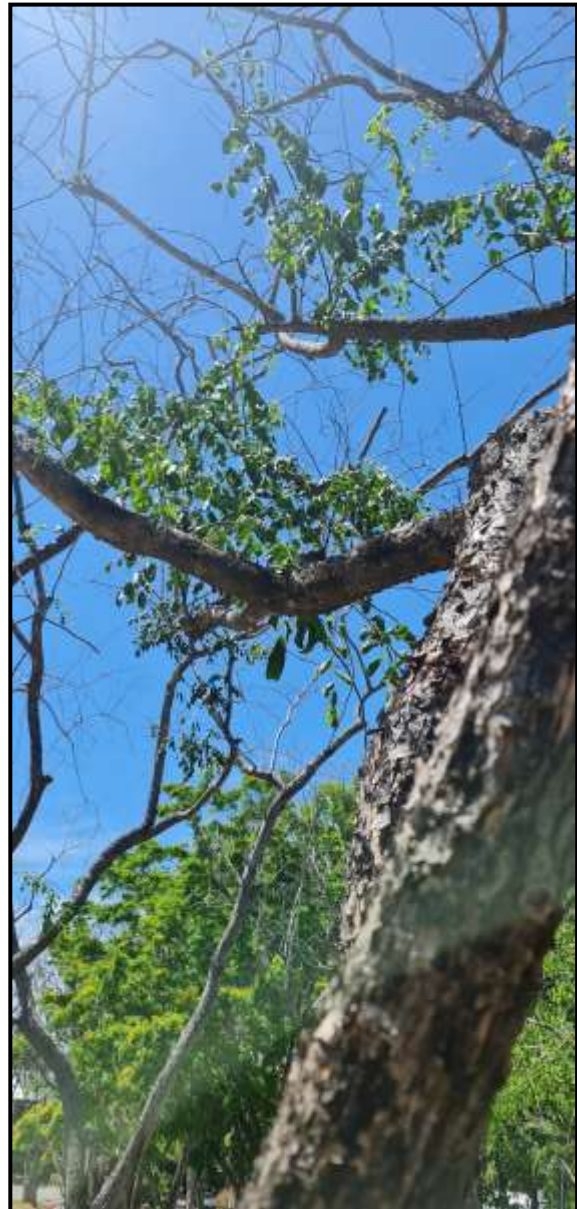
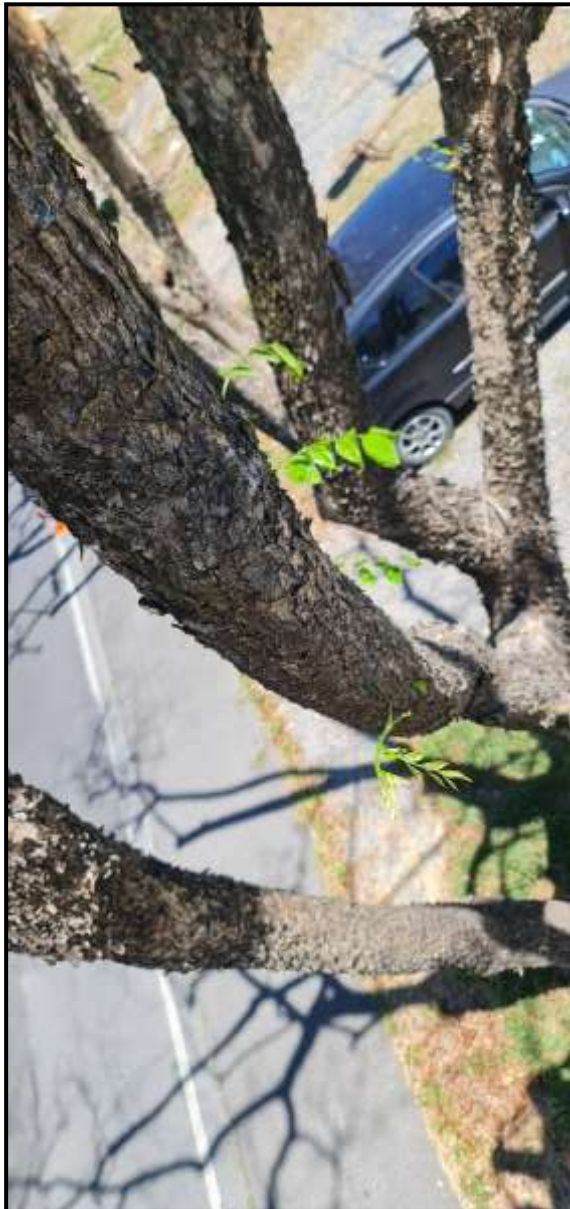
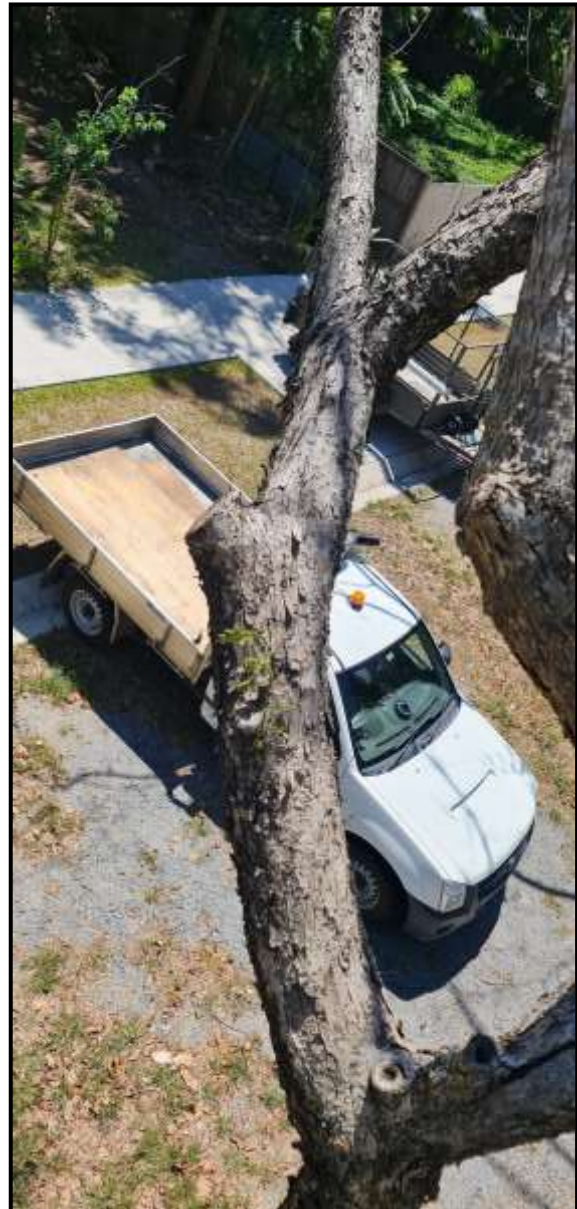
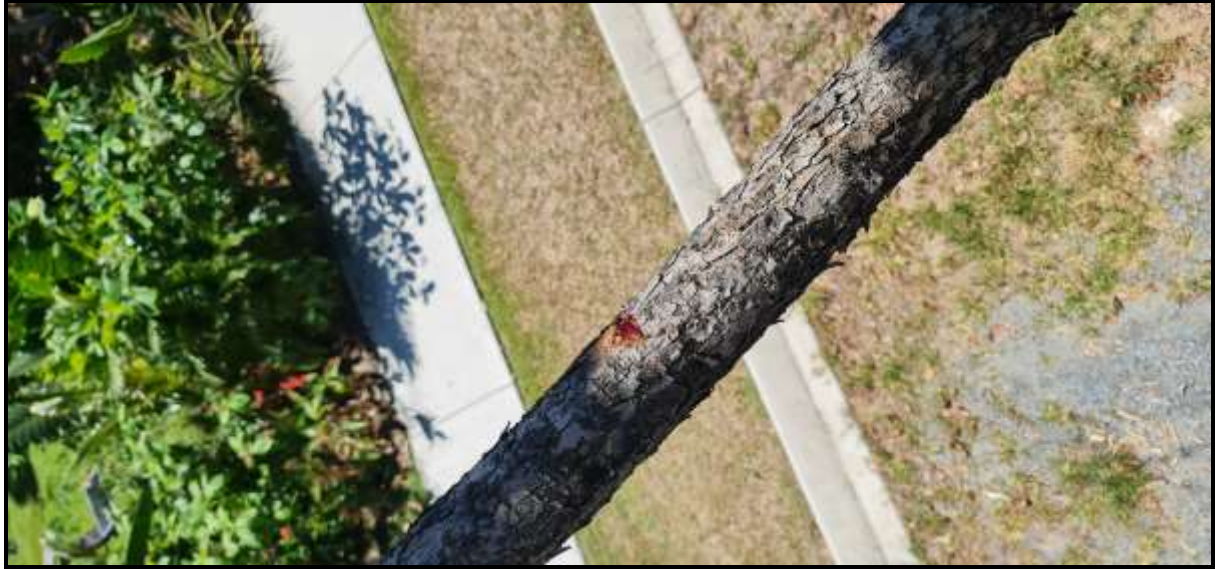
4.1 Photographic Evidence

We inspected the effected (Poisoned) trees on Monday 18/10/2021.

All tree again showed sap flow at the base, however on an Ariel inspection it is evident the sap flow has diminished in a larger percentage of the canopies.

The result is disappointing and likely affected by the present dry and obviously the herbicide incident.

That aside, we are able to work with the tree that have signs of regeneration.

Our recommendation is to remove approximately four trees marked with four blue dots on the footpath side of the trunk.

The remaining trees will need the canopy structure delicately reduced to the point of sap flow; this is generally 40-60 percent.

During the reduction process it is absolutely imperative to not knock the new regenerating shoots off the retained wood. In some areas these shoots are 20-50ml.

The contractor must have a minimum Level 5 Arborist supervising this process. All finished cuts must have angle to them and work along AAAS4709 guidelines

We also recommend a light application of Nitrophoska T.E slow release granules.
