Pre-planning Tree Health and Condition Report

Douglas Shire Council

Warner Street Upgrade, Port Douglas

RFQ 2018 - 065

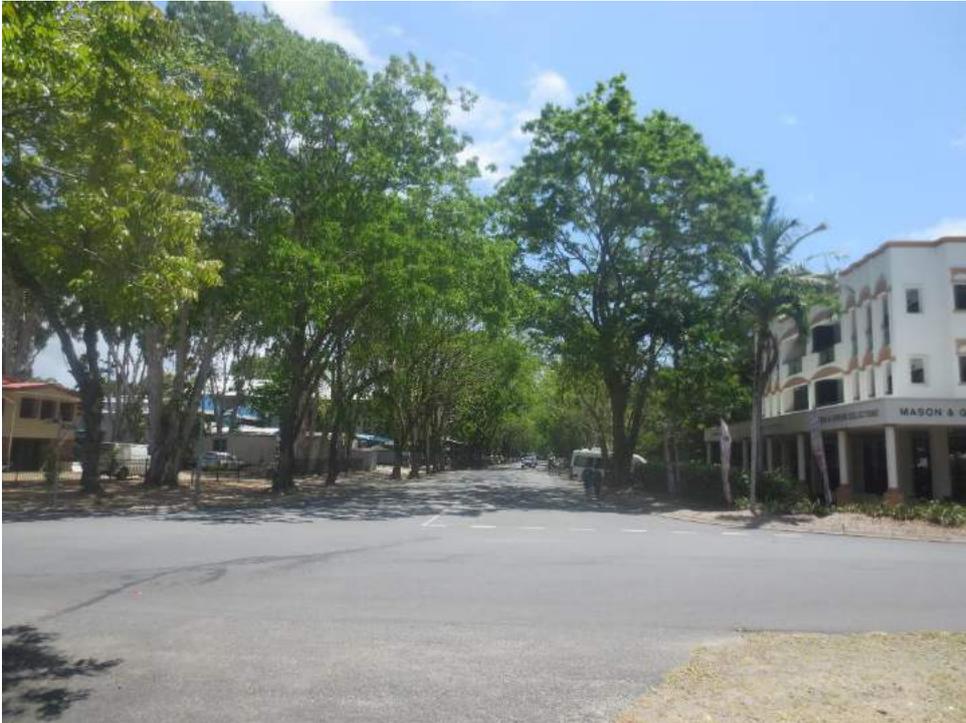
Image 1 – Avenue of Rosewoods along Warner Street

Although individual trees may have poor form and/or rectifiable defects, as an extended group, the overall level of amenity is generally high. In addition to this visual amenity, the trees also currently provide valuable shade and cooling effects during the warmer months.

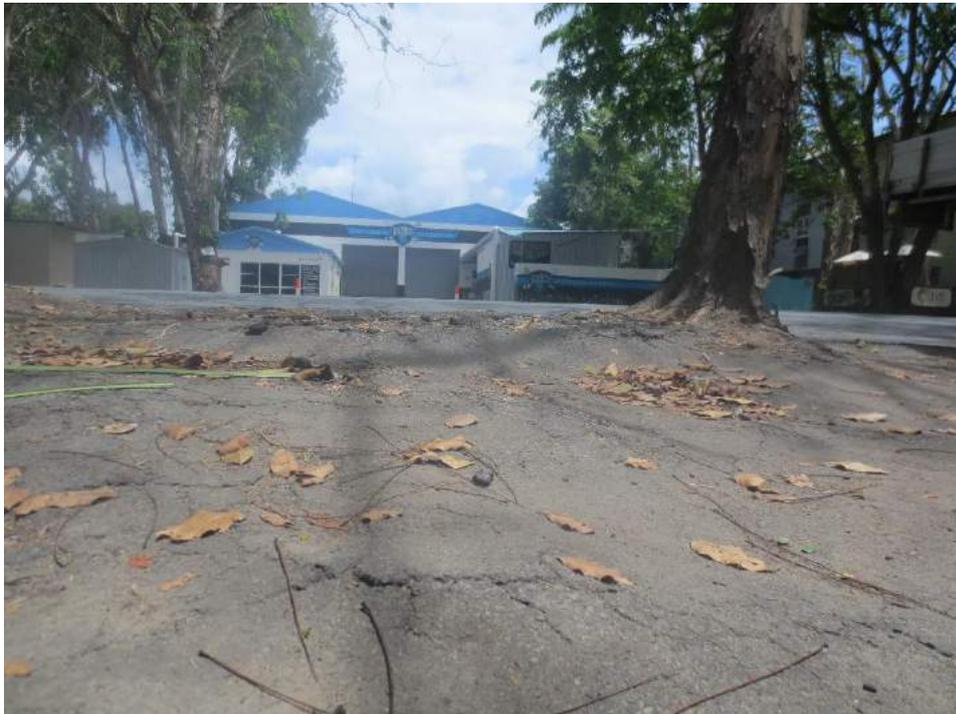
- Significant damage to paved areas throughout Warner Street. Surface roots have caused tarmac to be lifted both within parking areas and the main roadway.
- Surface roots impacting upon driveway and walkway access.
- Surface roots growing in immediate proximity to services access.
- Combined, the above points raise issues over safety and infrastructure reliability.

Image 2 – Impact of surface roots on parking and roadway

If the trees are to be retained in the longer term, a plan must be put in place to allow for surface root protection and possible restriction of further growth (where feasible). A number of trees located at the junction of Warner and Grant streets are a good example of what would ordinarily be expected for Rosewoods in such a location – these trees are currently surrounded by reasonably-sized garden beds which have allowed for the accommodation of most roots up to maturity.

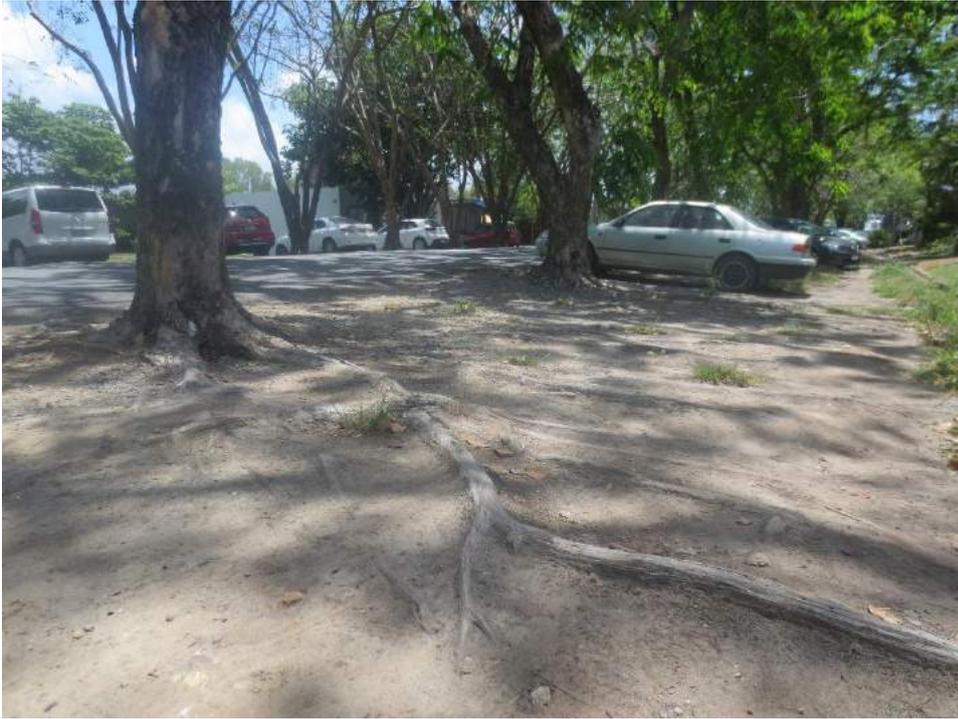
Image 3 – Typical surface roots at Warner Street
