5.11. OLD MOWBRAY RIVER BRIDGE REMOVAL

Attachment 1 - DRAFT- Level Two Structure Inspection Report (part) – Mowbray River Fishing Jetty

Level Two Structure Inspection Report

Structure ID:	188013	Bridge Name:	Mowbray River Fishing Jetty - 2 Span ti
Crossing:	Mowbray River	Road Number:	
Structure Type:	Jetty	Road Name:	Captain Cook Highway
Construction Type:	Girder	Owner:	Douglas Shire Council
Construction Material:	Timber	District:	Mowbray
Inspector:	Mark de Hayr	Local Authority:	DSC
Latitude:	-16.552986	Longitude:	145.481806
Inspection Date:	1/02/2016	Max Height (M)	3
Next Inspection Date:	1/02/2017	Width (M)	5.8
Total Length (M)	16.8	Bearing - AP1-AP2	West
Carriageway		Load Limit	
Footway		Status	Decommissioned
Chainage (Km)		From	To

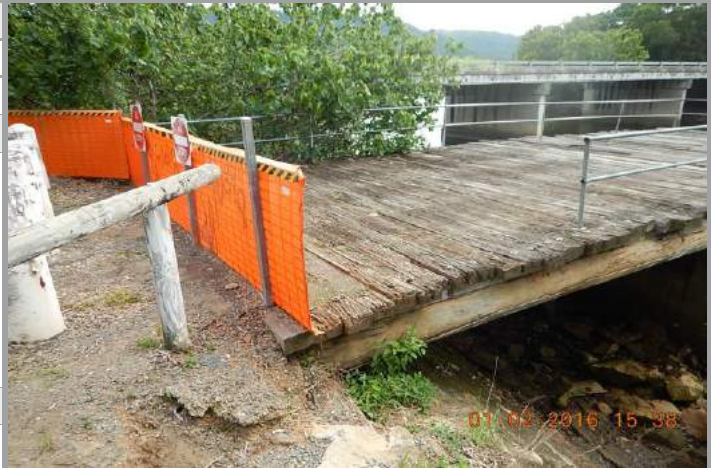
Modification:	Group:	Standard Number:	Component:
O	AP1	700	AP
ID:	DSCN4193.JPG	Inspection Date:	1/02/2016

Description:
Approach one

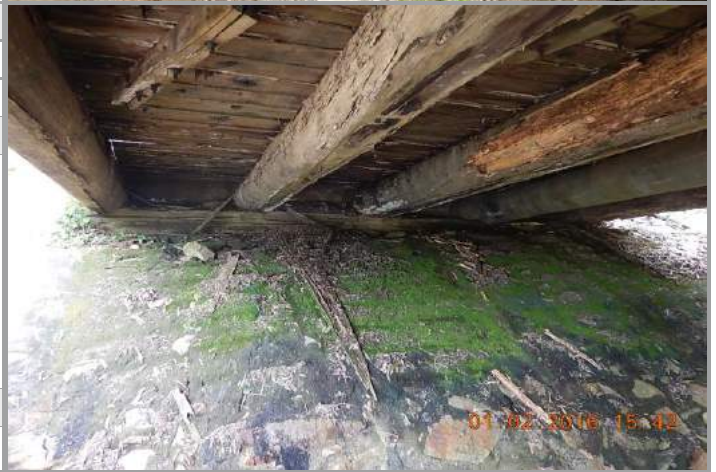
Modification:	Group:	Standard Number:	Component:
O	A1	50C	A
ID:	DSCN4201.JPG	Inspection Date:	1/02/2016

Description:
Abutment One

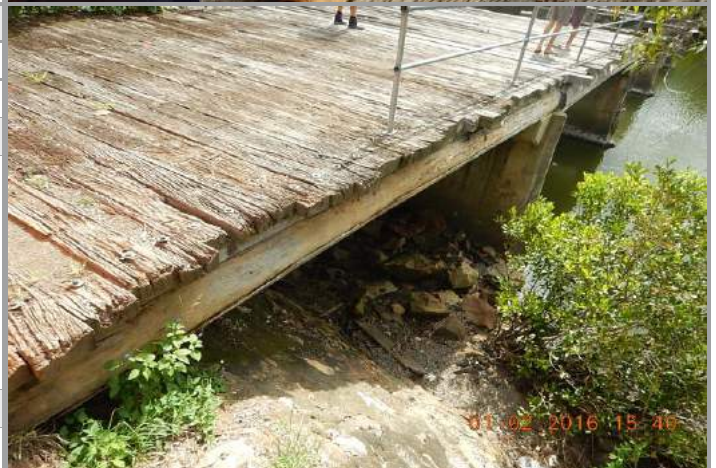
Modification:	Group:	Standard Number:	Component:
O	S1	2S	BR
ID:	DSCN4198.JPG	Inspection Date:	1/02/2016

Description:
RHS View

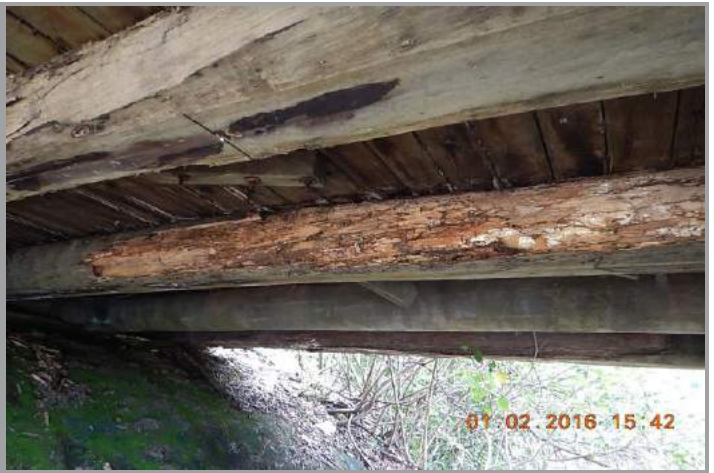
Modification:	Group:	Standard Number:	Component:
O	S1	22T	G
ID:	DSCN4202.JPG	Inspection Date:	1/02/2016

Description:
Detail of severe rot in Span One Girders

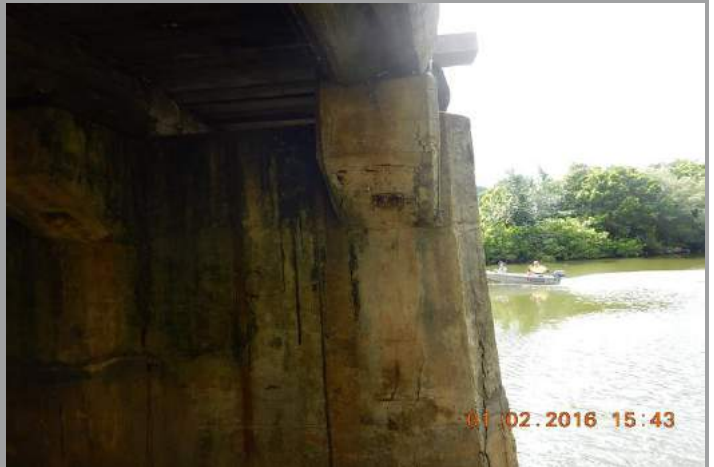
Modification:	Group:	Standard Number:	Component:
O	P1	58C	PW
ID:	DSCN4205.JPG	Inspection Date:	1/02/2016

O	S1	BR	2S	4	16.8	Lin m	0	13.8	3	0	<input type="checkbox"/>	Steel Tube Post with Two Rail Pedestrian Barrier is in Fair Condition. The first section on the RHS has been removed allowing free access onto the structure past the barrier across the front of the structure. This type of barrier is ineffective over water as it does not restrict small children or infants. [See Photo] - DSCN4198.JPG
O	S1	G	22T	4	5	Each	0	0	1	4	<input type="checkbox"/>	Locally sourced round timber girders. Girders 1,3,4&5 are in CS4 due to extreme surface rot and loss of section. Girder 2 has been classified as CS3. [See Photo] - DSCN4202.JPG
O	P1	PW	58C	4	25	m2	0	0	0	25	<input type="checkbox"/>	Cast in Situ Pier Walls are in Poor condition. There are numerous patches of severe spalling and exposed sections of reinforcement. The exposed reinforcement has severe sections of scaly rust and corrosion and complete loss of section in some instances. It is not known if there are Piles in addition beneath the pier wall. [See Photo] - DSCN4197.JPG, DSCN4203.JPG, DSCN4204.JPG, DSCN4205.JPG

Description:
Detail of Severe Spalling and exposed reinforcement in Pier One Face One

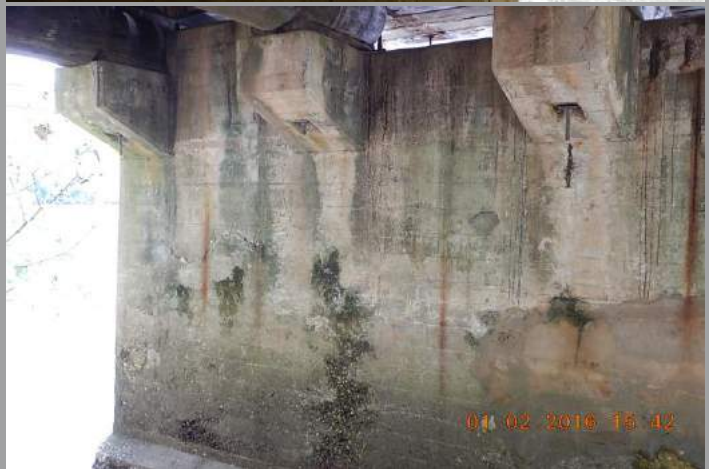
Modification:	Group:	Standard Number:	Component:
O	P1	58C	PW
ID:	DSCN4204.JPG	Inspection Date:	1/02/2016

Description:
Detail of Severe Spalling and exposed reinforcement in Pier One Face One

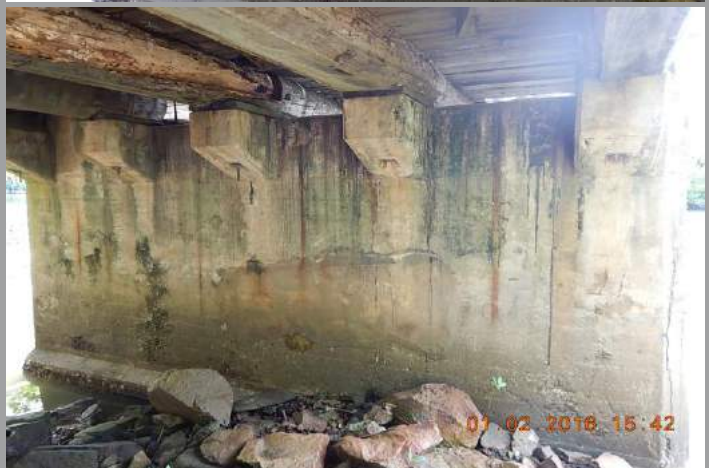
Modification:	Group:	Standard Number:	Component:
O	P1	58C	PW
ID:	DSCN4203.JPG	Inspection Date:	1/02/2016

Description:
Pier One Face One

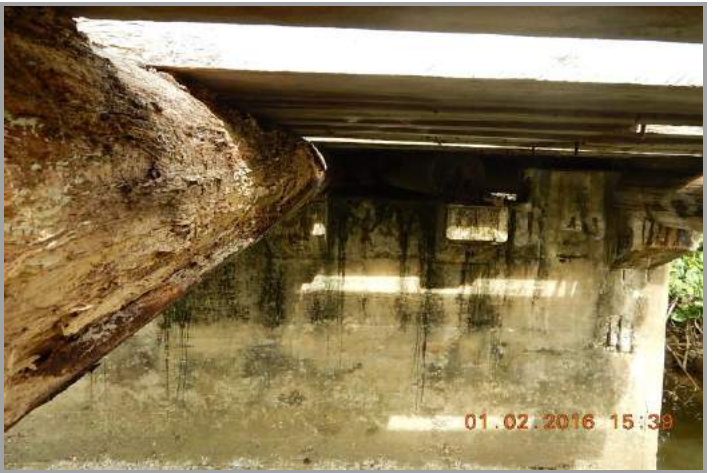
Modification:	Group:	Standard Number:	Component:
O	P1	58C	PW
ID:	DSCN4197.JPG		Inspection Date
			1/02/2016
Description:			
Detail of Severe Spalling and exposed reinforcement in Pier One face Two RHS

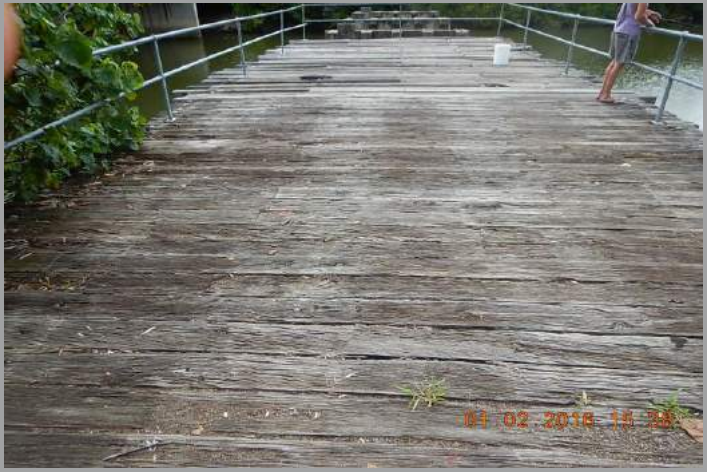
O	S2	D	29T	4	49	m2	0	0	20	29	<input type="checkbox"/>	100mm x 200mm hardwood deck planks are in poor condition with severe splitting and rotting Some planks have already fallen into the river and the deck is currently unsafe for pedestrian traffic. [See Photo] - DSCN4195.JPG
O	S2	BR	2S	4	22.6	Lin m	0	22.6		0	<input type="checkbox"/>	Steel Tube Post with Two Rail Pedestrian Barrier is in Fair Condition. This type of barrier is ineffective over water as it does not restrict small children or infants.

Modification:	Group:	Standard Number:	Component:
O	S2	29T	D
ID:	DSCN4195.JPG		Inspection Date
			1/02/2016
Description:			
General View of Deck from Approach one

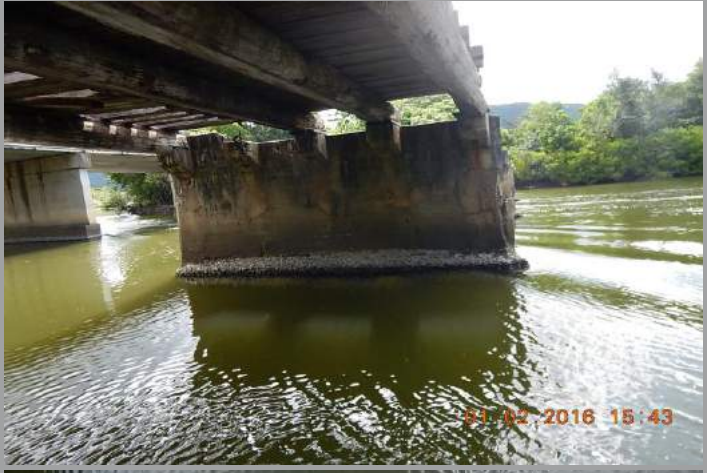
O	S2	G	22T	4	5	Each	0	0	1	4	<input type="checkbox"/>	Locally sourced round timber girders. Girders 1,3,4&5 are in CS4 due to extreme surface rot and loss of section. Girder 2 has been classified as CS3.
O	P2	PW	58C	4	25	m2	0	0	0	25	<input type="checkbox"/>	Cast in Situ Pier Walls are in Poor condition. There are numerous patches of severe spalling and exposed sections of reinforcement. The exposed reinforcement has severe sections of scaly rust and corrosion and complete loss of section in some instances. It is not known if there are Piles in addition beneath the pier wall. [See Photo] - DSCN4196.JPG, DSCN4206.JPG

Modification:	Group:	Standard Number:	Component:
O	P2	58C	PW
ID:	DSCN4206.JPG		Inspection Date
			1/02/2016
Description:			
Detail of Severe Spalling and exposed reinforcement in Pier Two Face One

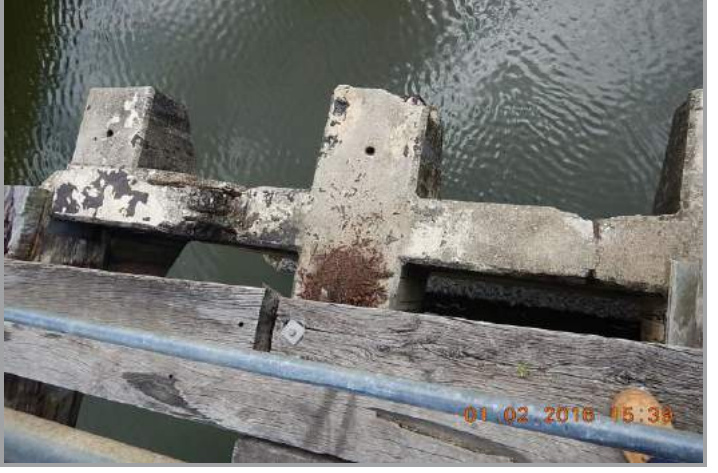
Modification:	Group:	Standard Number:	Component:
O	P2	58C	PW
ID:	DSCN4196.JPG		Inspection Date
			1/02/2016
Description:			
Detail of Severe Spalling and exposed reinforcement in Pier Two
