## **5.5. 'STAGE' STRUCTURE - 69R TEA TREE RD, DIWAN - REPAIR OR DEMOLITION**

**Our ref:** 51-2016/DSC19052016EIR

Subject      Engineering Inspection – Alexandra Bay Recreation Club.  
                Vacant structure at 69R Tea Tree Rd, Diwan.

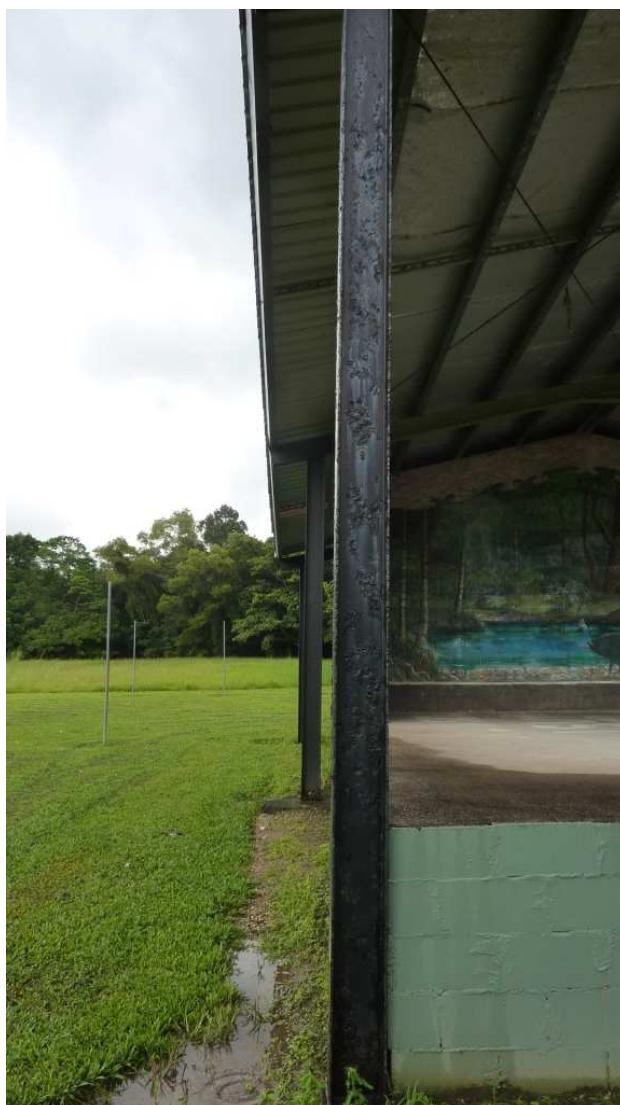
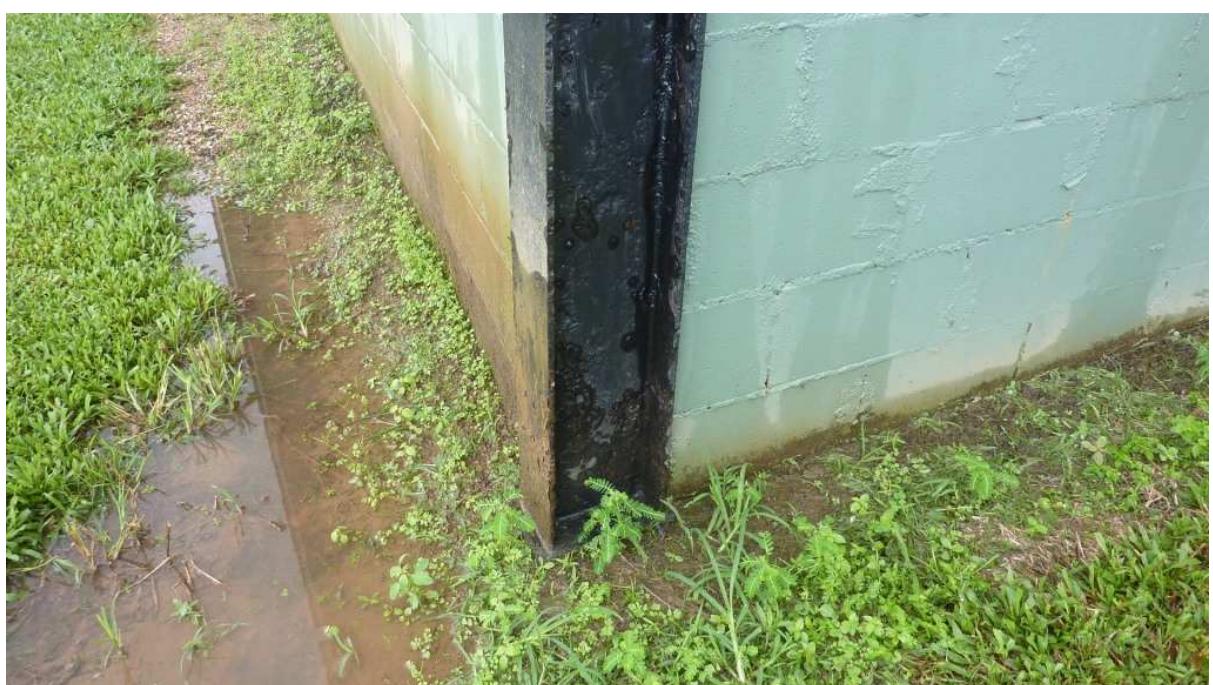
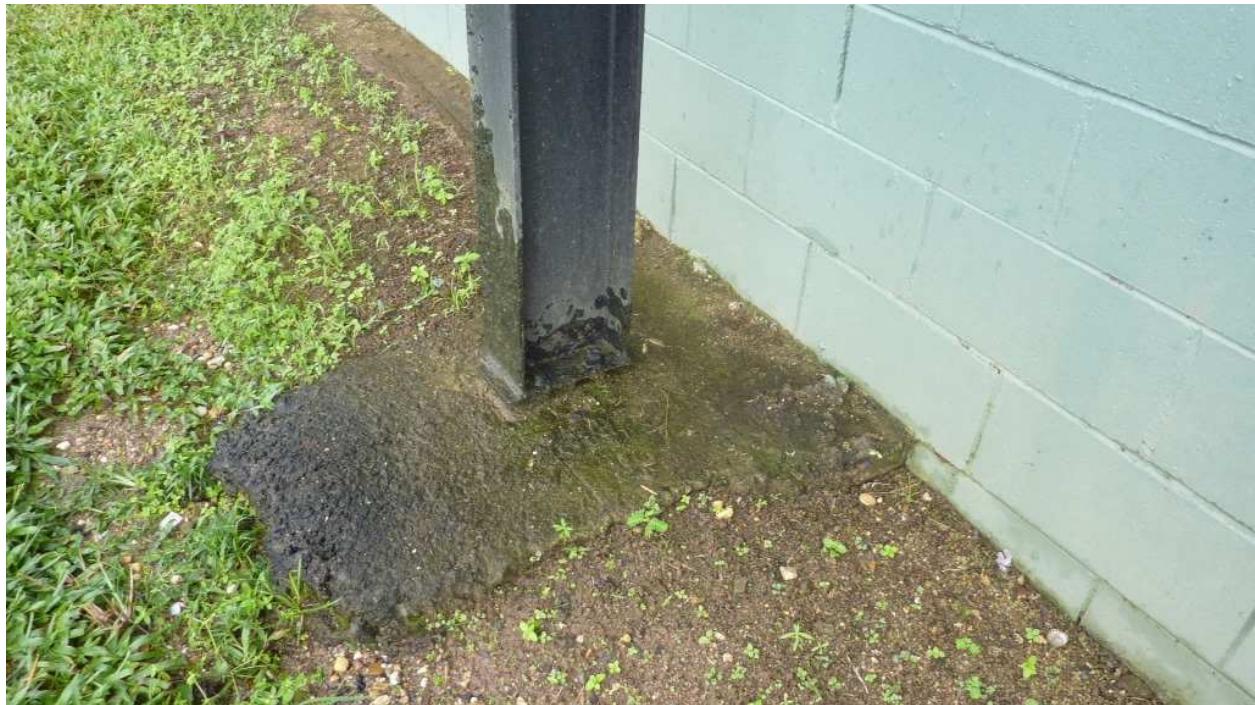
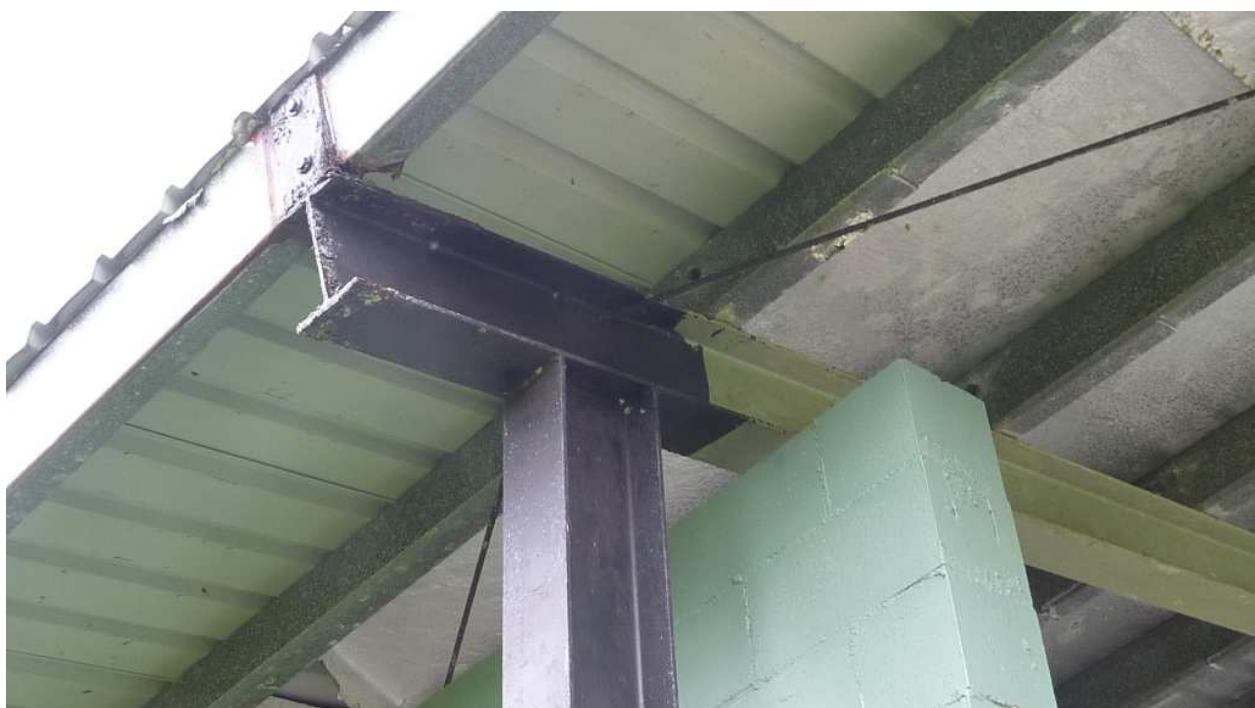
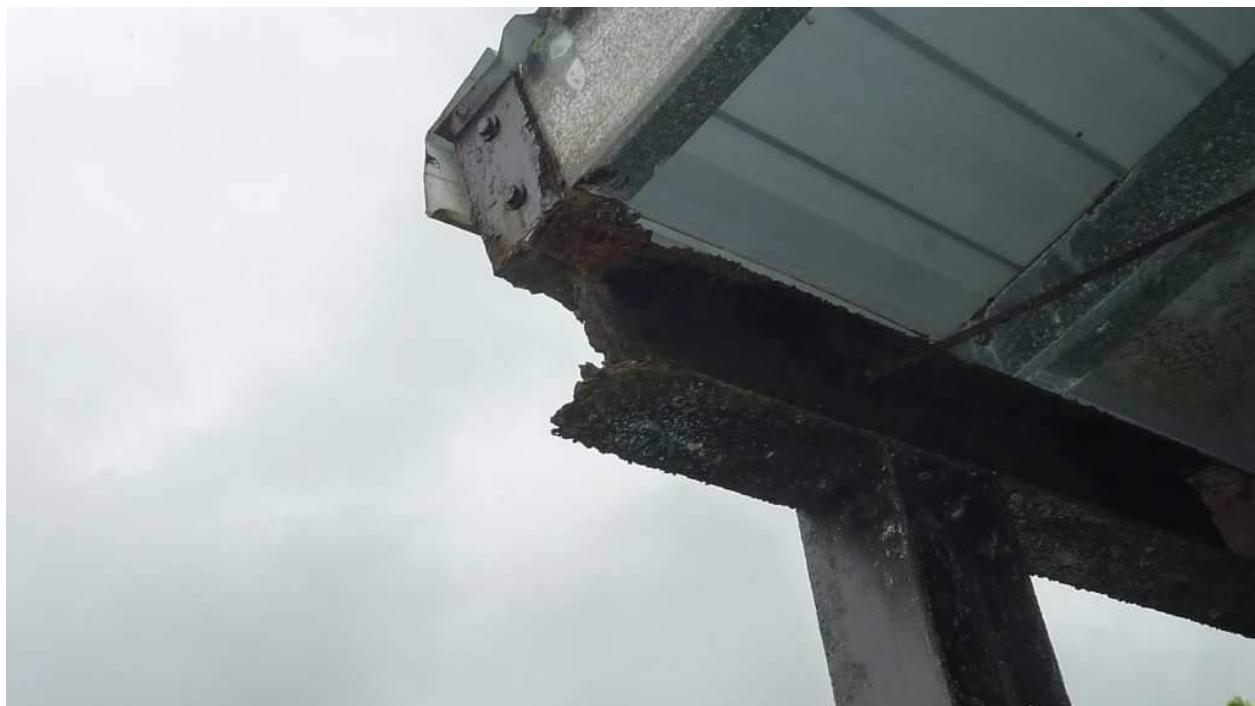
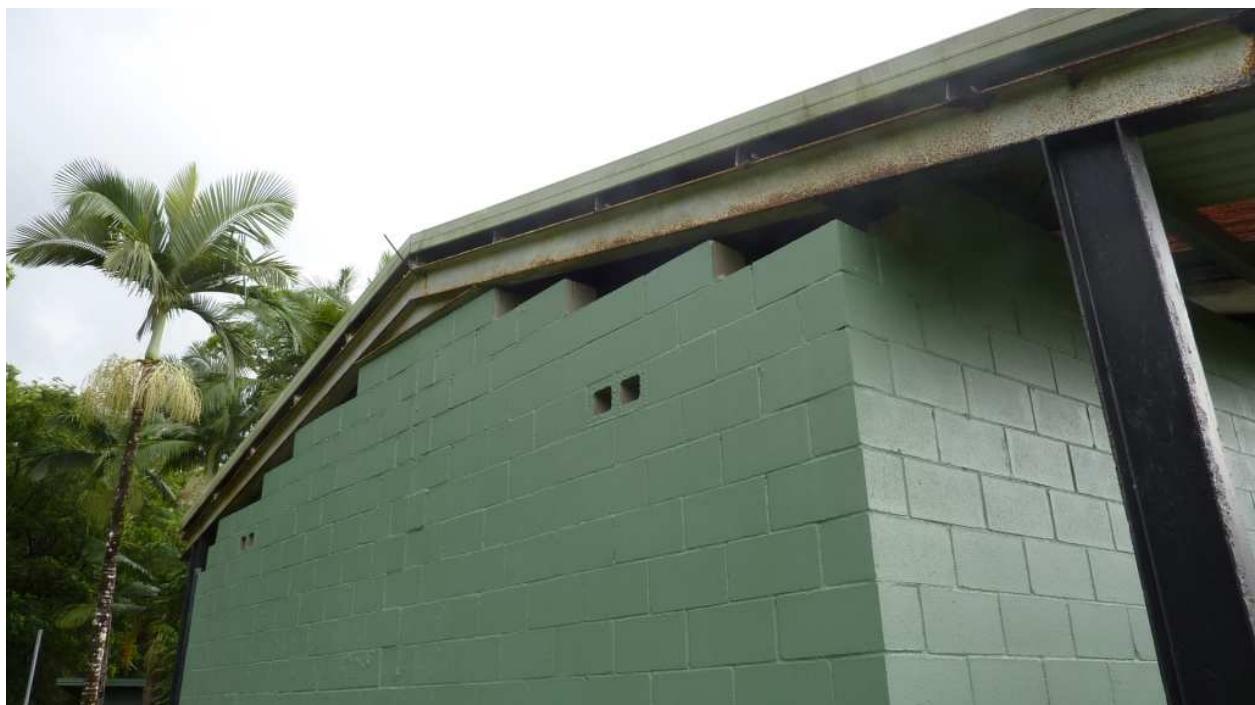
- Extensive corrosion is evident in the majority of steel members in the structure.
- There is a significant 'pitting' and overall loss of thickness from the steel columns.
- The steel corrosion has been treated in the past by removing rust and applying a paint protective coating without reinstating steel thickness.
- Column base plates and fixings are extensively corroded.
- There are no cracks evident in the masonry walls.
- Corrosion is evident in most roof cleats and brace rods.
- Roof purlins and bracing are in reasonable condition.
- The building footings and masonry walls are in reasonable condition
- Building floors are reasonably level and no substantial cracking is evident.
- No subsidence or swelling is evident in building foundations
- Roof sheeting was not inspected.

As the masonry cladding and footings are in reasonable condition the main area of remediation will be the superstructure steel frame.

- As a short term solution remedial options 1 or 2 could be considered however the labour and material component is unlikely to be cost effective.
- Supply and install new steel columns and beams with appropriate protective coating.
- Core fill and reinforce masonry walls if loads are to be fixed.
