5.10. RISK ASSESSMENT DAINTREE RIVER FERRY PRECINCT

RISK ASSESSMENT REPORT - Daintree Ferry Precinct Douglas Shire Council	Document No.: QSG17-027	Version No.: 2A
Release Date: 10 April 2017	Ordinary Council Meeting - 26 April 2017	Page 18 of 33

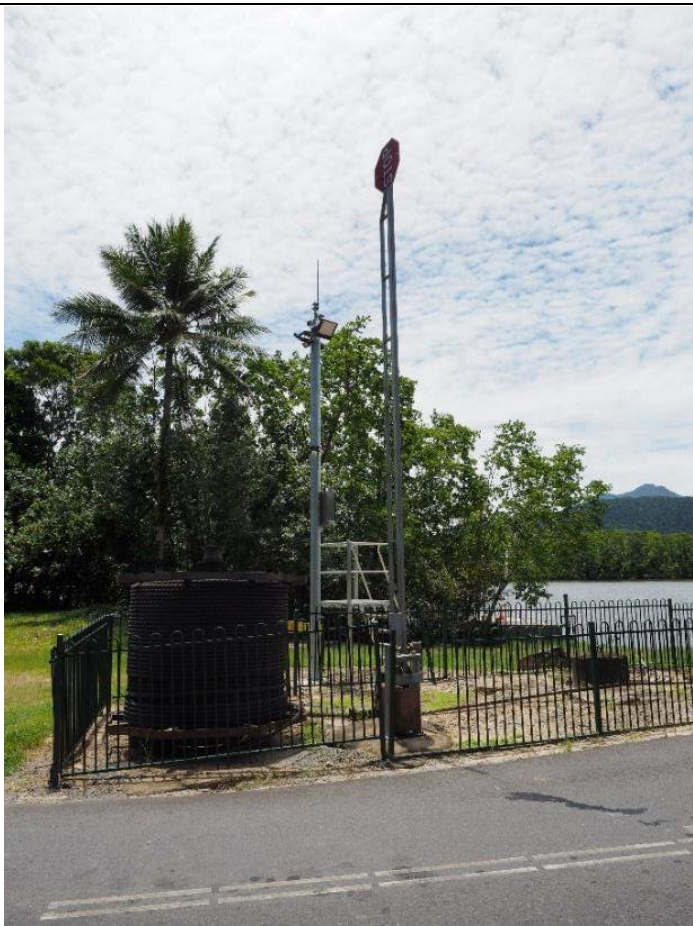
<p><u>Boom gate located on the Western Side of road on Southern Bank</u></p> <p>Issues increasing Risk Exposure</p> <ul style="list-style-type: none"> • Pool Type fencing surrounding Boom gate and Cable Storage is a significantly poor state of repair (gaps, sharp edges, rusty) • Fence is not effective in controlling unplanned human (passenger/tourist/other) interaction with either the Boom gate or the Cable Storage • Uneven unkept ground within fenced area

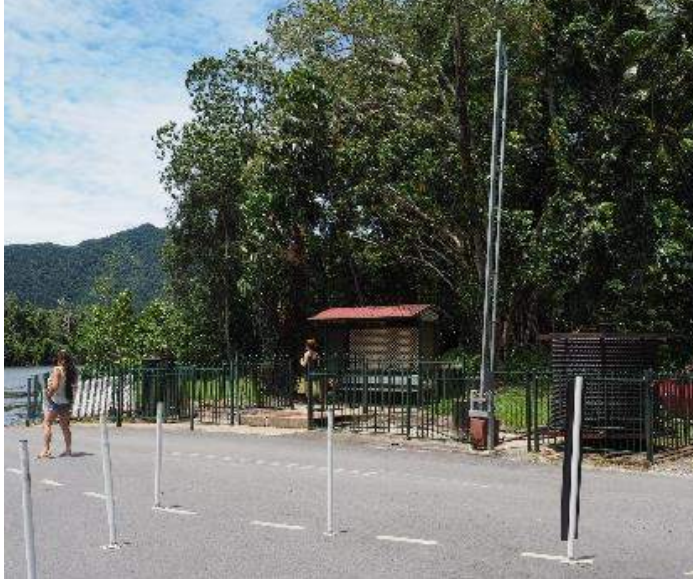
<p><u>Boom gate located on the Eastern Side of road on Southern Bank</u></p> <p>Issues increasing Risk Exposure</p> <ul style="list-style-type: none"> • Pool Type fencing surrounding Boom gate and Cable Storage is a significantly poor state of repair (gaps, sharp edges, rusty) • Fence is not effective in controlling unplanned human (passenger/tourist/other) interaction with either the Boom gate or the Cable Storage • Large gaps in fence with temporary measures such as ramps across the gaps • No Controls/Barriers preventing people walking on the roadway (as shown in picture)

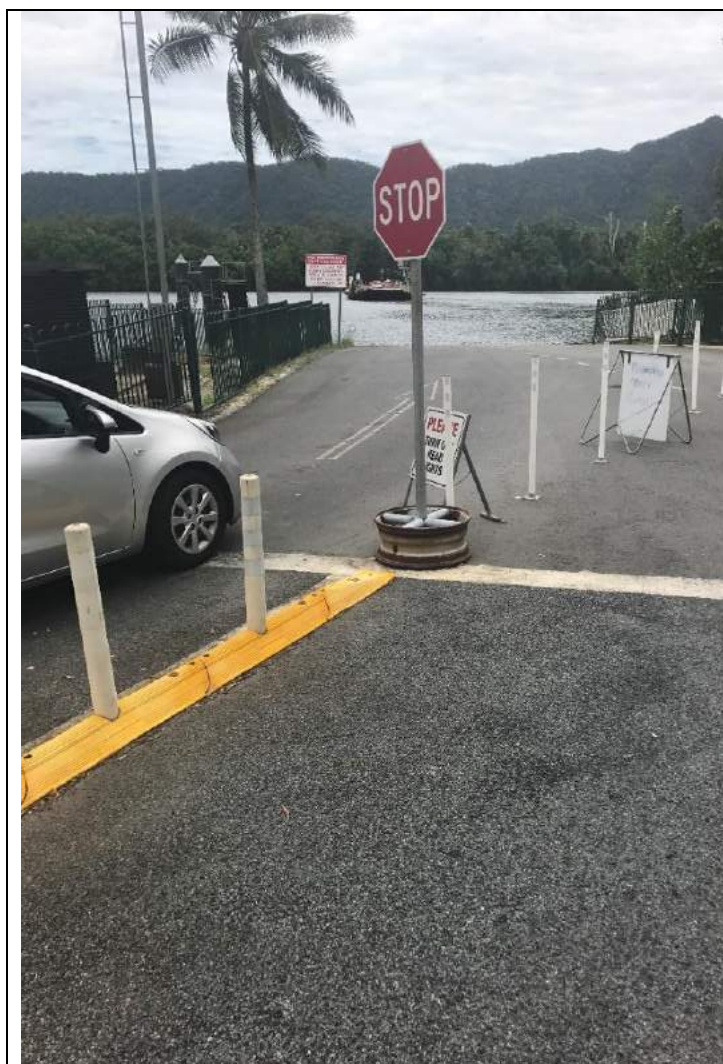
Issues increasing Risk Exposure

- Stop Sign is only administrative measure there is no physical control (barrier or boom gate) to control traffic movement prior to the arrival of the Ferry
- No controls in place to stop Human and Vehicle interaction
- No Staff present in this location to ensure compliance of vehicles.

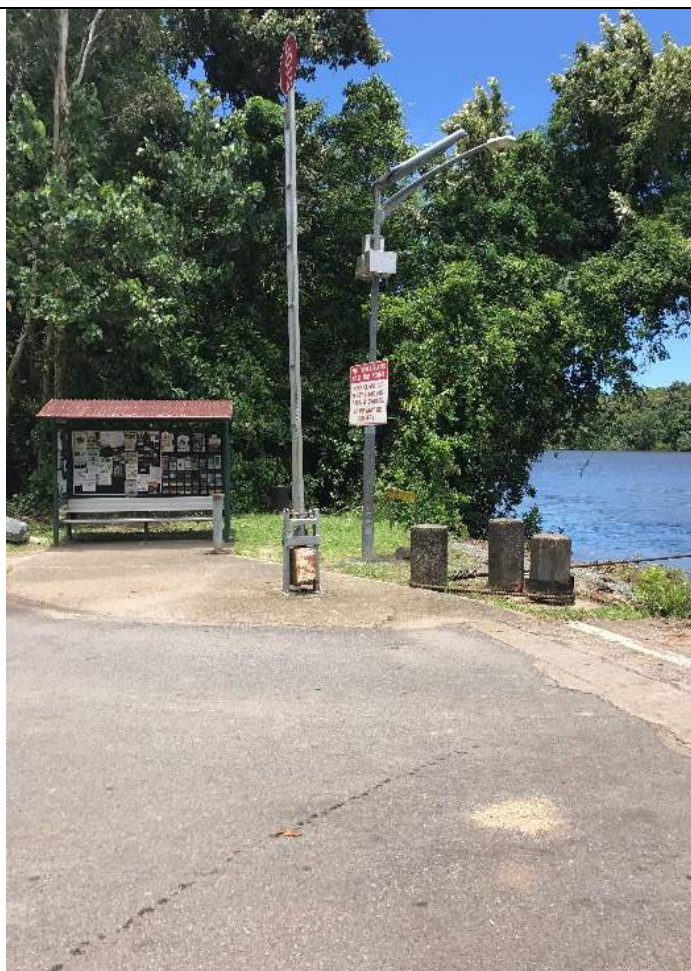
Issues increasing Risk Exposure

- No Physical controls preventing unplanned interaction with Boom gate
- No fencing or separation of humans and vehicles
- No controls preventing human interaction with cable
- No Controls prevent humans falling into water

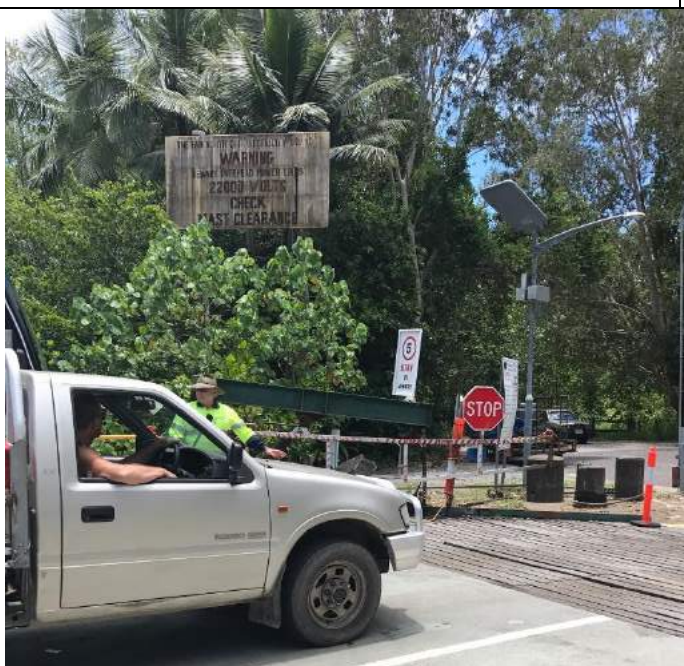
Boom gate located on the Western Side of road on Northern Bank

Issues increasing Risk Exposure

- No Physical controls preventing unplanned interaction with Boom gate
- No fencing or separation of humans and vehicles
- No controls preventing human interaction with cable
- No Controls prevent humans falling into water

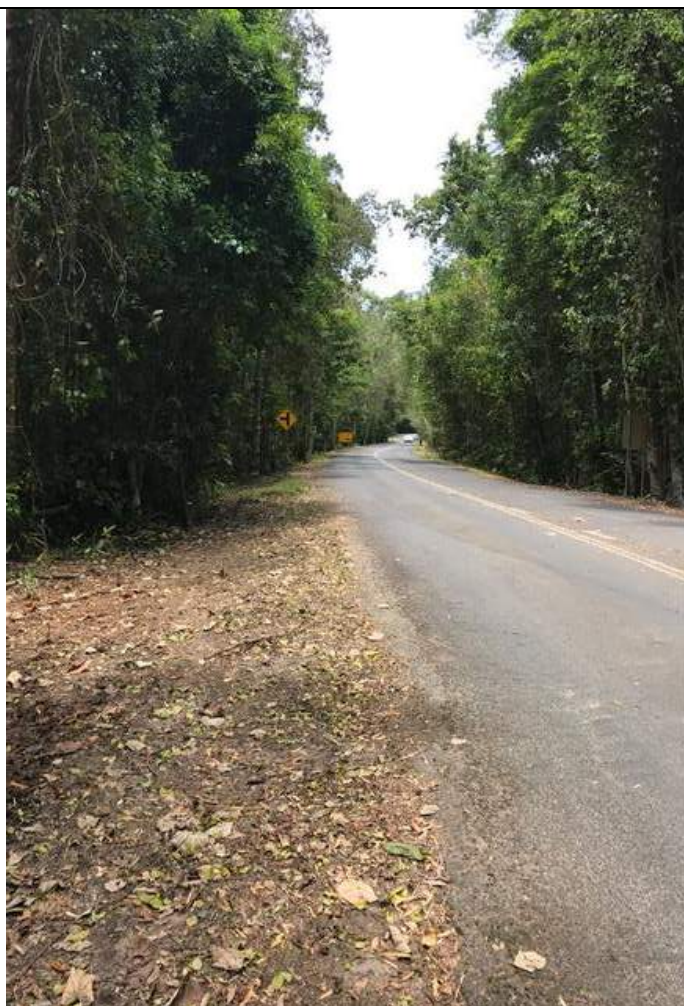
Issues increasing Risk Exposure

- No Physical controls preventing unplanned interaction between humans and vehicles
- At times of heavy congestions there is no verge for vehicles to get off road – meaning passengers in vehicle getting out of cars during waiting period are alighting onto a road (risk increases as the waiting line gets longer and extends around corners leaving blind spots for vehicles coming from the opposite direction.

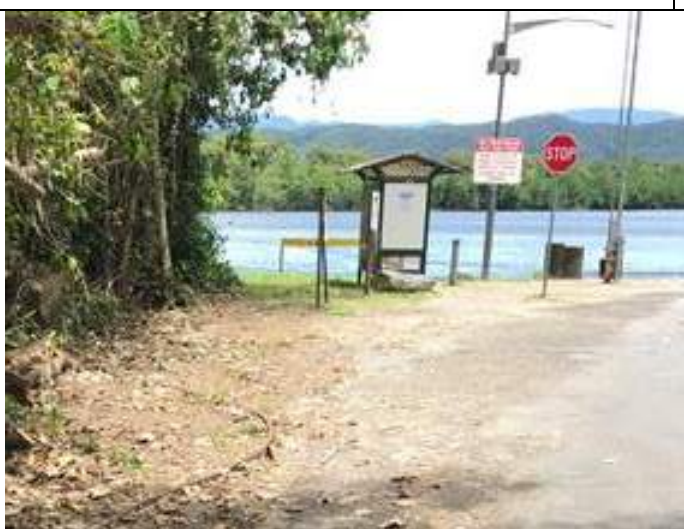
Looking South from the Northern Bank

Single Stop Sign

Issues increasing Risk Exposure

- Stop sign is the only control measure to control traffic
- Signage to the left of the stop sign is the only control for pedestrians
- No fencing or separation of humans and vehicles
- No Controls prevent humans falling into water
