5.6. BRIDGE RENEWAL PROGRAM - POLETTI'S BRIDGE

Level Two Structure Inspection Report

Structure ID:	8011	Name:	Poletti Road Bridge - 2 Span Timber brid
Crossing:	Saltwater Creek	Road Number:	
Structure Type:	Bridge	Road Name:	Poletti Road
Construction Type:	Girder	Owner:	Douglas Shire Council
Construction Material:	Timber	District:	Miallo
Inspector:	Mark de Hayr	Local Authority:	DSC
Latitude:	-16.407509	Longitude:	145.356155
Inspection Date:	4/06/2018	Max Height (M)	4.5
Next Inspection Date:	4/06/2019	Width (M)	4.5
Total Length (M)	18	Bearing - AP1-AP2	East
Carriageway		Load Limit	10
Footway	None	Status	Active
Chainage (Km)		From	To

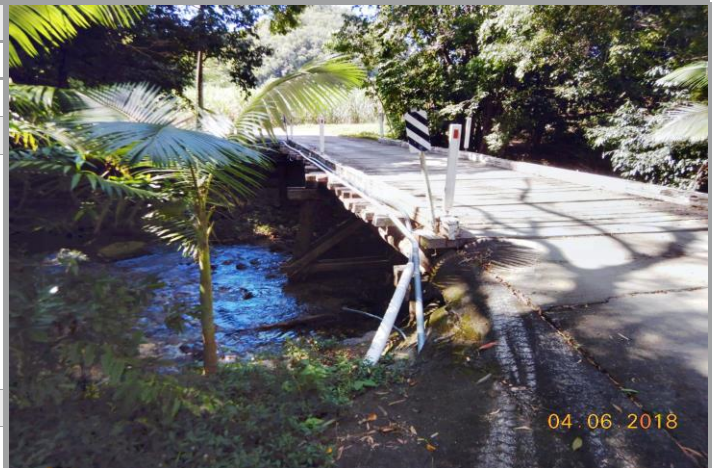
Approach One

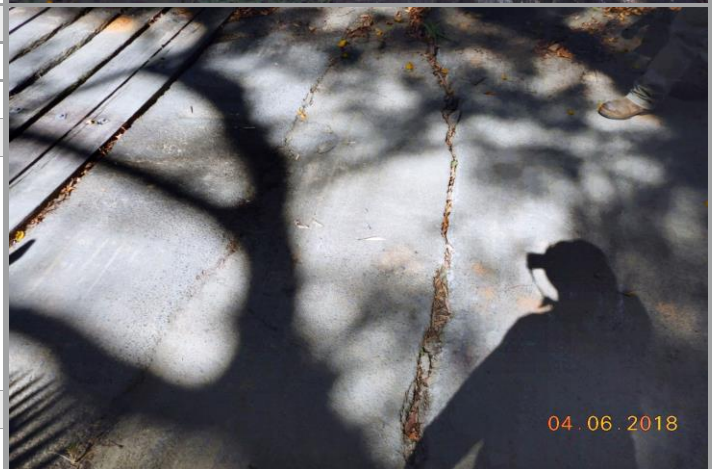
Transverse cracking in Approach One Bitumen Wearing Surface

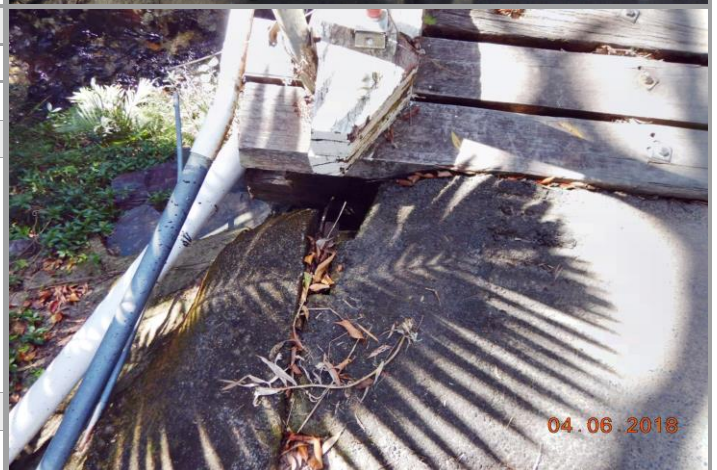
Minor Scouring at Approach One LHS

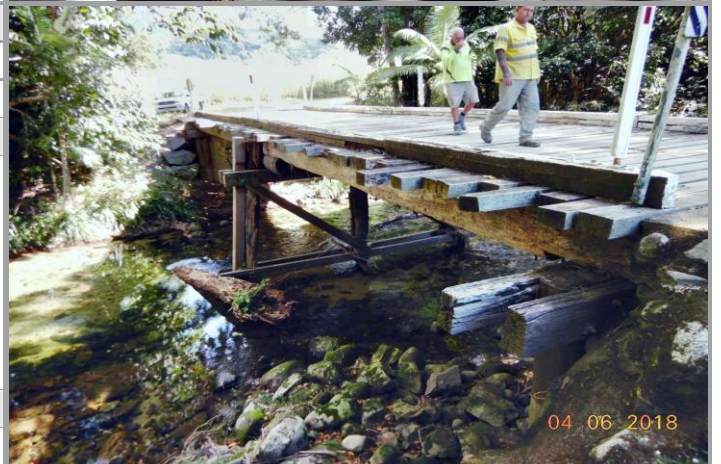
RHS view from Approach Two

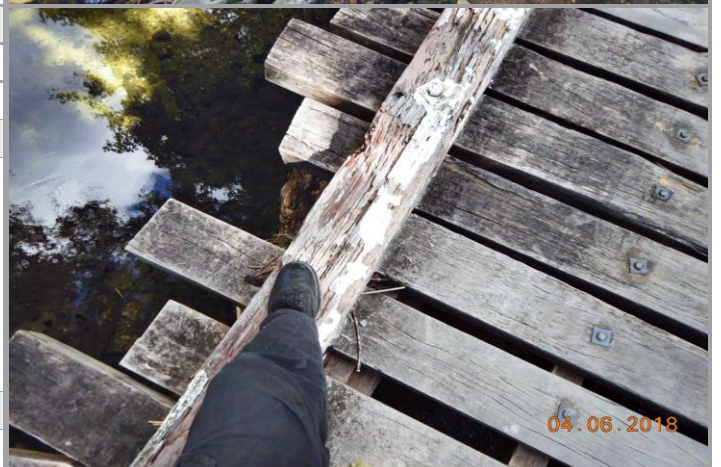
Hardwood Timber Kerb rotted

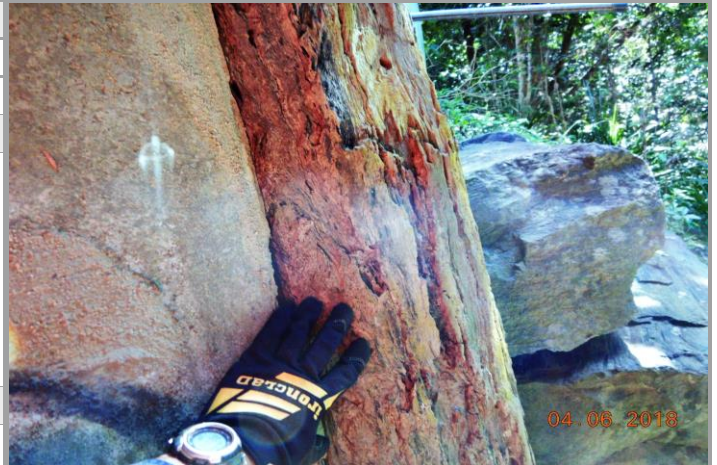
Surface rot in Abutment One Pile One

Inventory Comments							
Replace Pile							
ActivityNo:	Description:	Unit:	Qty	UnitRate:	Amount:	Priority:	Completed
TR61	Replace timber pile	each	1	\$3,267.00	\$3,267.00	2	<input type="checkbox"/>

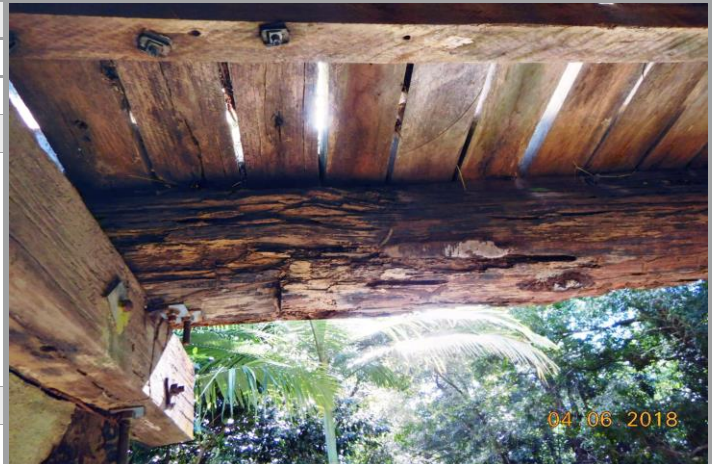
Girder One and Four in Span One and Girders Three and Four in Span Two have 20-30mm (40-60mm of effective dia) loss of

sapwood through surface rot and would be classed in CS3 without the over sniping issue.

Detail of surface rot in Span One Girder One

Inventory Comments							
Replace Girders							
ActivityNo:	Description:	Unit:	Qty	UnitRate:	Amount:	Priority:	Completed
TR10	Replace timber girder	each	3	\$5,794.00	\$17,382.00	2	<input type="checkbox"/>

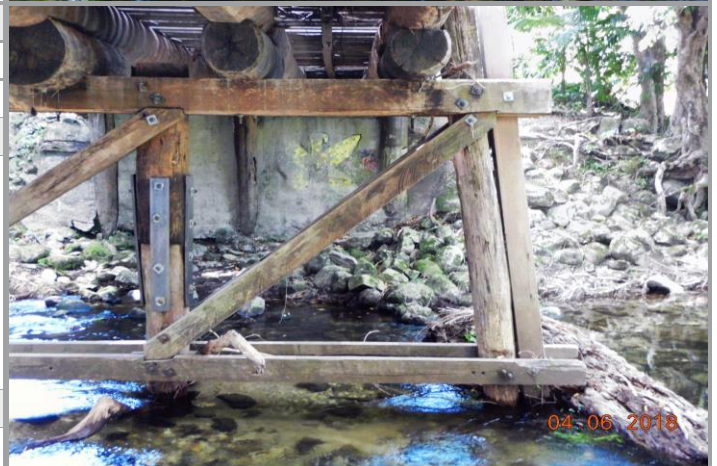
Temporary Works has been emplaced by adding a Fender Pile to Pier One RHS (Upstream Side).

Detail of "Fender " Pile added to Pier One Pile Three

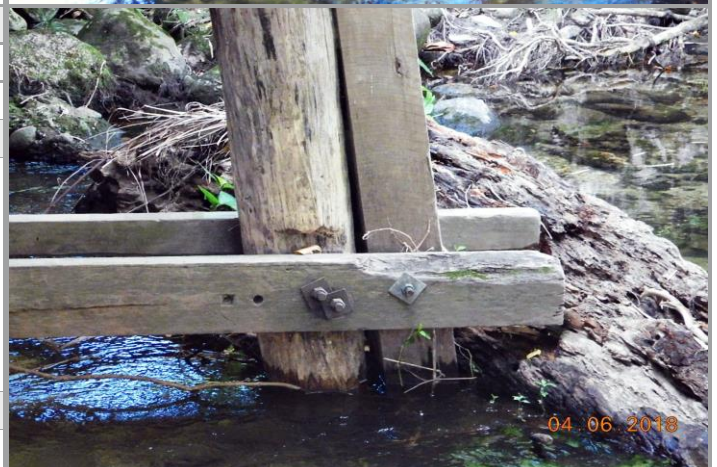
Detail of splitting in Whale in Pier One Face One RHS

Inventory Comments							
Replace Pile and Whales							
ActivityNo:	Description:	Unit:	Qty	UnitRate:	Amount:	Priority:	Completed
TR68	Add new braces/wales - timber	m	2	\$279.00	\$558.00	2	<input type="checkbox"/>
TR61	Replace timber pile	each	1	\$3,267.00	\$3,267.00	2	<input type="checkbox"/>

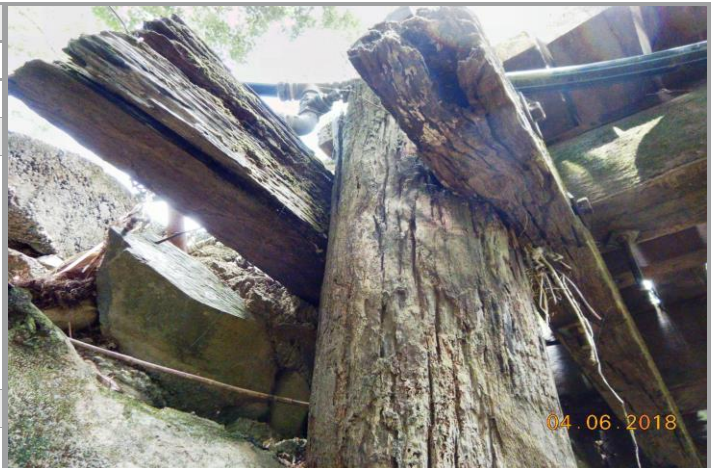
Detail of rot in Abutment Two Headsocks

Inventory Comments							
Replace Headstock							
ActivityNo:	Description:	Unit:	Qty	UnitRate:	Amount:	Priority:	Completed
TR56	Replace headstock in timber	each	2	\$4,650.00	\$9,300.00	2	<input type="checkbox"/>

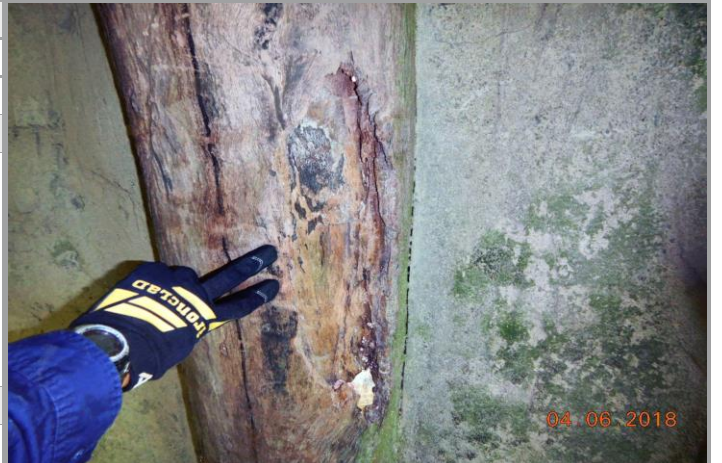
Detail of split and rot in Abutment Two Pile Two

RECOMMENDATIONS: As per the Timber Bridge Inspection Manual - Pile Two has previously been Spliced and Pile Three is in CS4 there is no option but to fully replace one or more of the Piles in the Pier or to replace / upgrade the existing structure. Piles One and Two in Abutment Two should be replaced.

Modification Group/ Component/ StandardNumber		ComponentName:	O	A2	P	56T	Piles & Encasements	
Inventory Comments								
Replace Pile								
ActivityNo:	Description:	Unit:	Qty	UnitRate:	Amount:	Priority:	Completed	
TR61	Replace timber pile	each	1	\$3,267.00	\$3,267.00	2	<input type="checkbox"/>

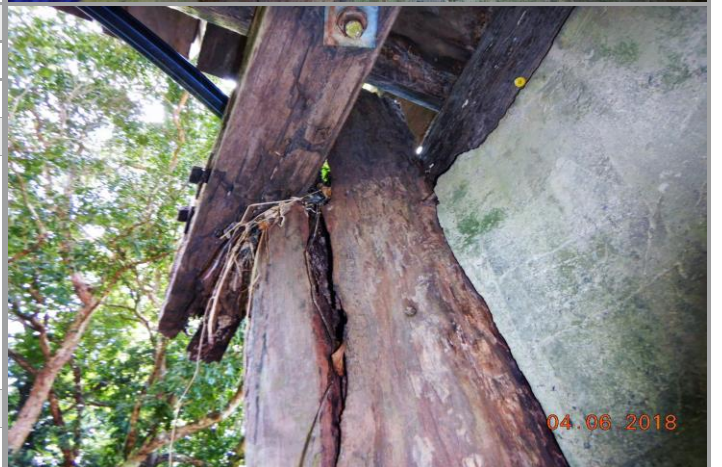
Detail of fully depth split in Abutment Two Pile One

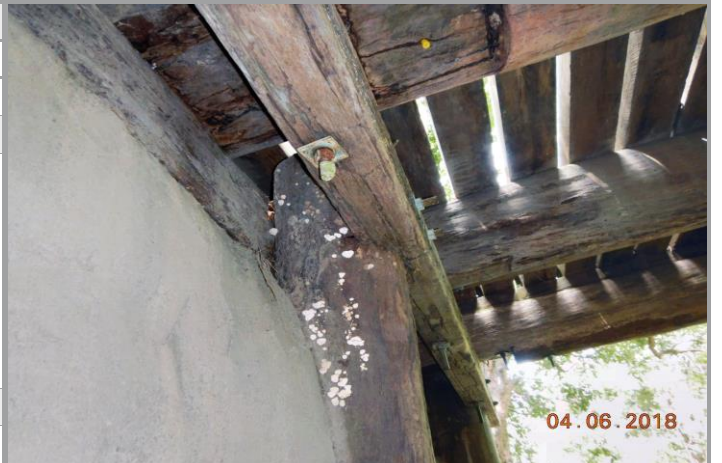
Detail of Lichen growth in Abutment Two Pile Two
