Inspection Pictures / Inspection: Stormwater Inspection

Location/Street Line 1	Town or suburb: Mossman Community	Date : 26/04/2012	Section number: 7	Sewer Ref.:
---------------------------	--------------------------------------	----------------------	----------------------	-------------

CAIRNS REGIONAL COUNCIL
MOSSMAN GORGE SUBDIVISION
ROADS AND INTERSECTIONS AUDIT

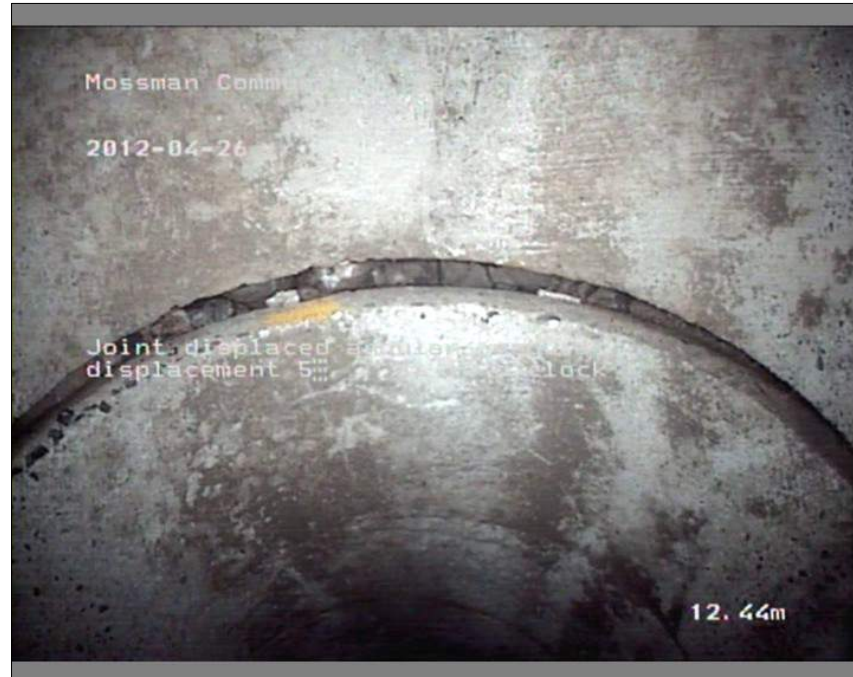
Photo: 7_8_30_A.JPG
12.44m, Joint displaced angular, angular displacement 5° , at 12 o'clock

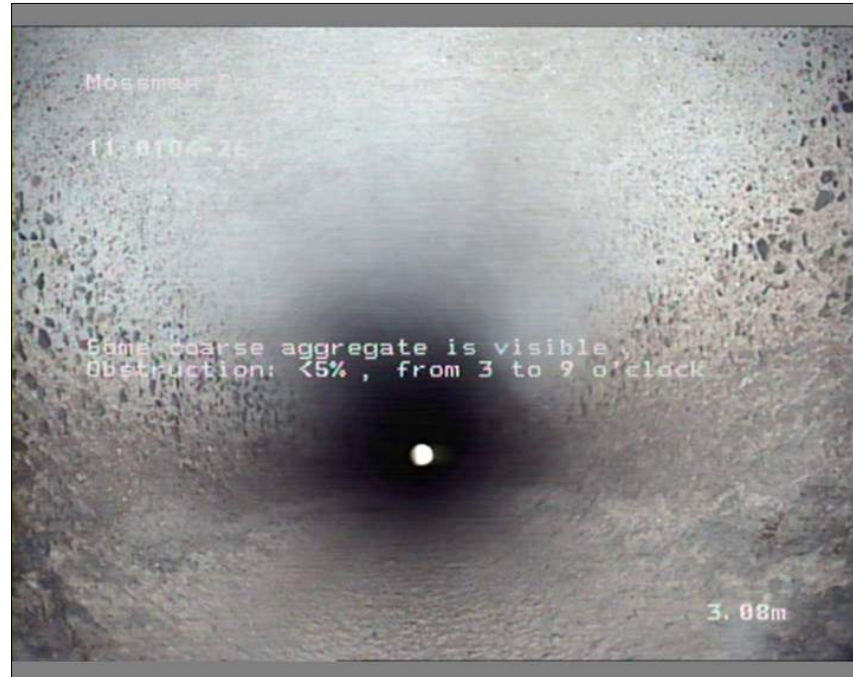
Photo: 8_9_35_A.JPG

3.08m, Some coarse aggregate is visible , Obstruction: <5% , from 3 to 9 o'clock

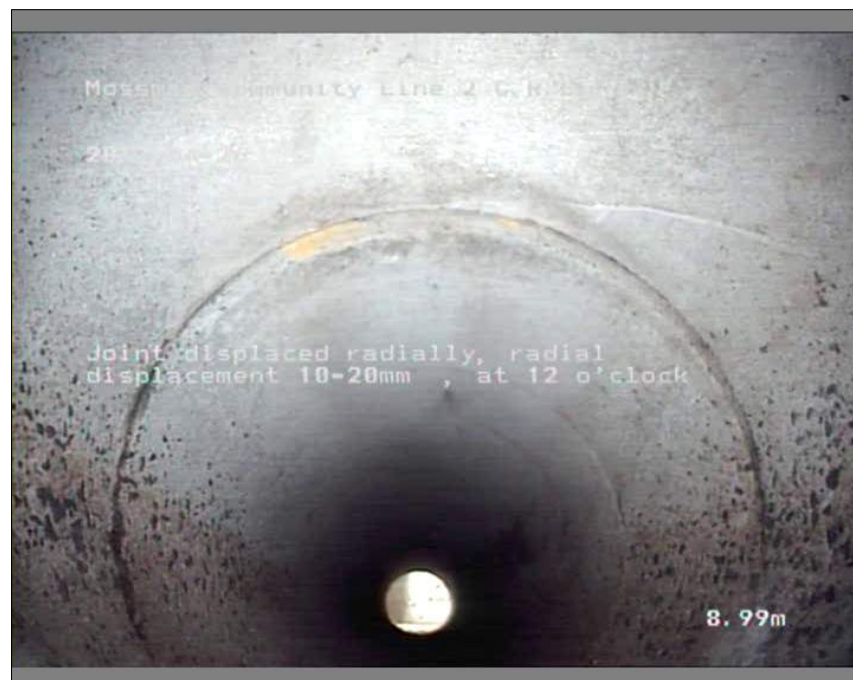
Photo: 8_9_36_A.JPG

8.99m, Joint displaced radially, radial displacement 10-20mm , at 12 o'clock

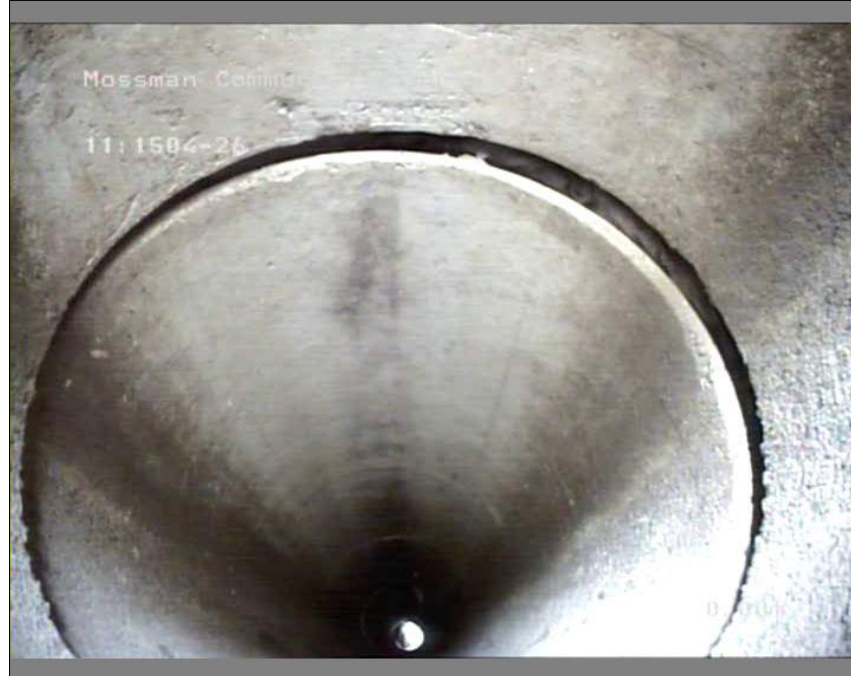
Photo: 9_10_40_A.JPG

0m, Joint displaced angular, angular displacement 10° , at 2 o'clock

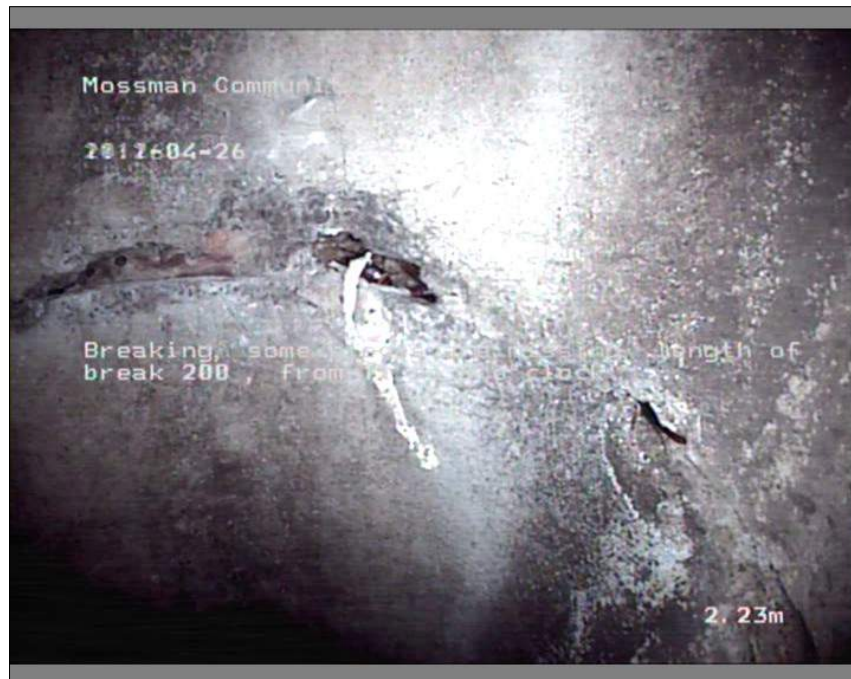
Photo: 9_10_41_A.JPG

2.23m, Breaking, some pieces are missing, length of break 200 , from 11 to 3 o'clock

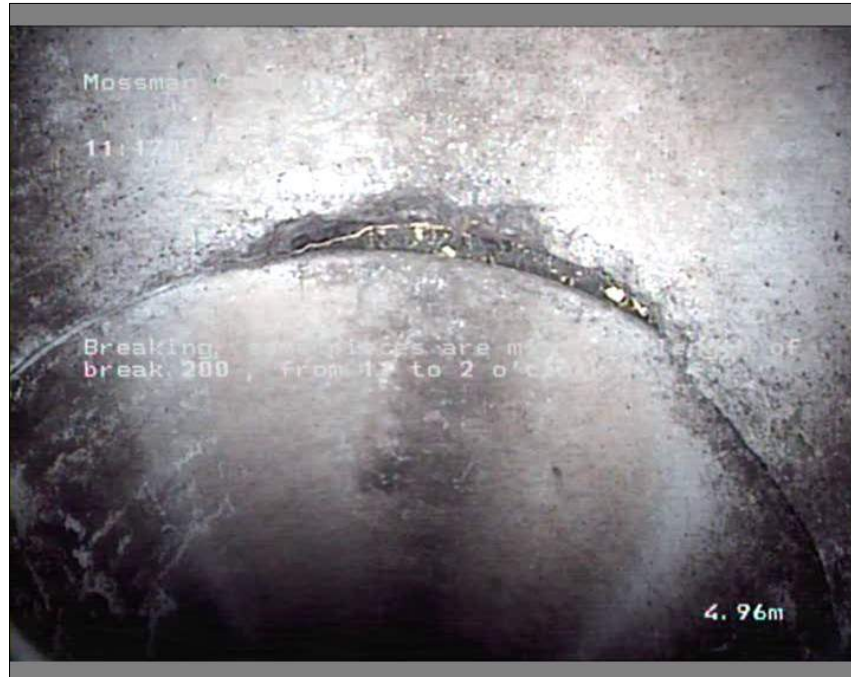
Photo: 9_10_42_A.JPG
4.96m, Breaking, some pieces are missing, length of break 200, from 11 to 2 o'clock

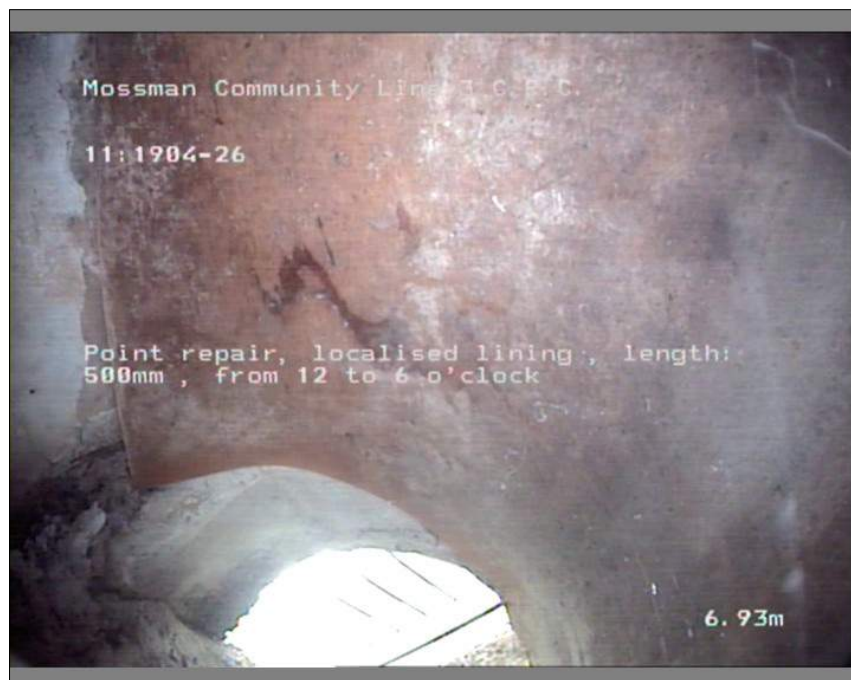
Photo: 9_10_43_A.JPG
6.93m, Point repair, localised lining, length: 500mm, from 12 to 6 o'clock

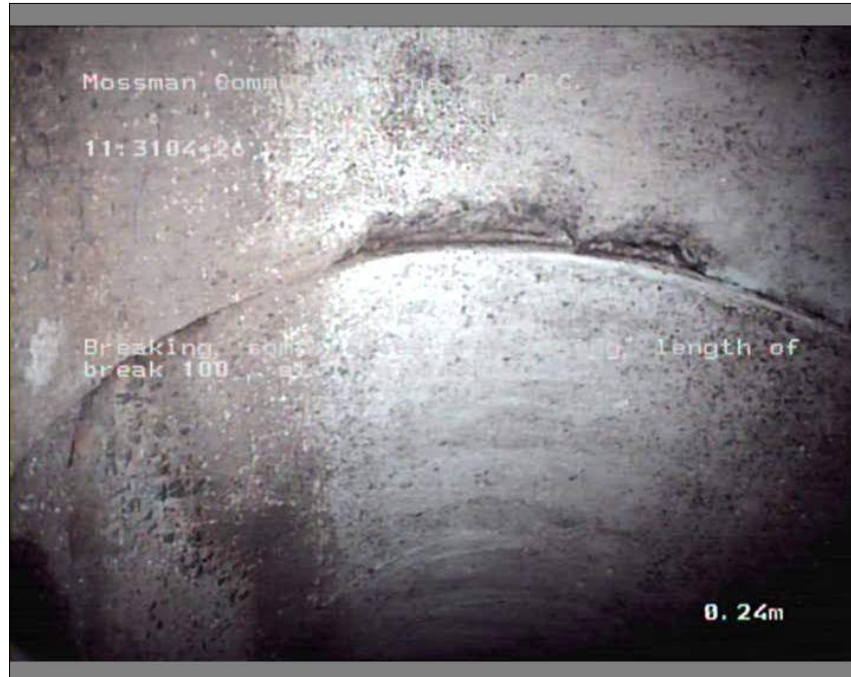
Photo: 10_11_47_A.JPG
0.24m, Breaking, some pieces are missing, length of break 100 , at 11 o'clock

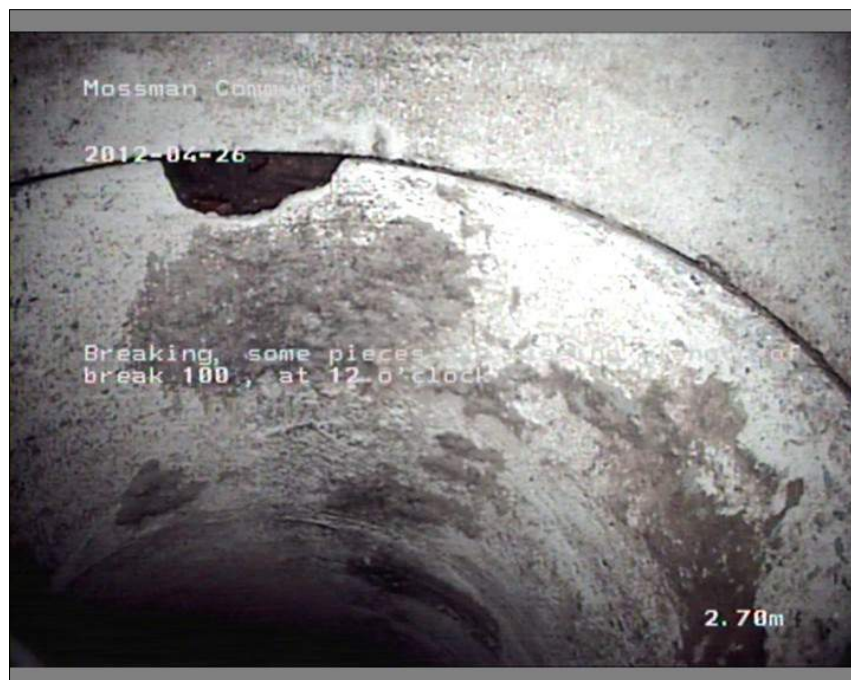
Photo: 10_11_48_A.JPG
2.7m, Breaking, some pieces are missing, length of break 100 , at 12 o'clock

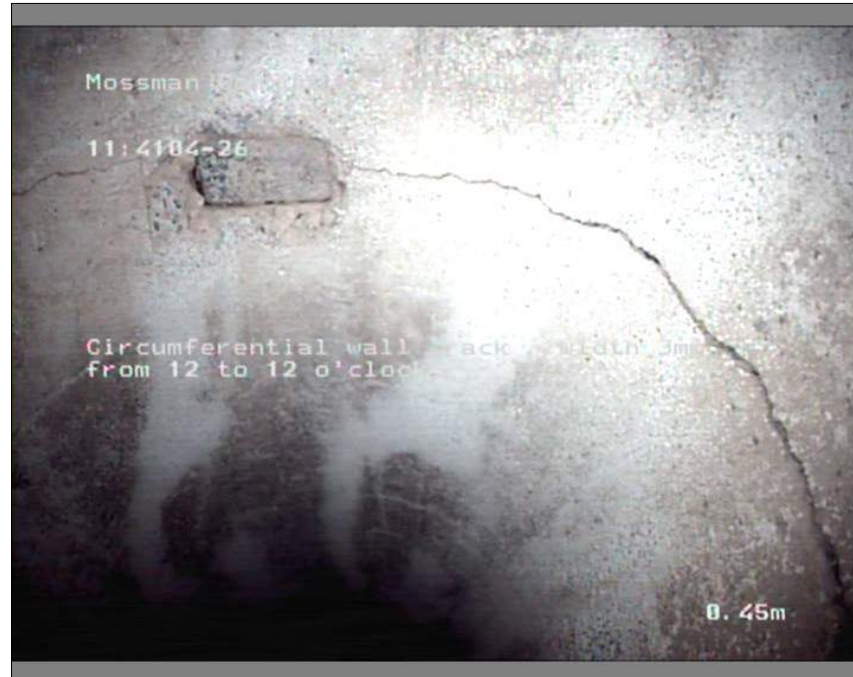
Photo: 11_12_52_A.JPG
0.45m, Circumferential wall crack , width 3mm , from 12 to 12 o'clock

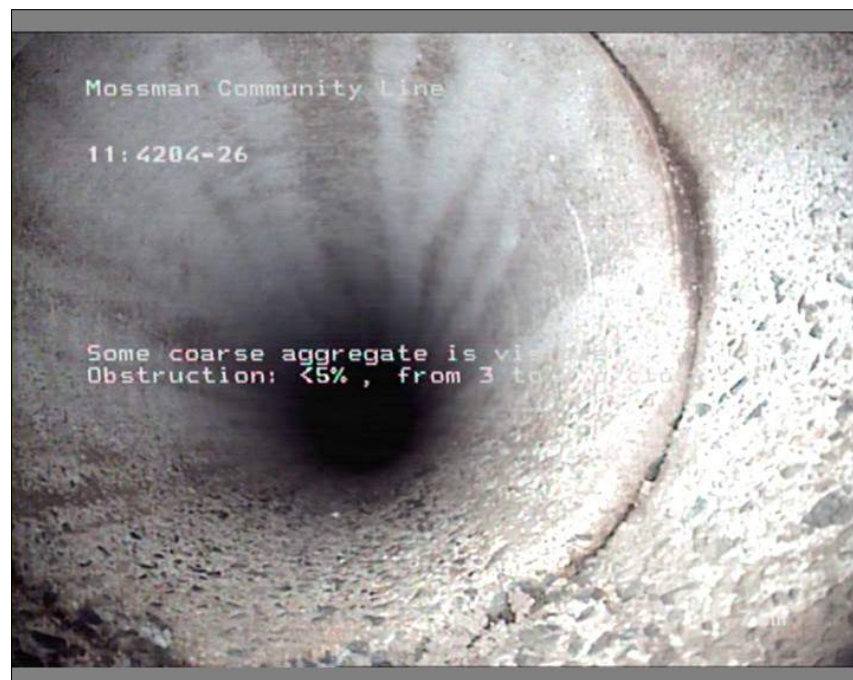
Photo: 11_12_53_A.JPG
1.76m, Some coarse aggregate is visible , Obstruction: <5% , from 3 to 9 o'clock

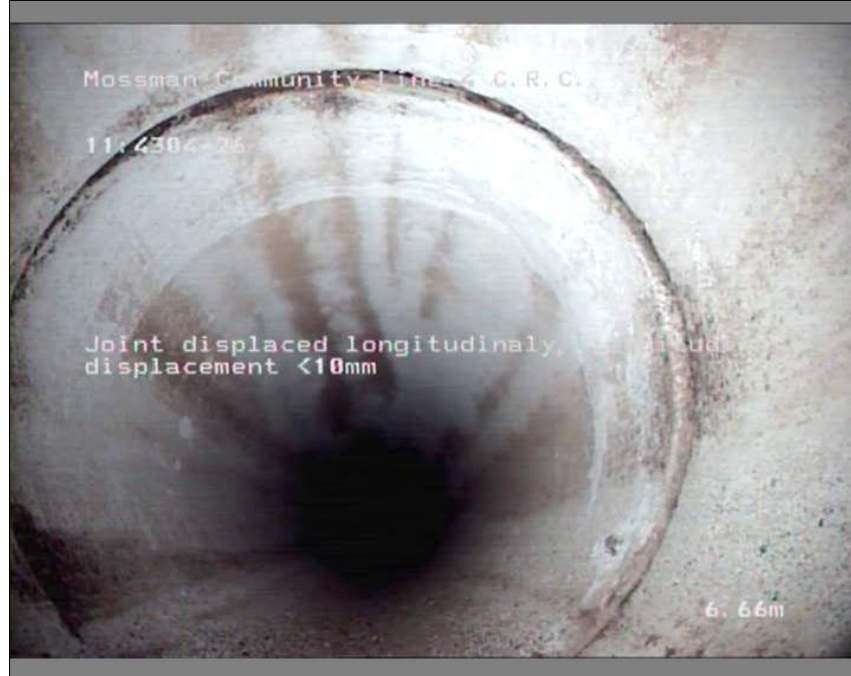
Photo: 11_12_54_A.JPG
6.66m, Joint displaced longitudinally, longitudinal displacement <10mm

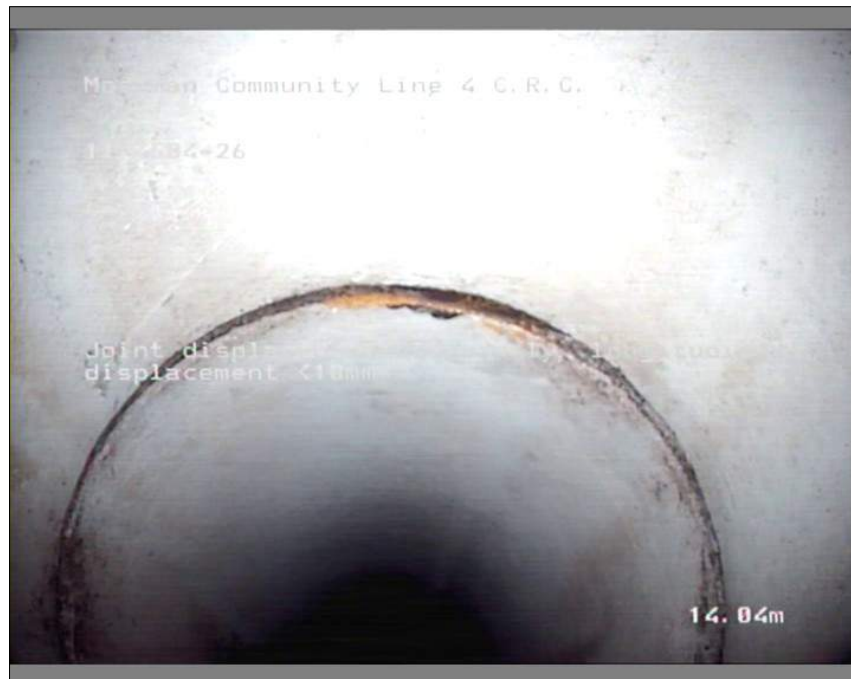
Photo: 11_12_55_A.JPG
14.04m, Joint displaced longitudinally, longitudinal displacement <10mm

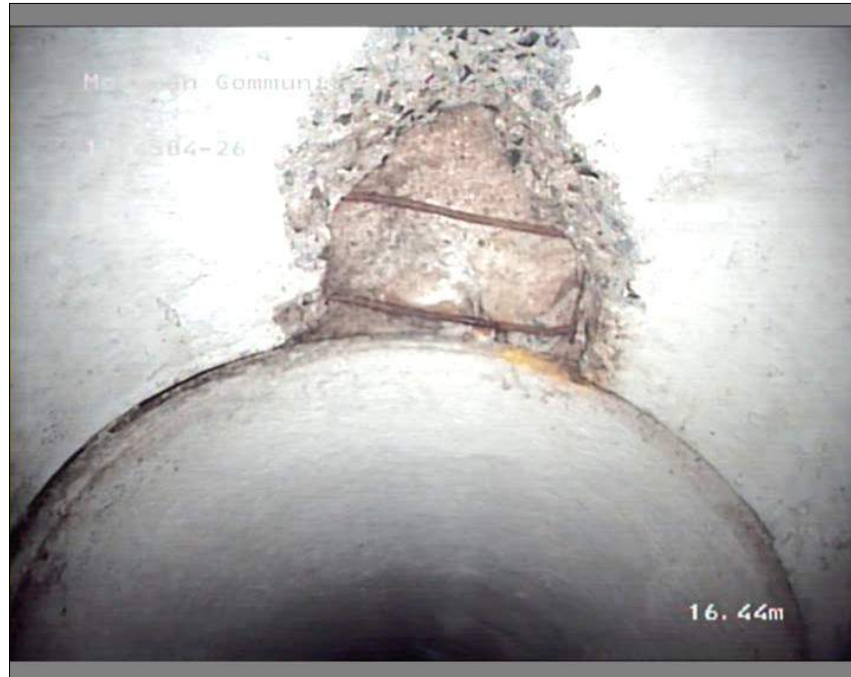
Photo: 11_12_56_A.JPG
16.44m, Breaking, some pieces are missing, length of break 200 , at 12 o'clock

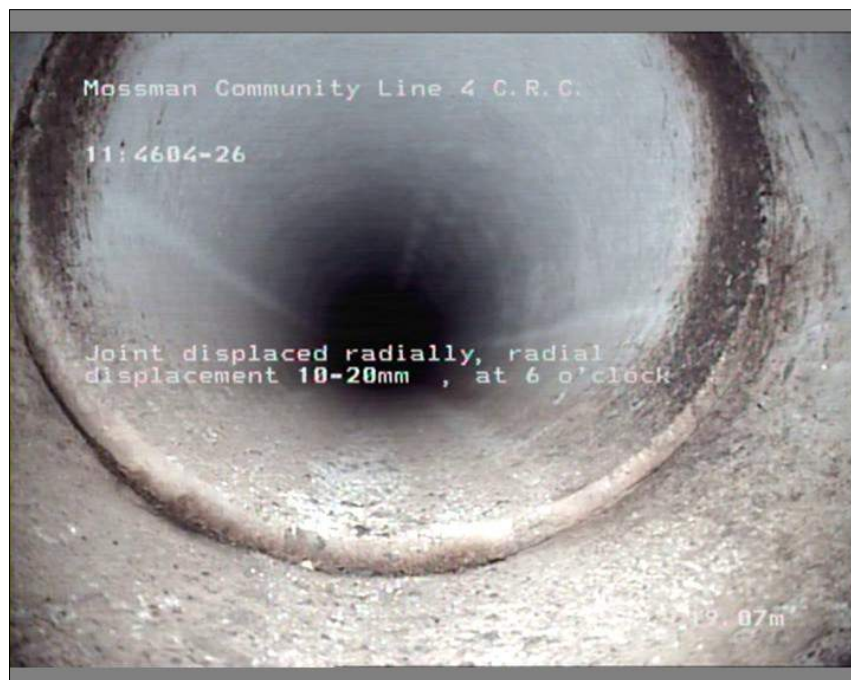
Photo: 11_12_57_A.JPG
19.07m, Joint displaced radially, radial displacement 10-20mm , at 6 o'clock

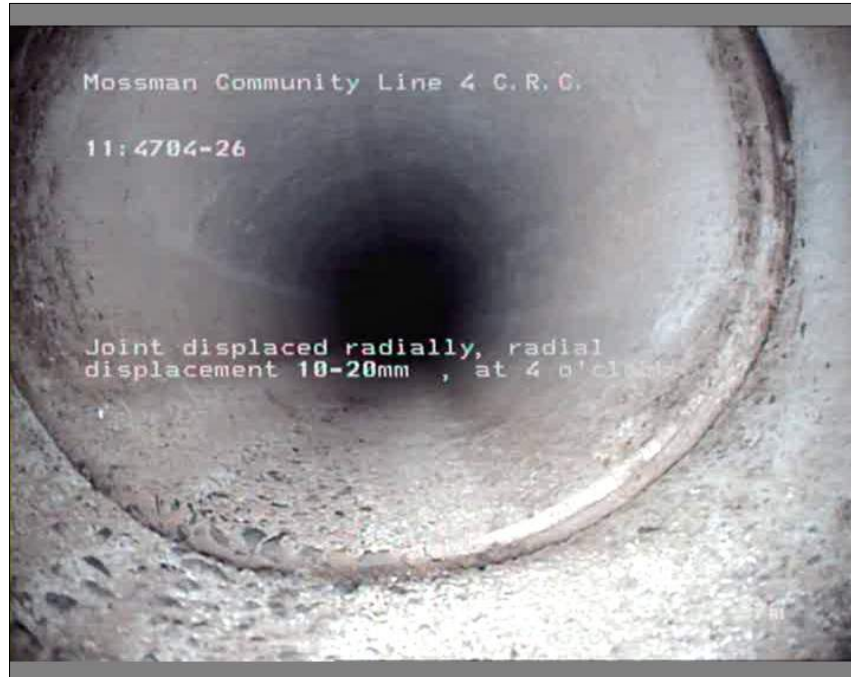
Photo: 11_12_58_A.JPG

21.37m, Joint displaced radially, radial displacement 10-20mm , at 4 o'clock

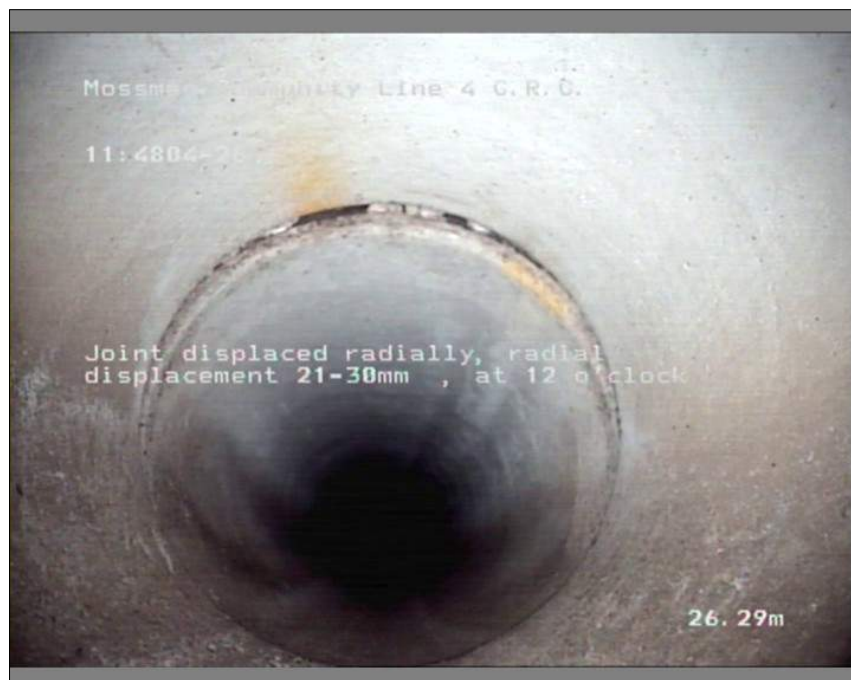
Photo: 11_12_59_A.JPG

26.29m, Joint displaced radially, radial displacement 21-30mm , at 12 o'clock

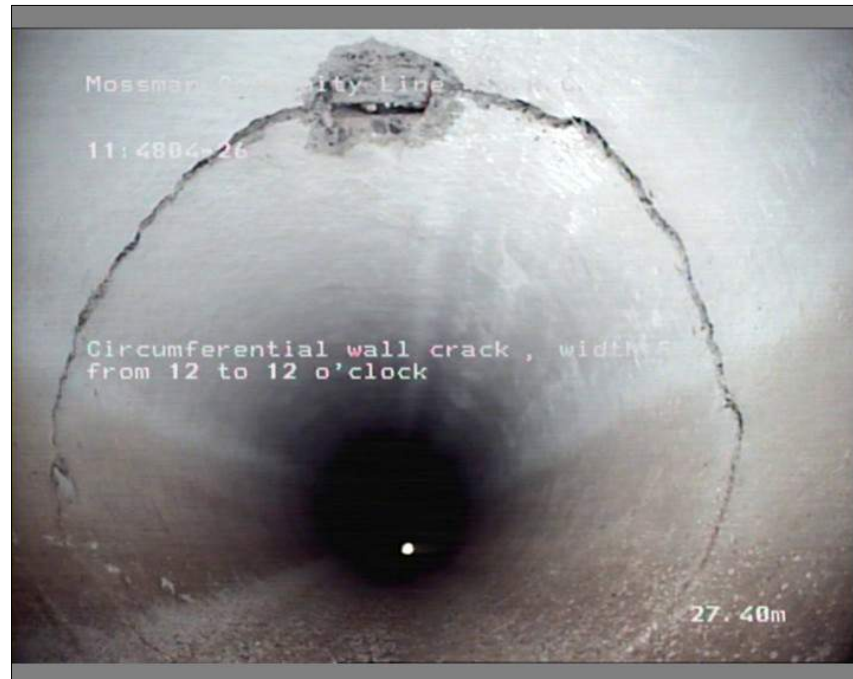
Photo: 11_12_60_A.JPG

27.4m, Circumferential wall crack , width 5mm , from 12 to 12 o'clock

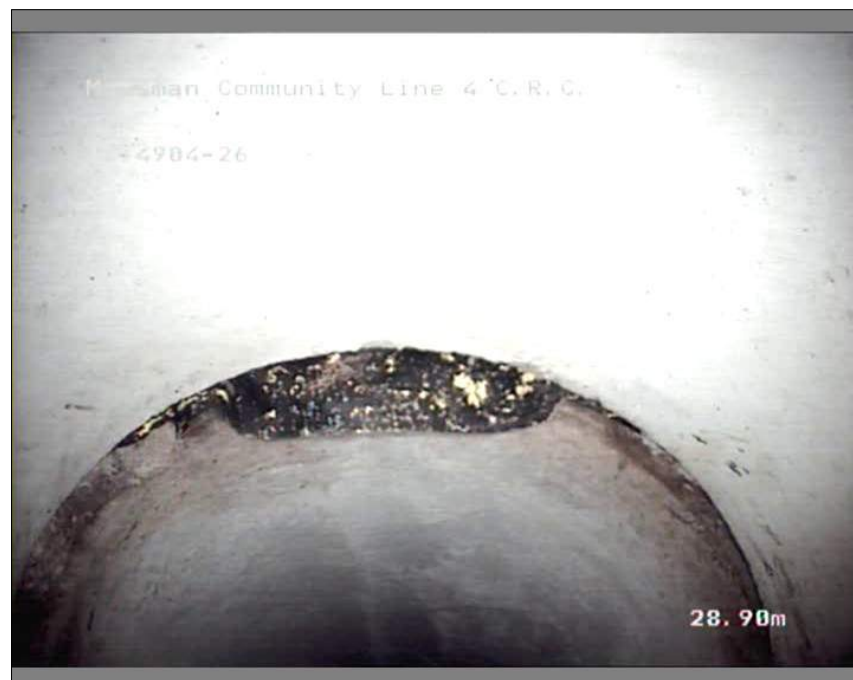
Photo: 11_12_61_A.JPG

28.9m, Joint displaced angular, angular displacement 10° , at 12 o'clock

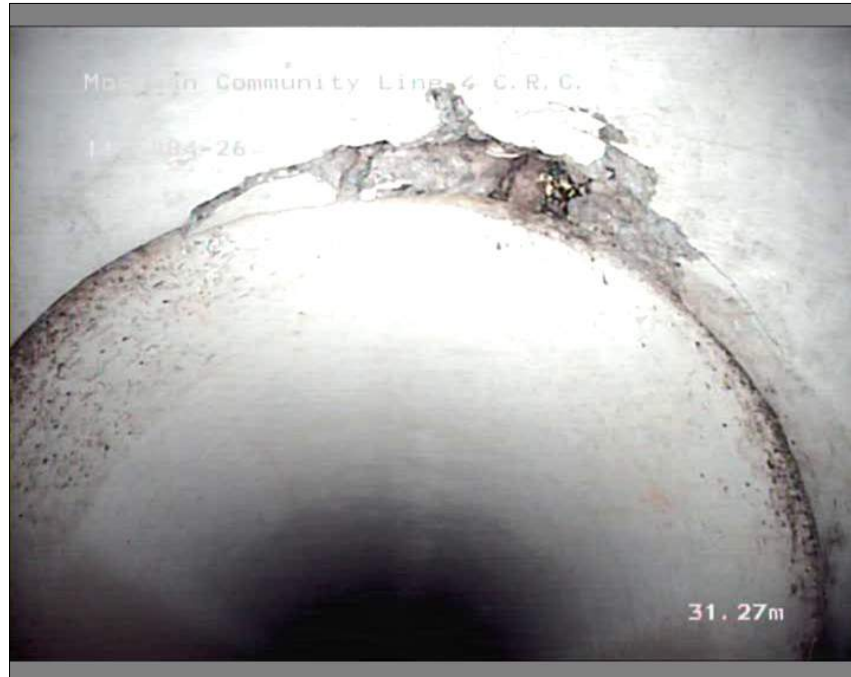
Photo: 11_12_62_A.JPG

31.27m, Breaking, all pieces are present but some of them are visibly displaced from position, length of break 200 , at 12 o'clock

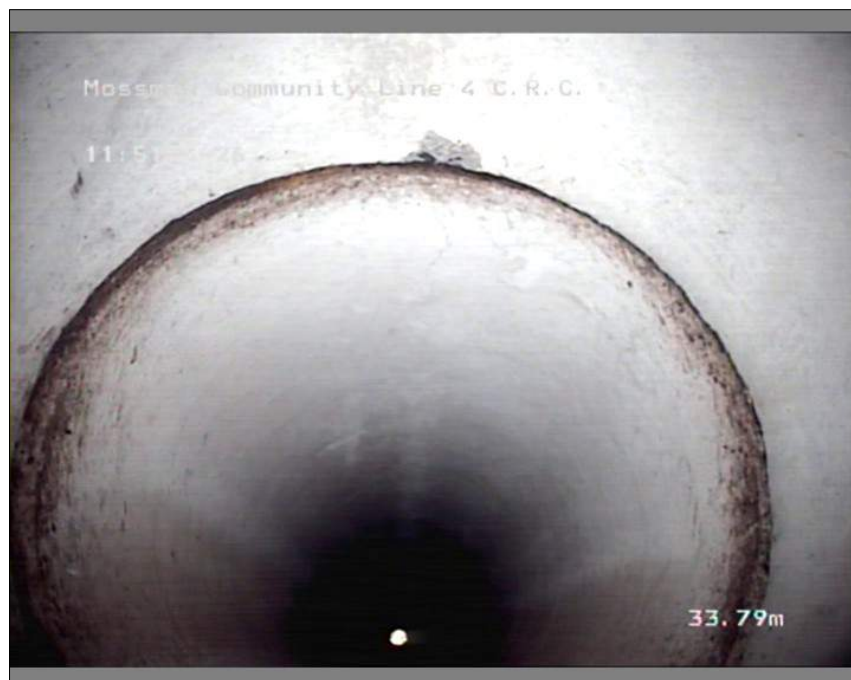
Photo: 11_12_63_A.JPG

33.79m, Joint displaced angular, angular displacement 10° , at 10 o'clock

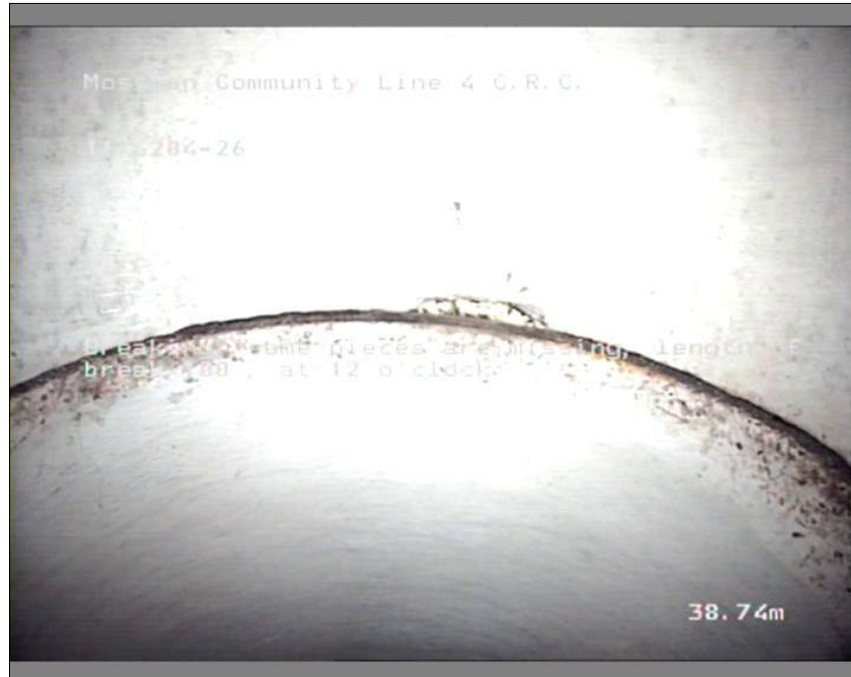
Photo: 11_12_64_A.JPG

38.74m, Breaking, some pieces are missing, length of break 100 , at 12 o'clock

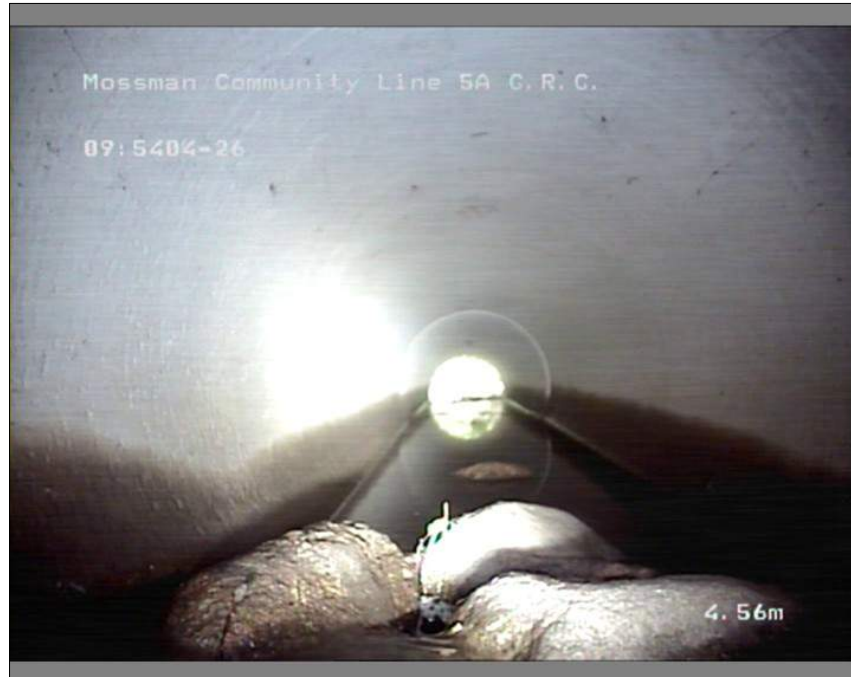
Photo: 6_7_25_A.JPG

4.56m, Inspection (survey) abandoned, obstruction , Large rocks

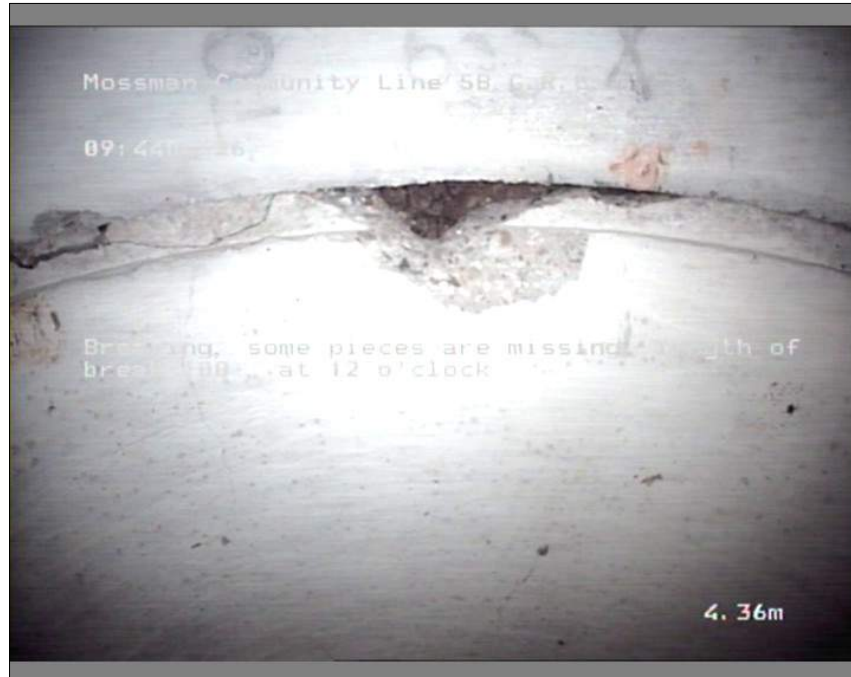
Photo: 5_6_20_A.JPG
4.36m, Breaking, some pieces are missing, length of break 100 , at 12 o'clock
