GEOTECHNICAL INVESTIGATION

**LOT 12 ZENA CLOSE
CAPE TRIBULATION**

REPORT NO: GT13-020-001R REV 1

APRIL 2013

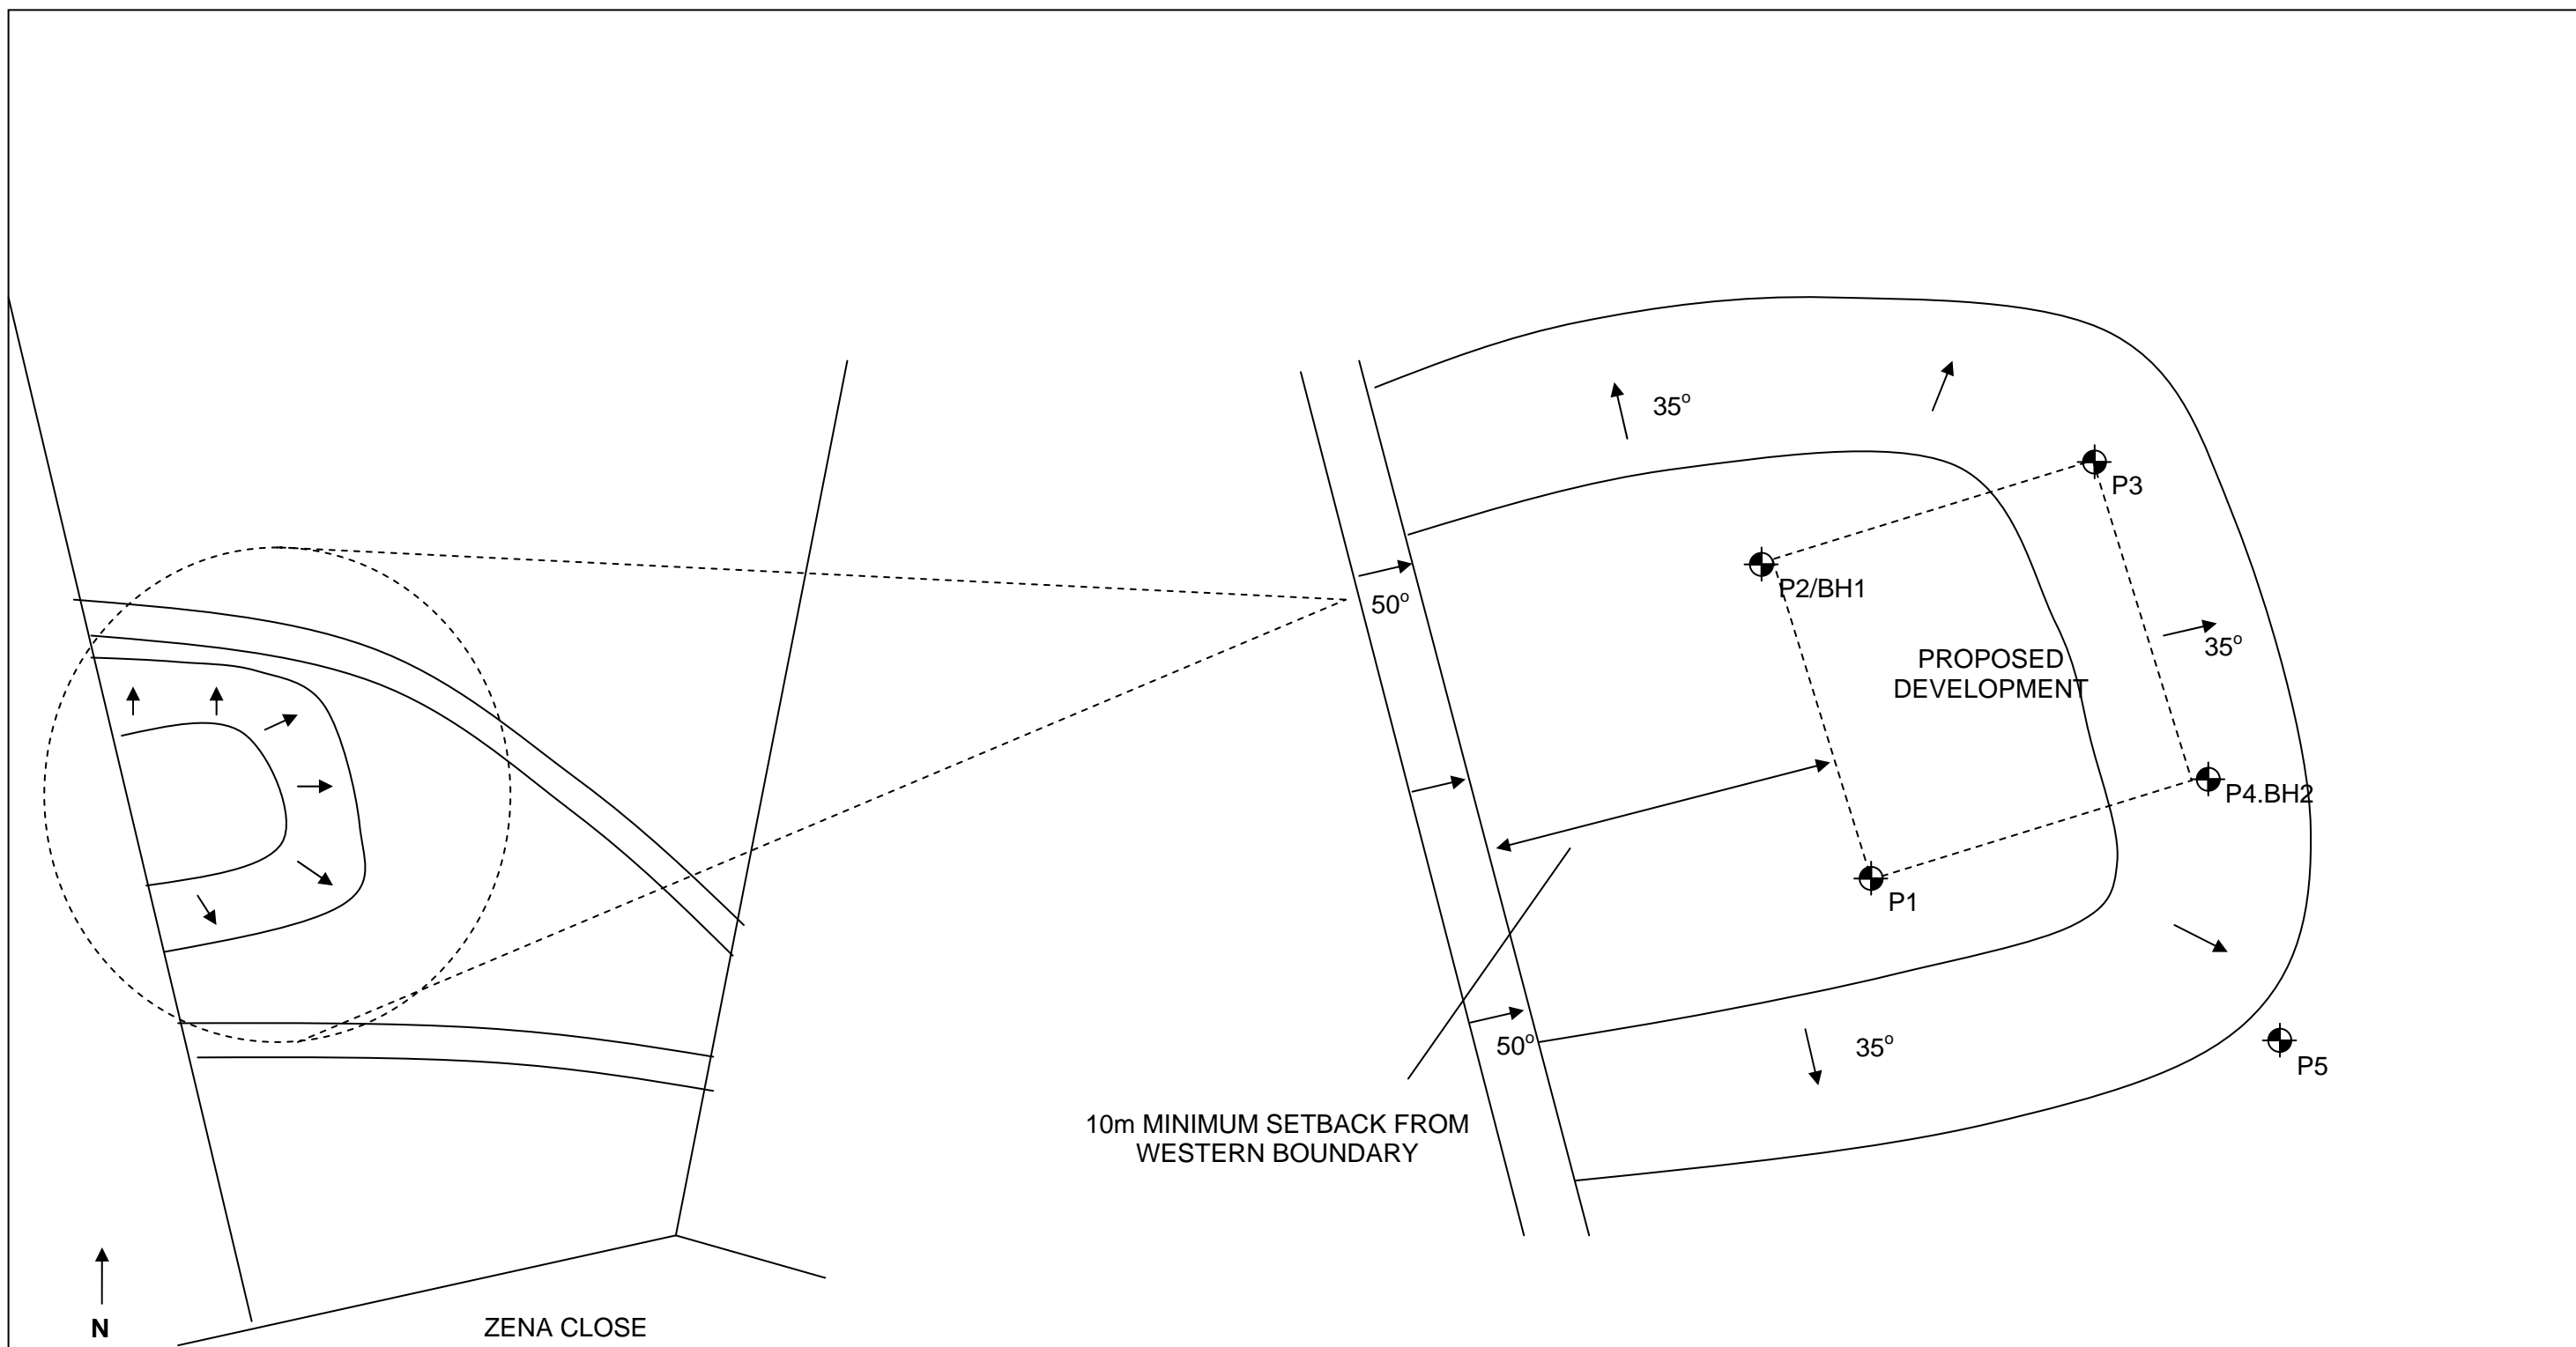
Borehole and DCP Locations

The classification is only valid for the location proposed as displayed in Figure 2, Appendix A.

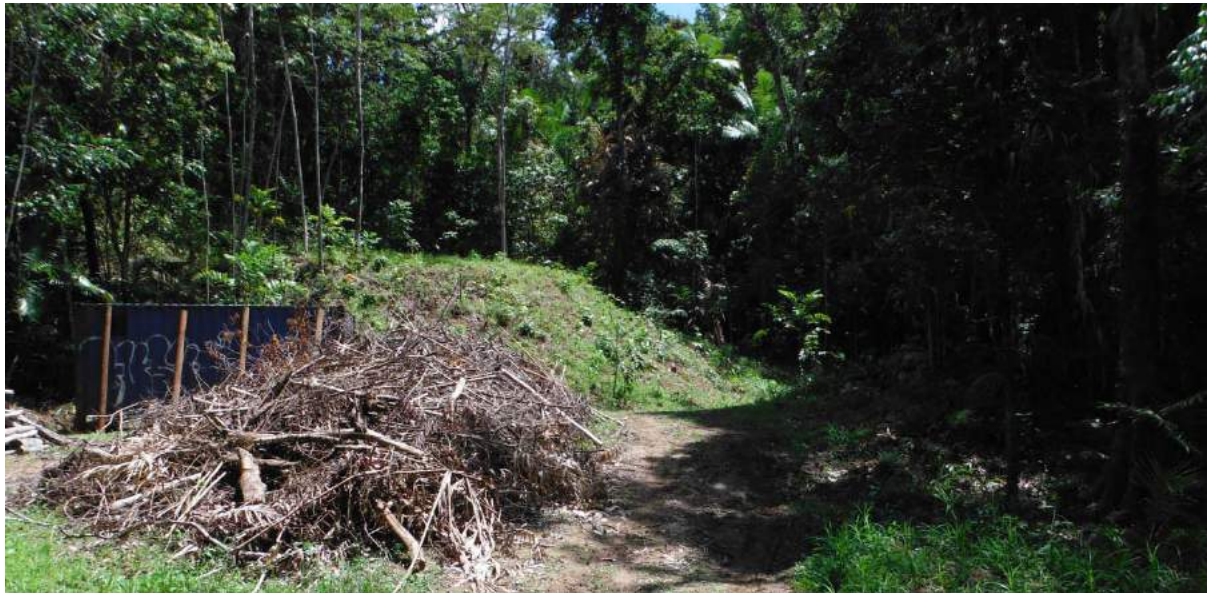
Looking north towards benched area

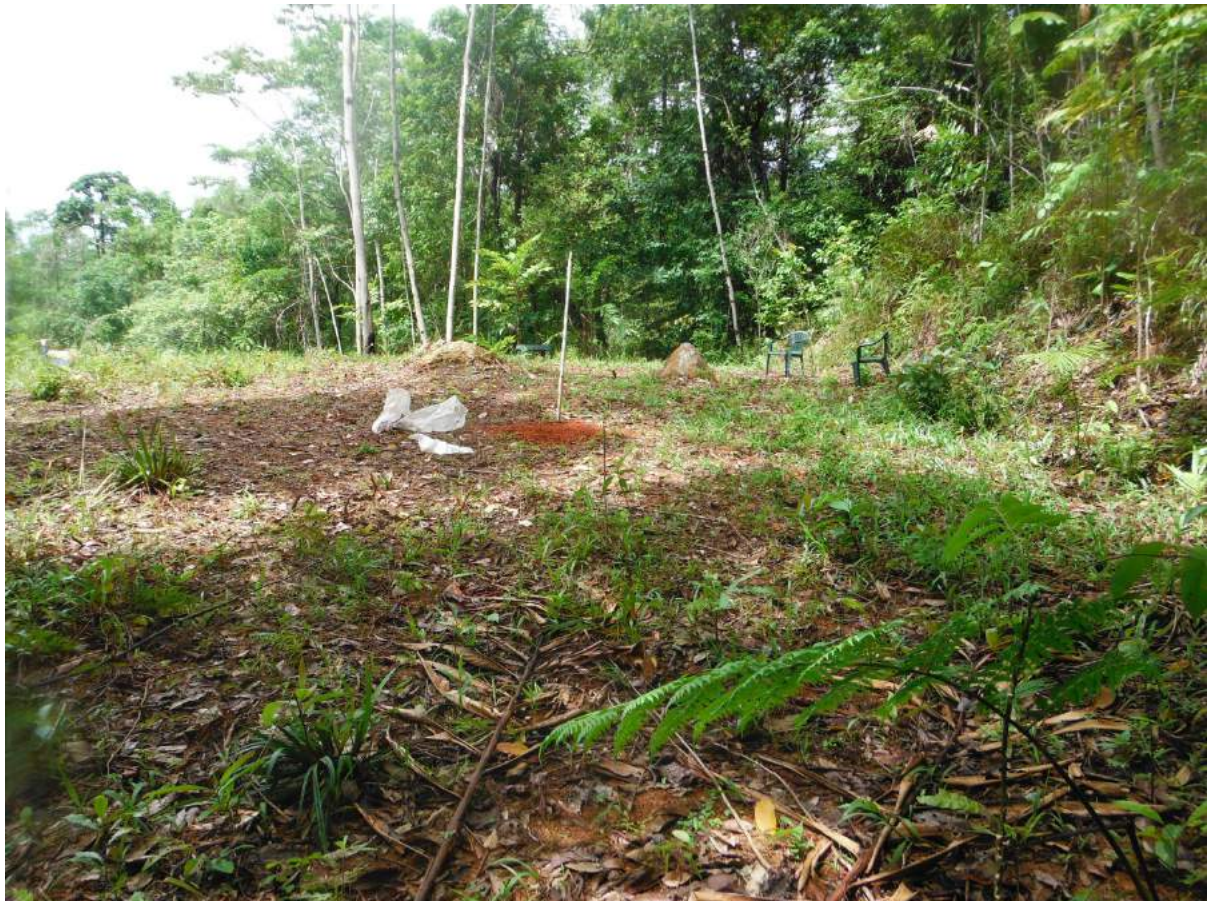
Looking south over building pad

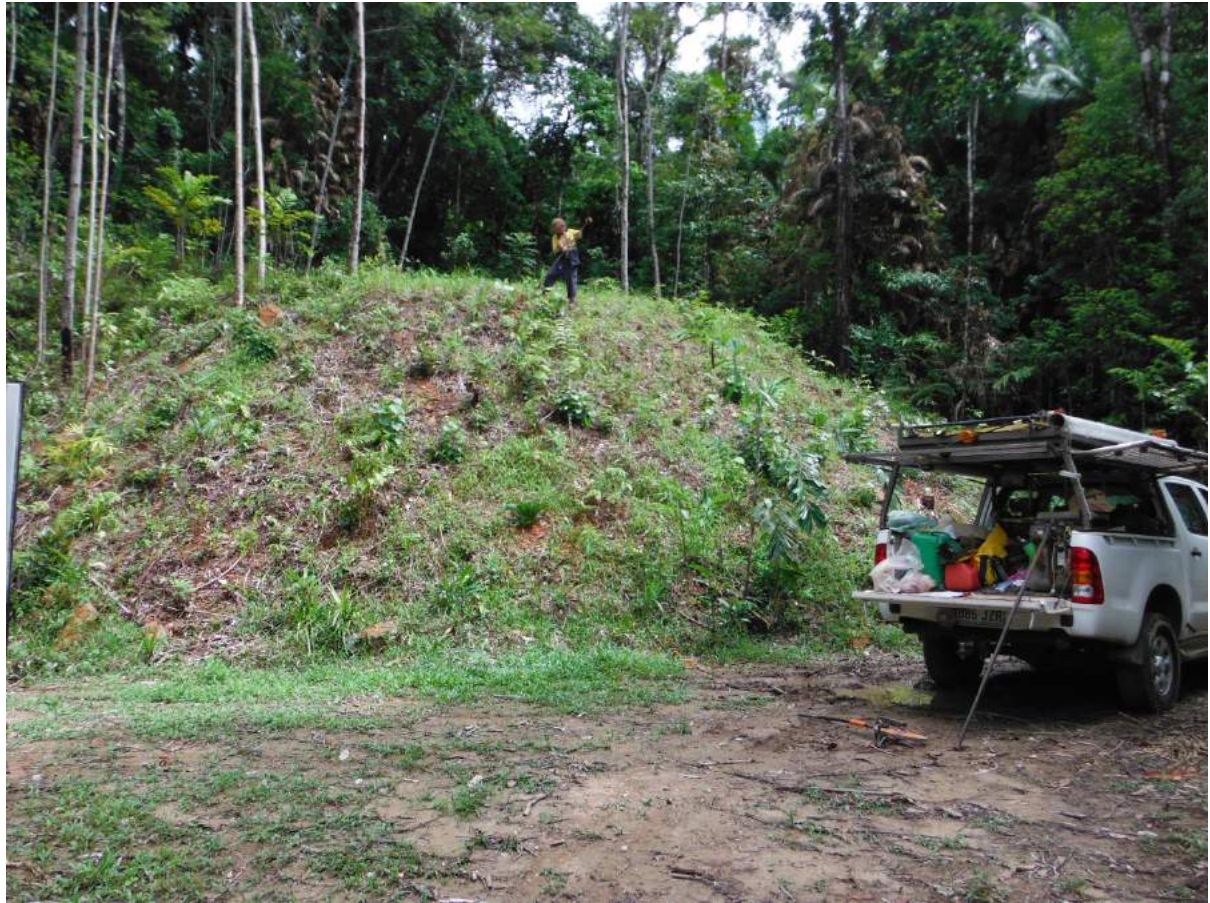
Looking west and benched area

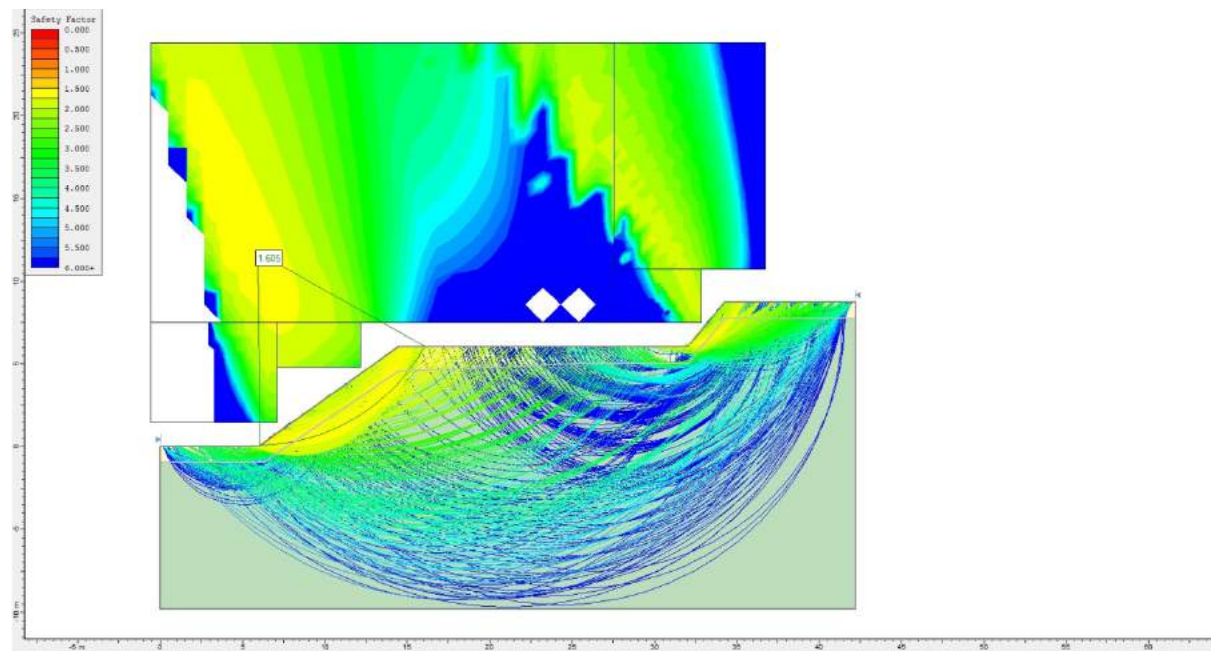
Current (Dry)

The analysis demonstrates that the site was marginally stable during both dry and saturated conditions. When a surcharge load was modelled at the ground surface the analysis showed failure surfaces around the batter are likely. The surcharge load was

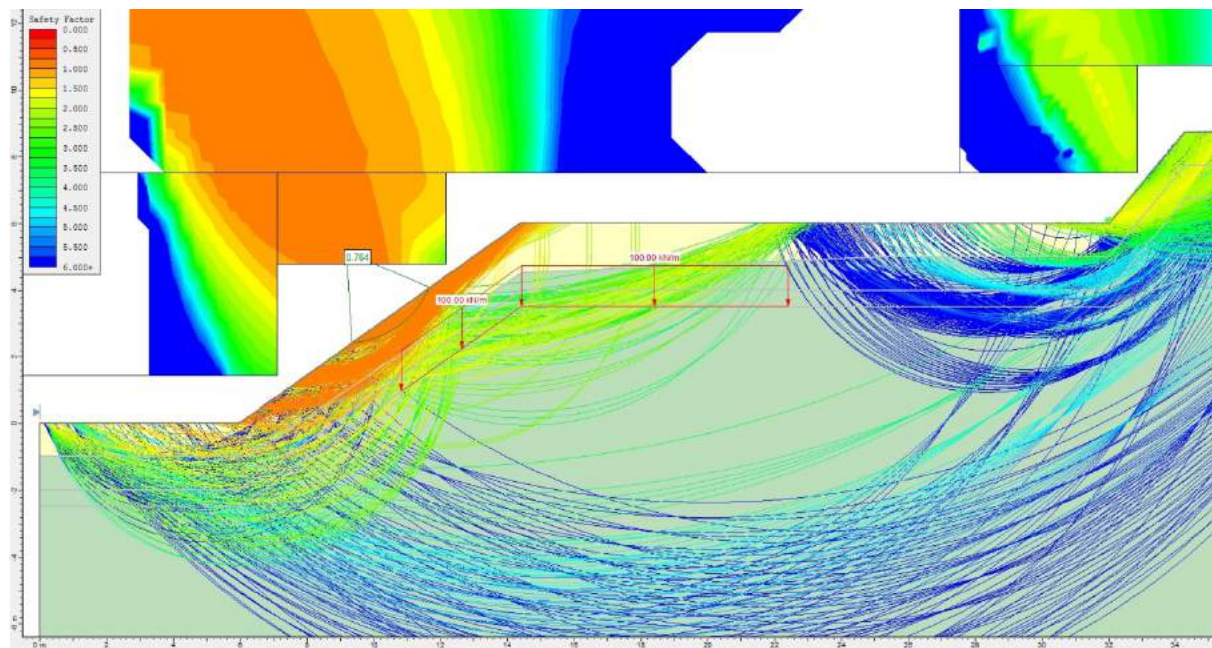
Load at 2.5m below ground surface level (Dry)

**SLIDE analysis output indicates failure above the depth of the foundation surcharge.*

also modelled 2.5m below the current ground surface into the residual soil. The analysis demonstrated that surficial failures are still likely however deep seated failures around the base of the surcharge were not observed.

- Structures should be founded into the residual soils at least 2.5m below the ground surface level;
- Footings should be designed to accommodate the potential lateral forces due to failure (landslip) of the upper soil profile;
