# **Tree Health and Condition Report**

**Port Explorers, Langley Rd**

**Port Douglas**

**31 August 2016**

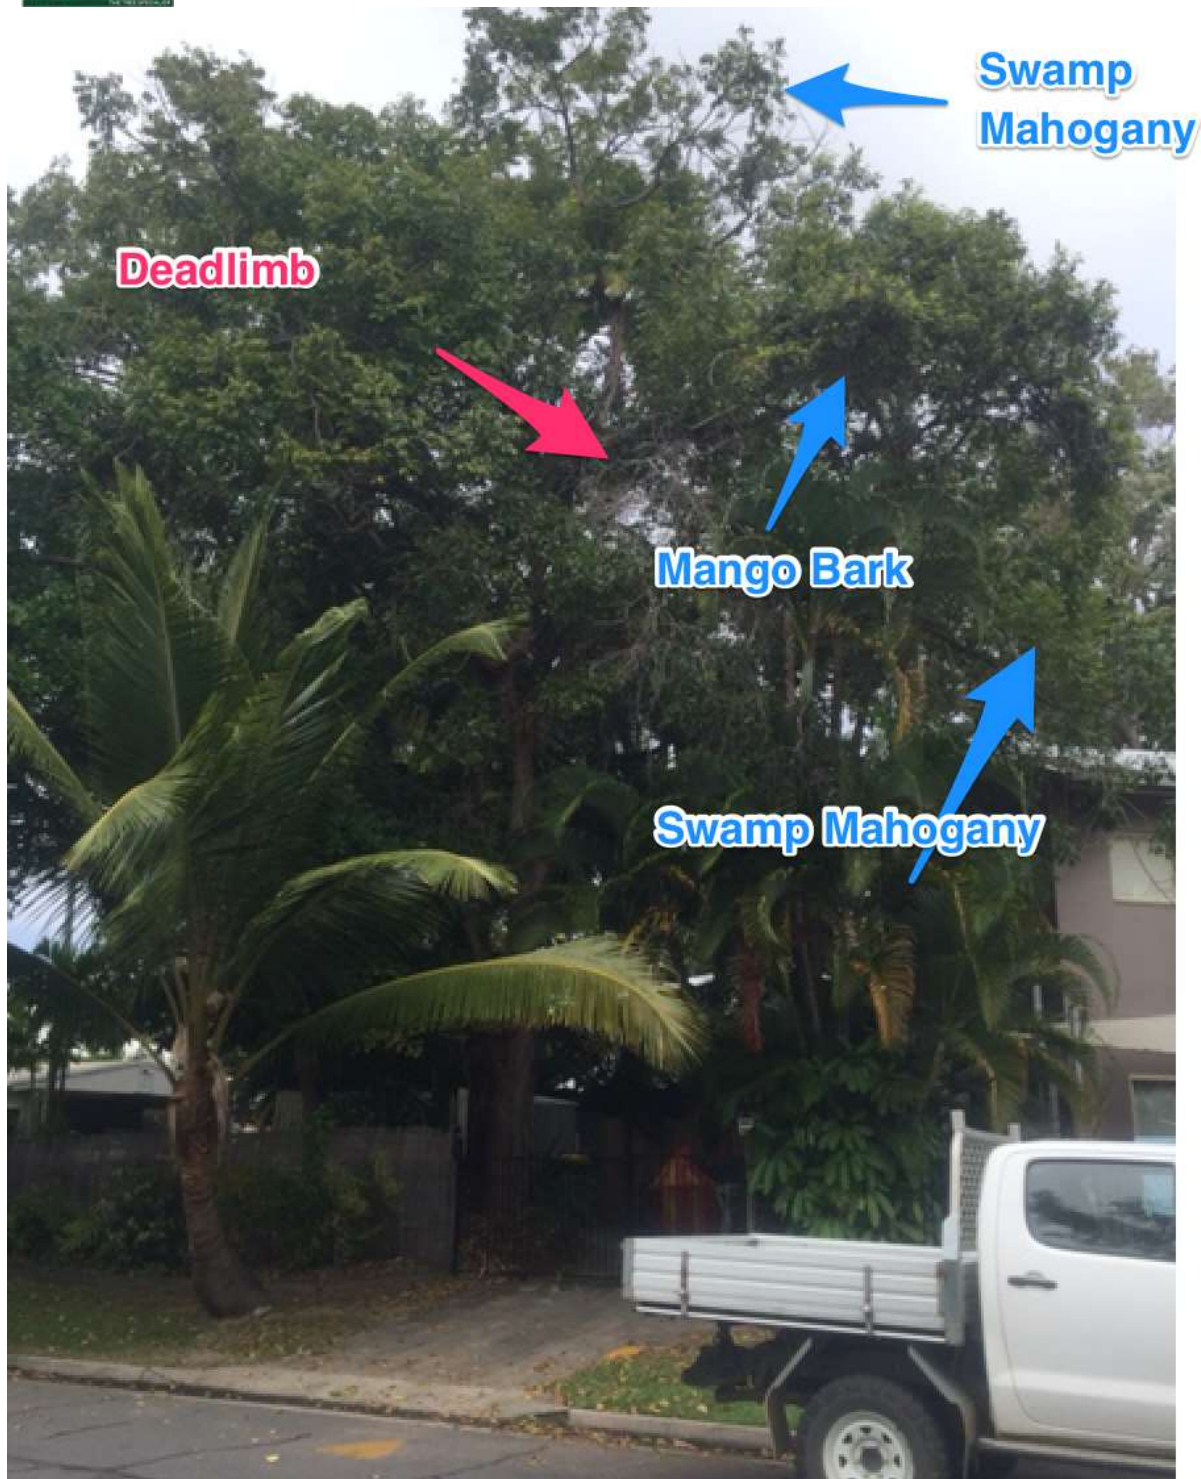
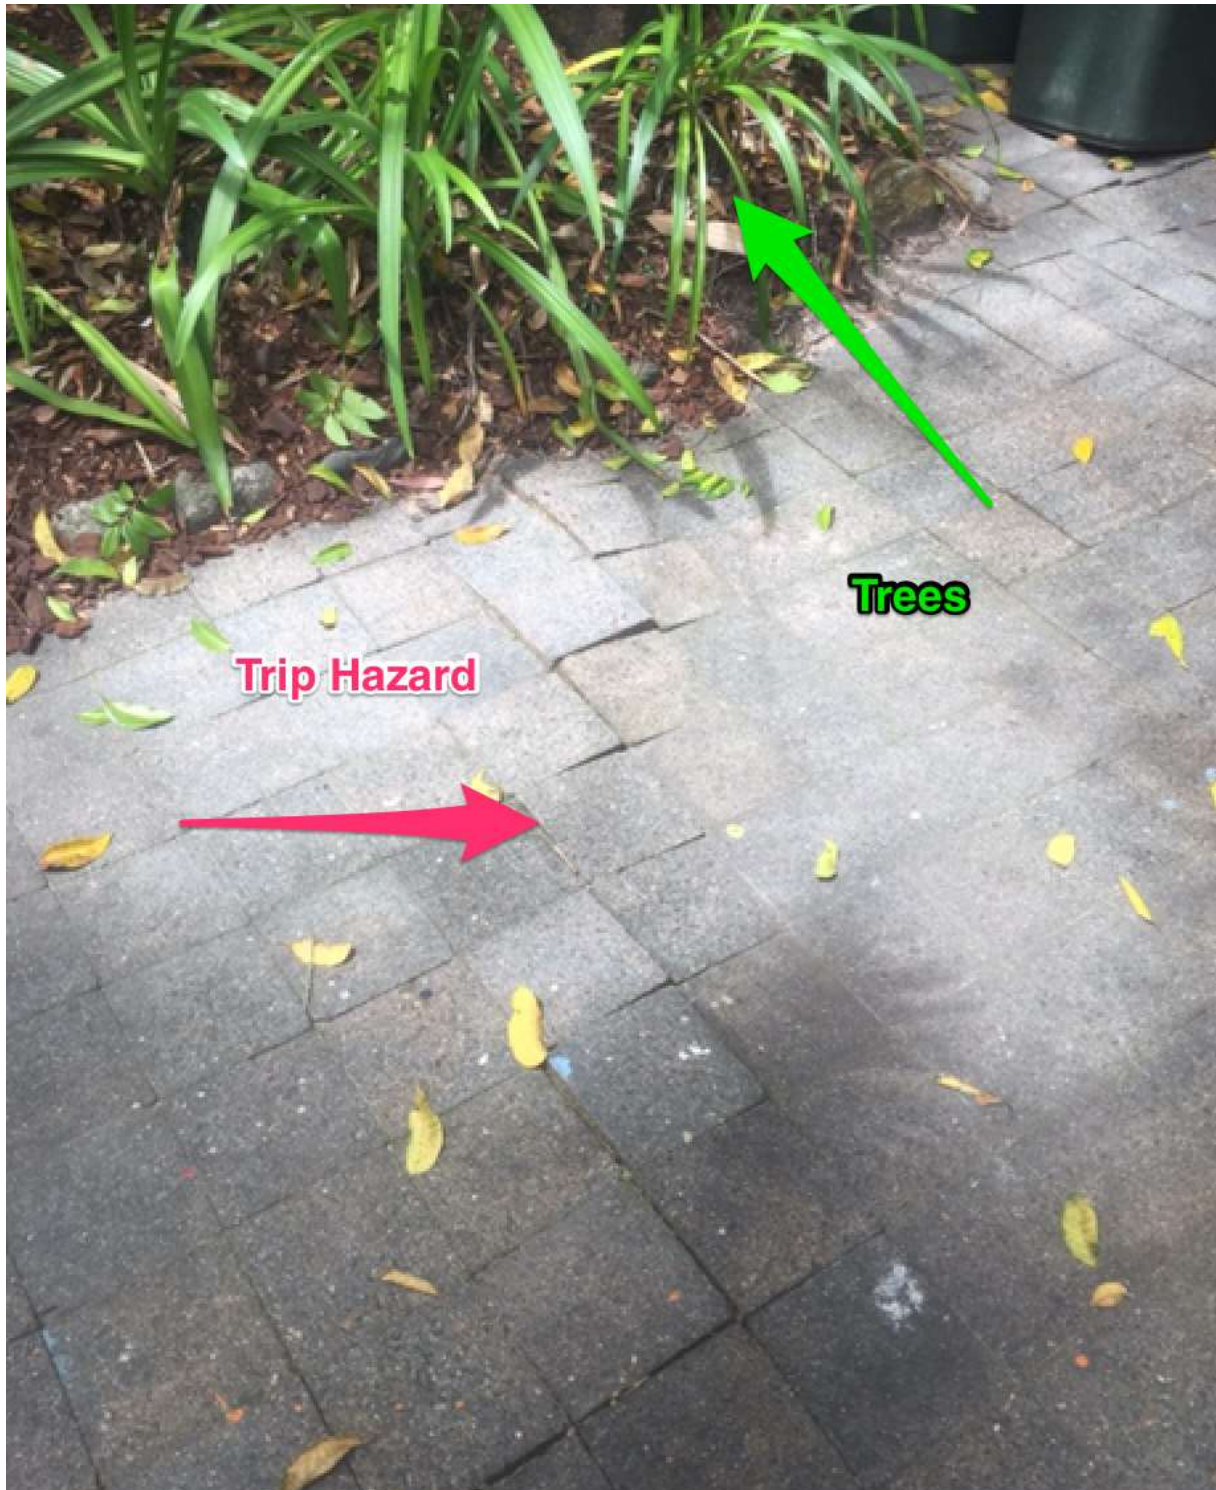
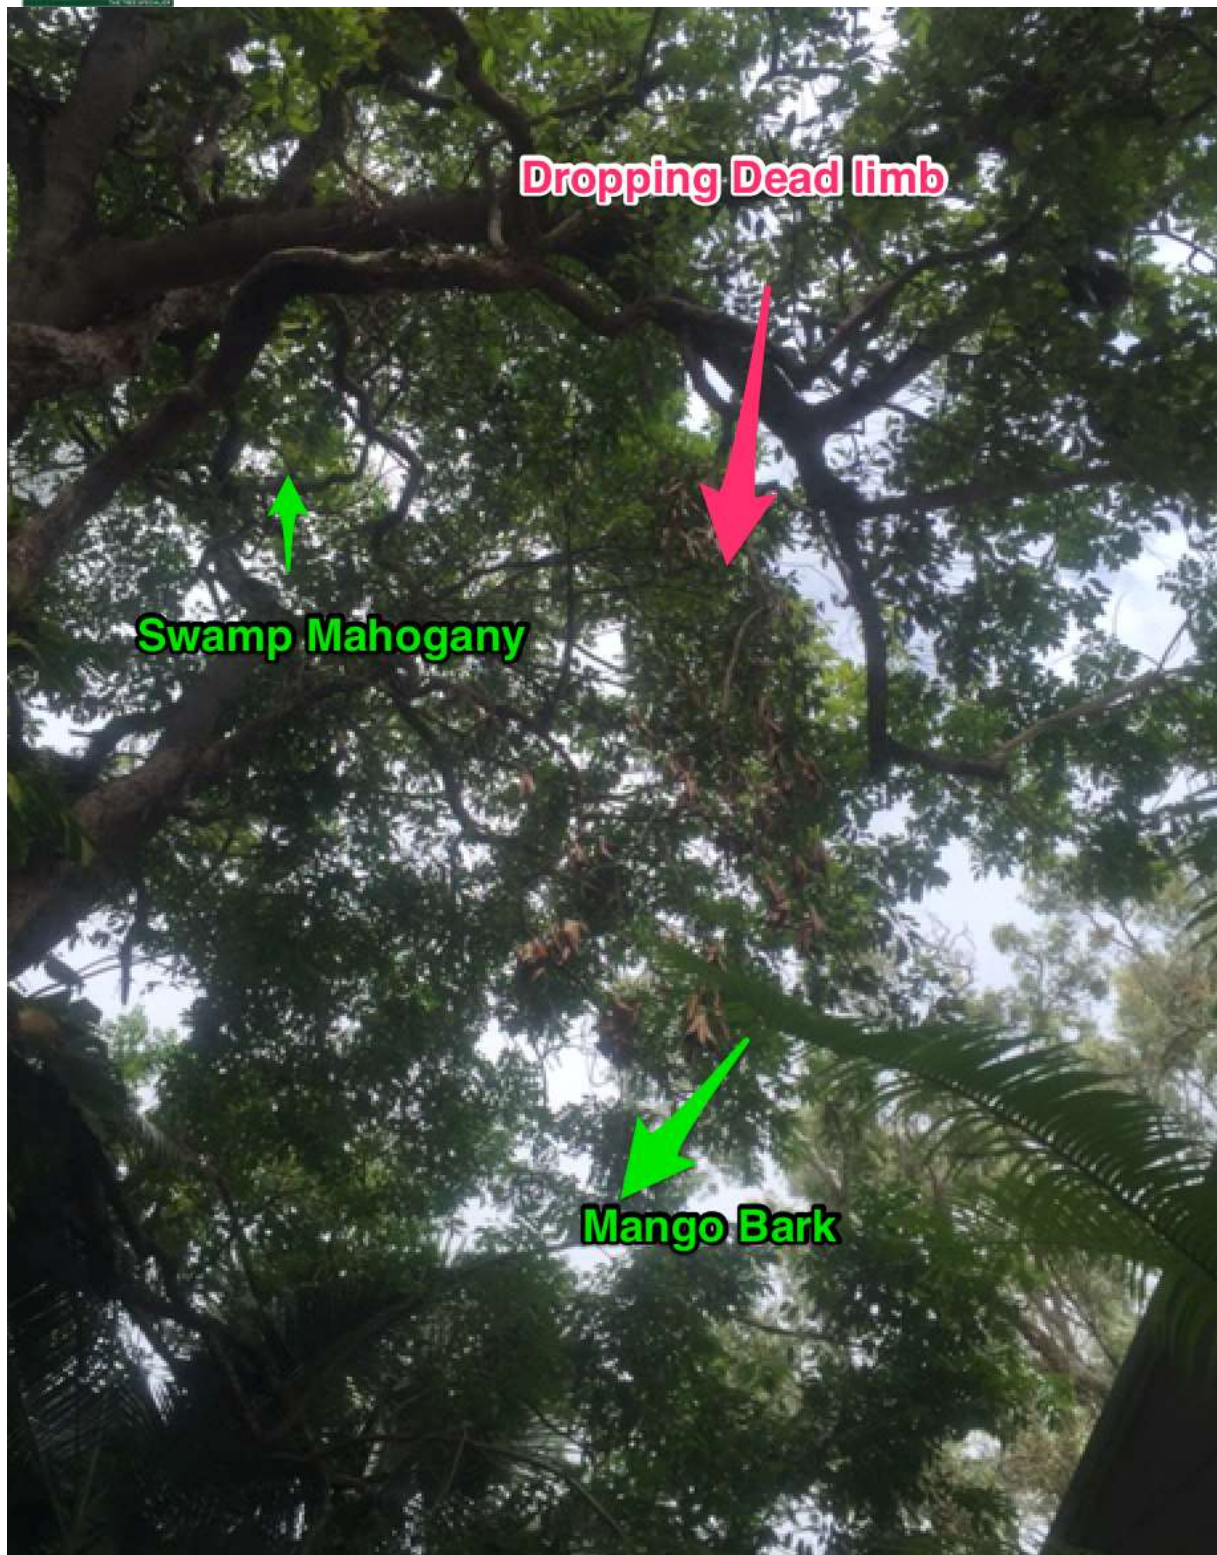
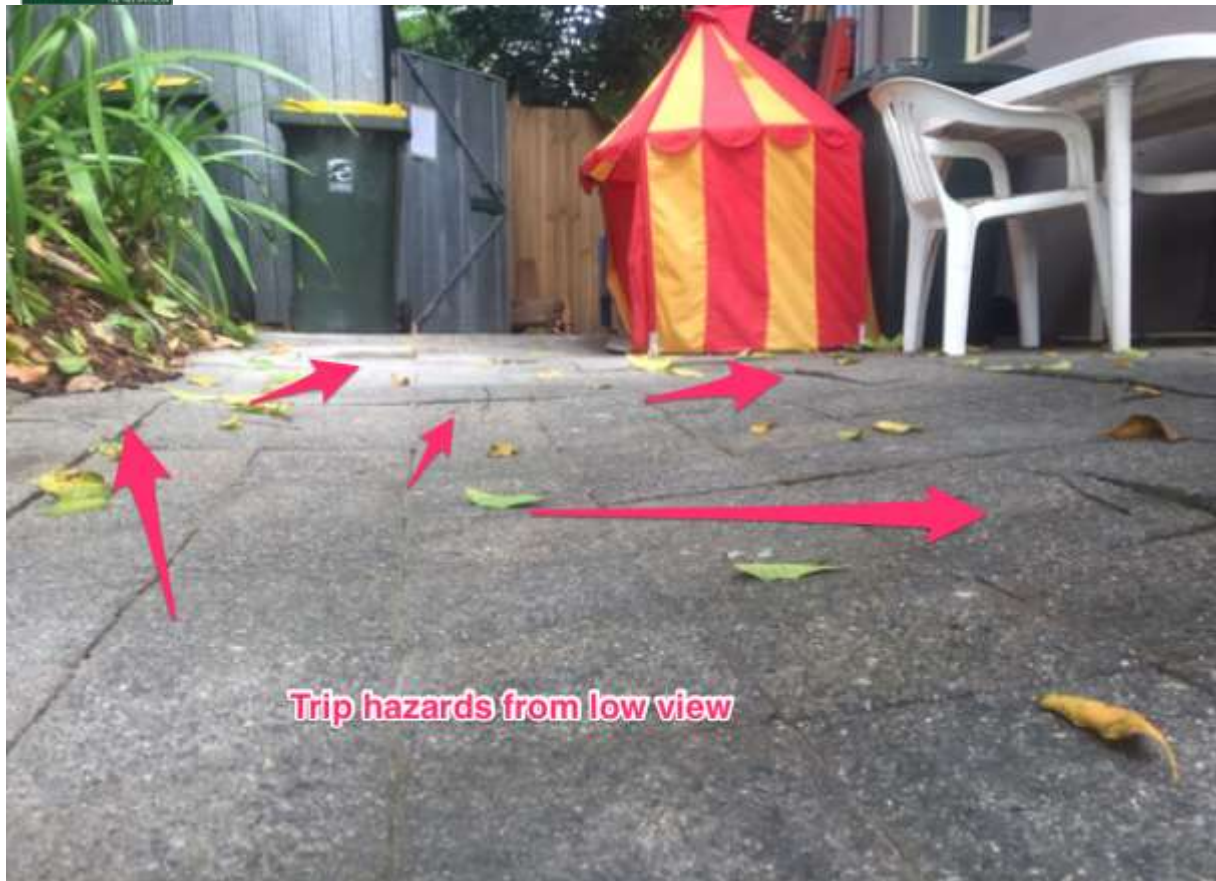
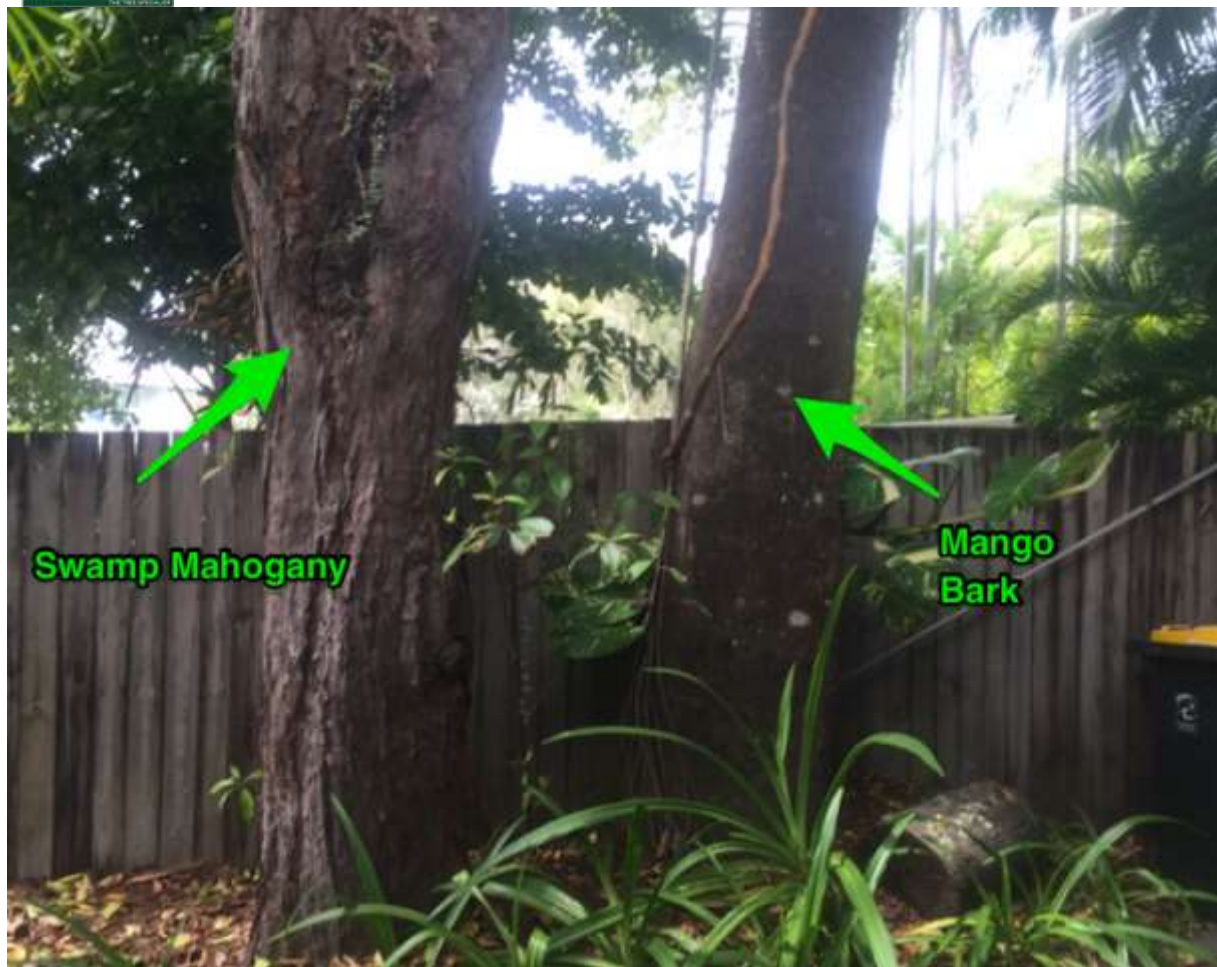
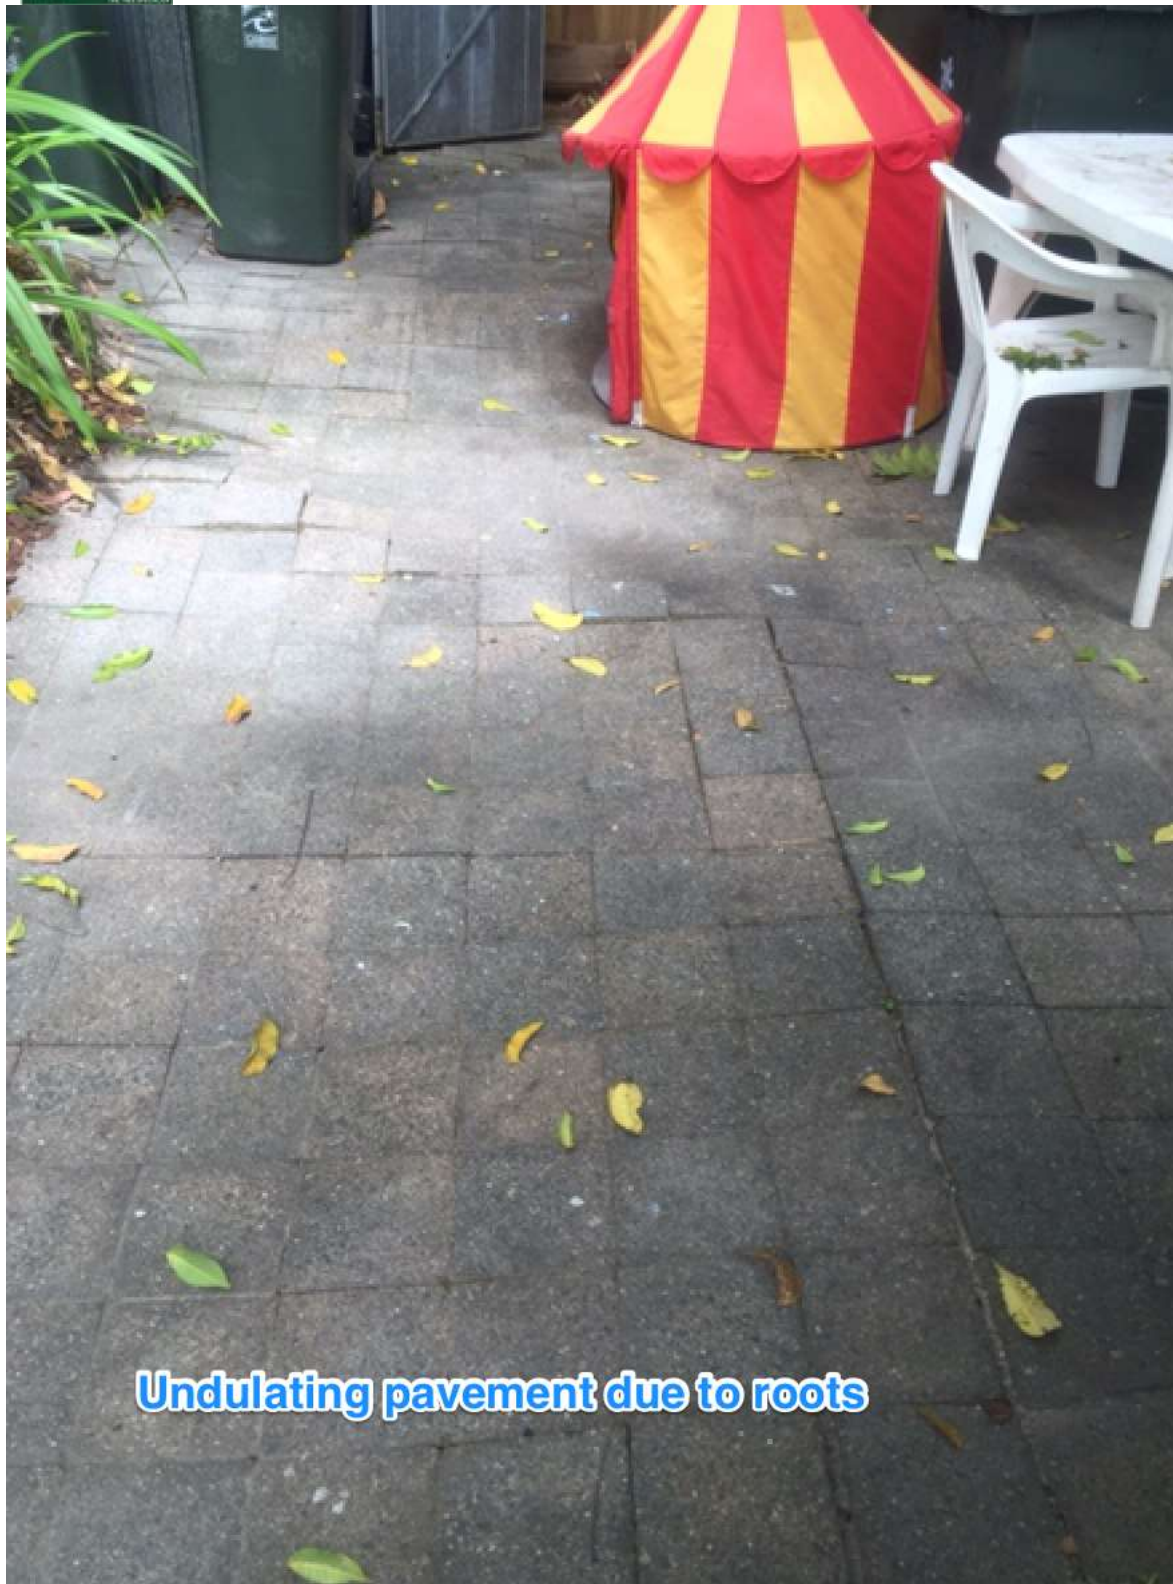
Comments	Recommendations	Priority
This tree is of mature age is located in a risen garden bed adjacent to the kindergarten. The crown hangs over both the kids playing area and the shed/smoko area. As per photos you can see the amount of deadwood falling on to building and hung up in crown. Also, the large root system from both this Swamp Mahogany and the adjacent Mango Bark tree have caused the pavement to lift and cause major trip hazards.	Due to the type of tree that the Swamp Mahogany is, it is prone to losing branches and deadwood. This, coupled with the fact that the roots are causing a liability and to repave and remove the roots would cause the integrity of the tree to be compromised and cause a further risk. As attached there is a report from an OHS compliance officer for the kindergarten that has stated the trip risk.	H

Comments	Recommendations	Priority
Mango Bark or Scrub Turpentines are typically a species that is spread by birds and end up growing near fence lines, being the stopping place for the bird's droppings. They are quite quick growing trees and have an aggressive root system because of this. Much of the damage caused to pavers is due to this tree. As stated previously and as attached, there is a OHS report done specifying the trip hazard of these.	It is recommended that this tree please be removed for the obvious OHS issues. Any work done to remove these roots will compromise the integrity of the tree and make it more of an issue. It has also had limbs fall at various times, which these trees are known to do, which is a concern as this area is also designated for smoko, and access to the tool shed.	M

Comments	Recommendations	Priority
This tree is on fence line adjoining the kid's playground. This tree is in poor condition and in decline as shown by limbs. This tree has been overshadowed by adjacent trees which has limited its growth and effected the structure of its crown.	To remove this tree as it is a clear risk to those playing in playground and will only continue to cause root problems in the future	H

Overall the priority of work is the removal of the trees as they pose an immediate risk to students and staff.

Trees 1, 2 and 3 have structure issues also, which are typical for their species, at this point in their life cycle. Also, to remedy the trip hazard the trees and roots will have to be removed, or as the alternative, cutting and removing the roots and placing on root barrier, will effect the integrity of the tree – this is not safe option.
