# Central Tree Services

# **Tree Health and Condition Report**

Douglas Shire Council Warner Street, Port Douglas 18<sup>th</sup> March 2021

Arborist: Jim Scott, B.Sc. (Hons) - Level 8 Arborist

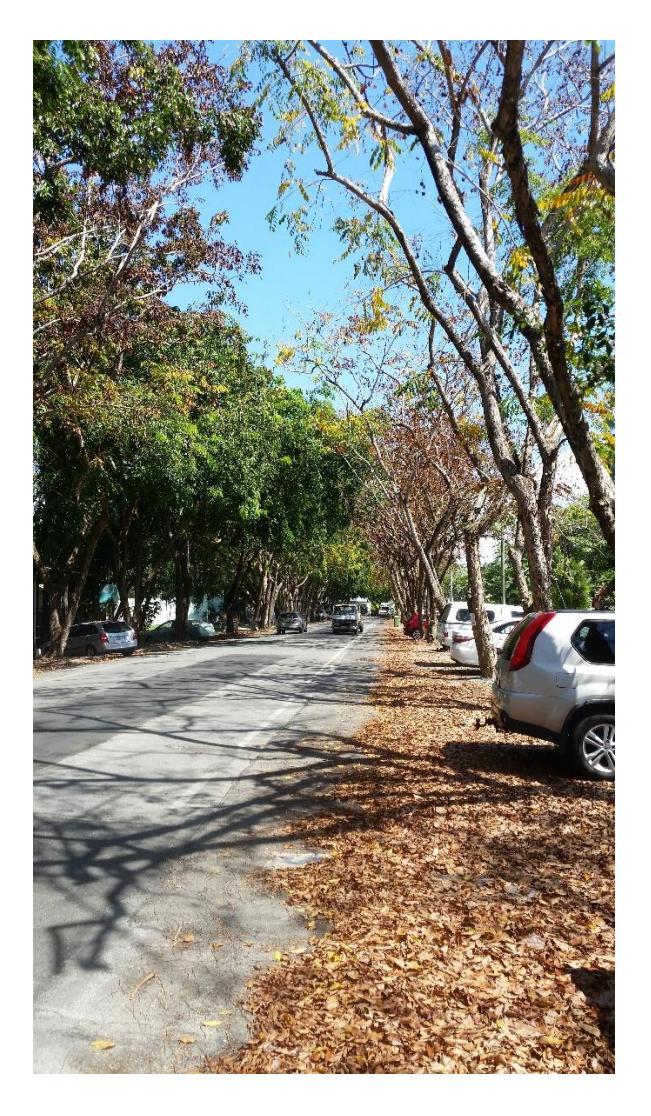
With the exception of a number of trees located within garden beds (corners of Grant and Owen Streets), the entirety of trees along the eastern side displayed advanced symptoms of rapid decline/death. Symptoms were uniform and consistent in nature, indicating an event which has impacted upon all of the affected trees within a short timeframe (see Image 1, below)

Image 1 – Avenue of Rosewoods along Warner Street, 18th March 2021

The severity of current damage to the trees is immediately apparent from Image 1, and can be seen in stark contrast when compared to the condition of the trees in a previous assessment (see Image 2, below).

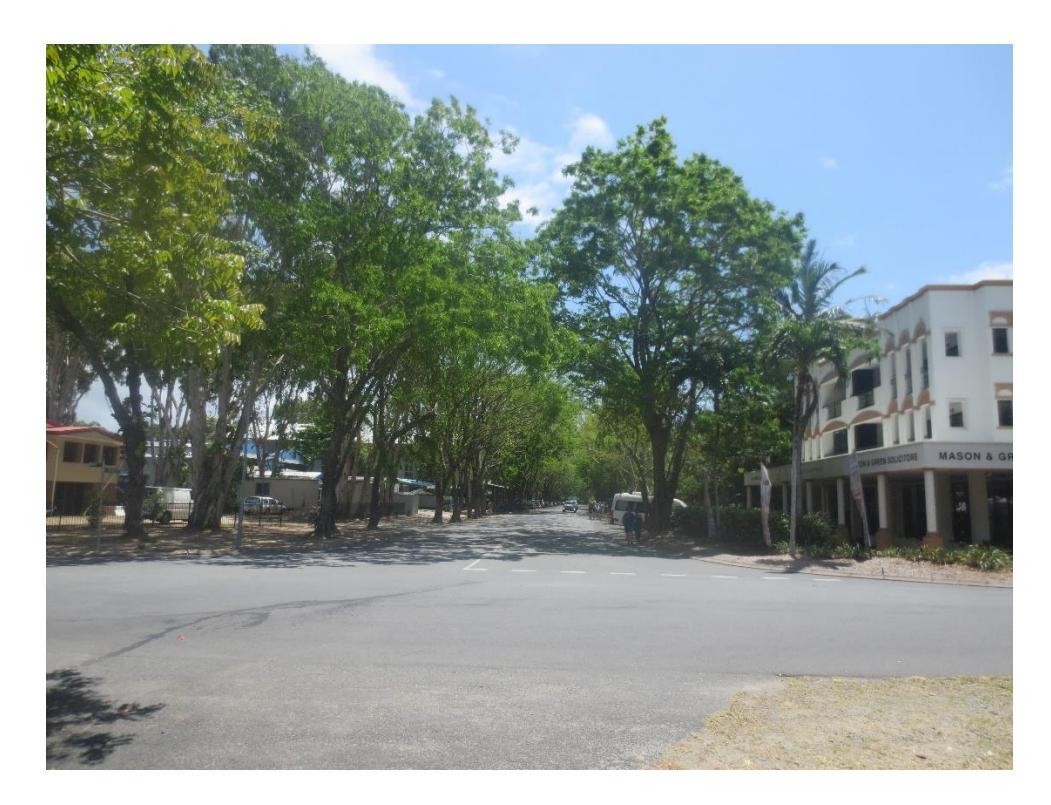
Image 2 – Avenue of Rosewoods along Warner Street, 17<sup>th</sup> October 2017

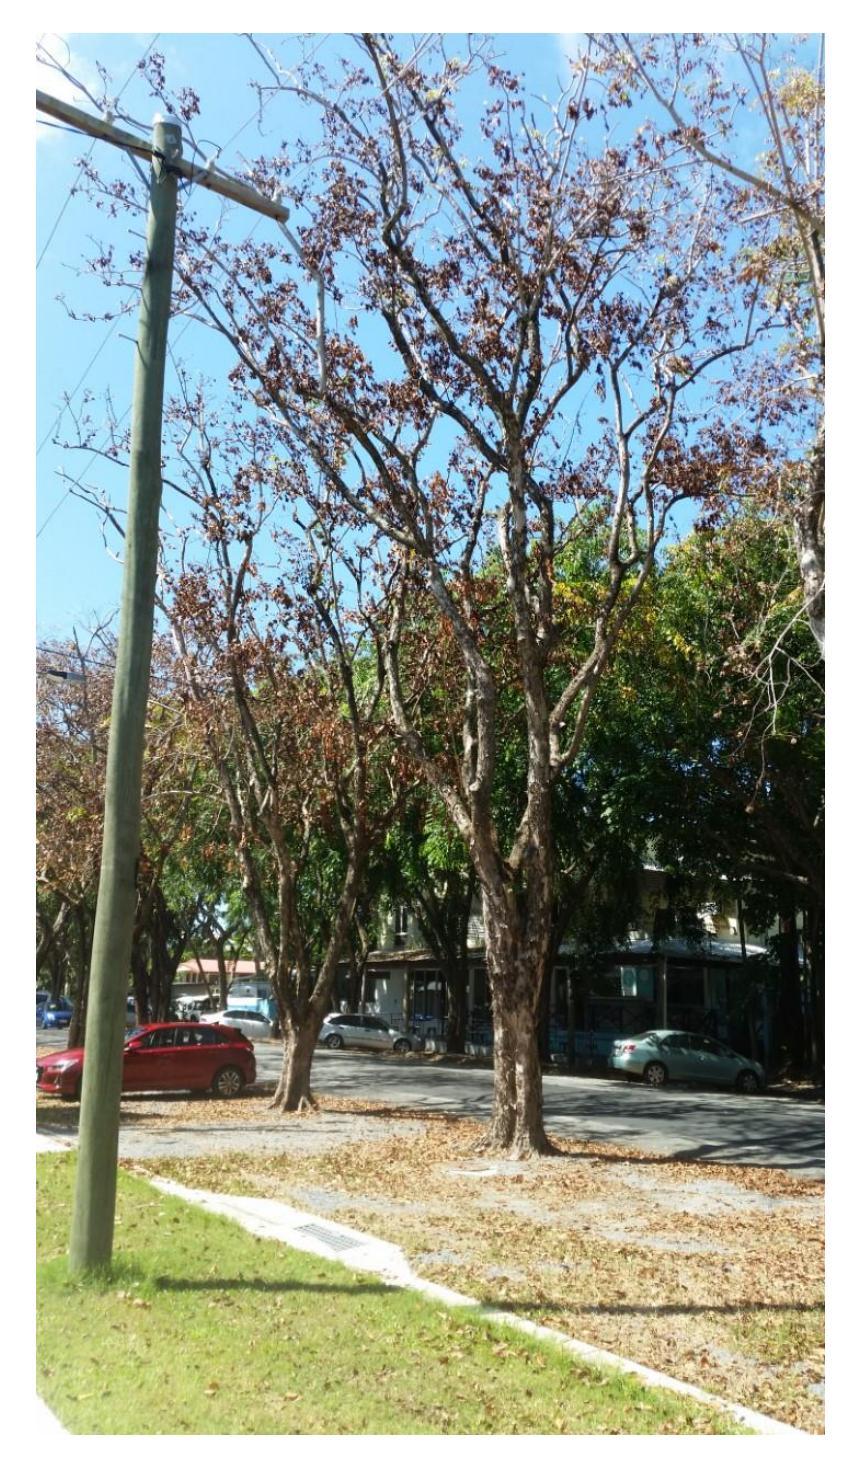
The consistent nature of decline and uniform symptoms observed, particularly along the eastern side of Warner Street, would indicate a rapid event which has led to almost instant dieback/death of the assessed trees (see Image 3, below).

Image 3 – Tree located next to 32 Warner Street (18/03/21). Rapid "brown out" of leaves indicating a sudden impact upon the tree.

The sudden and consistent nature of death/dieback would most likely suggest a uniform chemical impact event such as application of a woody weed herbicide around the base of affected trees.

Observed crown symptoms (rapid death of almost all foliage, also referred to as brown out) is consistent with the effects of woody weed herbicides such as Grazon (although this could only be accurately confirmed following laboratory analysis of affected plant tissue).

- Closely monitor all trees for any further signs of decline
- Once individual trees have been confirmed as being dead, prioritise removal. This is particularly important given species characteristics Rosewood trees typically have highly unstable deadwood.

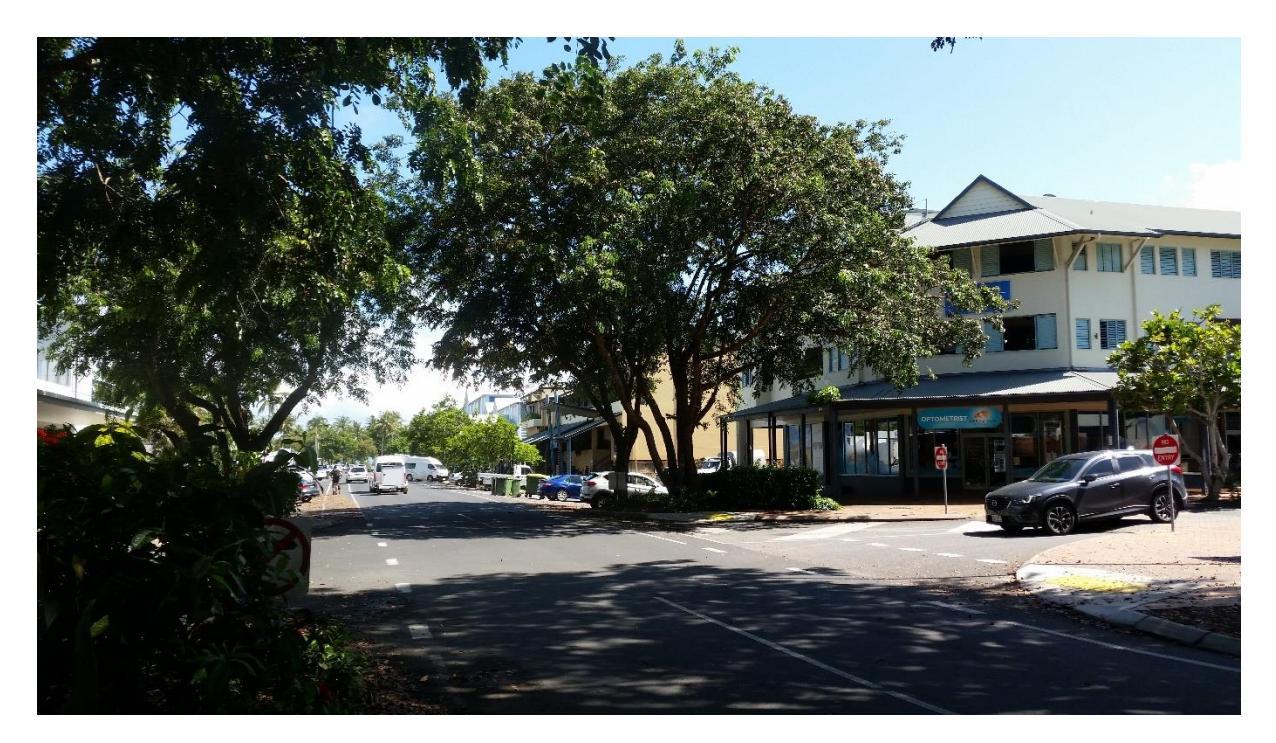
Image 4 – Typically healthy Rosewood tree located in garden bed at corner of Warner Street and Grant Street (18/03/21). Tree is in good vigour, with typically dense crown profile. No indications of dieback, brown out or otherwise

More importantly, a comparison between trees within the street on the day of assessment clearly shows that this is not a factor (see Images 3 and 4 in section 5 of this report).
