Geotechnical Investigation

69-73 Murphy Street Port Douglas QLD 4865

20039AA-D-R01-v1 Gurner 29 October 2020

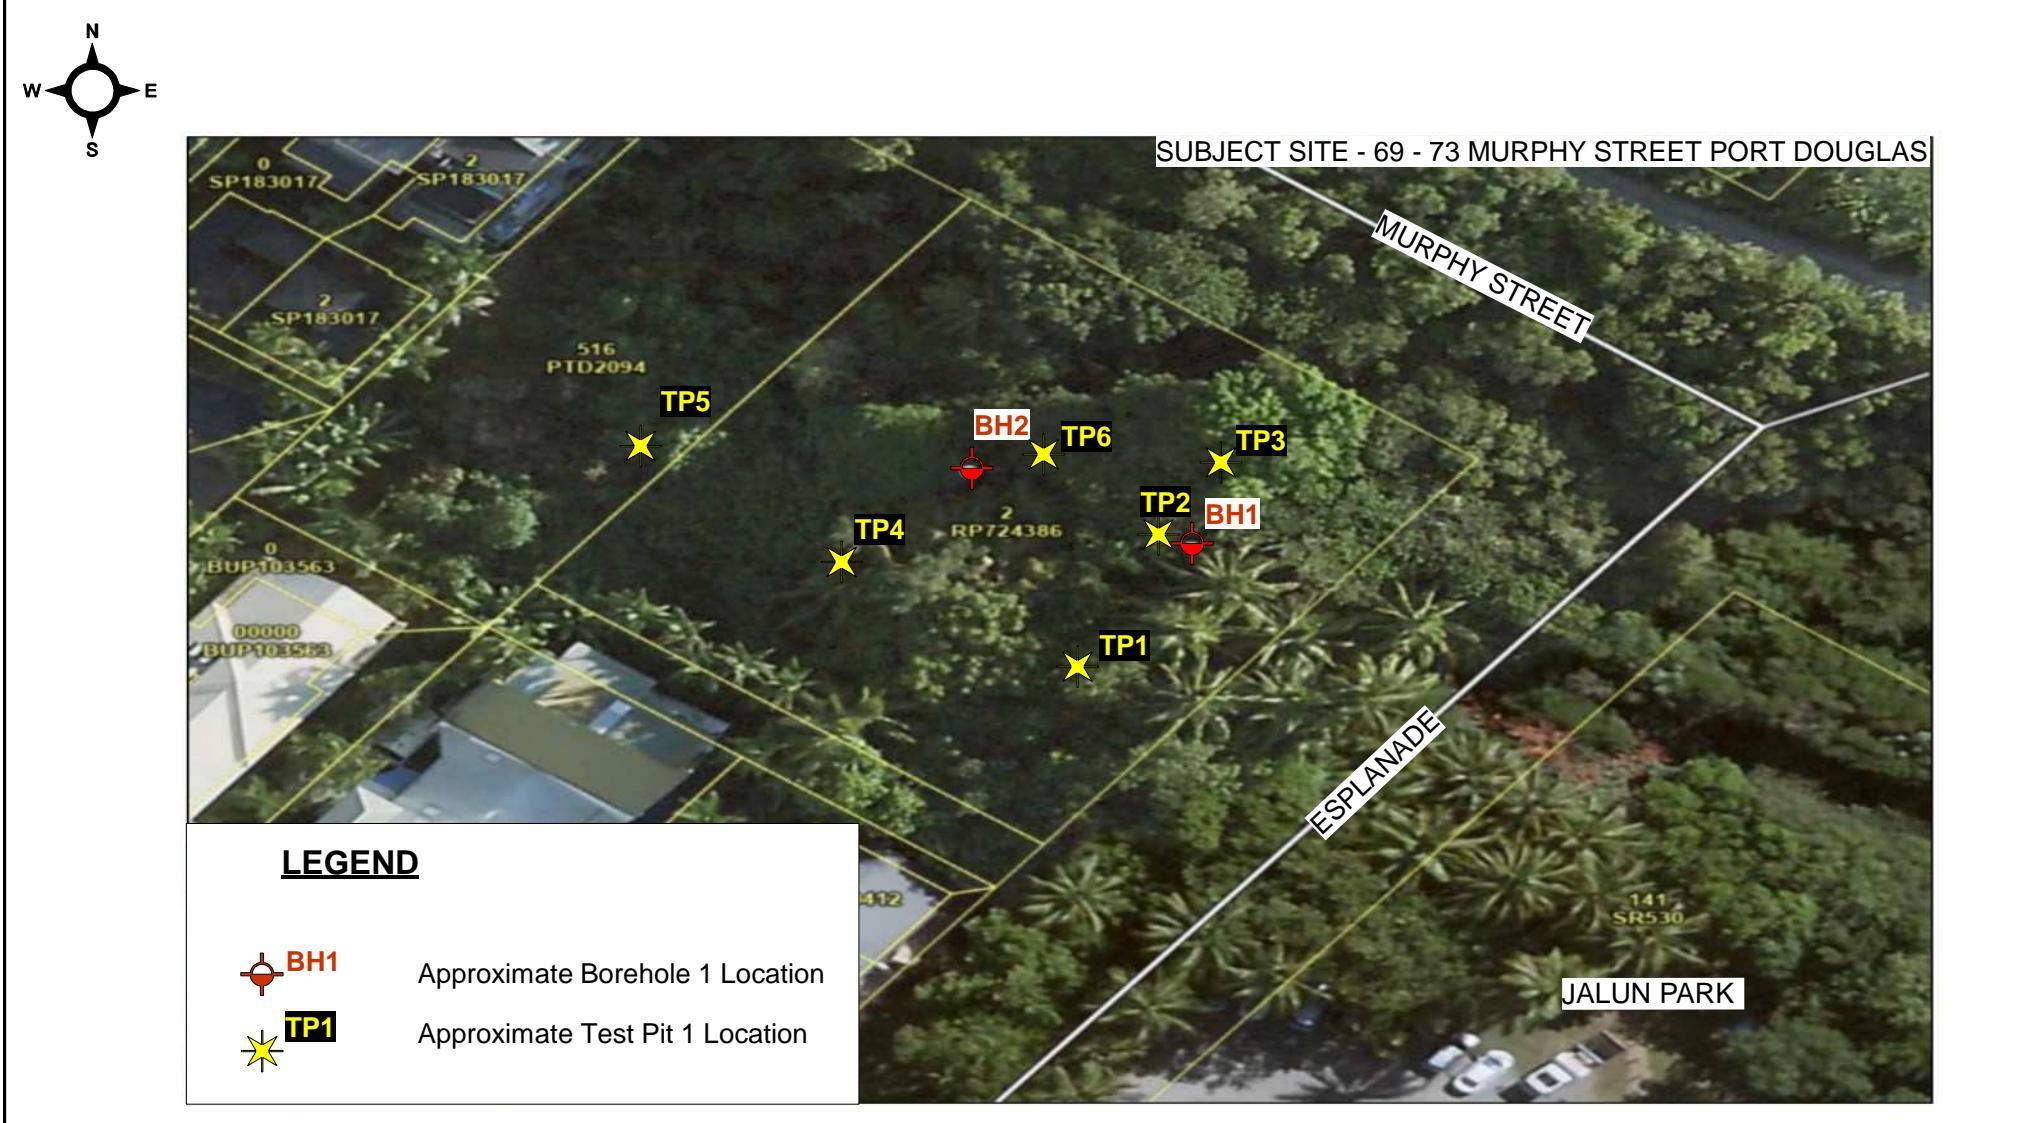
Figure 1 Site Plan

The results of the fieldwork are presented in Appendix A. The approximate locations of the field tests are shown in Figure 1.
