George Argyrou – Lot 5 RP 747684 – Information Request

EROSION & SEDIMENT CONTROL PLAN

REVEGETATION SITE SURVEY OF 16 MURPHY ST. PORT DOUGLAS

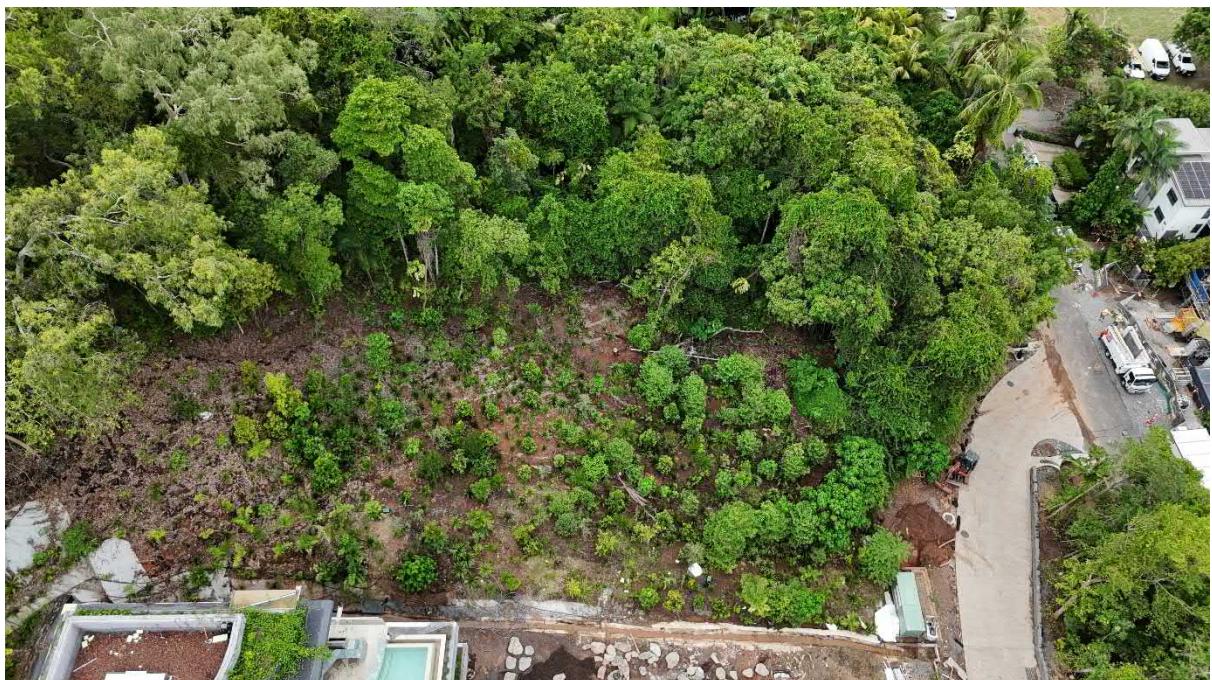
Figure 5 – Site Overview

The site surface is relatively steep running downhill from northeast to southwest with an estimated overall average slope surface of approximately 30%. Refer Figure 5 for photo of site.

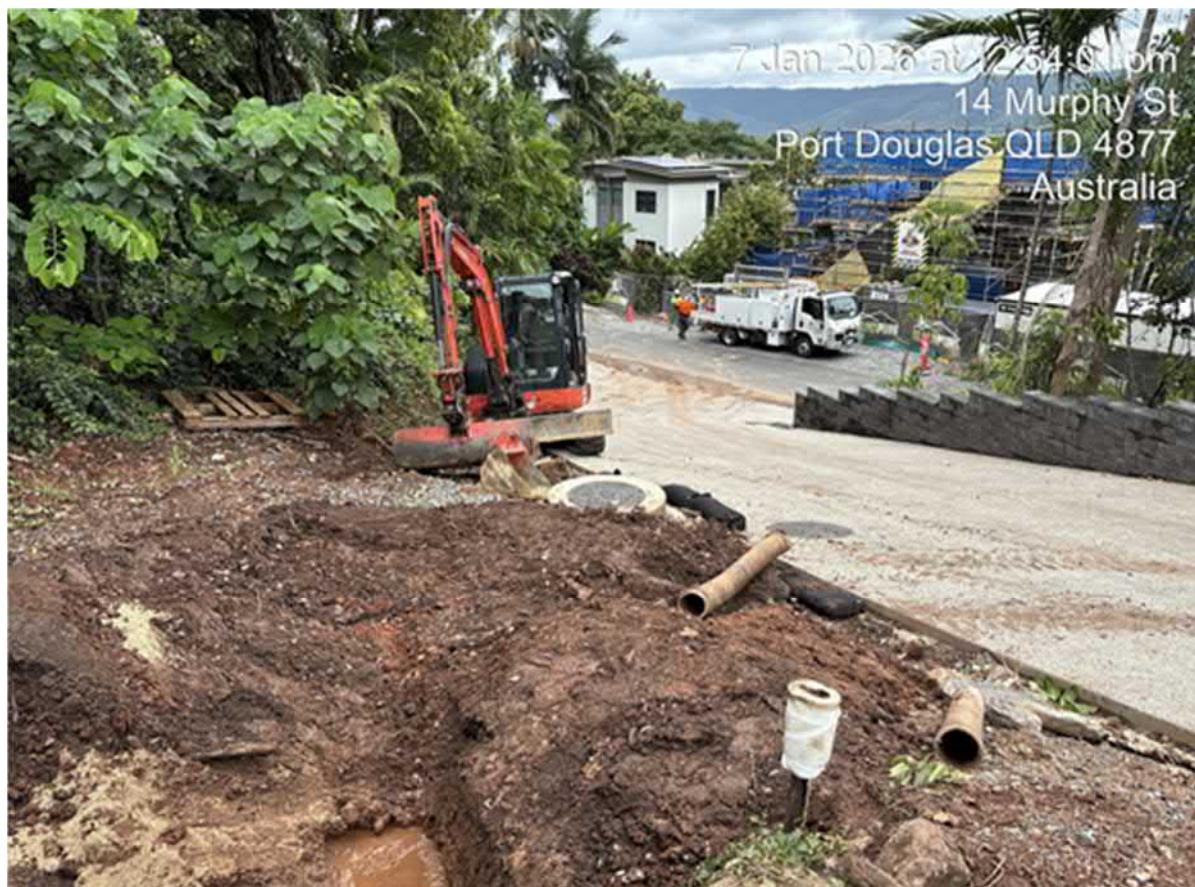
Figure 6 – Ergon Works

At time of inspection Ergon were undertaking works from Murphy Street to the Electrical Padmount Easement. After completion of these works by Ergon the area should be appropriately stabilised with use of topsoil and turf. Refer Figure 6 for photo of Ergon works.

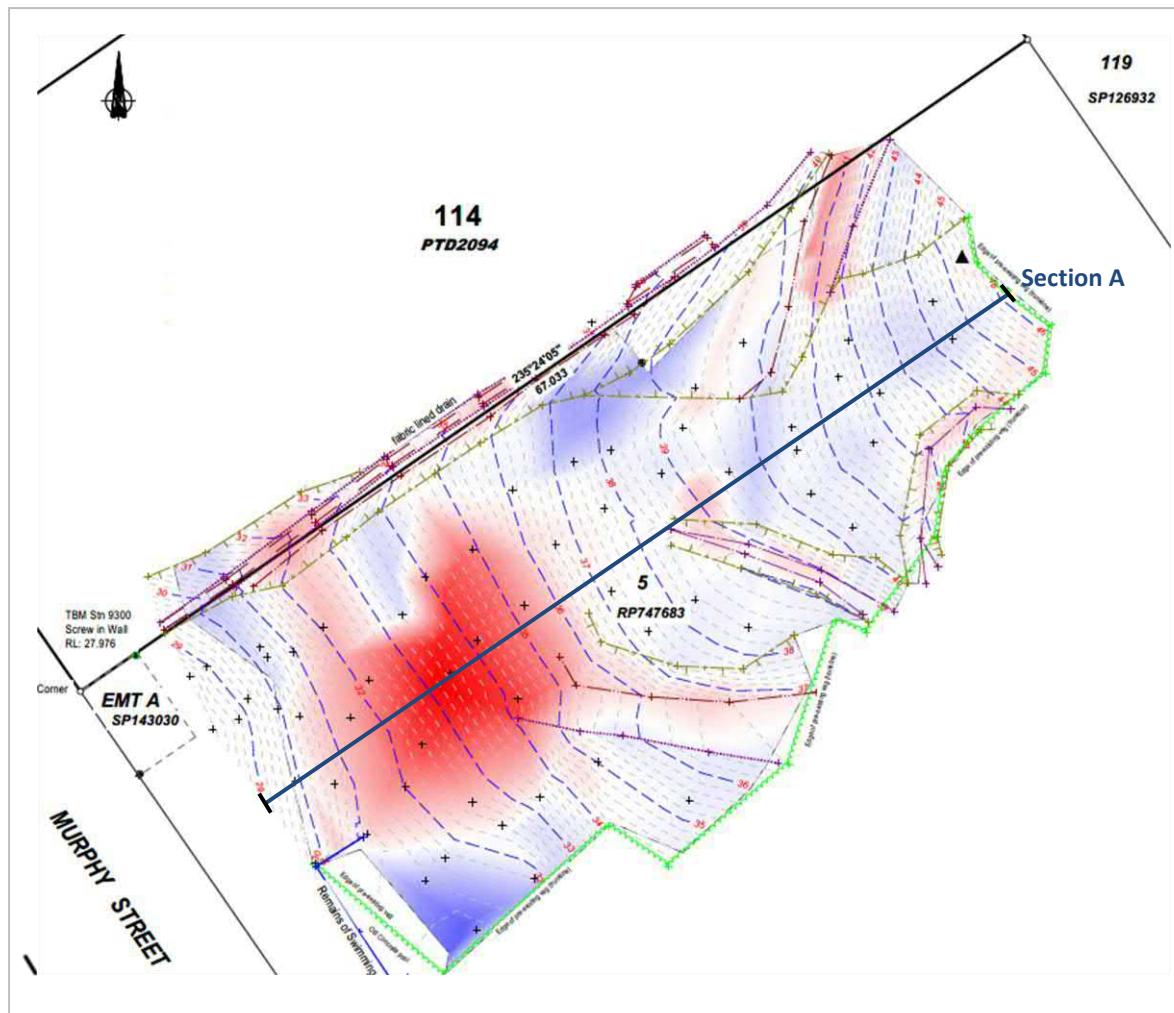
Figure 1: Section for Stability Analysis
(Extract from RPS Drawing PTD17397-107)

Given the results of the previous geotechnical investigations and inspections as outlined above and the developed geotechnical model, together with the survey data provided for the subject remediated Lot 5 area (attached), a slope stability analysis was carried out on the remediated area. The section used for the stability analyses noted as Section A, is shown below in Figure 1.

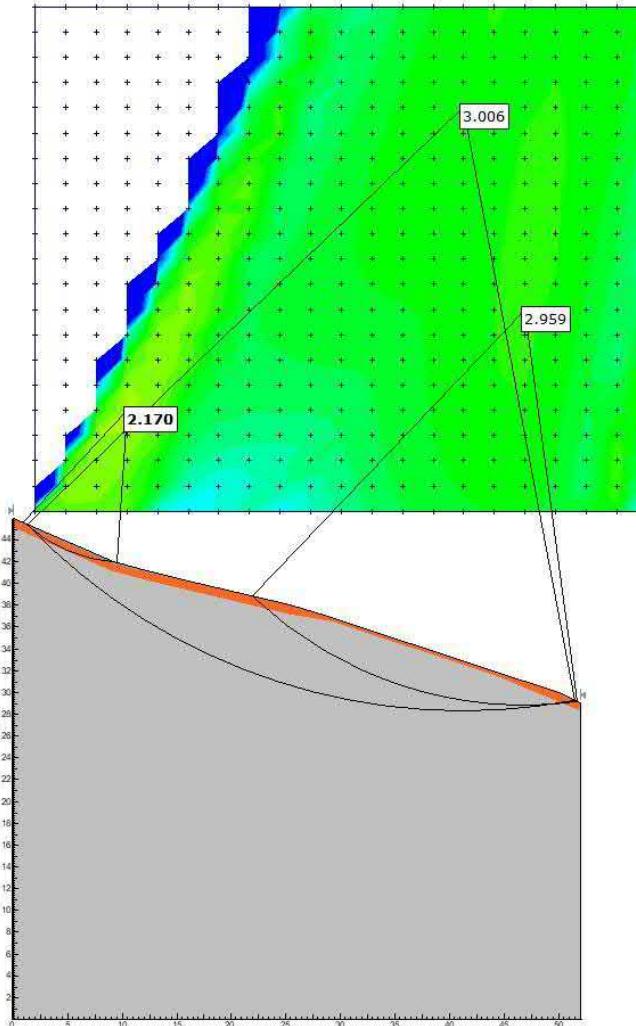
Client:	Hickory Constructions Group	GEOTECHNICAL ASSESSMENT
Drawn:	SRF	LOT 5 ON RP747683
Scale:	NTS	RESULTS OF STABILITY ANALYSES SECTION A DRY CONDITIONS
Project No:	24046AB-D

Failure Location	Calculated Factor of Safety (FOS)	
	Dry Conditions	Extreme Conditions
Upper Slope	2.17	1.843
Lower Slope	2.959	2.698
Global	3.006	2.730

The results of the stability analyses indicate that the FOS for instability for the potential failure surface areas along the remediated slope are >1.5 under the dry conditions modelled and wet/extreme conditions modelled. As such, it is considered that the overall site should be stable.

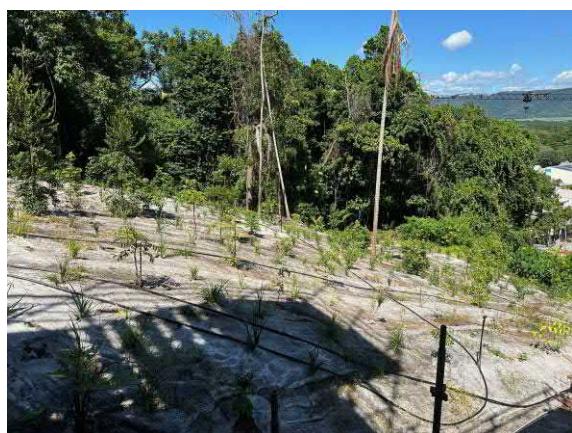
Photo February 2025

The photos below show the area of planting in February 2025, just after planting and again in September 2025. Good growth rates have been achieved, and the project delivers a much greater biodiversity than what was present prior to the site disturbance.
