## EXEMPTION CERTIFICATE

Removal of large Melaleuca tree near northern boundary.

Street Address: 127 Davidson Street Port Douglas  
Real Property Description: Lot 0 on BUP105672  
Local Government Area: Douglas Shire Council

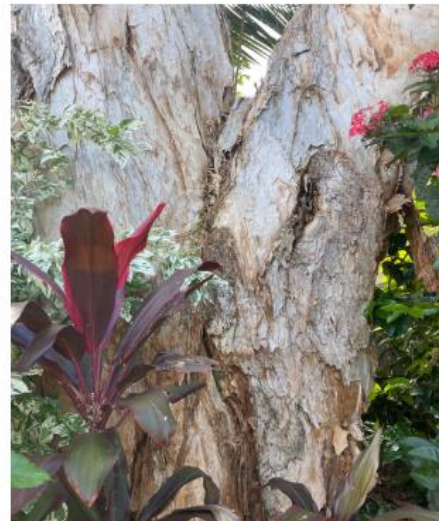
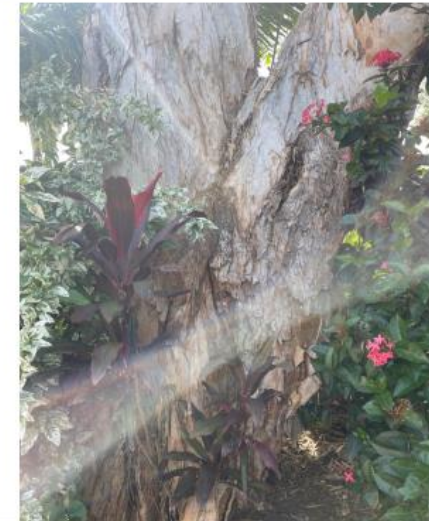
Tree is bifurcated from ground level to approximately 2.5 m, failure would be catastrophic. Evidence of previous termite damage in stem bark ridge

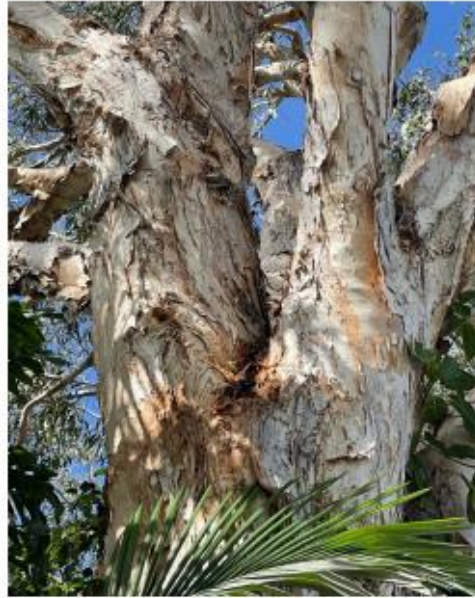
Left hand leader has multiple stem bark ridge with exudates flowing from eastern side leader.

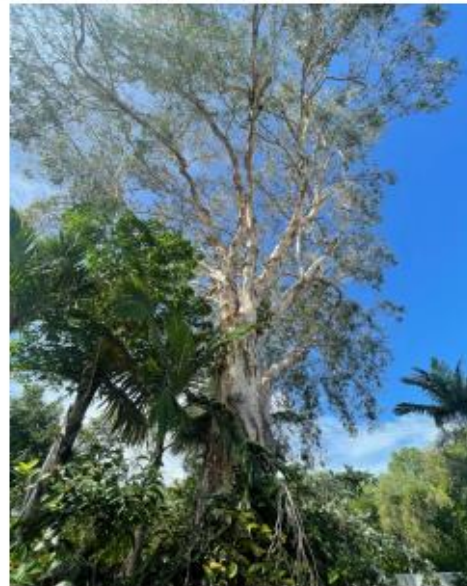
Tree has been directionally pruned away from infrastructure and power lines resulting in parts of canopy being predominantly epicormic.

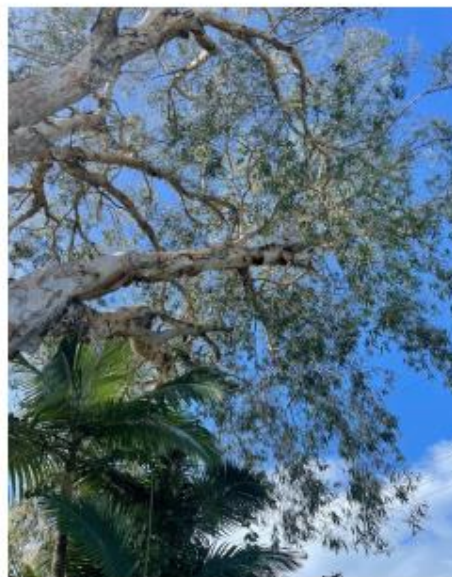
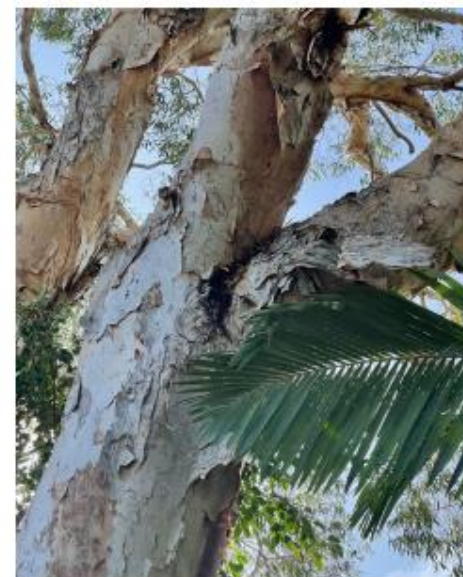
Right hand side leader leaning approximately 45 degrees toward high voltage powerlines and has large stem bark ridge displaying severely on top side.
