**RE: RESPONSE TO INFORMATION REQUEST - APPLICATION FOR OPERATIONAL WORKS (EARTH DAM) ON LAND LOCATED AT 22 MOUNTAIN VIEW DRIVE, SHANNONVALE (LOT4 SP134229) COUNCIL REF: OP2971/2019**

**AP and BR Eldridge, Mountain View Road, Shannonvale**  
**Analysis of Existing Dam on Lot 4 SP134229**

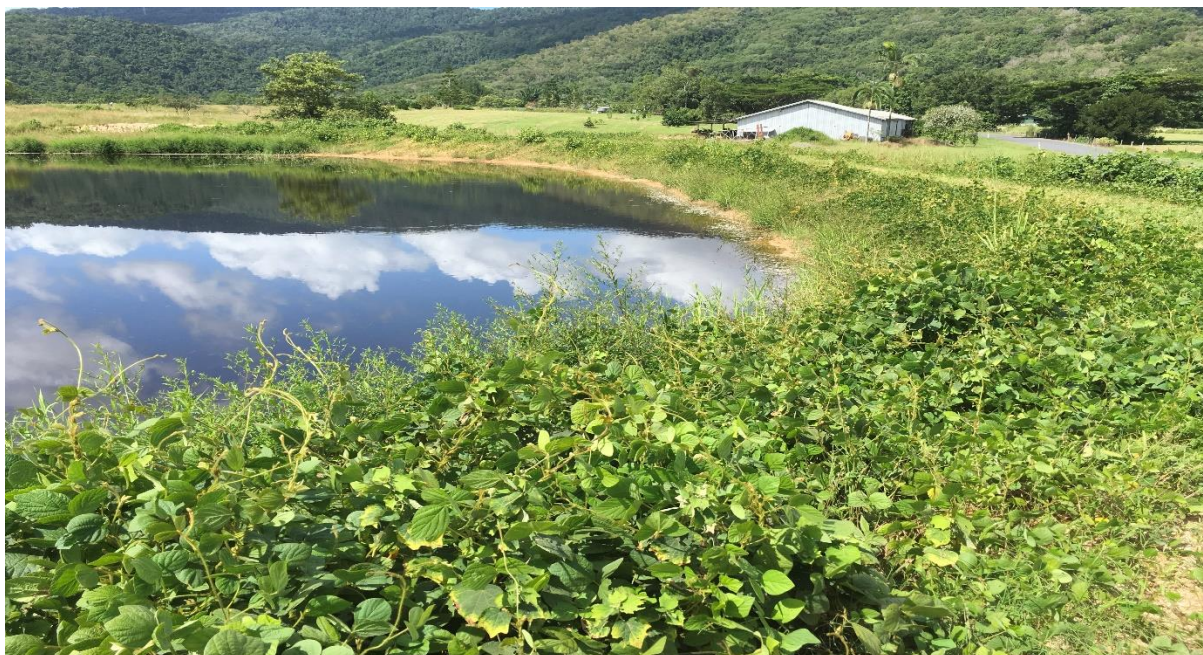
Photo of dam looking from east to west (towards Thomson Low Drive)

The dam is considered to be well constructed.

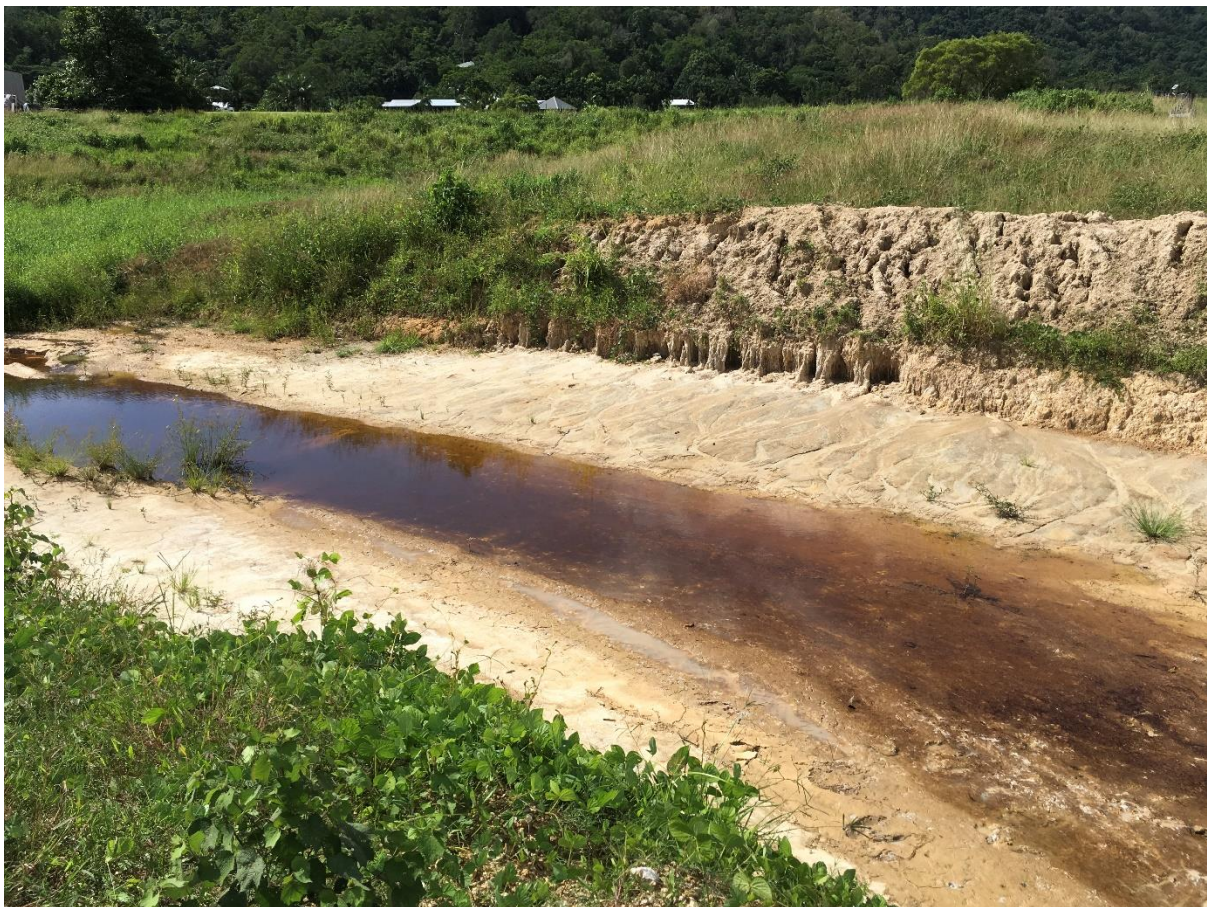
Spillway

With the depth of the spillway being 1.1m, the dam will not overtop with a PMF event. With the PMF, the dam still has 0.66m freeboard. The PMP is about three times the 1% AEP flood event in the catchment (1 in 100 year ARI event).

The spillway is capable of passing overflow from a PMF event.

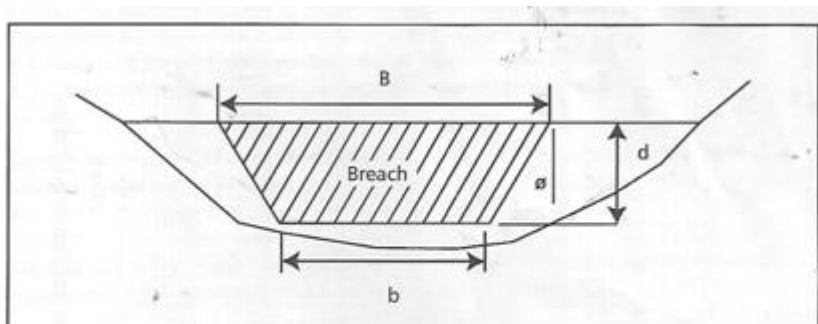
Figure 5 - Notation for breach parameters

In this case we have a relatively long low embankment and a small storage volume of water, so B/b and B/d for this dam also fall outside the parameters. Therefore, assume a dam failure occurs with the PMF storage level and that the whole dam fails at the upper limit of those parameters (worst result/conservative)

Obviously the dam is outside the parameters in the Guidelines. There cannot be 9 metres of water behind the dam. However, as a guide, the Breach Development Time (BDT) was calculated based on the volume of material removed as the dam fails ( $V_m$ ) (Guidelines Fig 6.)  $V_m$  from the characteristics of the dam =  $2,262 \text{ m}^3$ . Therefore BDT came out as 37 minutes
