**REQUEST FOR RECONSIDERATION OF COUNCIL  
RECOMMENDATION**

**36 MURPHY STREET,  
PORT DOUGLAS**

**REQUEST FOR RECONSIDERATION OF COUNCIL RECOMMENDATION  
IN RELATION TO MATERIAL CHANGE OF USE (IMPACT) FOR MULTIPLE  
DWELLINGS (RESIDENTIAL) – TWO (2) UNITS UNDER A SUPERSEDED  
PLANNING SCHEME  
36 MURPHY STREET, PORT DOUGLAS**

APPENDIX A – REPORT PREPARED BY DOUGLAS PARTNERS

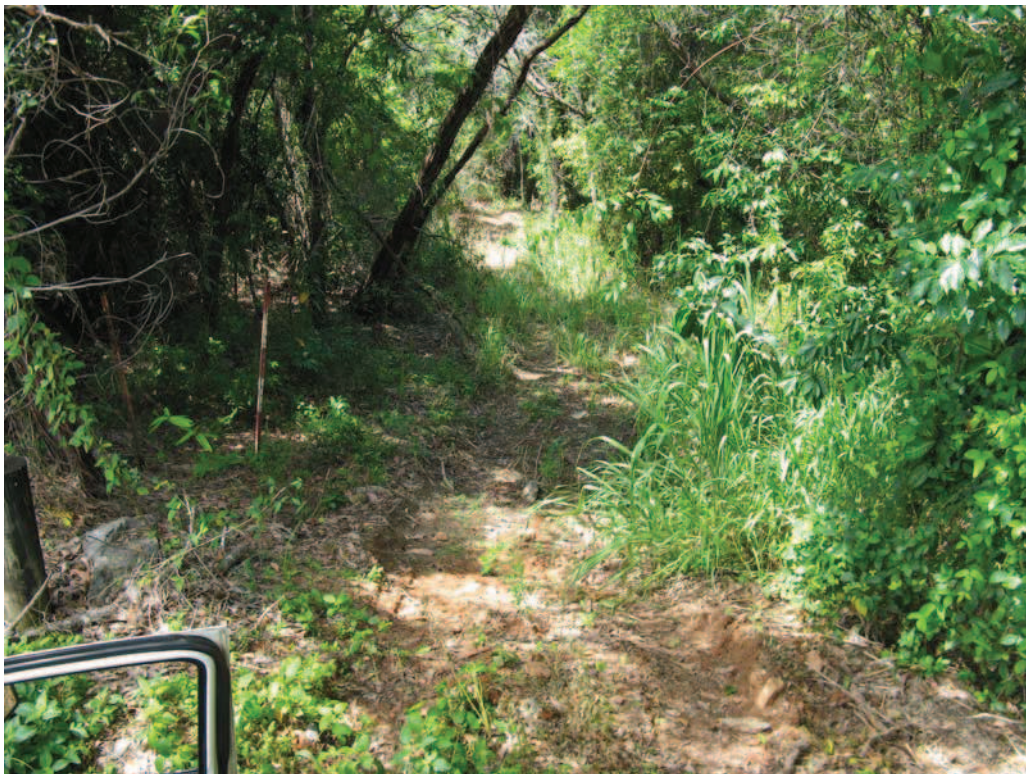
generally obscured by leaf mulch and vegetation, and was generally battered at about 1V:1H. Similar fill depths and batter slopes were observed along the western side of the unformed access track.

Vegetation in areas adjacent to the existing cut track mostly comprised numerous shrubs and relatively immature trees, with trunk diameters up to about 150mm, but mostly smaller.

**Plate 1 – View from Island Point Road looking south along the existing unformed track**

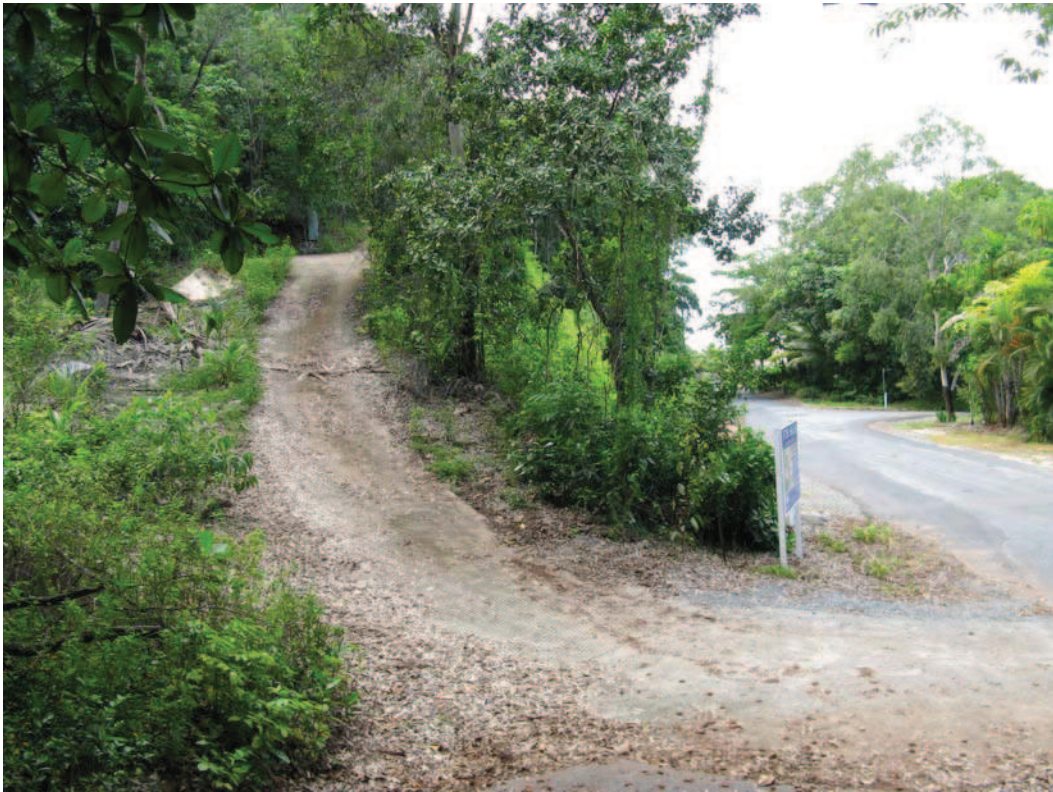
**Plate 1 – View along sealed portion of existing service track, looking south-east**

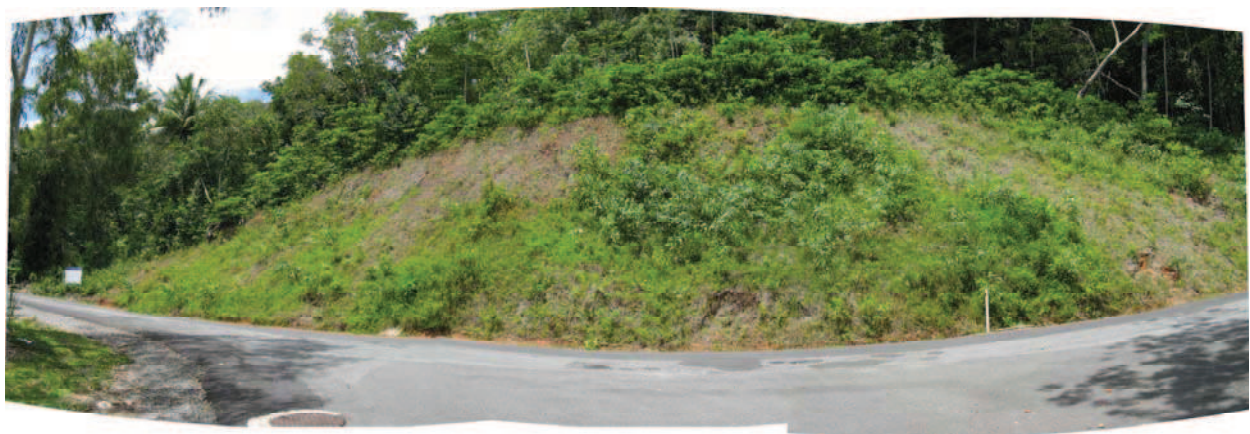
**Plate 2 – Stitched view of steep cut, looking north-east from Murphy Street**

The toe of the very steep cut is approximately 2m or less from the edge of the sealed pavement along Murphy Street, and within this distance, an unlined stormwater drain had been recently cut, showing outcropping bedrock (refer Plate 3).

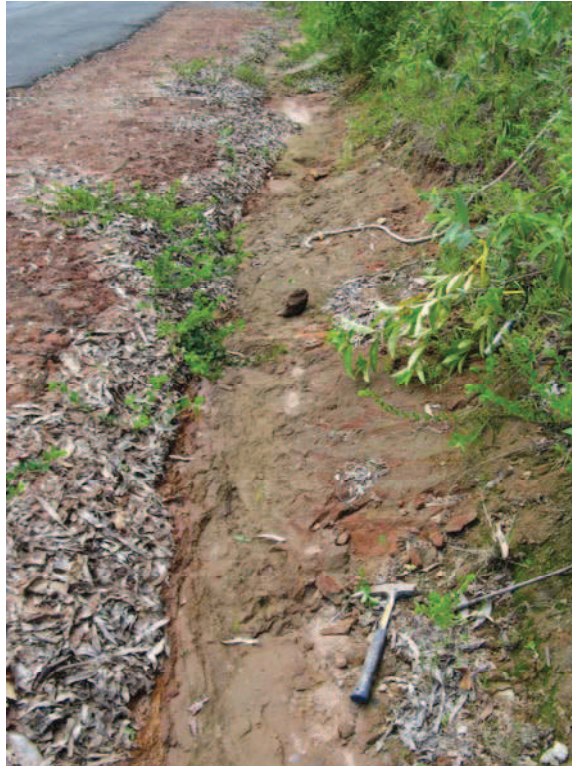
**Plate 3 – View of bedrock in unlined stormwater drain at toe of cut**

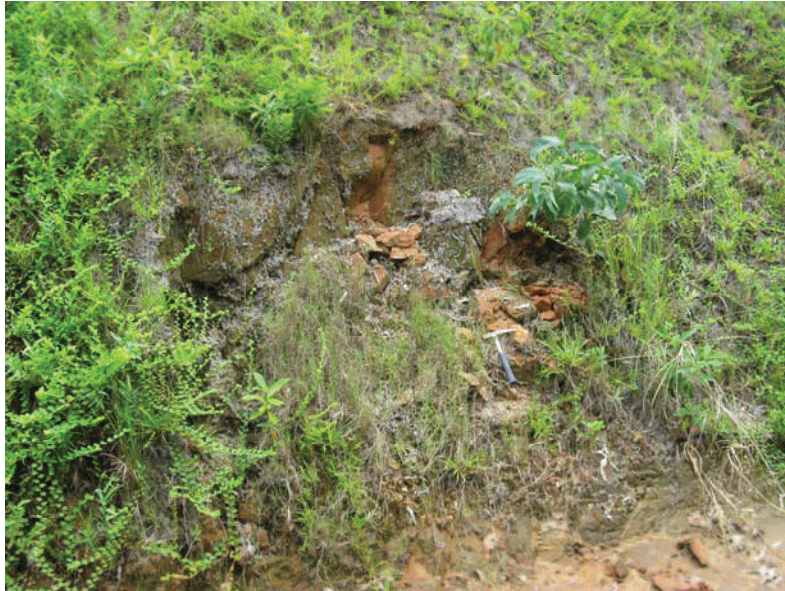
- Several small shallow and localised slips were located near the toe of the very steep slope, just north-west of Section 2 (refer Drawing 2). These slips were located in an area of very low strength, highly fractured arenite, were generally 2m to about 4m in height, 2m to 3m in width, and about 0.5m deep. No debris from these areas were

observed at the toe of the slope. A photograph of one such area of slope failure is shown below as Plate 4.

**Plate 4 – View of small slope failure at toe of slope**

It follows that remedial works will be required to be undertaken on this slope, to achieve the required 'low' risk of future instability. This remedial work is summarised on Table 4, and further discussed below. It should be noted that appropriate remediation of the existing slope is likely to be costly to implement, and will require additional geotechnical design to be undertaken.
