# Diggers Bridge Replacement, Mowbray River

## Options Analysis Report

December 2016

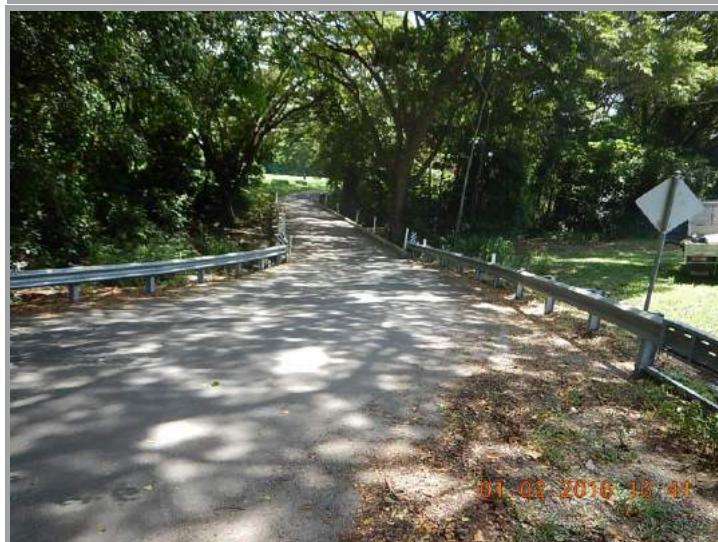
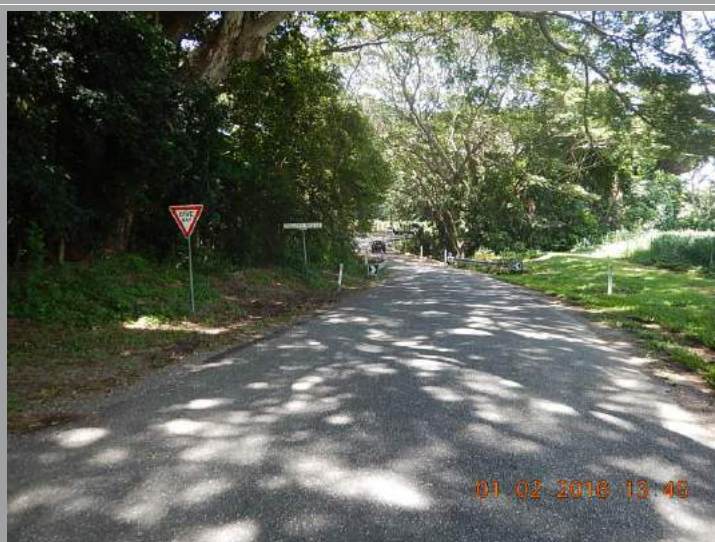
Six Span, Single Lane Timber Girder Style Bridge over the Mowbray River on the Mowbray River Road. Approach 1 is from the southern approach to the bridge. Approach Two is Giveaway controlled. Inspected at high tide. Crocodiles are present in the waterway. A 20T load limit has been applied to this structure. While inspecting the bridge a number of large tipper trucks were seen going back and forth over the bridge. When loaded these vehicles would be exceeding the recommended load limit. A considerable amount of movement and flexing of the structural components could be seen when the trucks were going over the bridge.

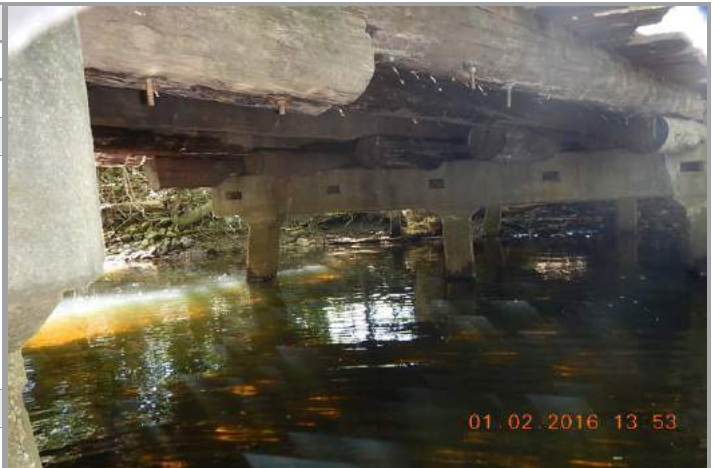
Pier Two Face One

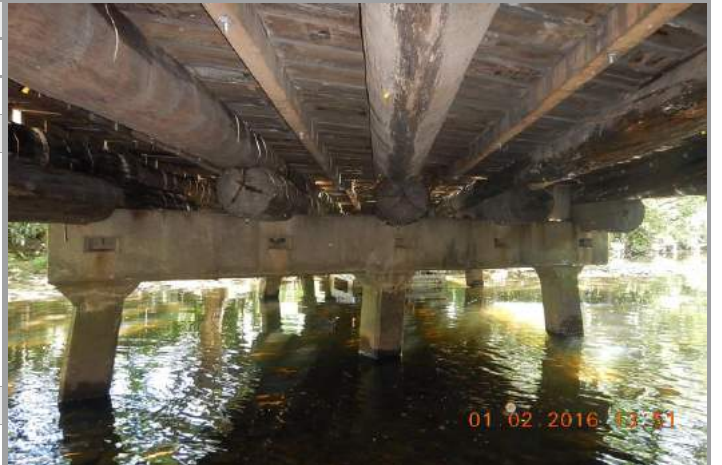
Detail of Severe cracking in Pier Two Pile 2&3 Face One

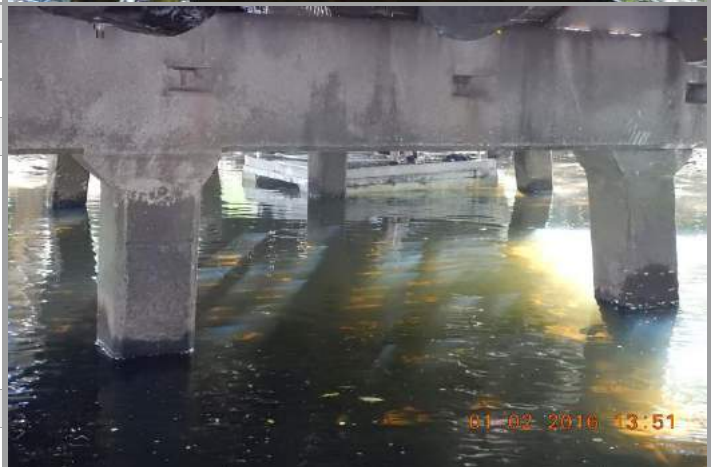
Detail of Severe cracking in Pier Two Pile One Face One
