Sugar Wharf Concrete Apron – Structural Report

The Port Douglas Sugar Wharf has been part of the history of Port Douglas for more than one hundred years and was entered on the Queensland Heritage Register (QHR: 600466) in 1992.

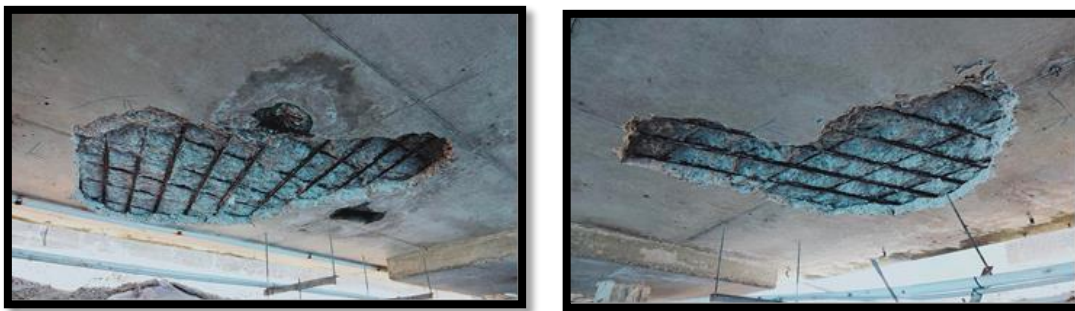
A recent structural inspection of the concrete jetty found significant corrosion had impacted the steel reinforcing causing significant damage to the structure, some of which was now becoming apparent visually. This has led Council to undertake repairs to the concrete jetty which further exposed large areas of concrete delamination

Pic 001 & 002 [concrete areas that let go during repair work]

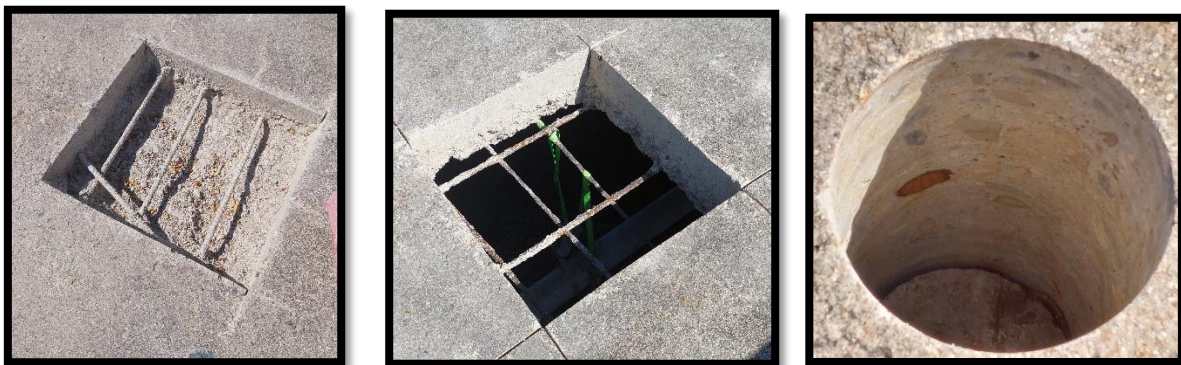
At this point the Engineer and Council became concerned as to the structural integrity of the concrete jetty and decided that further testing would need to be carried out to determine the full extent of the corrosion. For this reason, three core samples were taken to establish the compressive strength of the concrete and five concrete cut-outs were undertaken from the top of the concrete jetty. These were undertaken to determine the condition of the internal reinforcing steel. A sixth hole was cut through the concrete jetty to confirm the presence of two rows of steel reinforcing.

Pic 003 [one of five test holes]

Pic 004 [test hole six]

Pic 005 [one of three core samples]

The results of the testing identified the quality of the concrete in the jetty was below what would be expected for a structure of that age (built in mid 1980s) and that while some areas of the concrete jetty were in fair condition, other areas showed significant corrosion penetration and separation of the concrete between the bottom and top sections. For this reason, the engineer has re-classified the condition state to a four.

Due to this new condition report, the concrete jetty will require the following new weight restrictions, with six monthly inspections to allow continued use at this new rating until remedial works are undertaken:

- Limit of **200 pedestrians** (higher pedestrian limit subject to specific permission by APEC);
- Does not include fixed seating;
- Wheeled vehicles are **not** permitted (including catering vehicles);
- Area is **not** to be used as an emergency assembly area; and
- Area is not to allowed for stages in public assembly areas.

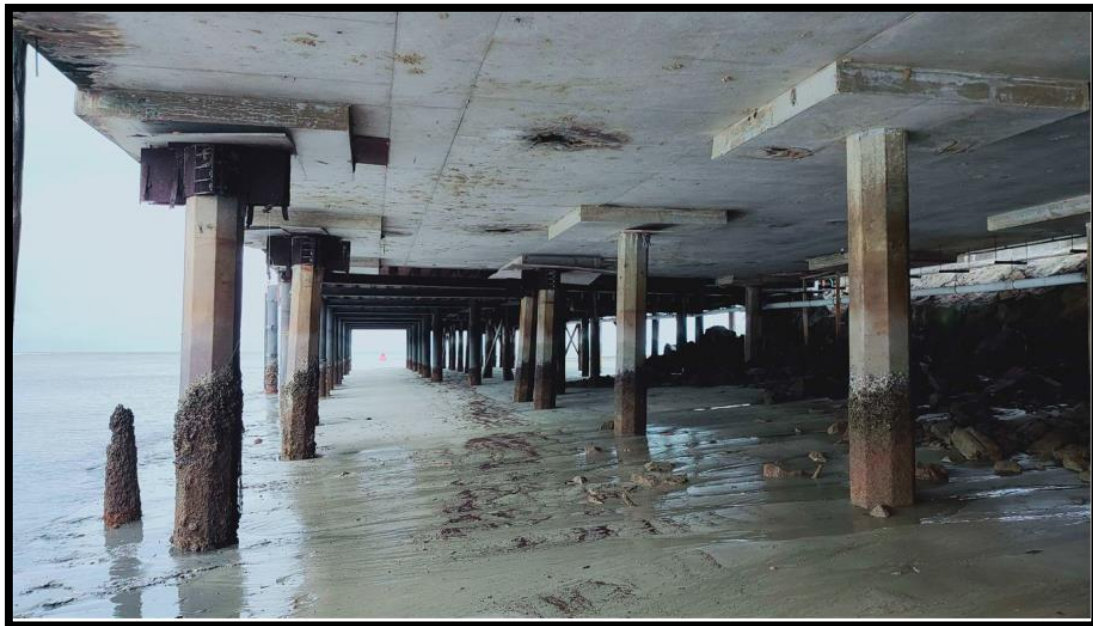
Pic 006 [piles supporting concrete jetty]

Moving forward, the Engineer has recommended that each of the twenty concrete piles that support the concrete jetty be tested to ascertain their condition and assist in planning the concrete jetty's future both short and long term.
