## **5.5. WATER AND WASTEWATER QUARTERLY REPORT FOR THE PERIOD ENDING 31 MARCH 2019**

1. Water and Wastewater Quarterly Report for the period ending 31 March 2019 **[5.5.1]**

## 1 January – 31 March 2019

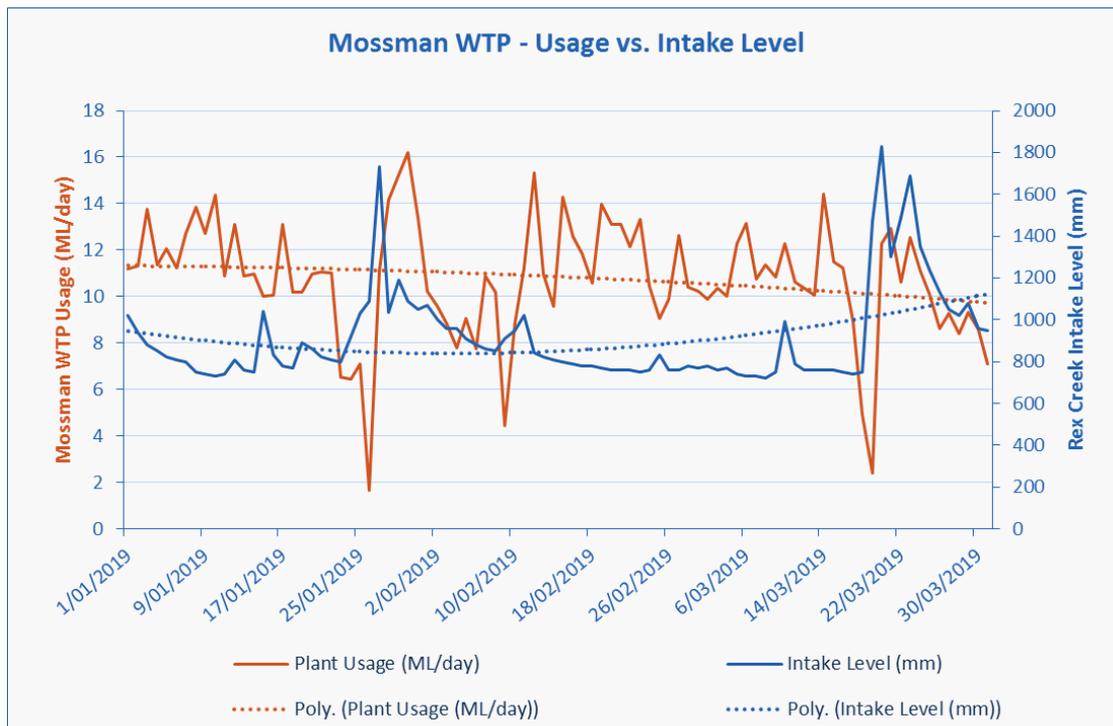
Figure 1 shows the Mossman Water Treatment Plant usage and Rex Creek Intake levels for the period 01 January through to 31 March 2019.

**Fig 1. Mossman WTP usage and Rex Creek intake levels for the period 1 January 2019 – 31 March 2019**

Rex Creek intake levels have increased due to heavy rains and the catchment has been well and truly replenished resulting in good flows at the intake.

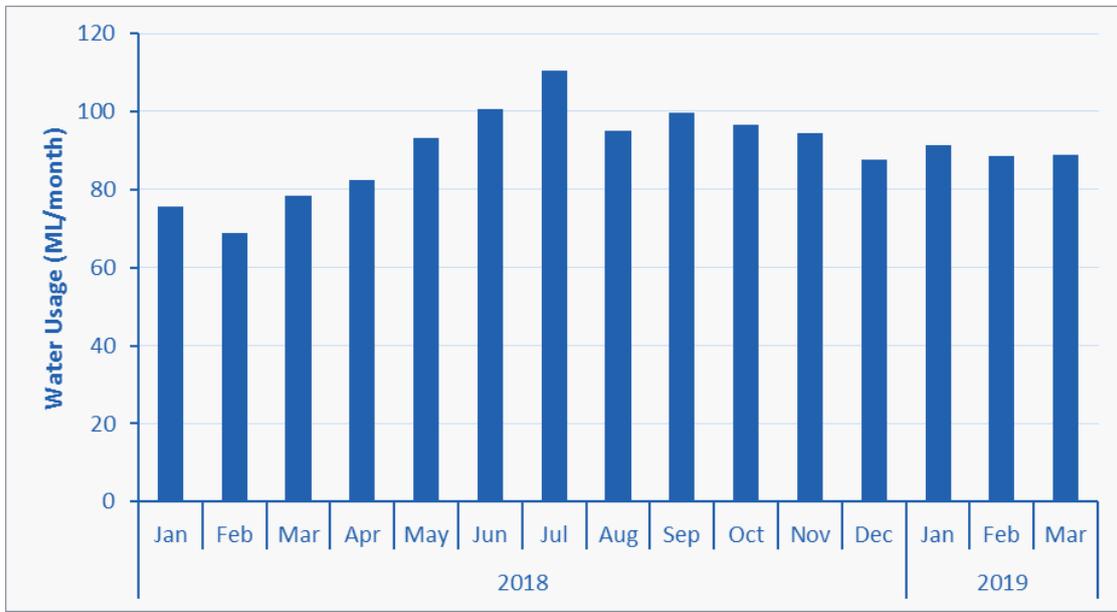
The total monthly consumption of water in Mossman, Cooya Beach and Newell Beach areas can be seen in Figure 2.

**Fig 2. Mossman Scheme Monthly Consumption Figures**

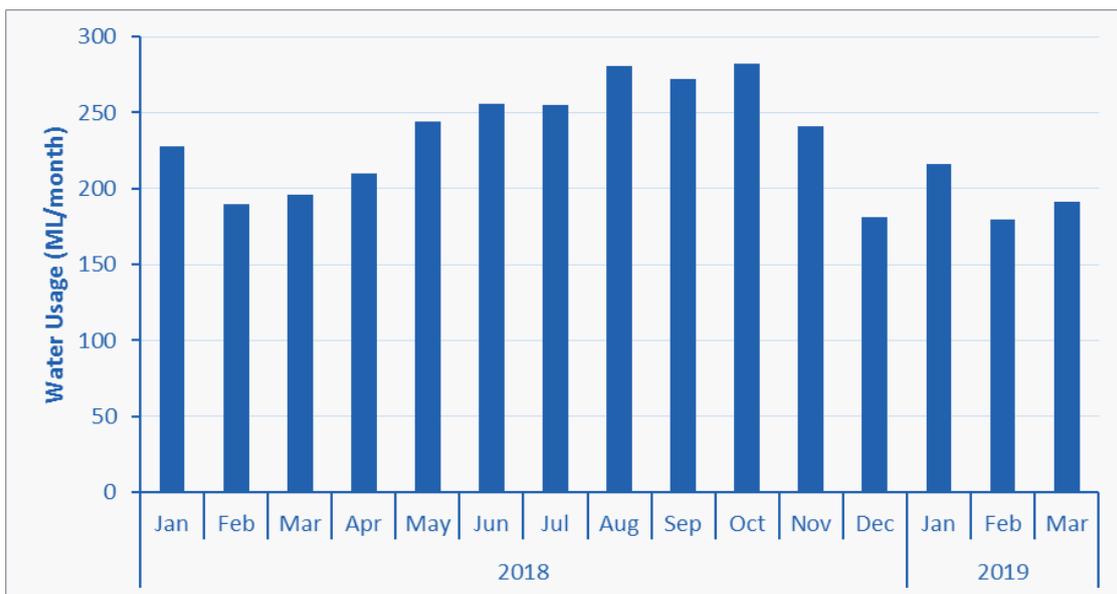
The total monthly consumption of water in Port Douglas can be seen in Figure 3.

**Fig 3. Port Douglas Scheme Monthly Consumption Figures**

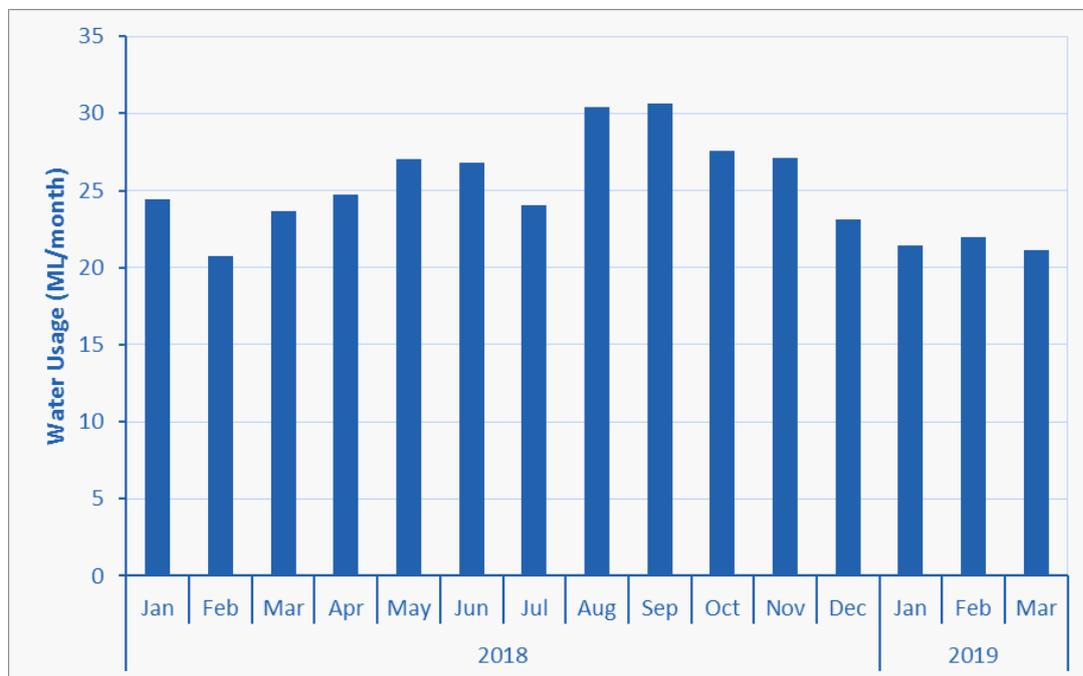
The total monthly consumption of water in the Whyanbeel scheme can be seen in Figure 4.

**Fig 4. Whyanbeel Scheme Monthly Consumption Figures**

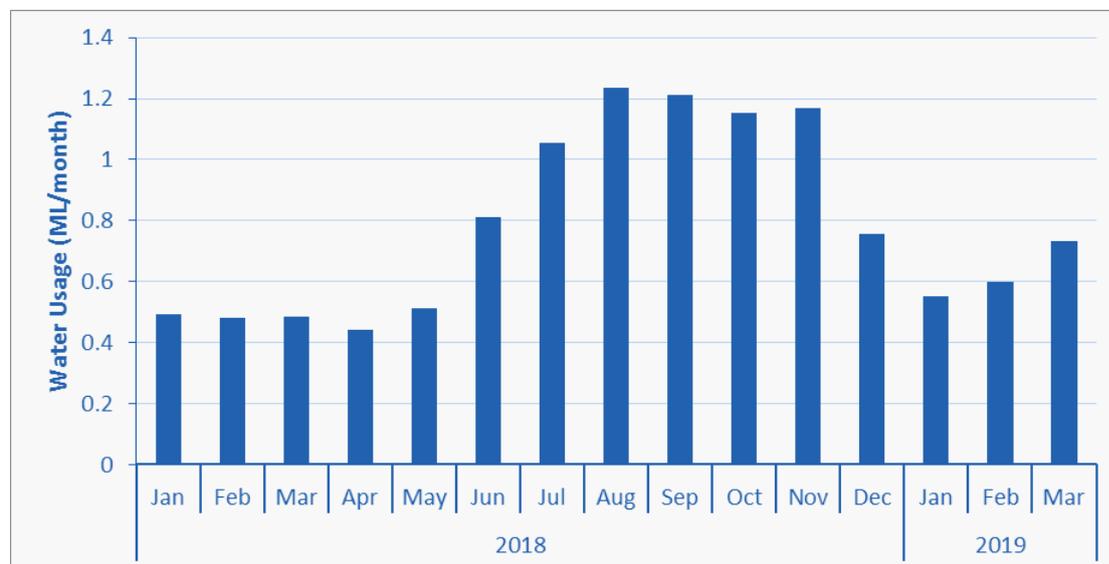
The total monthly consumption of water in the Daintree scheme can be seen in Fig 5.

Fig 5. Daintree Scheme Monthly Consumption Figures

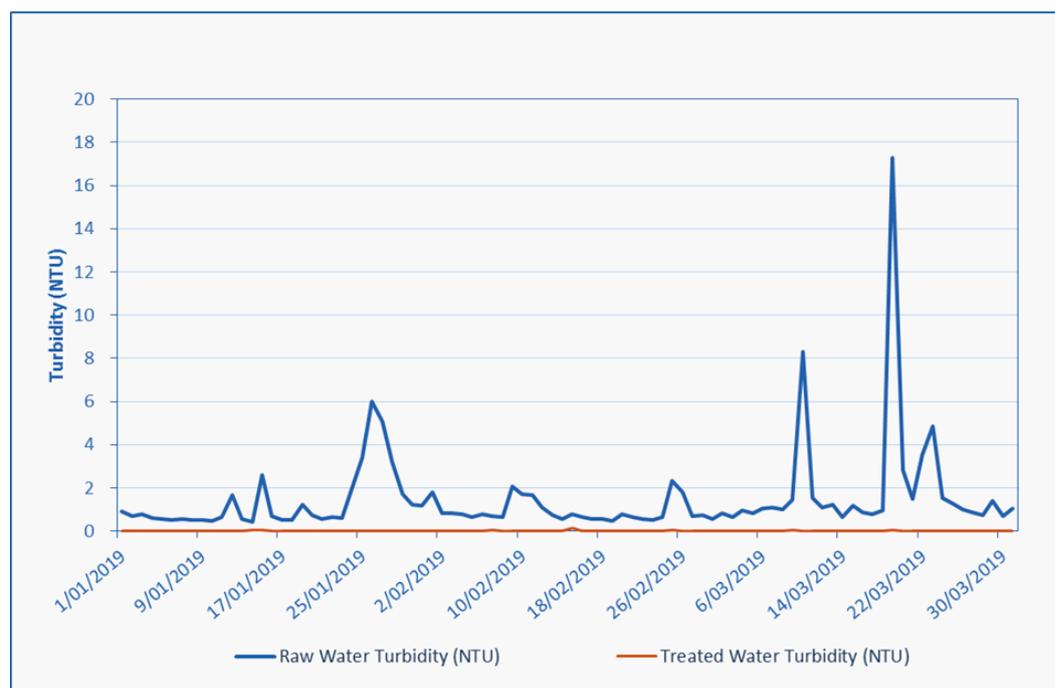
**Fig 6. Turbidity trends at the Rex Creek intake and treated water at the Mossman Water Treatment Plant**

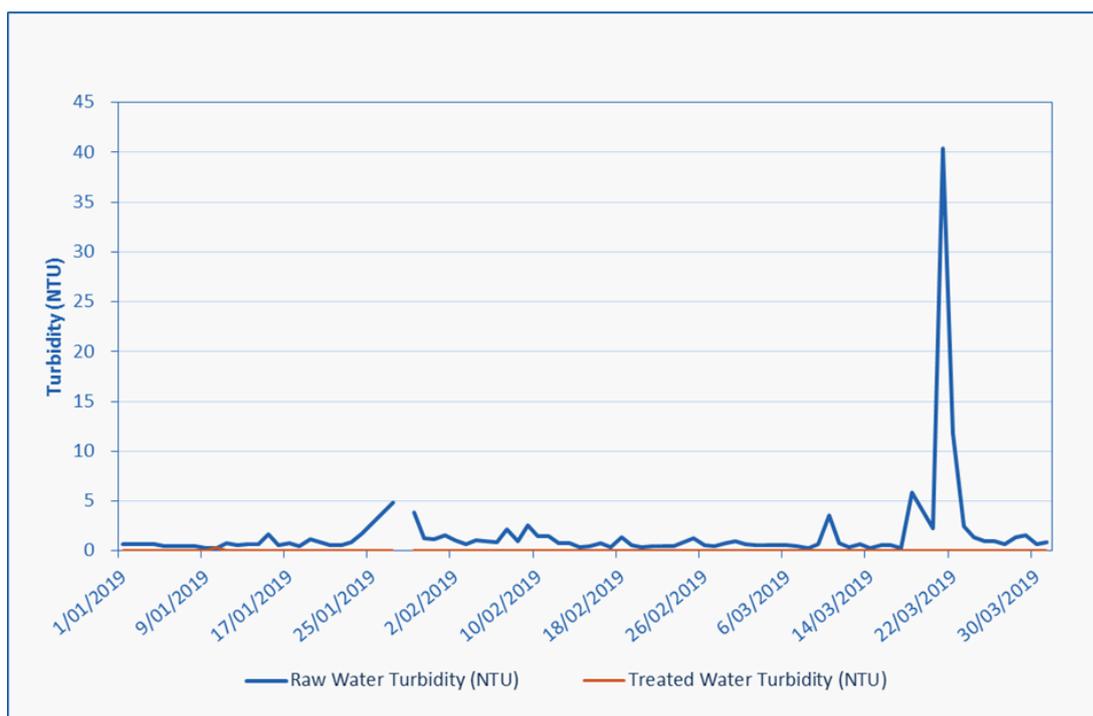
**Fig 7. Turbidity trends at the Little Falls Creek intake and treated water at the Whyanbeel Water Treatment Plant. Whyanbeel WTP was offline during 27/1/19 – 28/1/19.**

Whyanbeel Water Treatment Plant met all demand requirements during the reporting period. However, the little falls creek intake was impacted heavily by heavy rain and flooding in the catchment resulting in numerous blockages and high raw water turbidity shut downs.

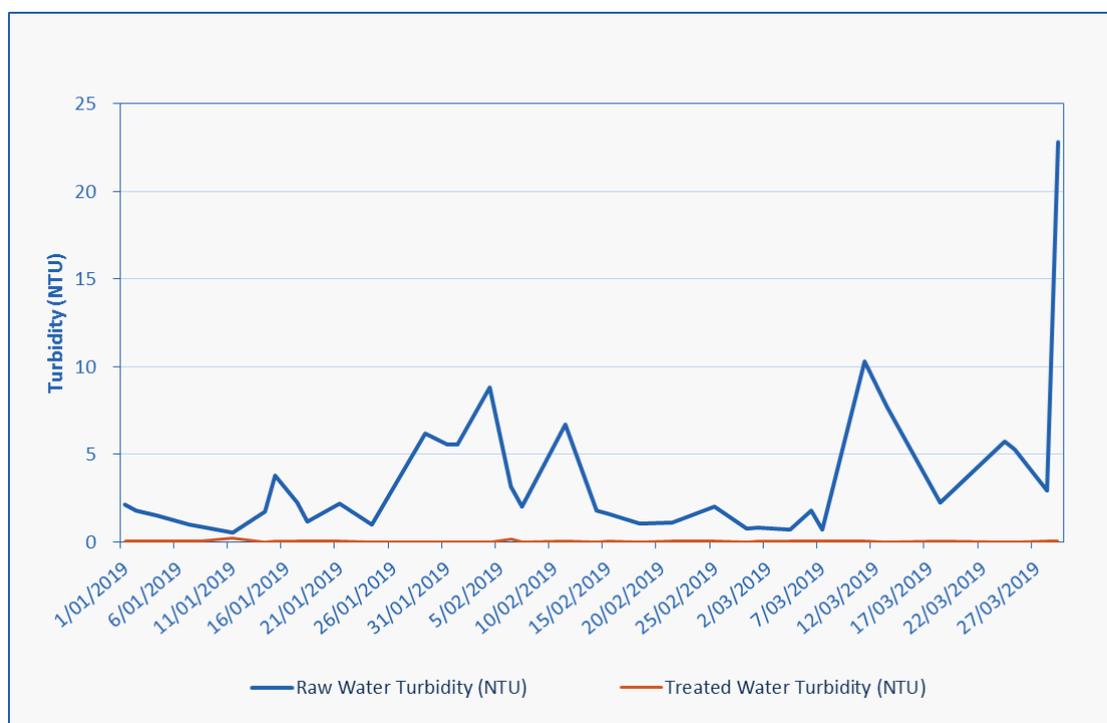
**Fig 8. Turbidity trends at the Intake/Martin Creek intake and treated water at the Daintree Water Treatment Plant. Daintree WTP was offline several times during this period.**

Daintree Water Treatment Plant met all demand requirements during the reporting period. However, intake levels at intake creek were impacted by heavy rains and flooding resulting in numerous blockages at the intake and raw water pipeline.

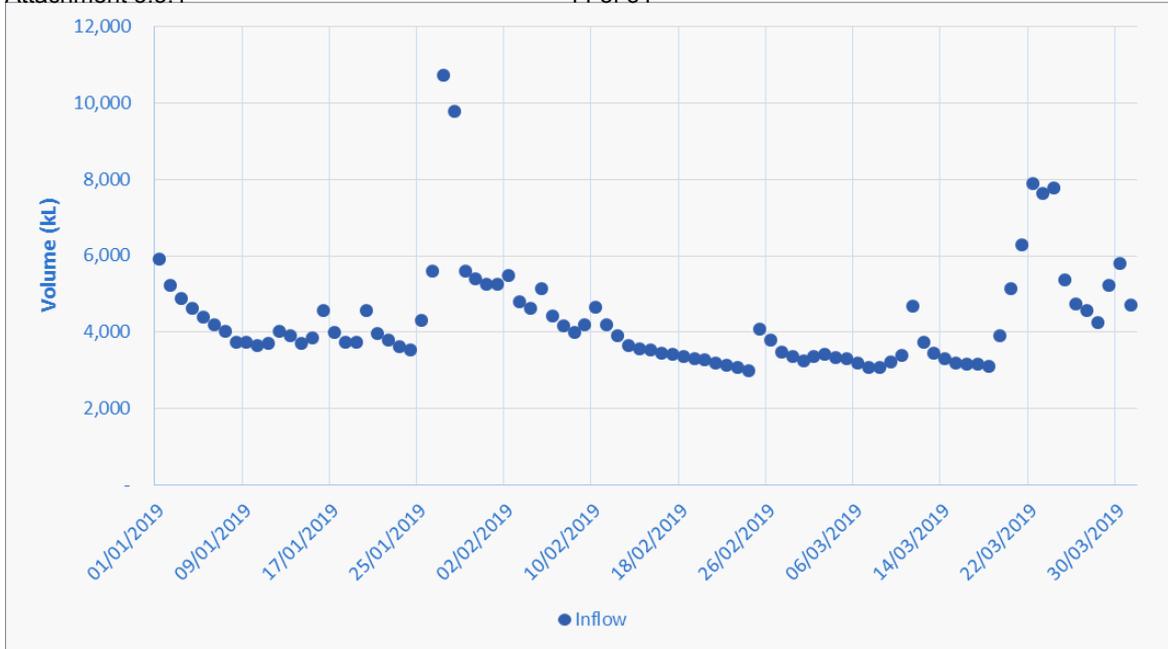
Daily inflows and total monthly flows for the reporting period are presented in Fig 9 and 10 respectively.

**Fig 9. Port Douglas Daily Inflow**

A total of 388,022 kL of influent entered the Port Douglas Wastewater Treatment Plant during the reporting period. The average daily flow was 4,311 kL/day. Tanker truck contractors delivered 552 kL of septage to the plant and 2,003 kL of Leachate from the Killaloe Landfill and Transfer Station. Influent is treated in a Sequencing Batch Reactor (SBR) which produced compliant effluent during the reporting period. A total of 24% of the treated effluent was pumped to two resorts and the remaining discharged into the Dickson Inlet. The Sheraton Mirage received 61,184 kL and Palmer Sea Reef received 11,588 kL of treated effluent during this period. Total rainfall on site during the reporting period was measured as 1,659.5 mm. On 27 January 2019, the highest rainfall on a day was recorded as 255 mm in the Reef Park weather station.

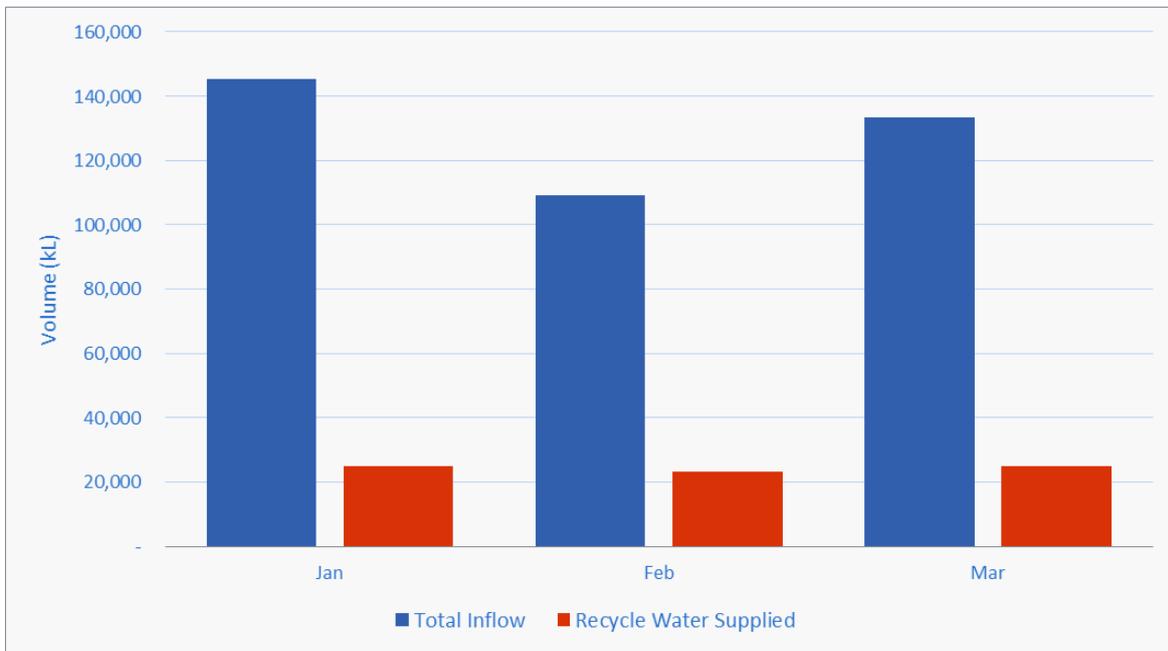
**Fig 10. Port Douglas Total Monthly Flow 2019**

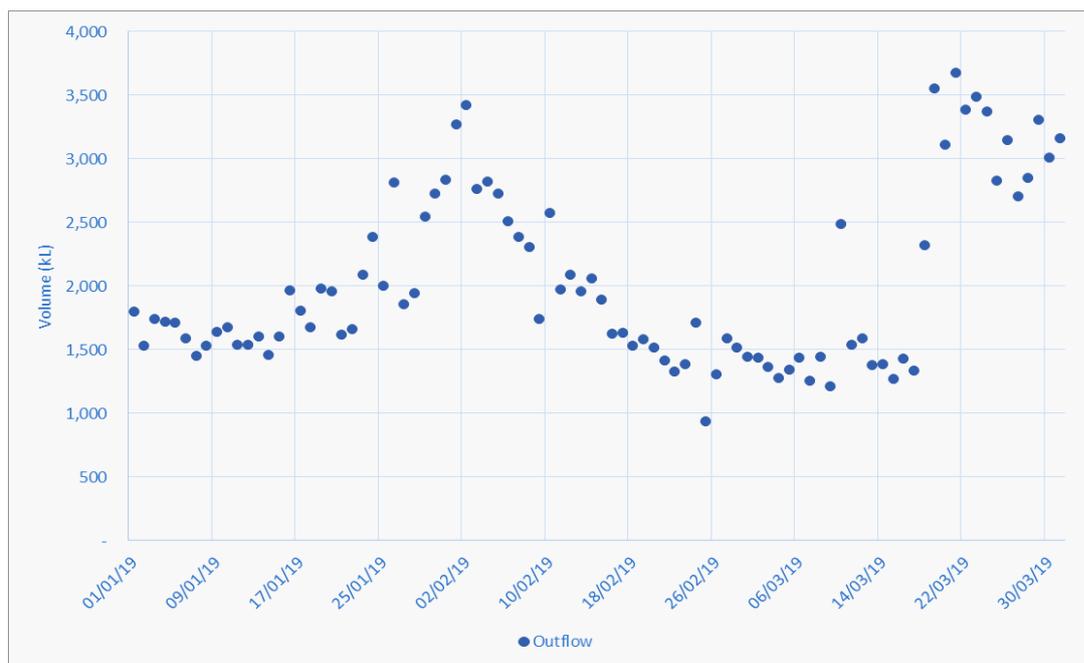
Outflow and Inflow data for the reporting period are shown in Fig 11 and 12 respectively.

**Fig 11. Mossman Wastewater Treatment Plant Daily Outflow**

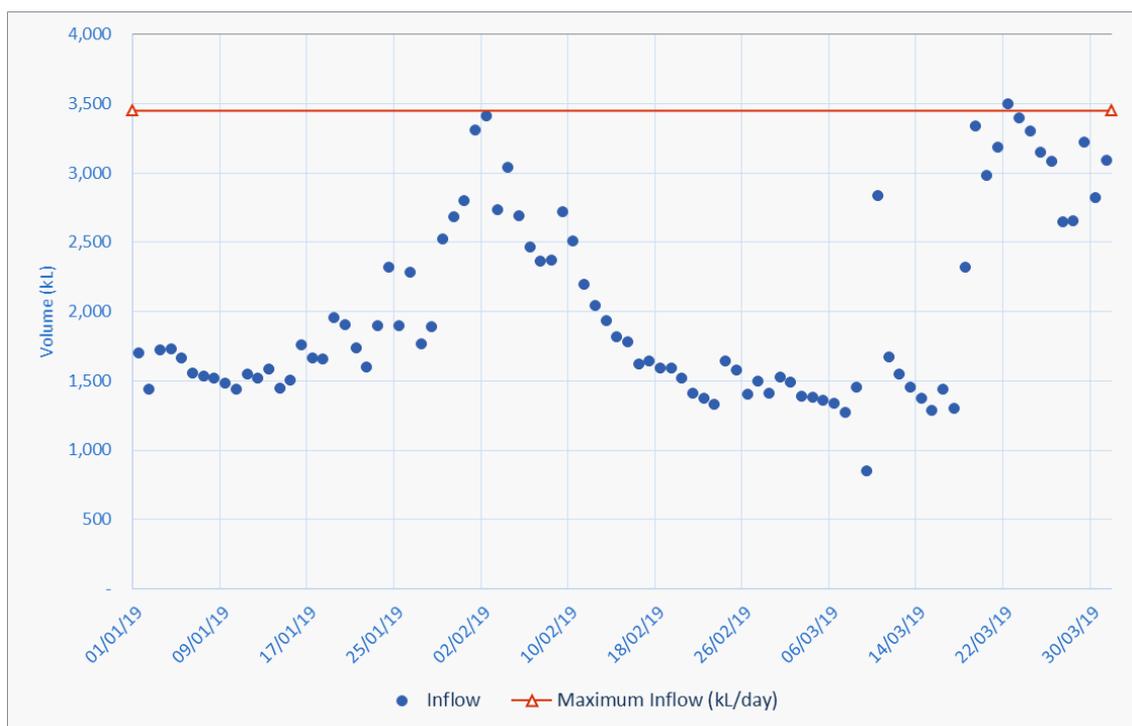
**Fig 12. Mossman Wastewater Treatment Plant Total Daily Inflow 2019**

Douglas Shire Council Environmental Authority Permit EPPR01790513 states an inflow limit: Inflows must not exceed the peak design capacity of three times the Design Average Dry Weather Flow (DADWF) of 1.15 ML/day – equating to 3.45 ML/day – on any day unless the standard treatment processes of the plant are bypassed. One exceedance of the inflow was reported to DES for flow on 22 March 2019. The exceedance did not result to an environmental harm, as all the inflow was processed through the normal treatment process.

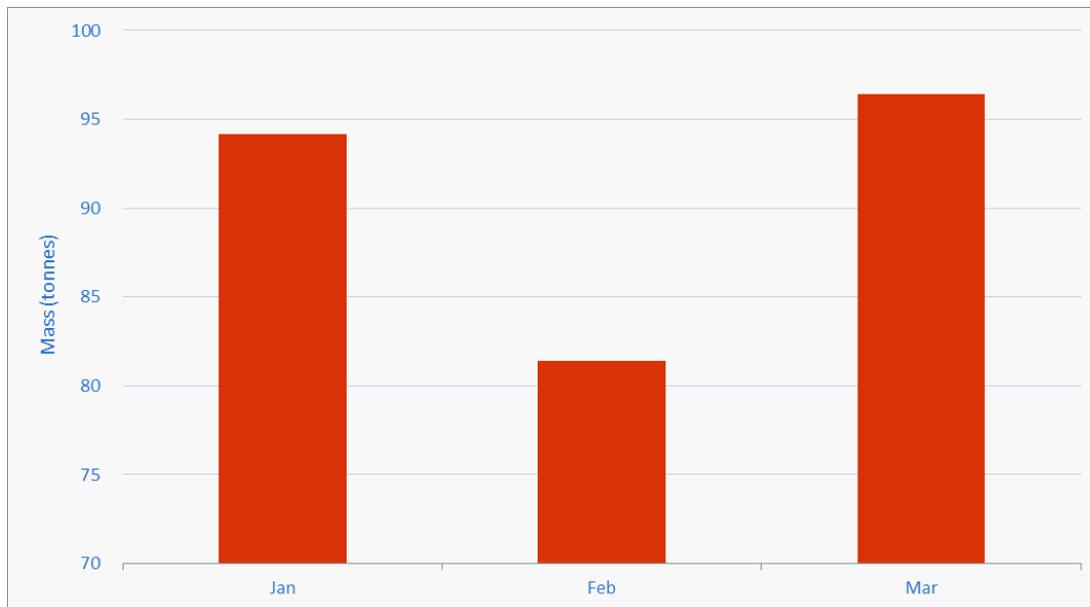
The monthly bio-solids production trends can be seen in Figure 13.

**Fig 13. Port Douglas Wastewater Treatment Plant monthly bio-solids production 2019**

At Port Douglas Wastewater Treatment Plant, 272 tonnes of wet biosolids were produced during the reporting period and sent to farms for beneficial reuse. This amount of wet biosolids equates to 30.7 dry tonnes.

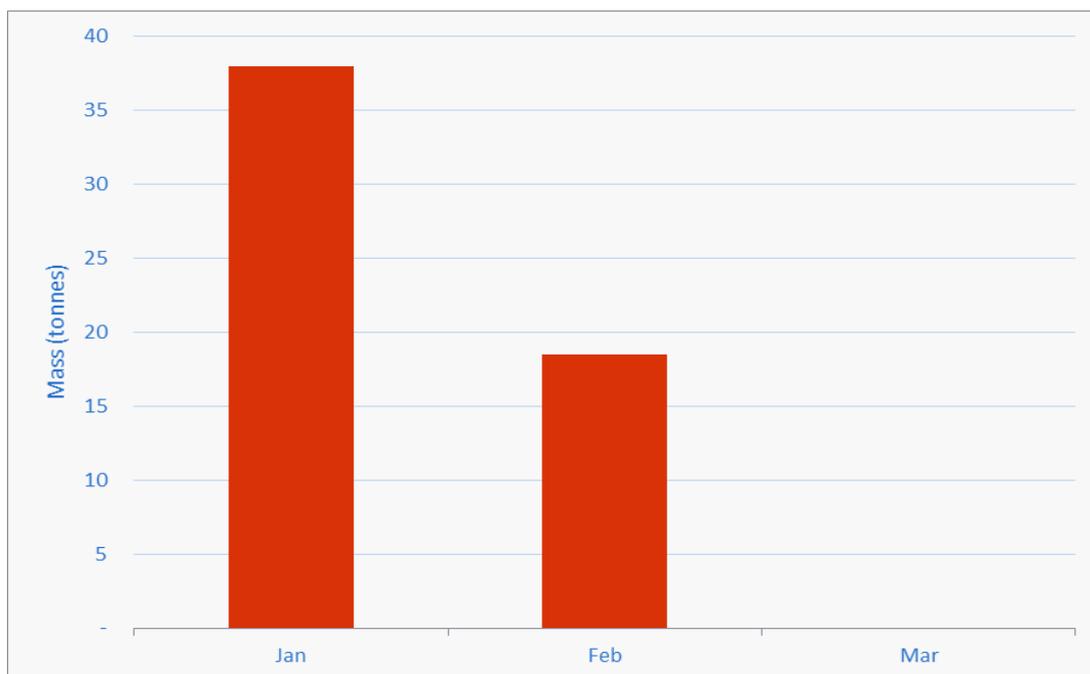
At Mossman Wastewater Treatment Plant, 56.4 tonnes of wet biosolids were produced during the reporting period and sent to farms for beneficial reuse. This amount of wet biosolids equates to 7.5 dry tonnes. The monthly bio-solids production trends can be seen in Figure 14.

**Fig 14. Mossman Wastewater Treatment Plant monthly bio-solids production 2019**  
\*No Bio-solids removed in March 2019.

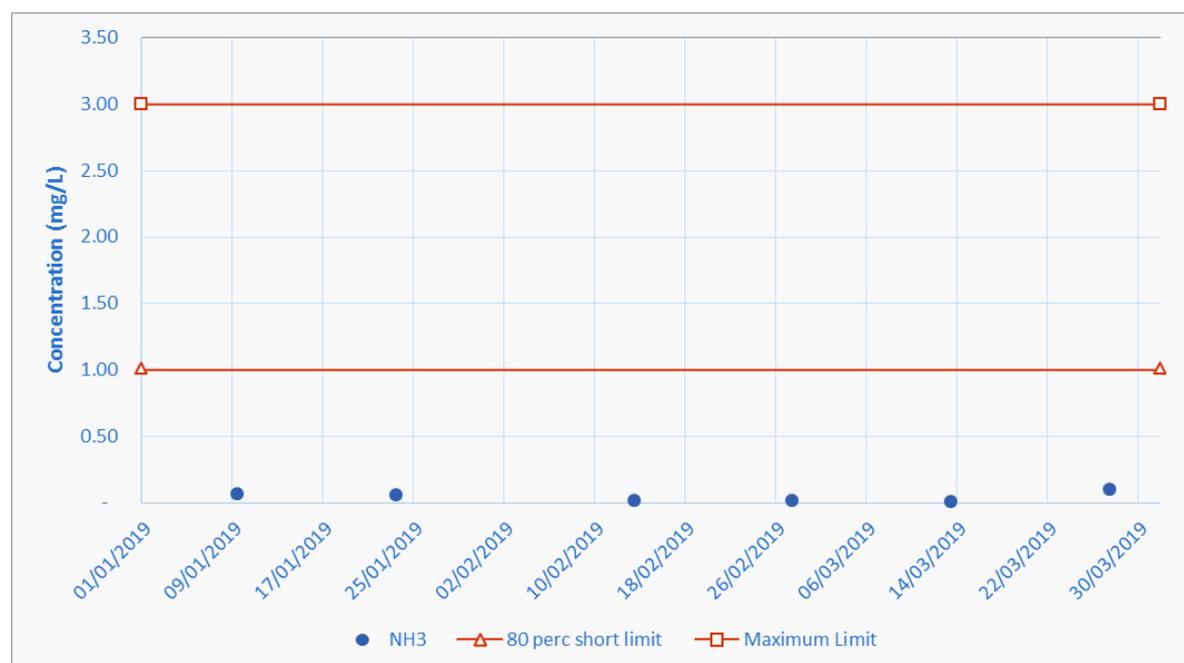
The results for final effluent key licence compliance parameters (Ammonia, Total Phosphorous, and Total Suspended Solids & BOD<sub>5</sub>) are shown in Figure 15, 16, 17 & 18.

**Fig 15. Port Douglas Wastewater Treatment Plant Final Effluent Test Results for Ammonia**

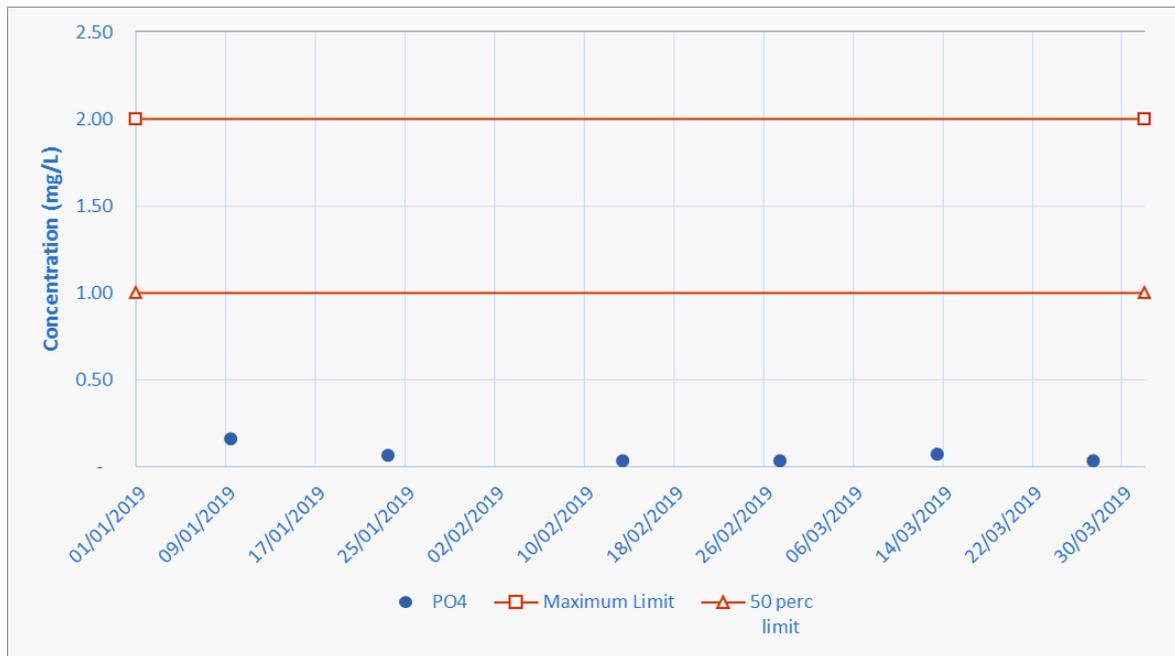
**Fig 16. Port Douglas Wastewater Treatment Plant Final Effluent Test Results for Total Phosphorous**

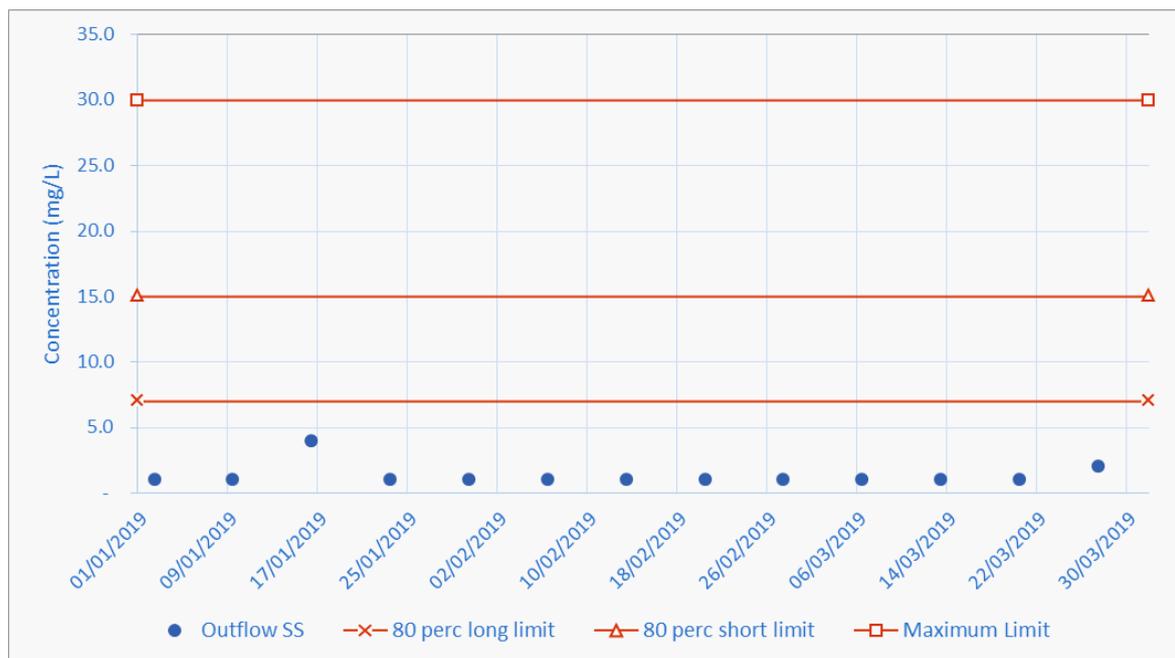
**Fig 17. Port Douglas Wastewater Treatment Plant Final Effluent Test Results for Total Suspended Solids**

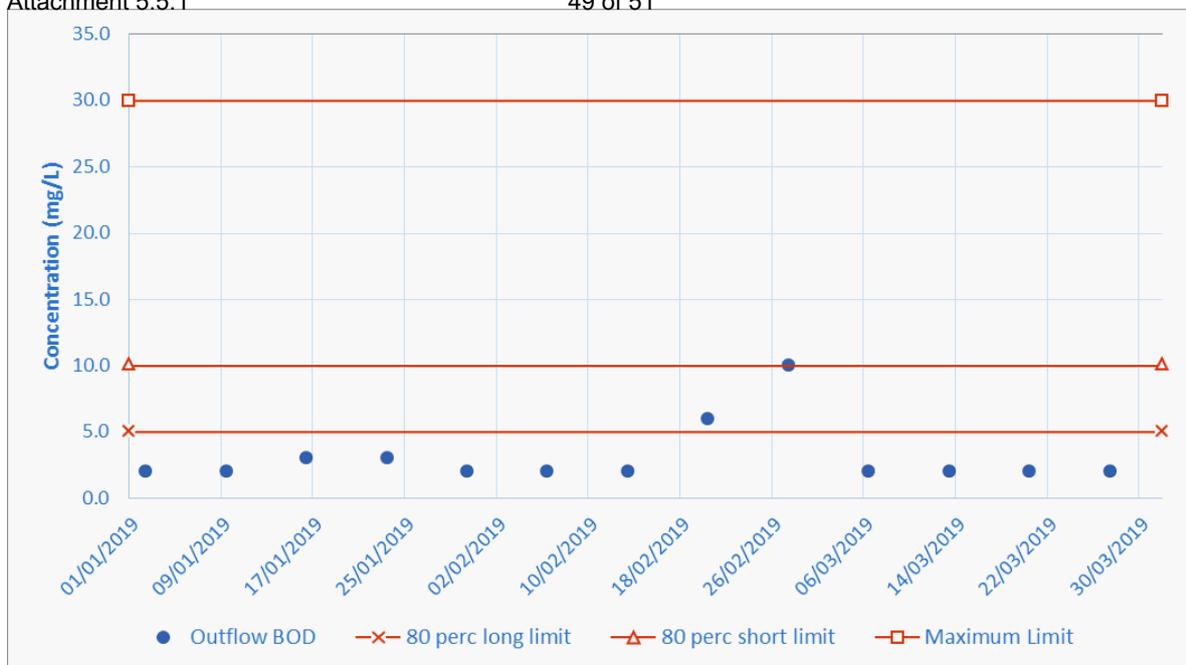
**Fig. 18 Port Douglas Wastewater Treatment Plant Final Effluent Test Results for BOD<sub>5</sub> (Biochemical Oxygen Demand)**

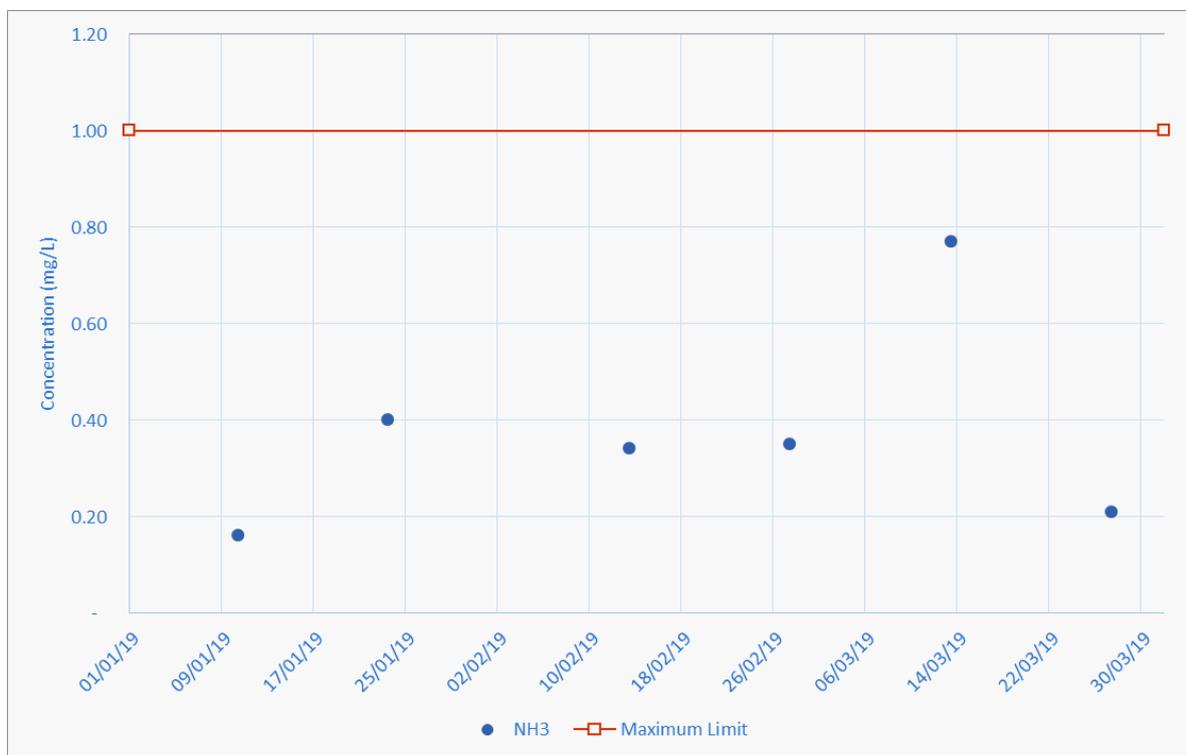
The results for final effluent key licence compliance parameters (Ammonia, Total Phosphorous, Total Suspended Solids & BOD<sub>5</sub>) are shown in Figures 19, 20, 21 & 22.

**Fig. 19 Mossman Wastewater Treatment Plant Final Effluent Test Results for Ammonia**

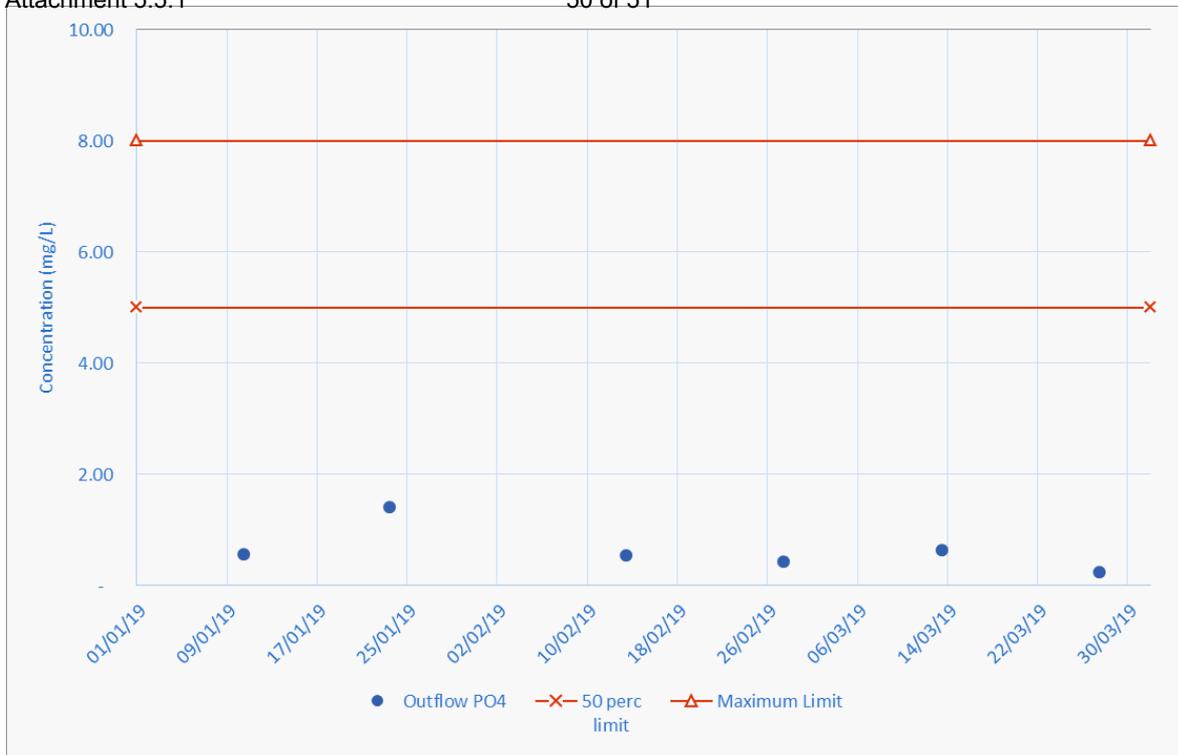
**Fig. 20 Mossman WWTP Final Effluent Test Results for Total Phosphorous**

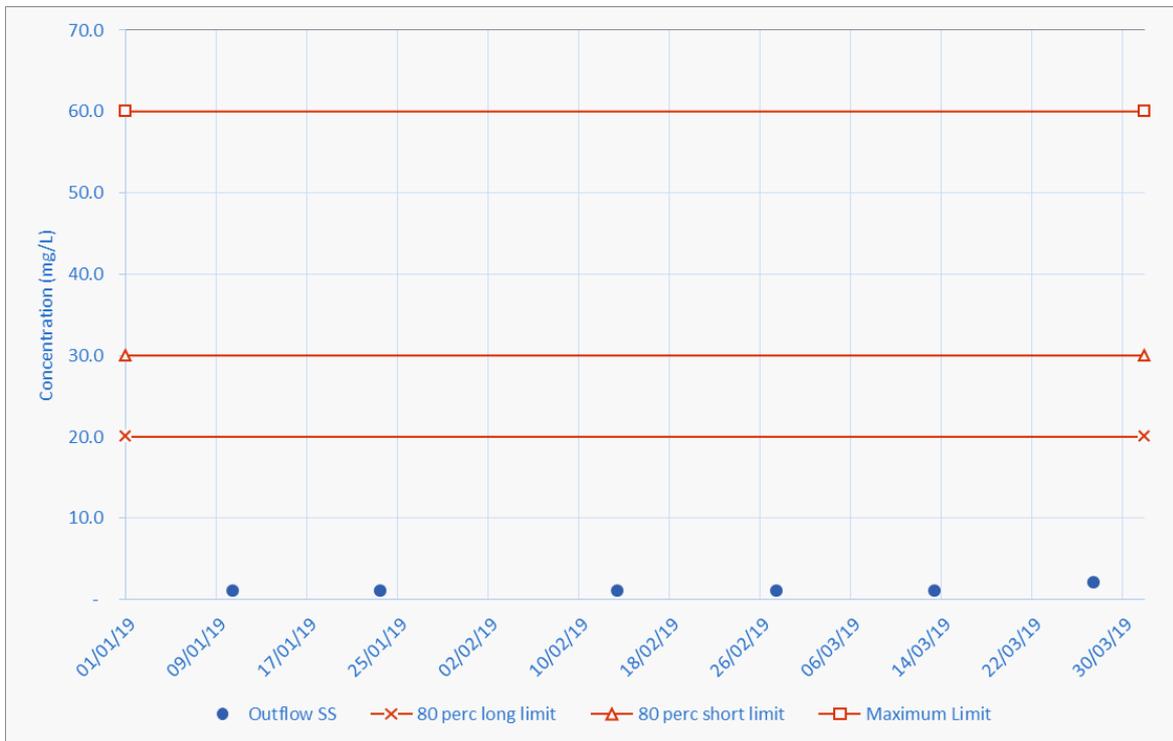
**Fig. 21 Mossman WWTP Final Effluent Test Results for Total Suspended Solids**

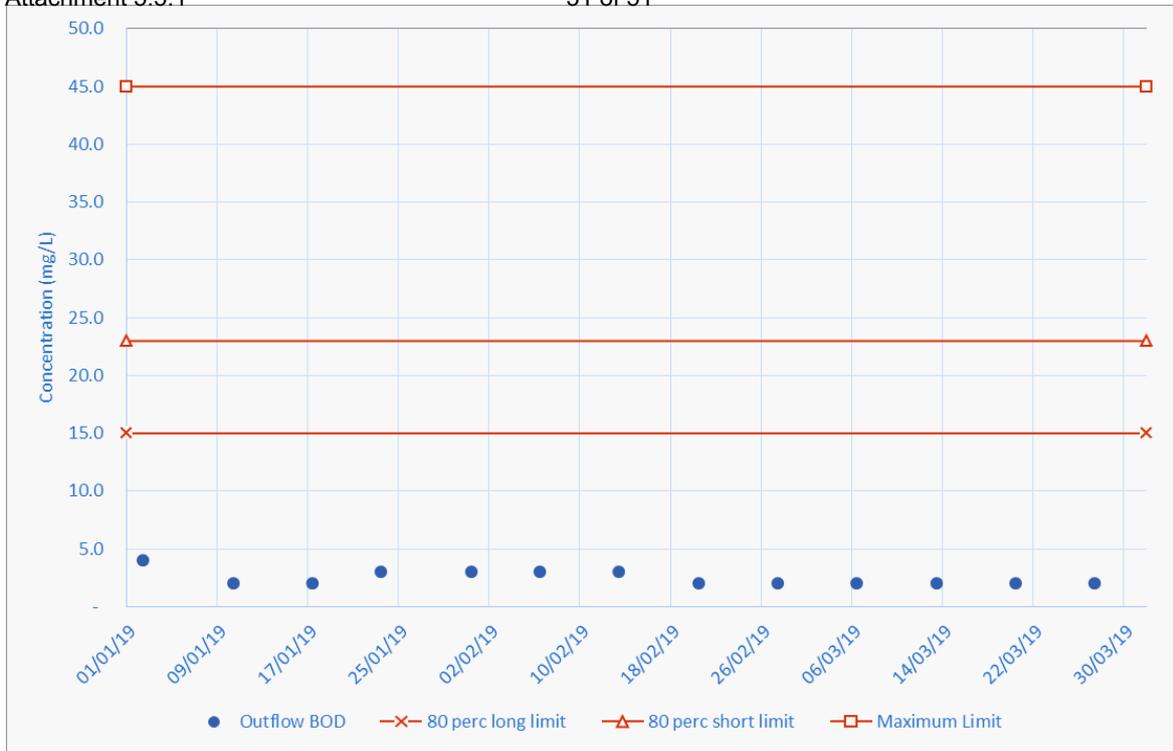
**Fig. 22 Mossman Wastewater Treatment Plant Final Effluent Test Results for BOD<sub>5</sub> (Biochemical Oxygen Demand)**
