NEWELL BEACH EROSION MITIGATION

Newell Beach Erosion

Reference number 62-001-001R

For Douglas Shire Council November 2014

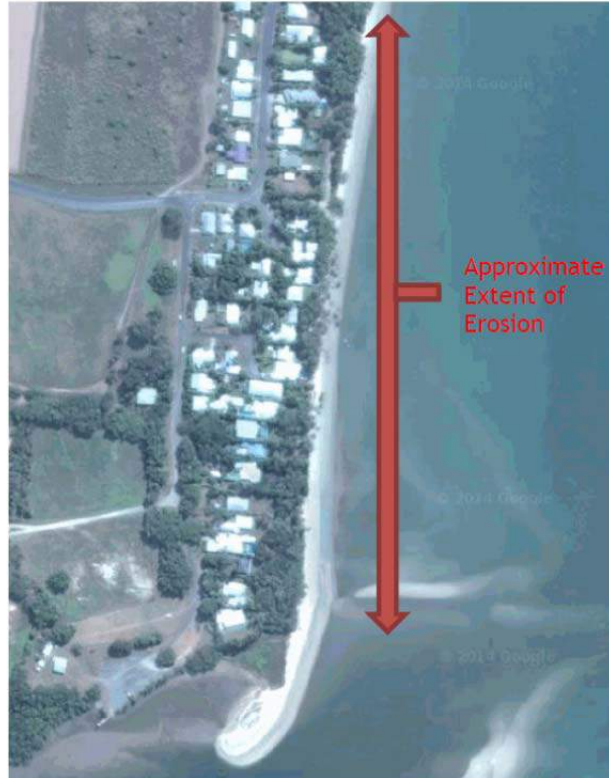
Figure 4.2 – Approximate Extent of Erosion (photograph courtesy of Google Maps)

An inspection of Newell Beach by Projex Partner and Douglas Shire Council's has revealed that significant erosion is apparent at the beach, particularly in front of the existing residences. This is obvious from the exposed roots of vegetation in the area. Also obvious is the reduction in the beach front properties back yard areas by benchmarking with fence, pool and deck infrastructure being exposed. There does not appear to be any erosion along the beach north of the residences.

The approximate extent of erosion is shown in **Figure 4.2** and the following photographs show the site observations.

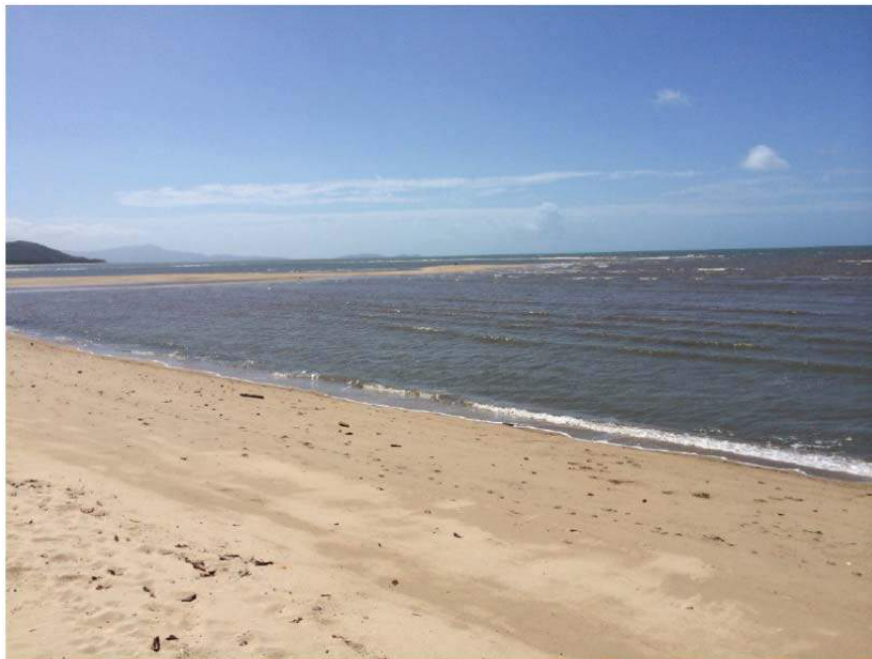
Photo 4.1 – Sand Bar at Southern End of Newell Beach looking from Cooya Beach

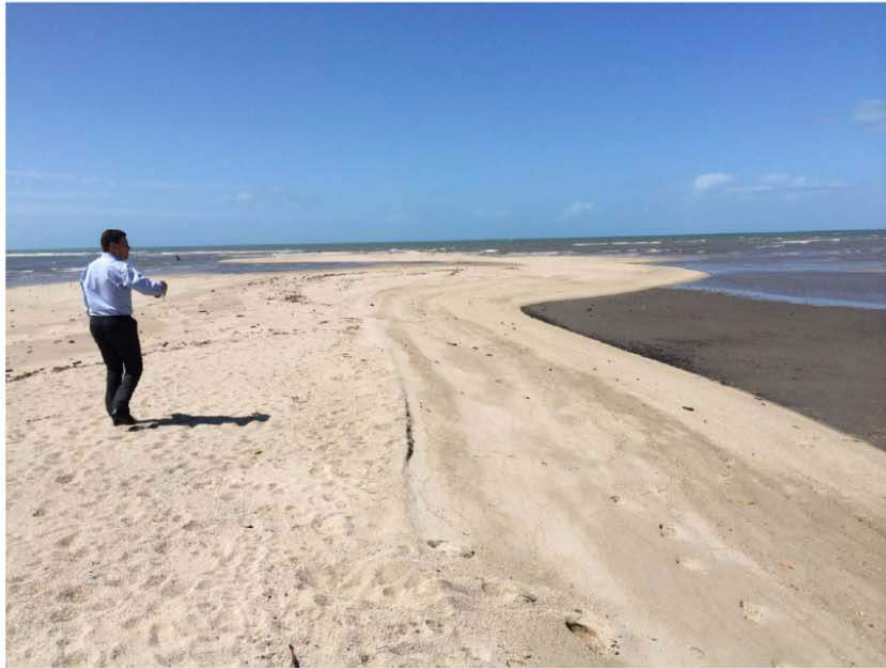
Photo 4.2 – Walking Along the Sand Bar from the Beach

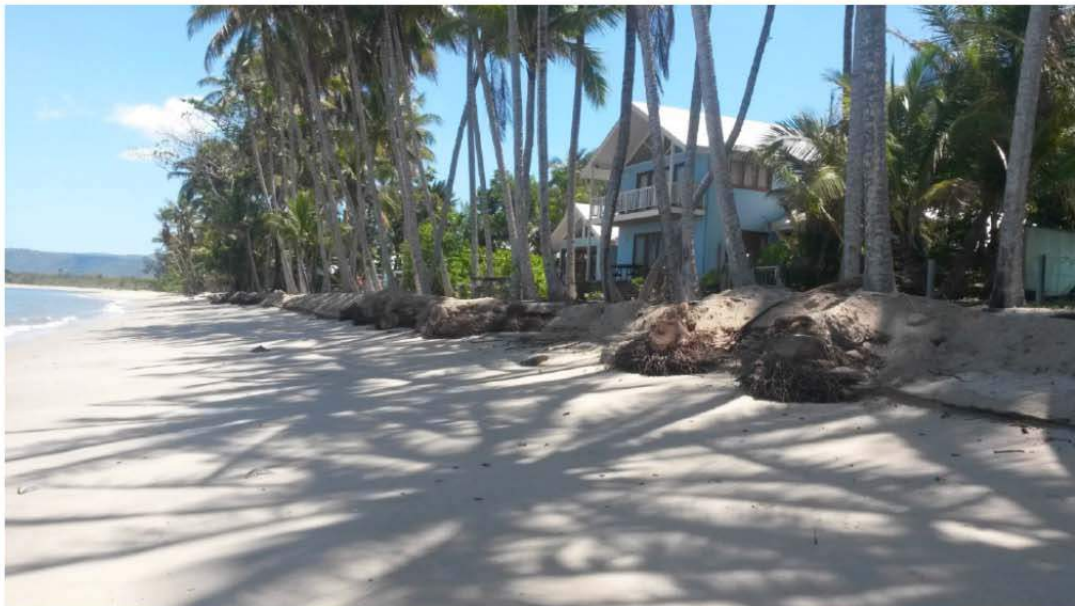
Photo 4.3 – Erosion at Beach Front Property No. 1

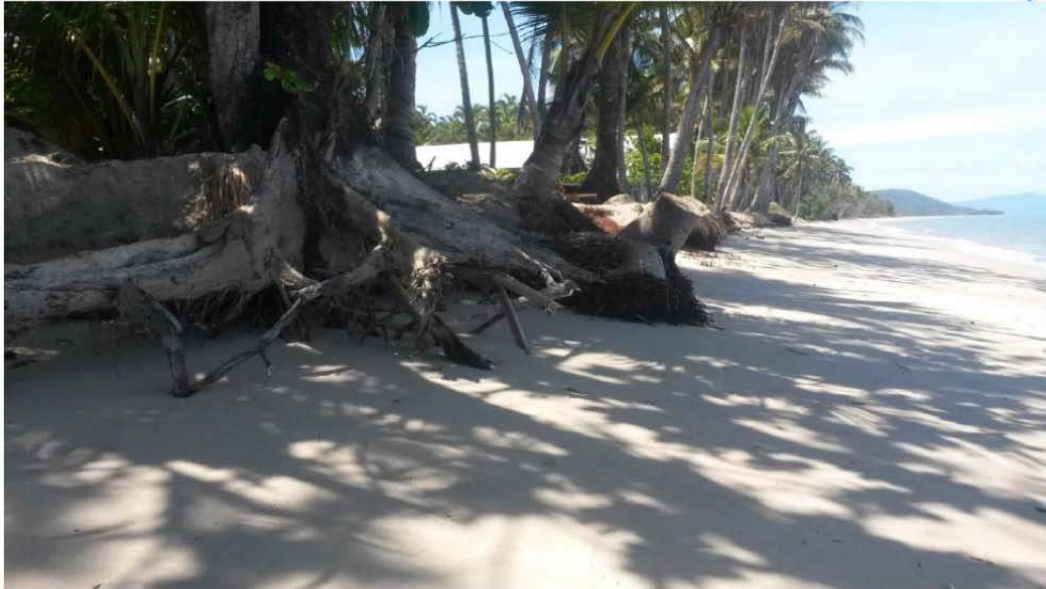
Photo 4.4 – Erosion at Beach Front Property No. 2

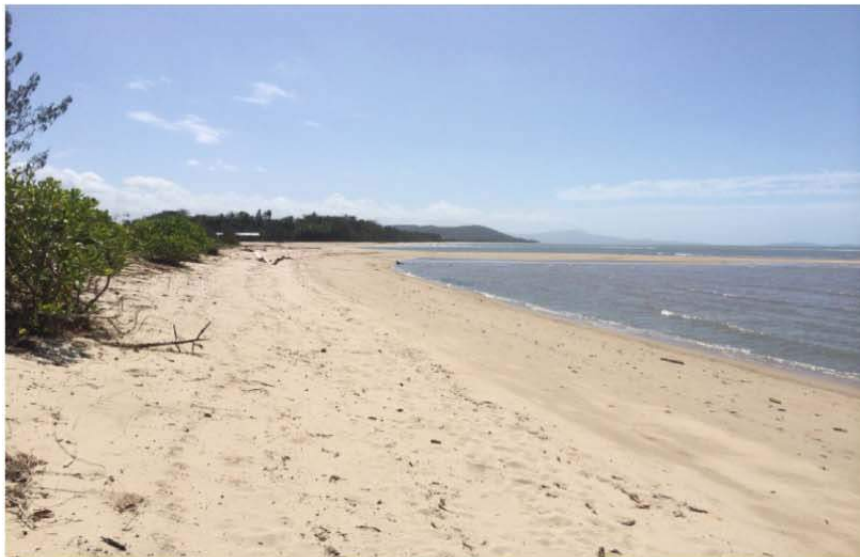
Photo 4.5 – Cooya Beach

A Newell Beach resident confirms that over time he has witnessed sand loss at Newell Beach and that beach profile has steepened. During the site visit when comparing the Newell Beach profile to the adjacent beach to the south (Cooya Beach - refer **Figure 1.1** for location) it was observed that the Cooya Beach profile is significantly flatter than that of Newell Beach. Further inspection of Cooya Beach by Projex Partners revealed that Cooya Beach does not have the same erosion issues that are occurring at Newell Beach. In fact, the northern end of Cooya Beach is showing evidence of an increasing sand deposit adjacent to the sand bar.

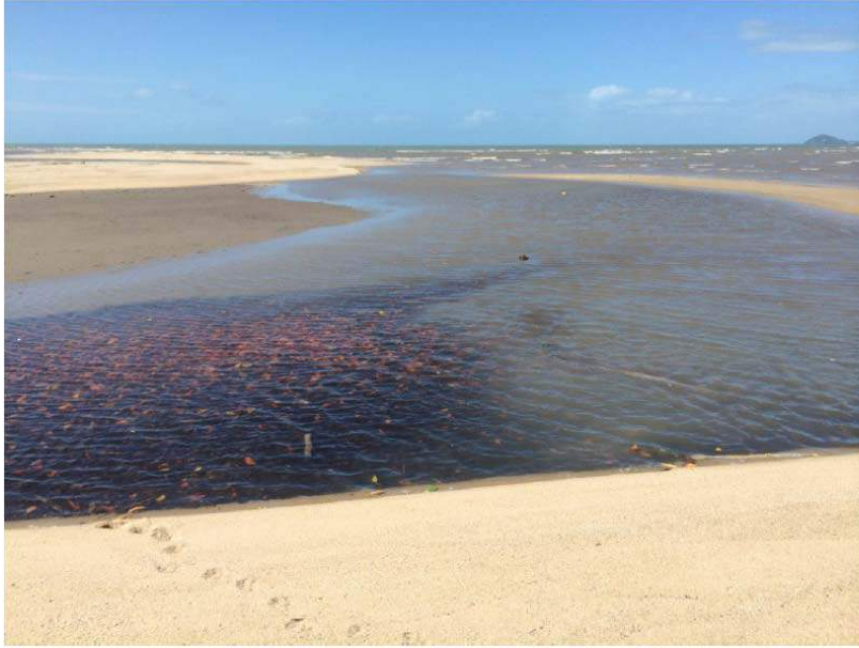
Photo 4.6 – Cooya Beach Sand Deposit with Sand Bar Upper Left of Photo

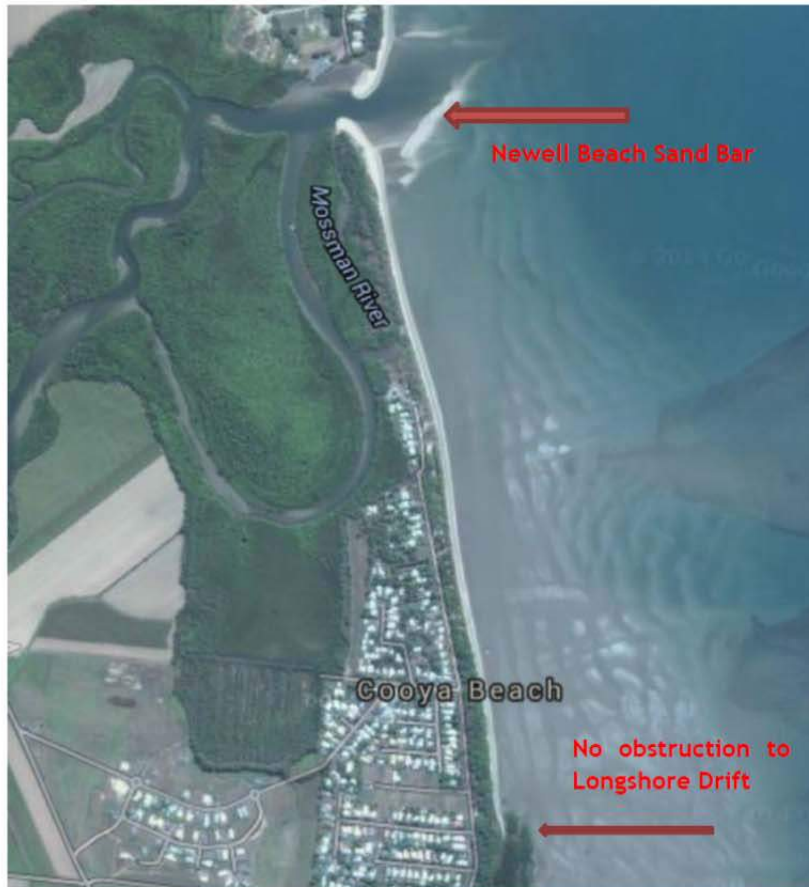
Photo 5.1 – Southern Cooya Beach (courtesy of Google Maps)

Section 4 of this report identified that Cooya Beach immediately to the south of Newell Beach is not showing the same significant level of erosion as Newell. This is because the longshore drift processes contributing sand to Cooya Beach is not being interrupted by a sand bar or other blockage (refer **Figure 5.1**).

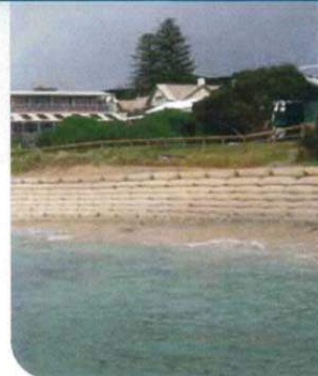
CIROVNES AND BREAKWATERS

ELCOROCK[®] containers are widely used in the construction of groynes and breakwaters, which extend into the wave zone to control the movement of sand and provide marina and beach protection. The type of ELCOROCK[®] container used is dependent primarily upon the wave climate. The ELCOROCK[®] containers have proven durability over many years in the aggressive, exposed marine environments. The use of vandal deterrent ELCOROCK[®] containers provides a softer, visually acceptable finish, allowing the structure to blend into the existing environment.

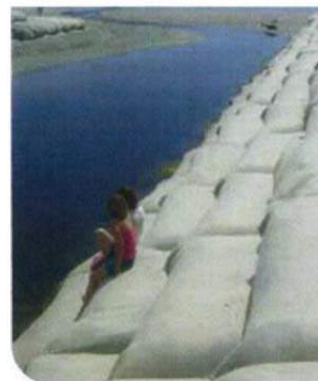
CUSTOM STRUCTURES

ELCOROCK[®] containers have been used for a wide variety of applications, including artificial reefs, bunds, cofferdams and temporary working platforms. The range and capabilities of our manufacturing facilities makes the most difficult application possible. The ELCOROCK[®] system has been used in many emergency protection works where rapid installation is required, such as sea wall toe protection and sand dune protection. The system can also be removed after the structure has served its purpose, with little risk or inconvenience to beach users.

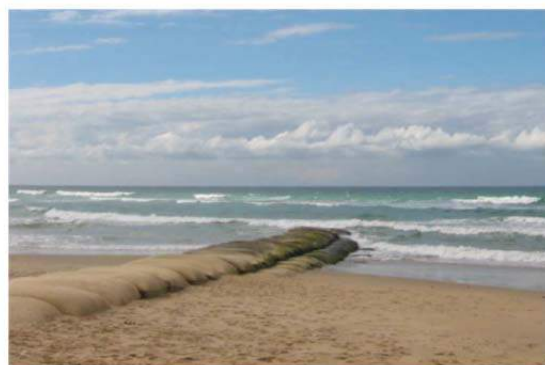
Due to the success of the Maroochydore ELCORock® sea wall constructed as emergency protection to the Cotton Tree caravan park, the council called for the design and construction of a groyne constructed from Geosynthetic sand containers. The tender called for a groyne 2.5m high by 100m long which could withstand 3m high waves. Another important criteria was that the geotextile should provide some form of vandal resistance.

The Council selected the ELCO Solutions proposal, designed by ICM, consisting of a multiple container structure, which would maximise flexibility, and minimise the potential effects of vandalism. The design incorporated a number of innovative features, namely:

Due to the ongoing erosion of Maroochydore beach, the Maroochy Shire Council instructed WBM Oceanics to assess the cause of the problem and recommend an interim solution. Modelling at the Queensland hydraulics laboratory identified that beach nourishment together with a groyne located at the northern end of the beach would meet the criteria.

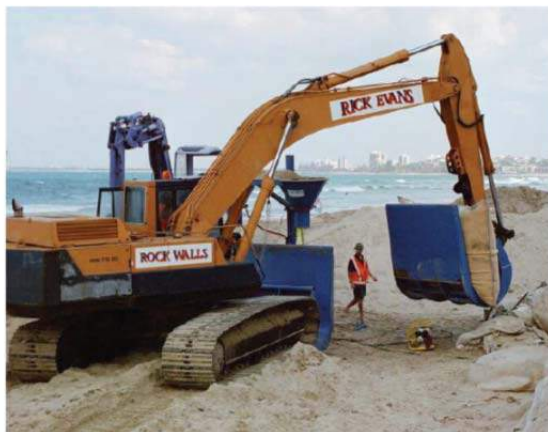
Filling and Placement Apparatus

- Vandal Deterrent Composite Geotextile.
- 5 tonne Sand Containers.
- Specialised Filling & Placing Apparatus.

ELCO Solutions Australia provided the specialised, filling and placement equipment, to ensure effective filling and simplified placement of containers. A total of 2,000 No. 2.5m³ vandal deterrent containers were used for the construction of the 3 groynes. The construction period was 2 months.

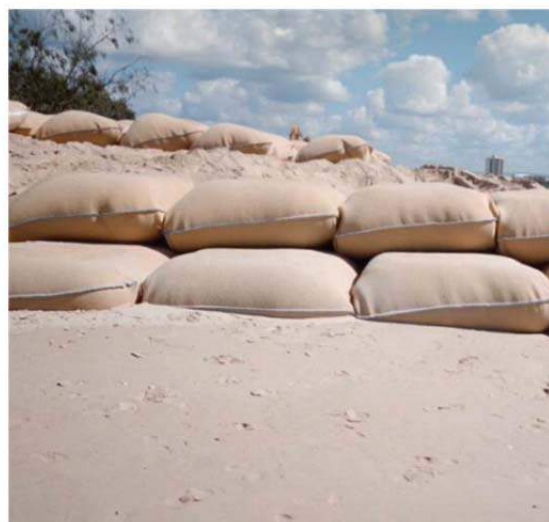
During construction 2003

The areas between the groynes were nourished with 30,000m³ of sand from a sand source north of the Maroochy River.
