# Graben Pty. Ltd.

## Surf Port Douglas Engineering Report

June 2021

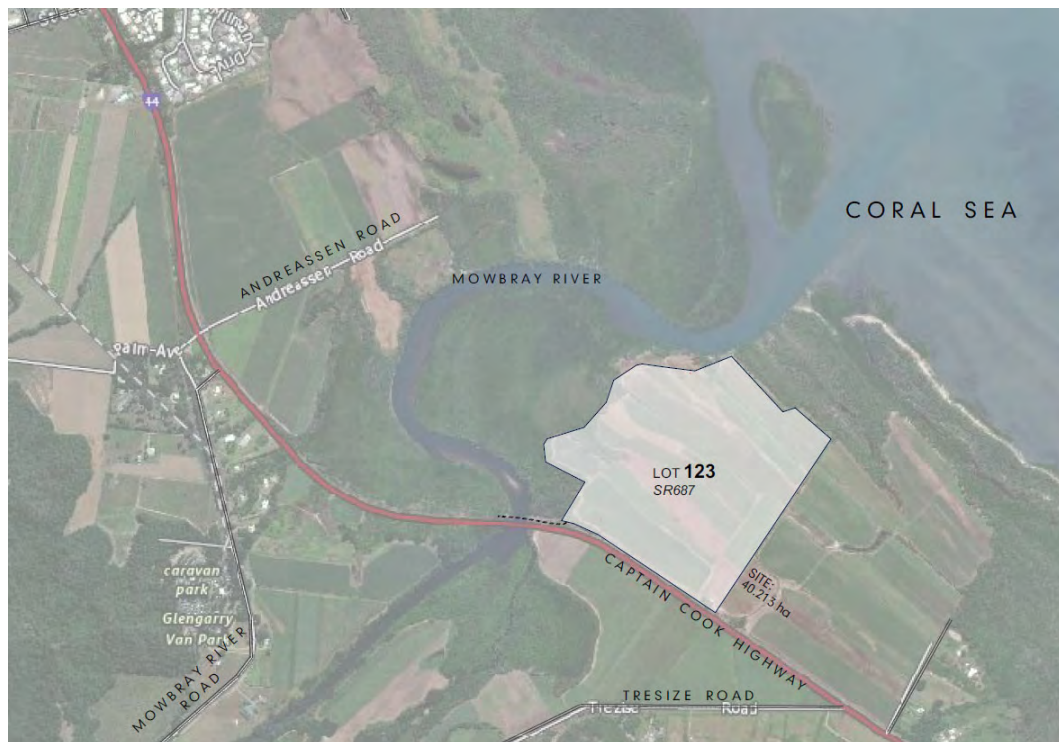
Figure 1 Site Location

The site for the proposed development is described as Lot 123 SR687 and has an area of 40.21 Ha and is located south of Port Douglas immediately south of the Mowbray River and east of the Captain Cook Highway. The site is zoned Rural and is currently used for agricultural activities involved in the production of sugar cane. Existing access for rural activities is from the state-controlled Captain Cook Highway.

Graben Pty. Ltd proposes to reconfigure land described as Lot 123 SR687, shown in Figure 1 below, from the current 1 lot into a community title scheme containing a resort, surf pool, internal lagoon, villas and 42 short term accommodation lots shown in Figure 2 below. All buildings, facilities and infrastructure will be body corporate controlled and managed. A copy of the proposed architectural by Hunt Design will be provided in the overall submission package.

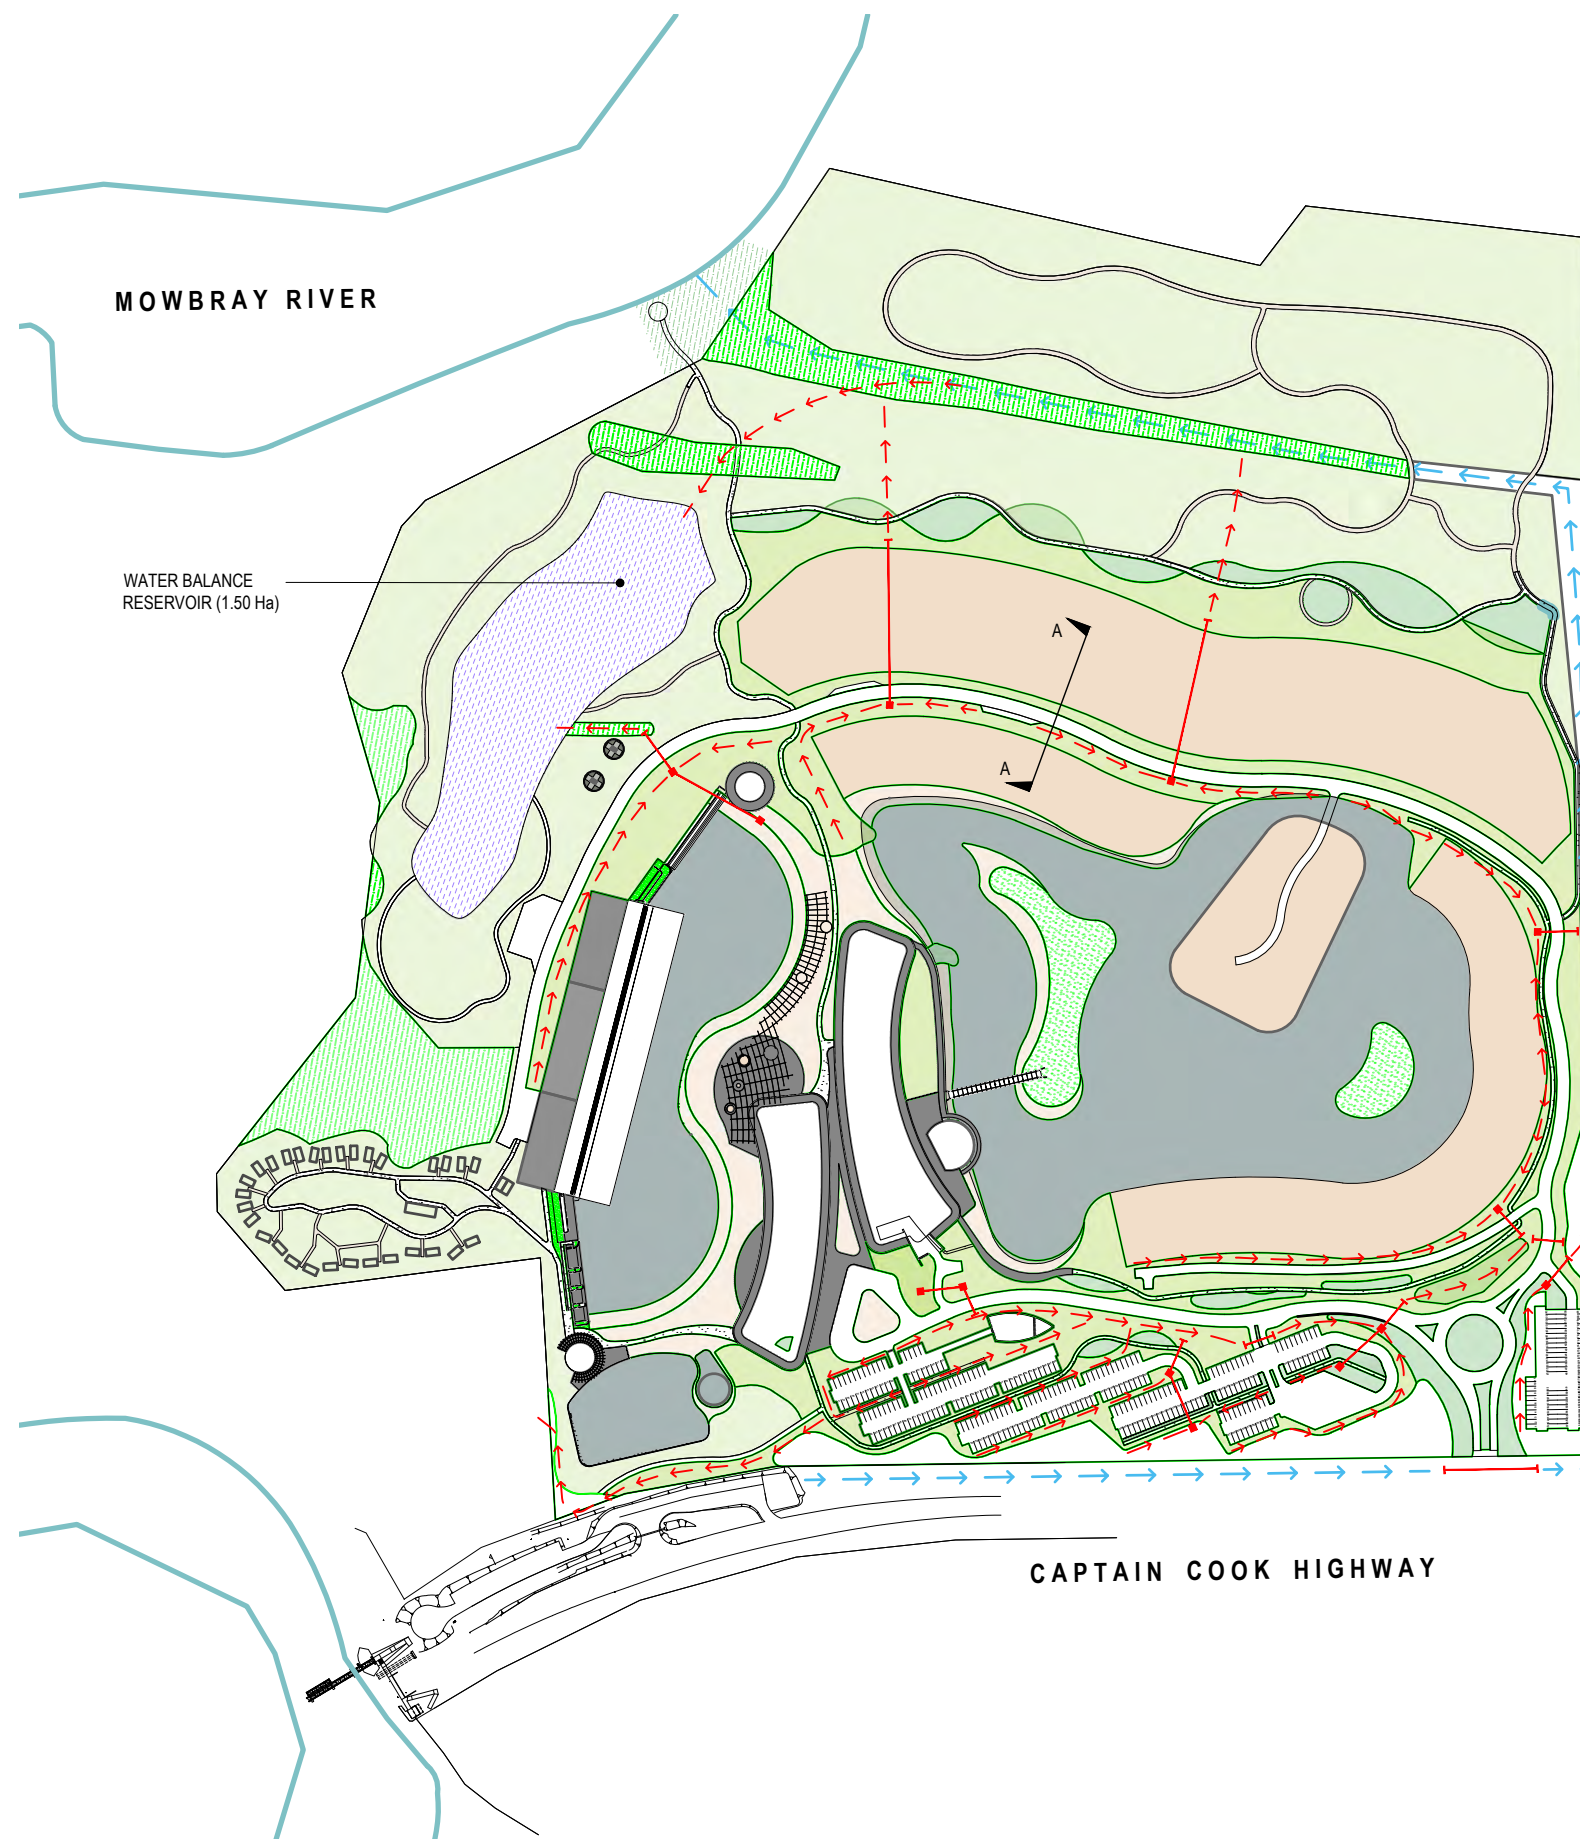
CONCEPT DRAINAGE

- → → → EXISTING DRAINAGE PATH
- → → → PROPOSED DRAINAGE PATH
- PROPOSED DRAINAGE STRUCTURE

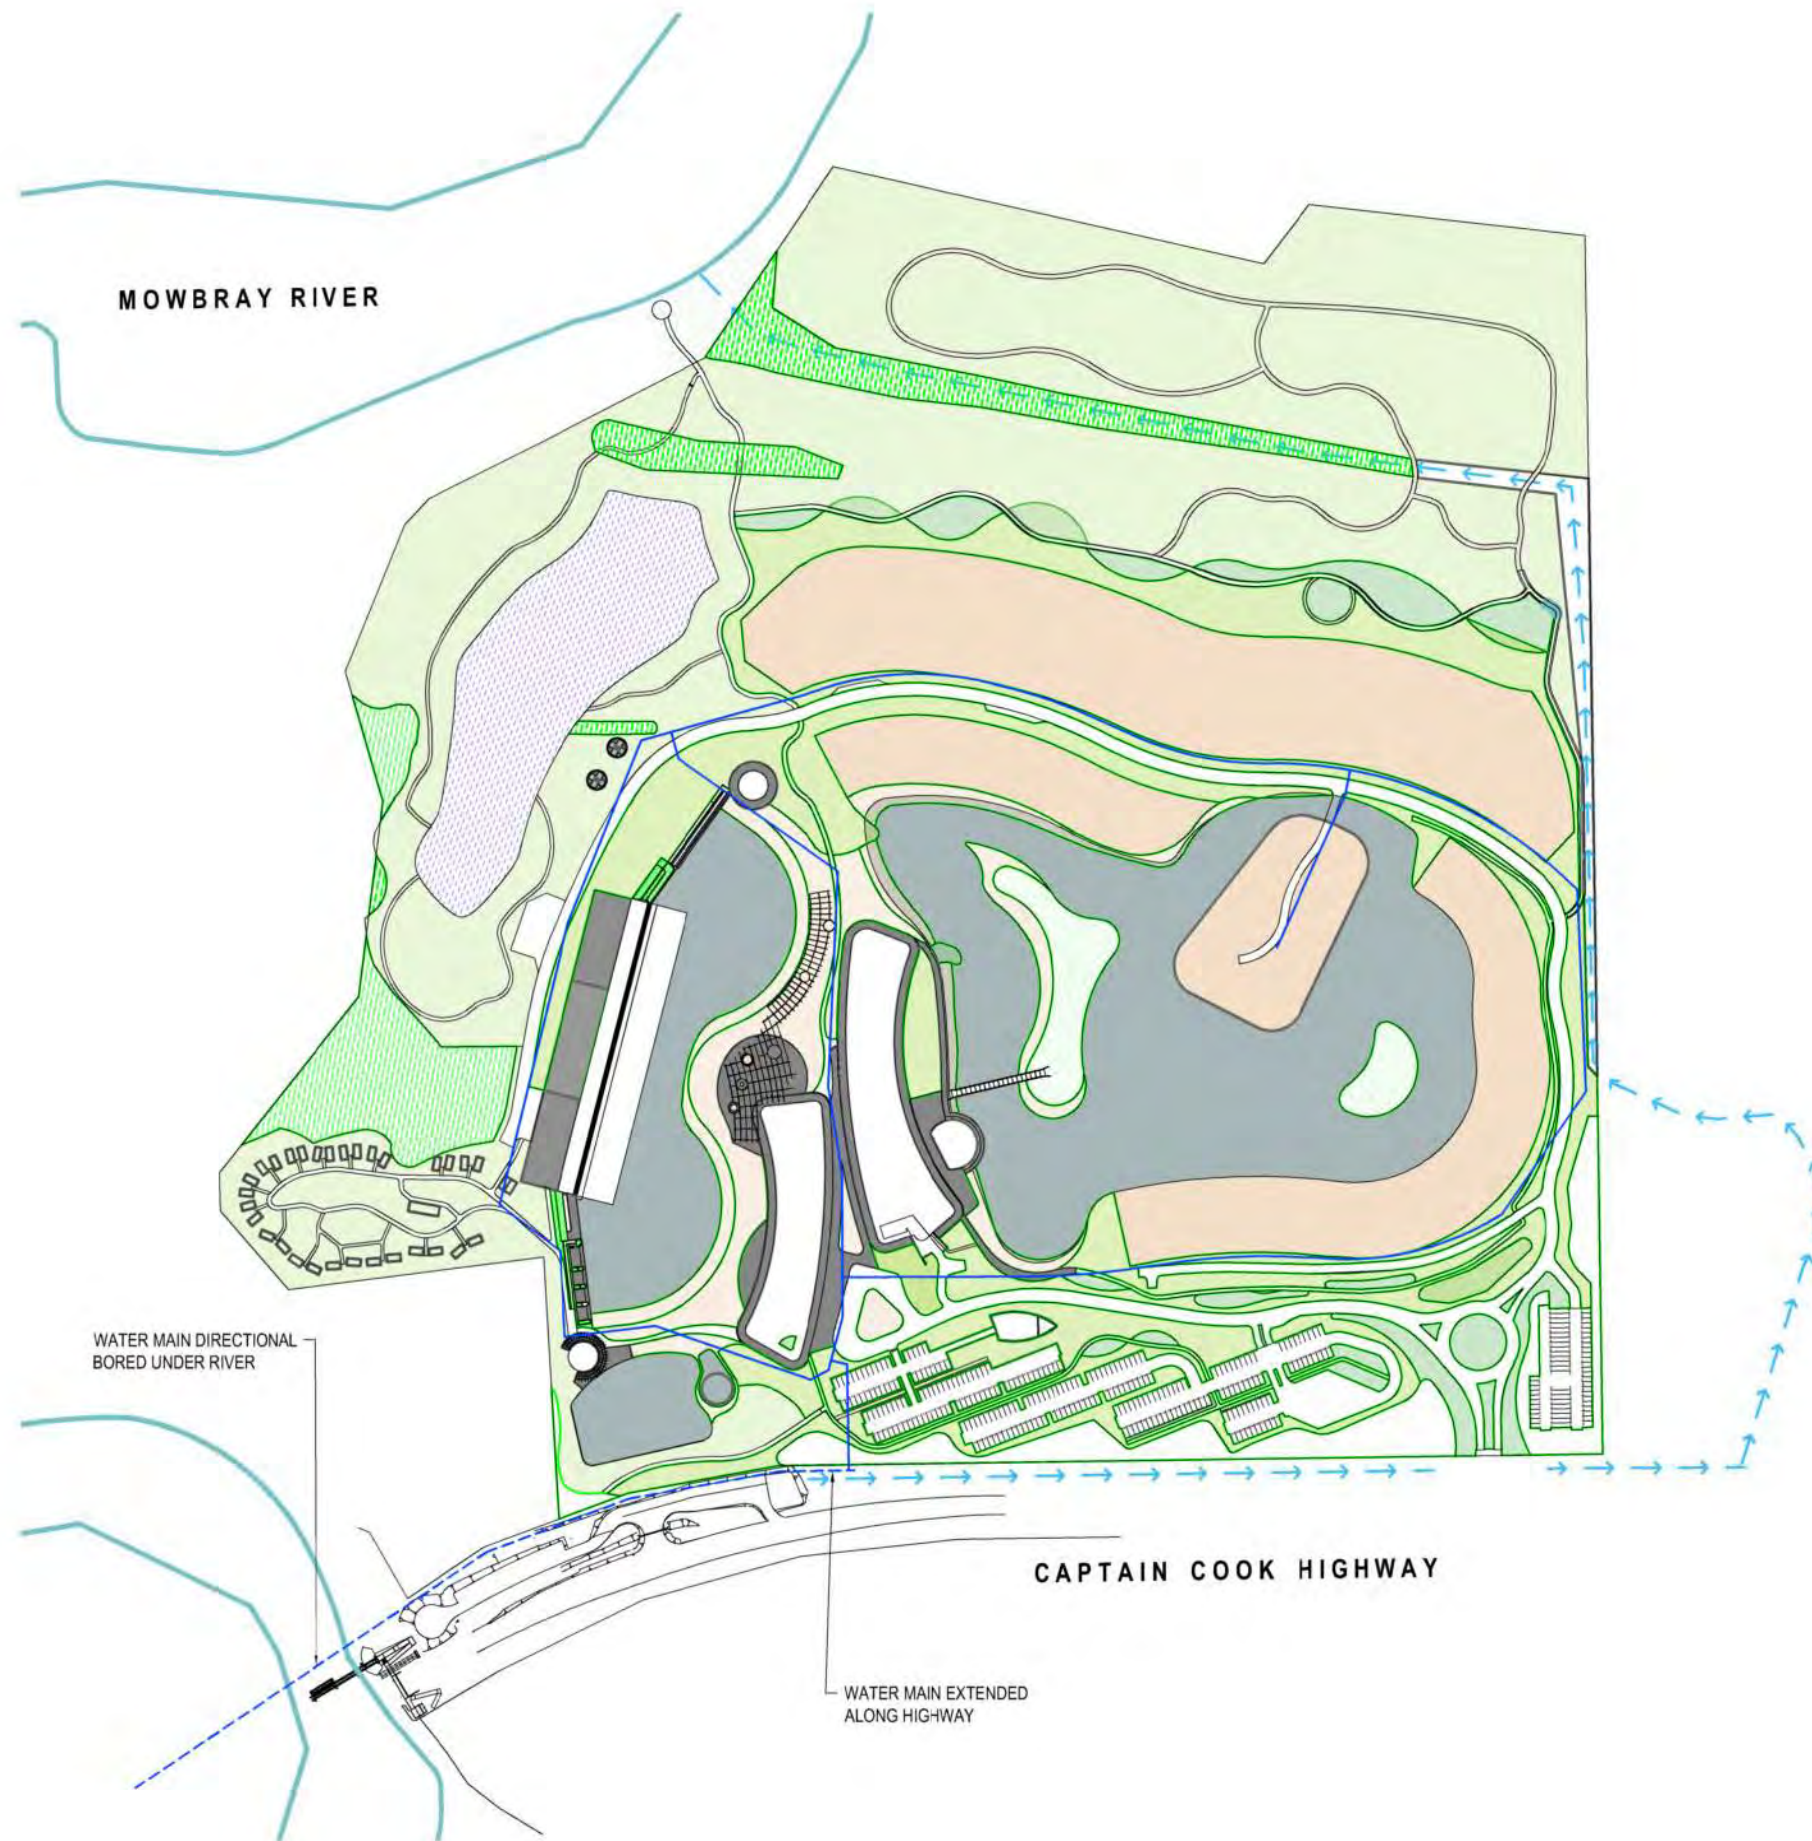
CONCEPT WATER

A Water Storage Lagoon with 1.5 hectares surface area and 50 mega-litre capacity was sized based on the 85<sup>th</sup> percentile driest year using historical climatic data (rainfall and evaporation). It is assumed that excess flows during wet seasons from the Recreational Lagoon and surrounding site catchments will be captured in the Water Storage Lagoon and pumped back during dry seasons. More detail on this assessment can be found in Appendix C.

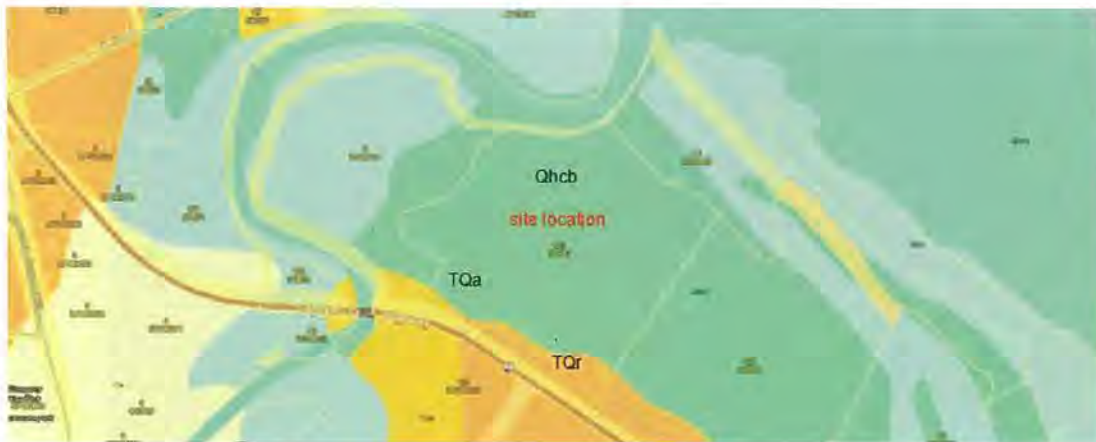
Plate 1 Regional geology (DNRM)

An excerpt of the regional geology map published electronically by the Queensland Department of Natural Resources and Mines (DNRM) is presented in Plate 1. The map indicates that the site is underlain by the following geological units:

- Qhcb - Quaternary (Holocene) age deposits comprising sand ridges in the lower lying areas of the site;
- TQa – Quaternary/Tertiary age high-level alluvial deposits comprising sand, silt, clay and minor gravel in the area along the Captain Cook Highway nearer the Mowbray River; and
- TQr – Quaternary/Tertiary age colluvial and residual soil deposits (generally on older land surfaces) comprising clay, silt, sand, and gravel in the area along the Captain Cook Highway further away from the Mowbray River.

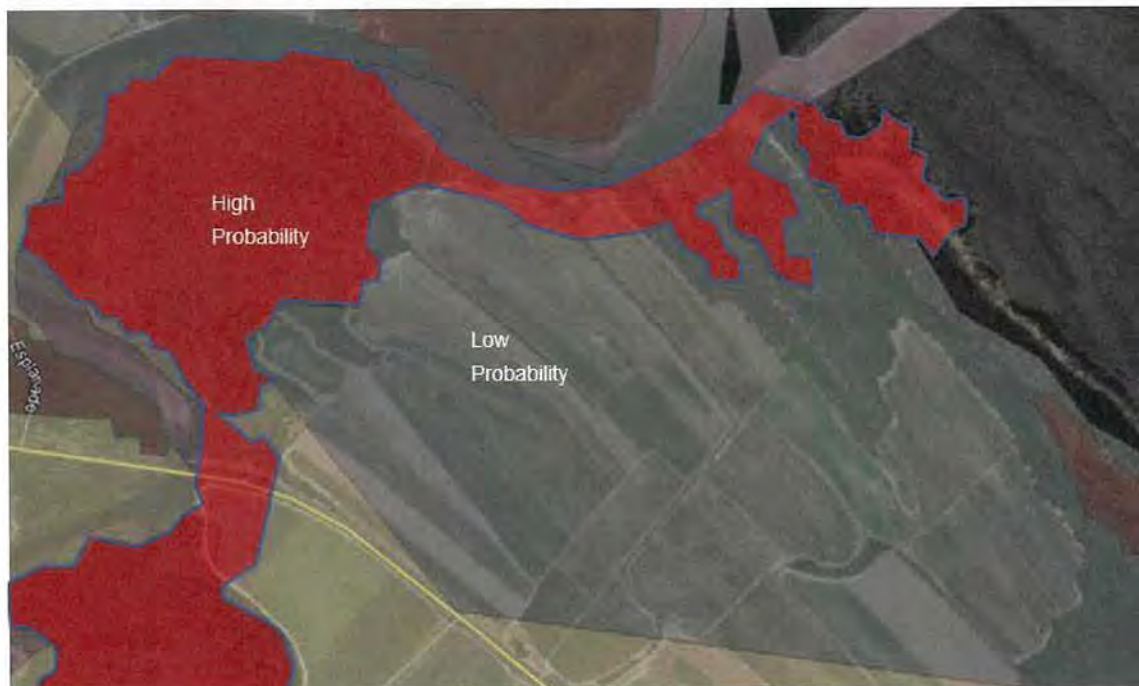
Plate 3 ASS Risk Map

An excerpt from the ASRIS ASS risk map is shown on Plate 3. The map indicates a low probability of occurrence across most of the site. The map also indicates a high probability of ASS occurrence near parts of the north western and north eastern site boundaries.

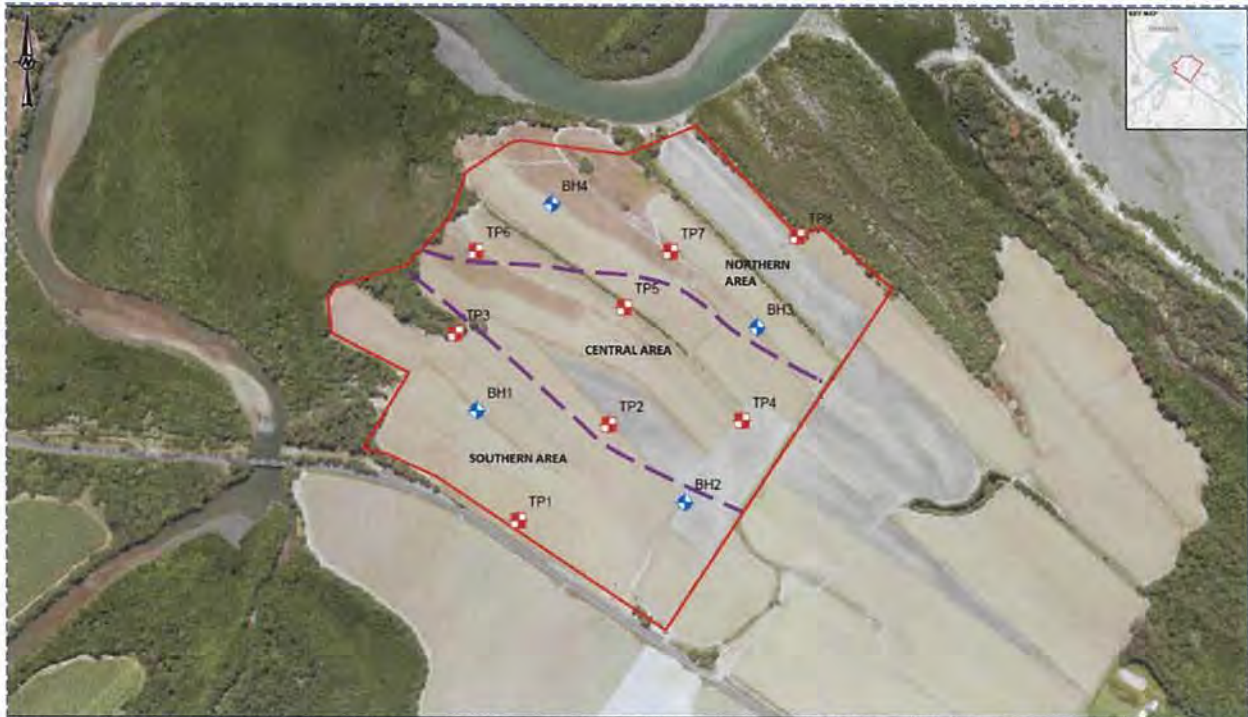
Plate 4: Site areas

For discussion purposes the site has been divided into three main areas (northern, central, southern) based on subsurface conditions encountered during the investigation. These areas are shown in Plate 4.

As outlined in Section 1.0, the aims of the studies were to provide a broadscale assessment of near-surface ground and groundwater conditions across the site. On this basis the site has been divided into three main areas (northern, central, southern) based on subsurface conditions encountered during the investigation. The inferred extent of each area is shown in plan on Plate 4 in Section 4.2 and in cross section on Figure 2.

- Southern Area – Predominantly stiff to hard clays to depths greater than about 4 m;
- Central Area – Variable thickness of loose to dense sands to depths ranging to about 4 m, overlying stiff to hard clays; and
- Northern Area - Predominantly loose to dense sands to depths greater than about 4 m,

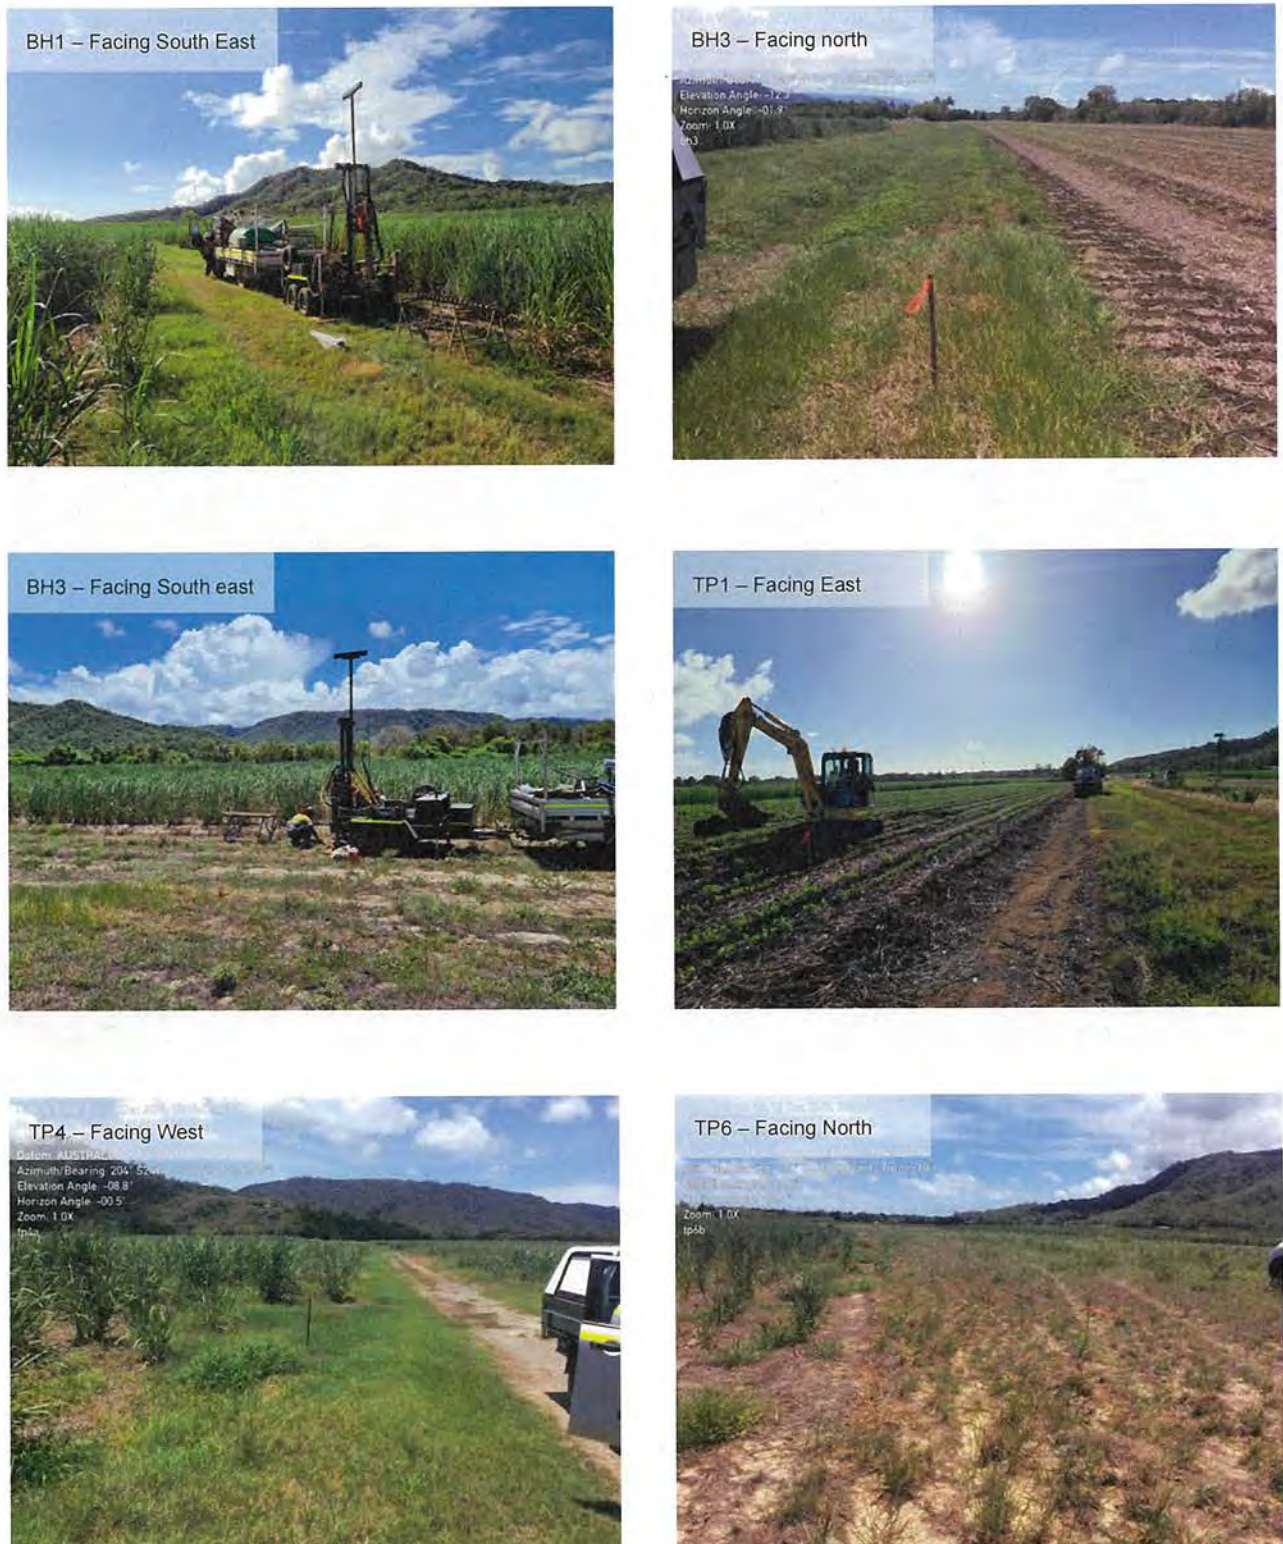
Plate 5: Selected photographs at time of investigation

Selected site photographs at the time of the site investigation are presented in Plate 5.

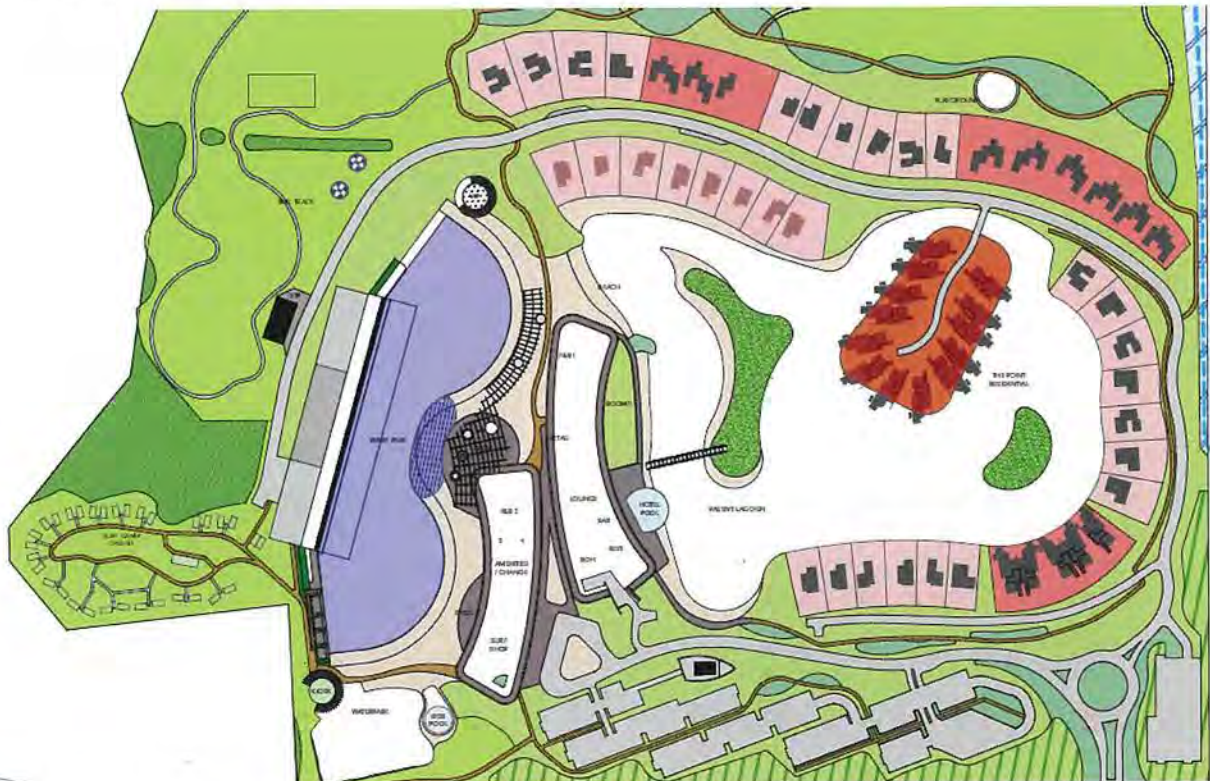
**Plate 6: Schematic layout of proposed development**

A copy of the schematic layout of the proposed development from a drawing provided by Hunt Design is presented in Plate 6.

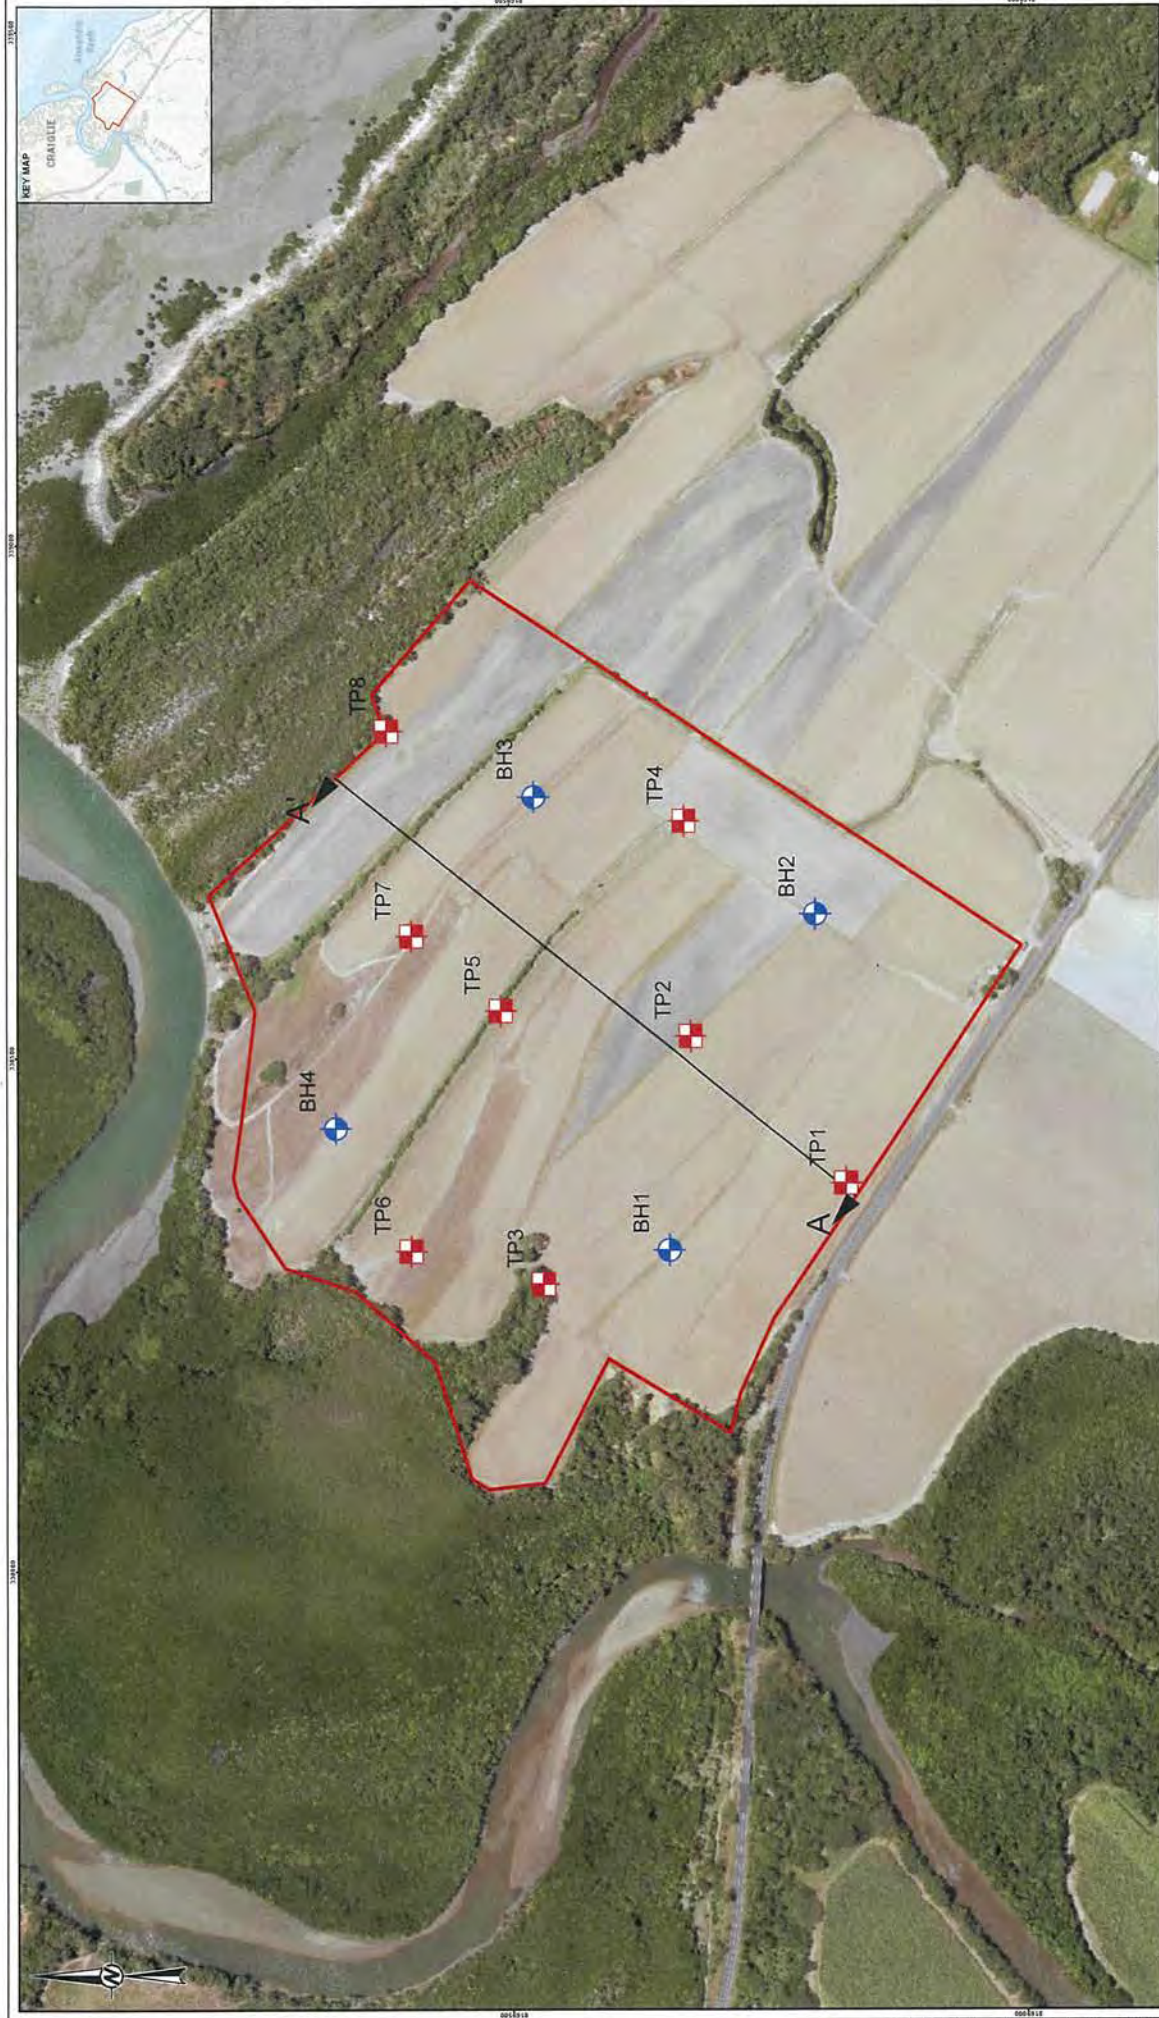
- Test Pit
- Borehole
- Land Parcel

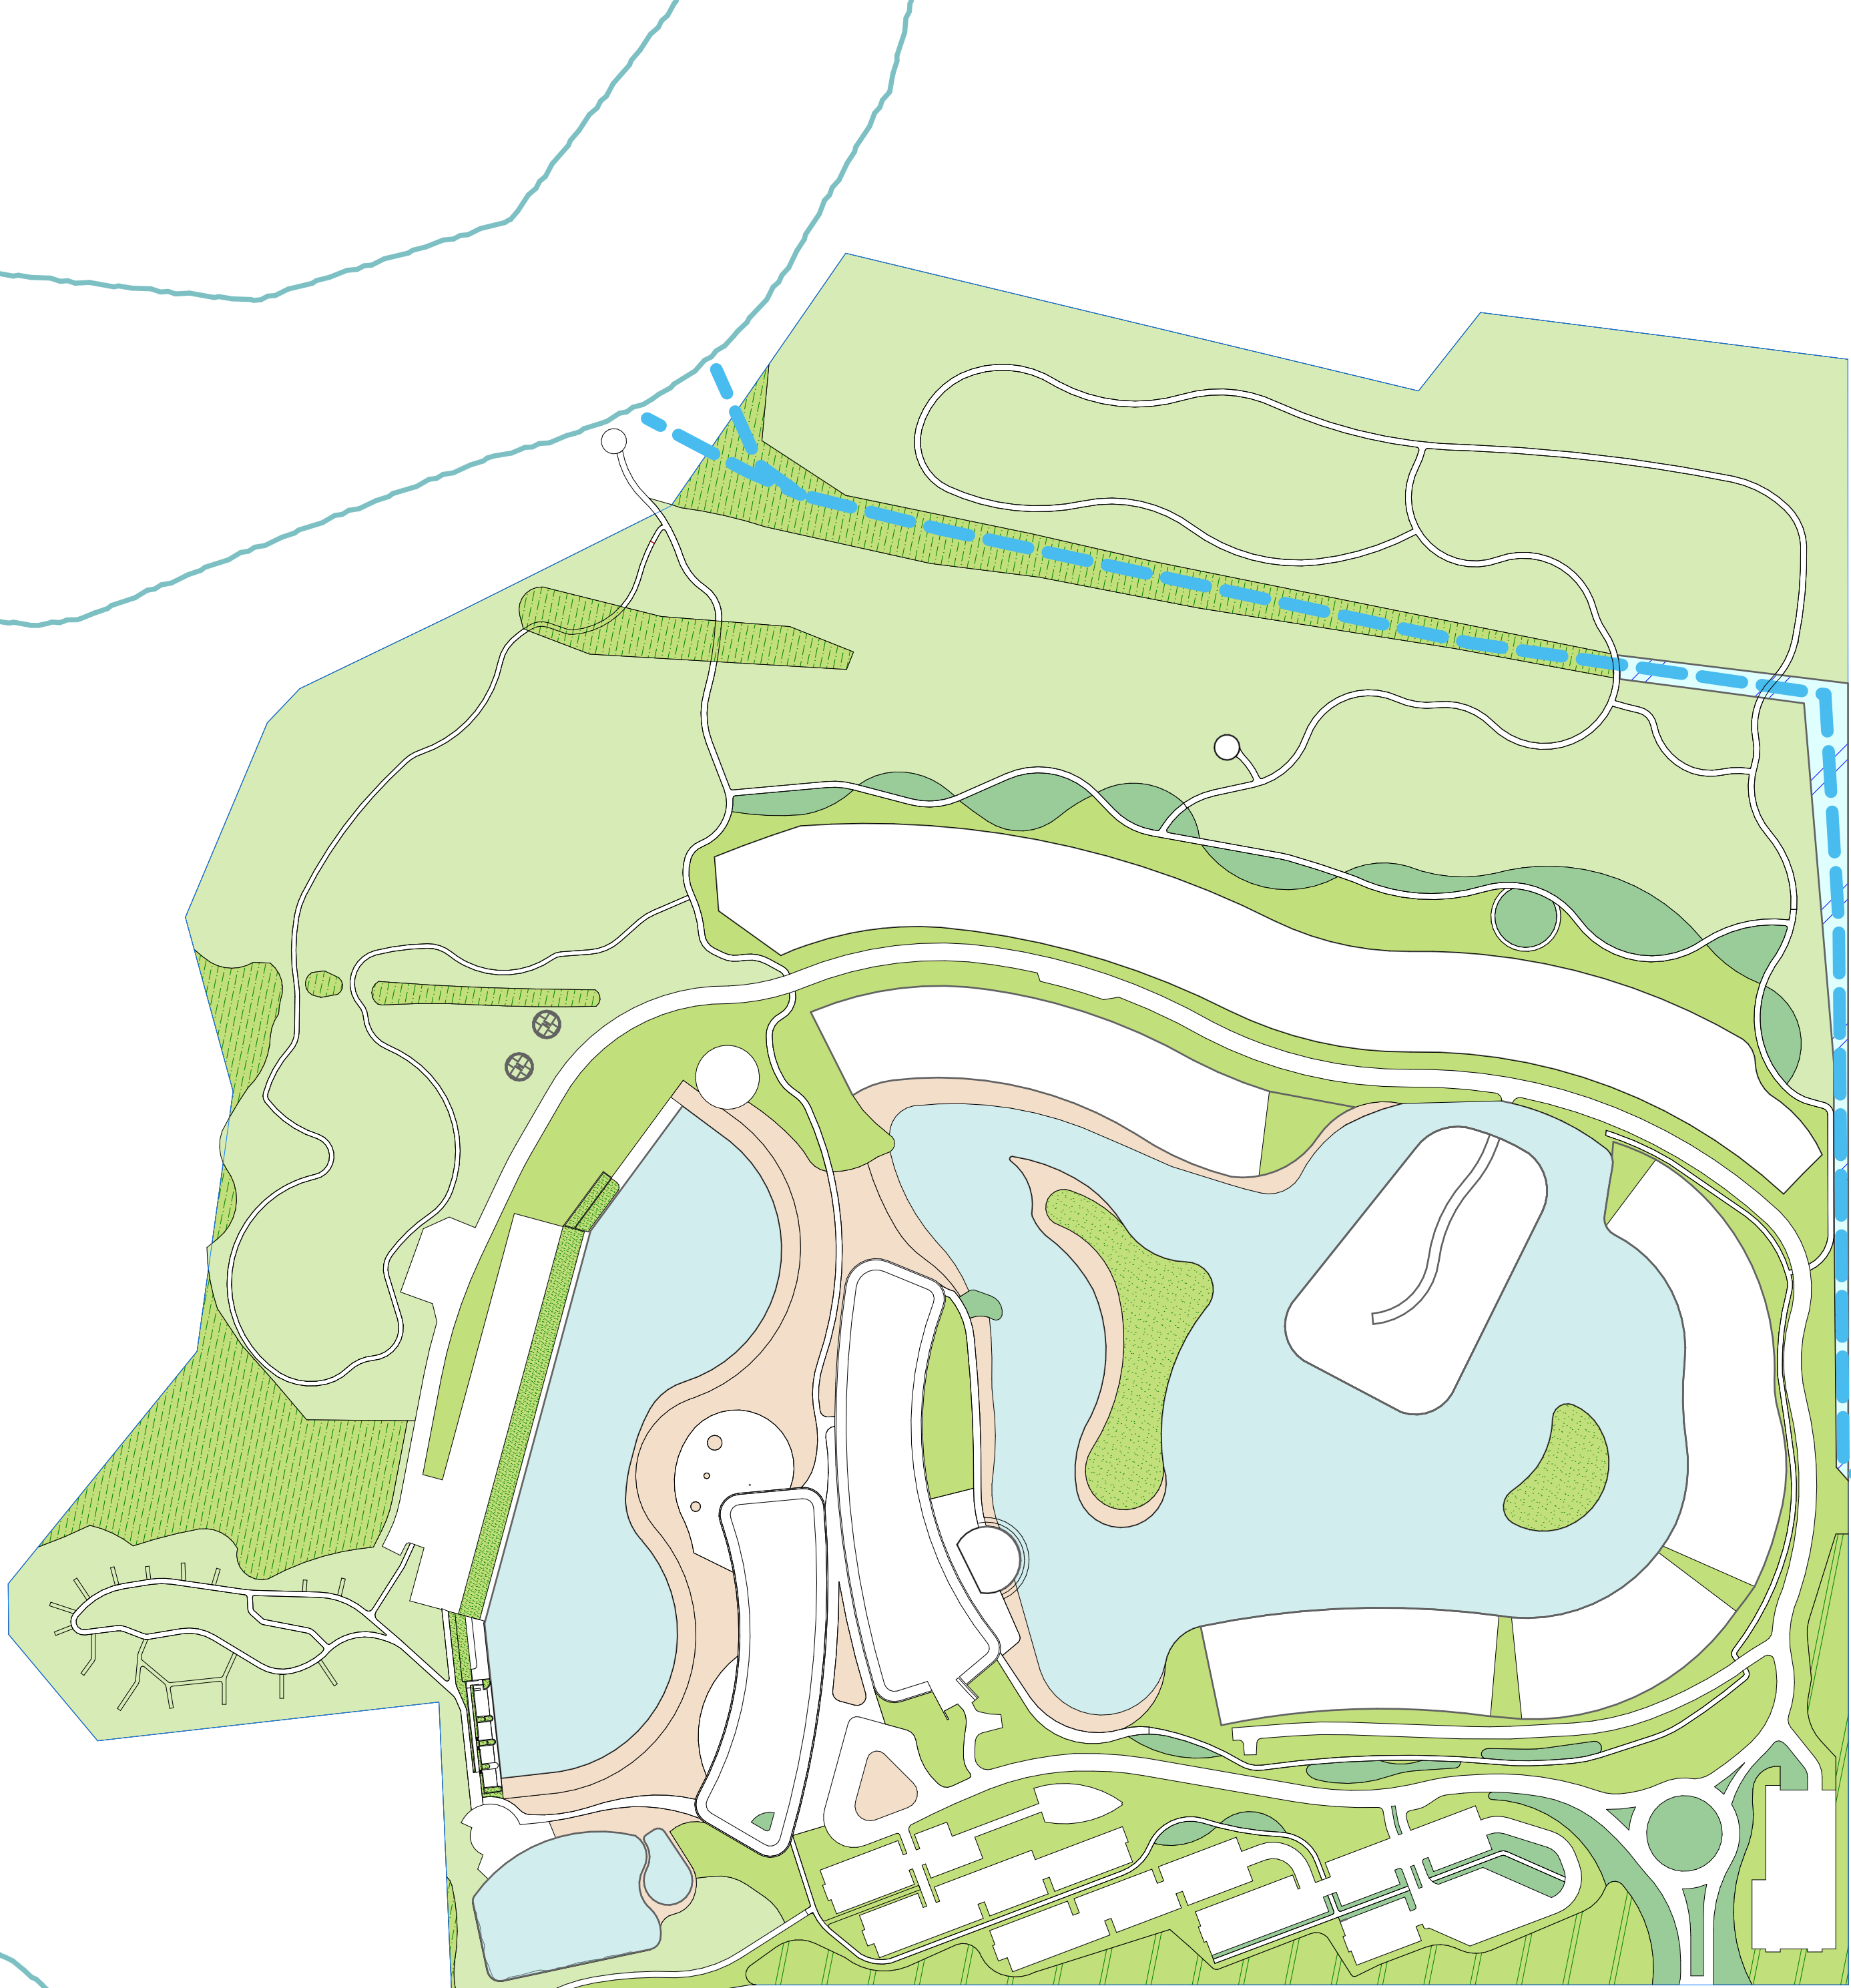
LANDSCAPE AREAS		
Name	Area	Plan
COASTAL LANDSCAPING / BEACH	15,557	
EXISTING	18,402	
GARDEN	10,994	
GRASS	32,149	
ISLAND	14,632	
RE-VEGETATION	135,478	
TREE BUFFER	7,853	
TROPICAL PLANTER	1,908	
	236,971 m <sup>2</sup>

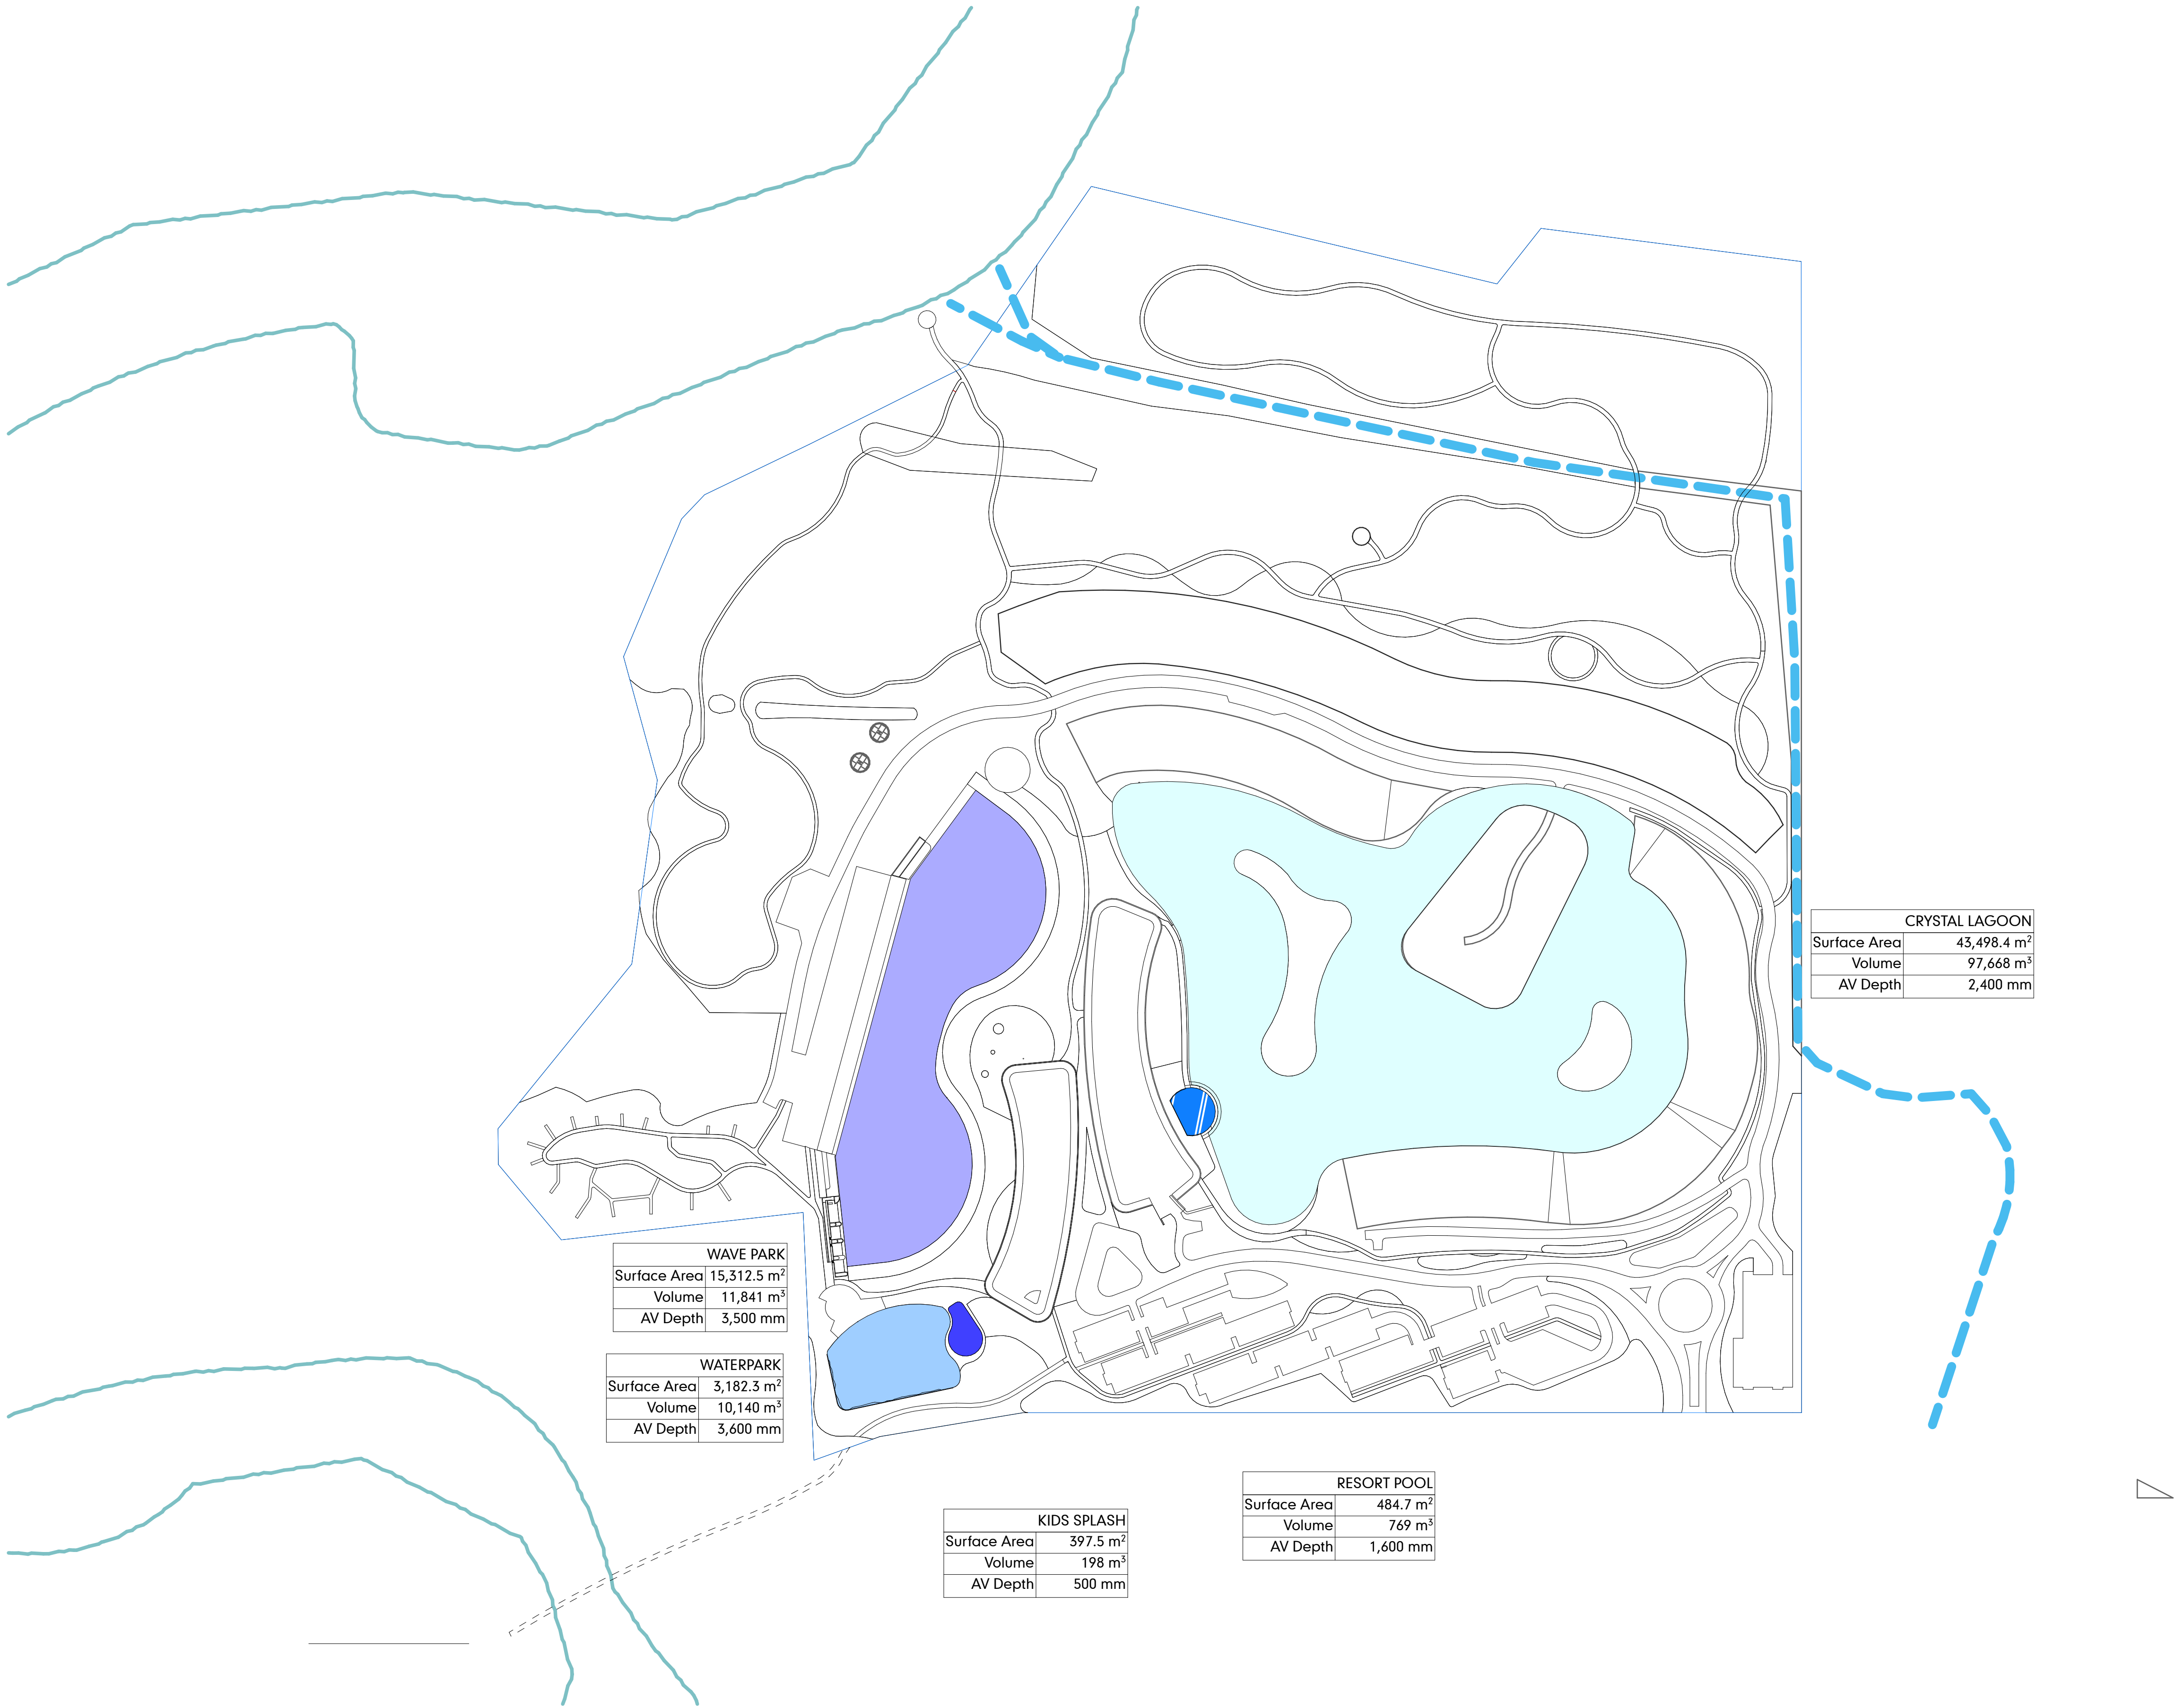
WATER VOLUMES				
WATER BODY	VOLUME	AREA	FILL	NOTE
CRYSTAL LAGOON	97,668	43,498	<div></div>	
KIDS SPLASH	198	398	<div></div>	
RESORT POOL	769	485	<div></div>	
WATERPARK	10,140	3,182	<div></div>	
WAVE PARK	11,841	15,312	<div></div>	Total Water Surface area (Static): 12,429m²
	120,615 m³	62,875 m²

CRYSTAL LAGOON	
Surface Area	43,498.4 m²
Volume	97,668 m³
AV Depth	2,400 mm
