# Graben Pty. Ltd.

## Surf Port Douglas Engineering Report

June 2021

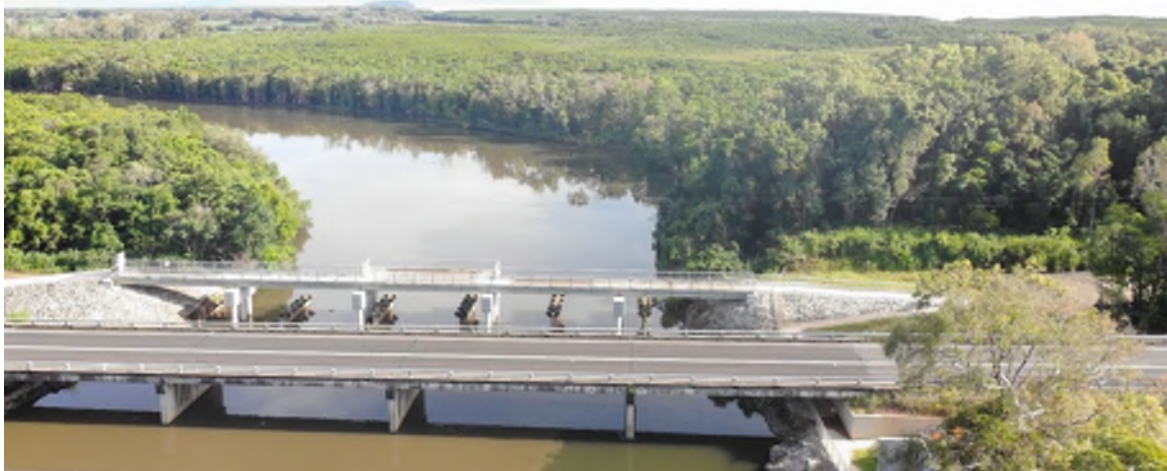
Figure 2-1. Mowbray River bridge and Wangetti trail bridge

Details of bridge structures, Mowbray River bridge and Wangetti trail bridge, as shown in Figure 2-1, were obtained from GHD, who have also been engaged by Hunt Design on this project. The details of these structures were modelled in the TUFLOW model. Bridge information such as deck level, thickness, opening dimensions and guardrail height were estimated from supplied engineering drawings. The drawings are contained in Appendix – As Constructed Drawings.

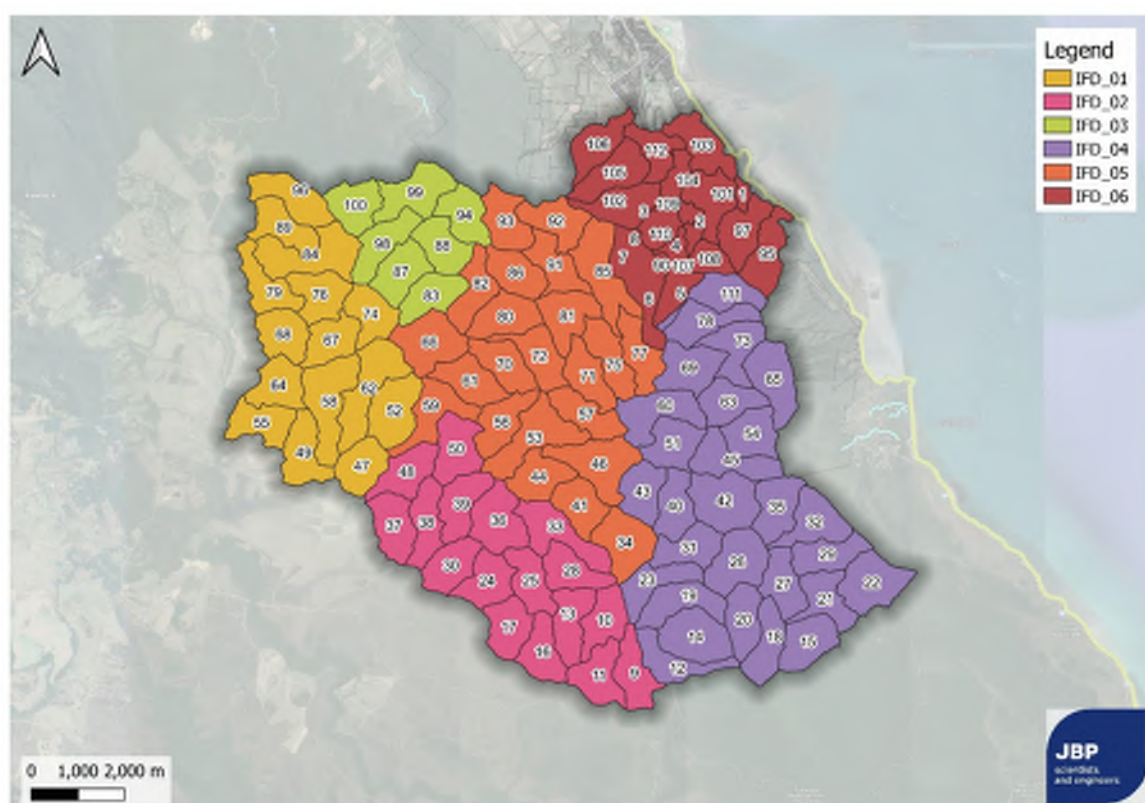
Figure 3-2. Application of IFDs to hydrological modelling across the catchment

Due to the topographic variability and size of the catchment, it was deemed that using one IFD would not accurately represent the catchment, and on the other end of the spectrum, it was not considered practical, or necessary to generate an IFD for 112 individual sub-catchments. As displayed in Figure 3-2 the catchment was delineated into six regions, with the centroids of each IFD region used to download the Bureau of Meteorology's (BoM's) IFD data.

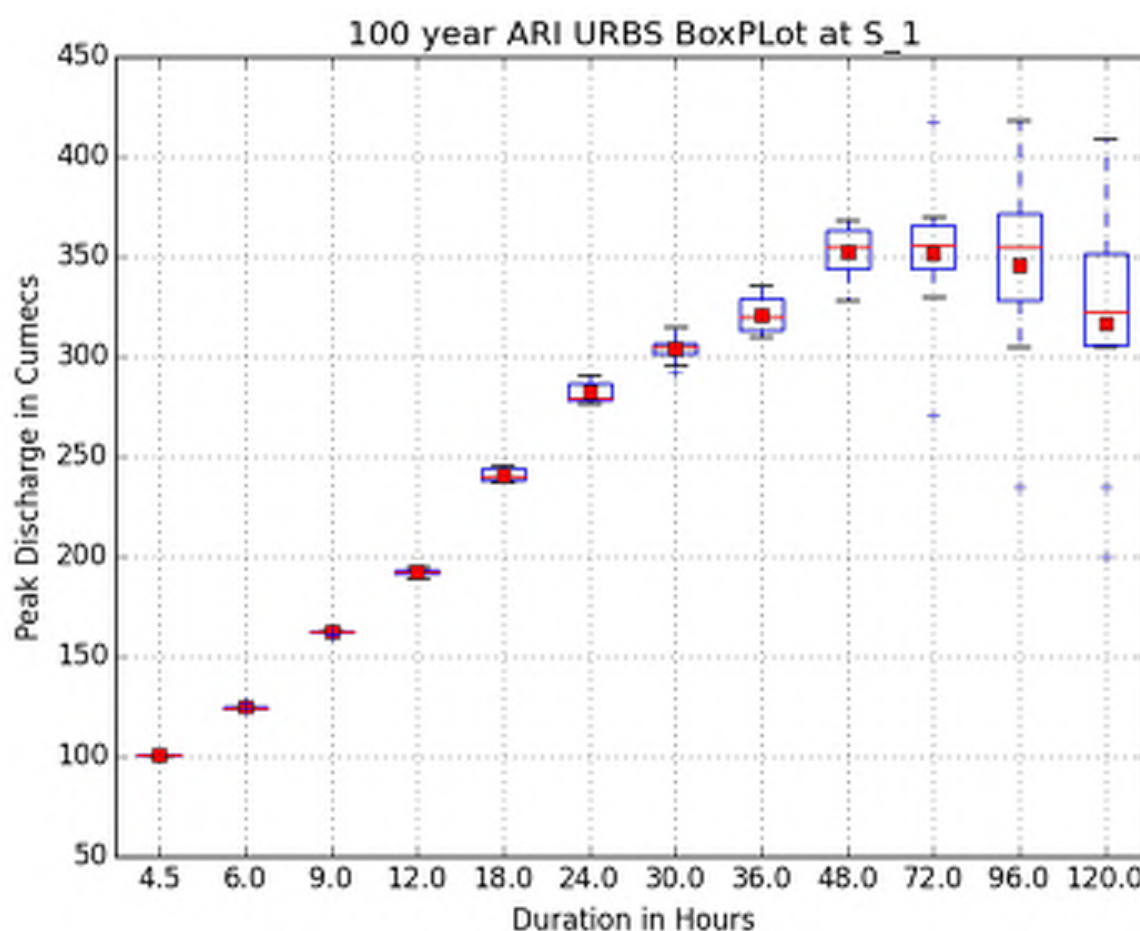
Various duration hydrographs from 6 hour to 120 hours were assessed to determine the critical duration for each sub-catchment. The approach adopted for the design flood estimation was to select the pattern and duration that was closest to the median (or one higher than the median) as an input to the hydraulic model. Figure 3-3 shows the ensemble results for each duration and 1%AEP as box and whisker plot for catchment outlet. Critical inflow duration for that location was 48 hours. It is noted that these critical durations may differ from the hydraulic model critical durations as any floodplain storage will be more accurately modelled in the hydraulic model. The validity of estimated peak flood discharge at the catchment outlet was investigated by Regional Flood Frequency Estimation Model, ARR, which the results show consistency with lower confidence limit of 1%AEP peak flow.

Figure 3-3. Box and whisker plot of ensemble temporal patterns modelled in the URBS hydrological model. Reported at river outlet (sub-catchemnt1)

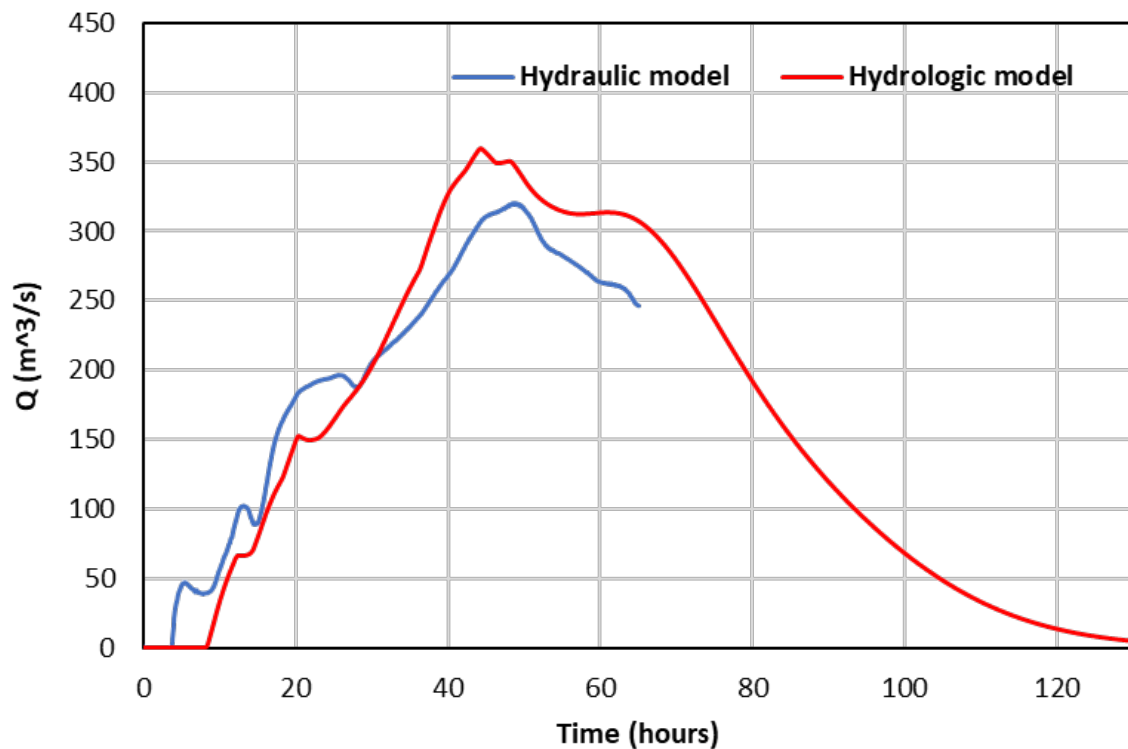
Figure 4-1. Comparison between hydrological and hydraulic model results near the site.

As discussed in Section 3-1, the estimated inflow hydrographs were extracted from the hydrological model at the TUFLOW model inflow locations. Reporting location nearby the site and downstream of the bridge were used to compare the results between the hydrological and hydraulic models, for evaluating the performance of the hydraulic mode. As shown in Figure 4-1, a comparison of hydrologic and hydraulic model results, show good agreement between the two model. The small differences in the hydrograph shape and peak are most likely related to the fact that floodplain storages are more accurately modelled in the hydraulic model.
