***GEOTECHNICAL SITE INVESTIGATION  
FOR NOAH CREEK TRAIL HEAD  
CAMP GROUND***

***REFERENCE: GG0032-001R***

# GEOTECHNICAL SITE INVESTIGATION FOR NOAH CREEK TRAIL HEAD CAMP GROUND

## **Noah Creek Development Pty Ltd**

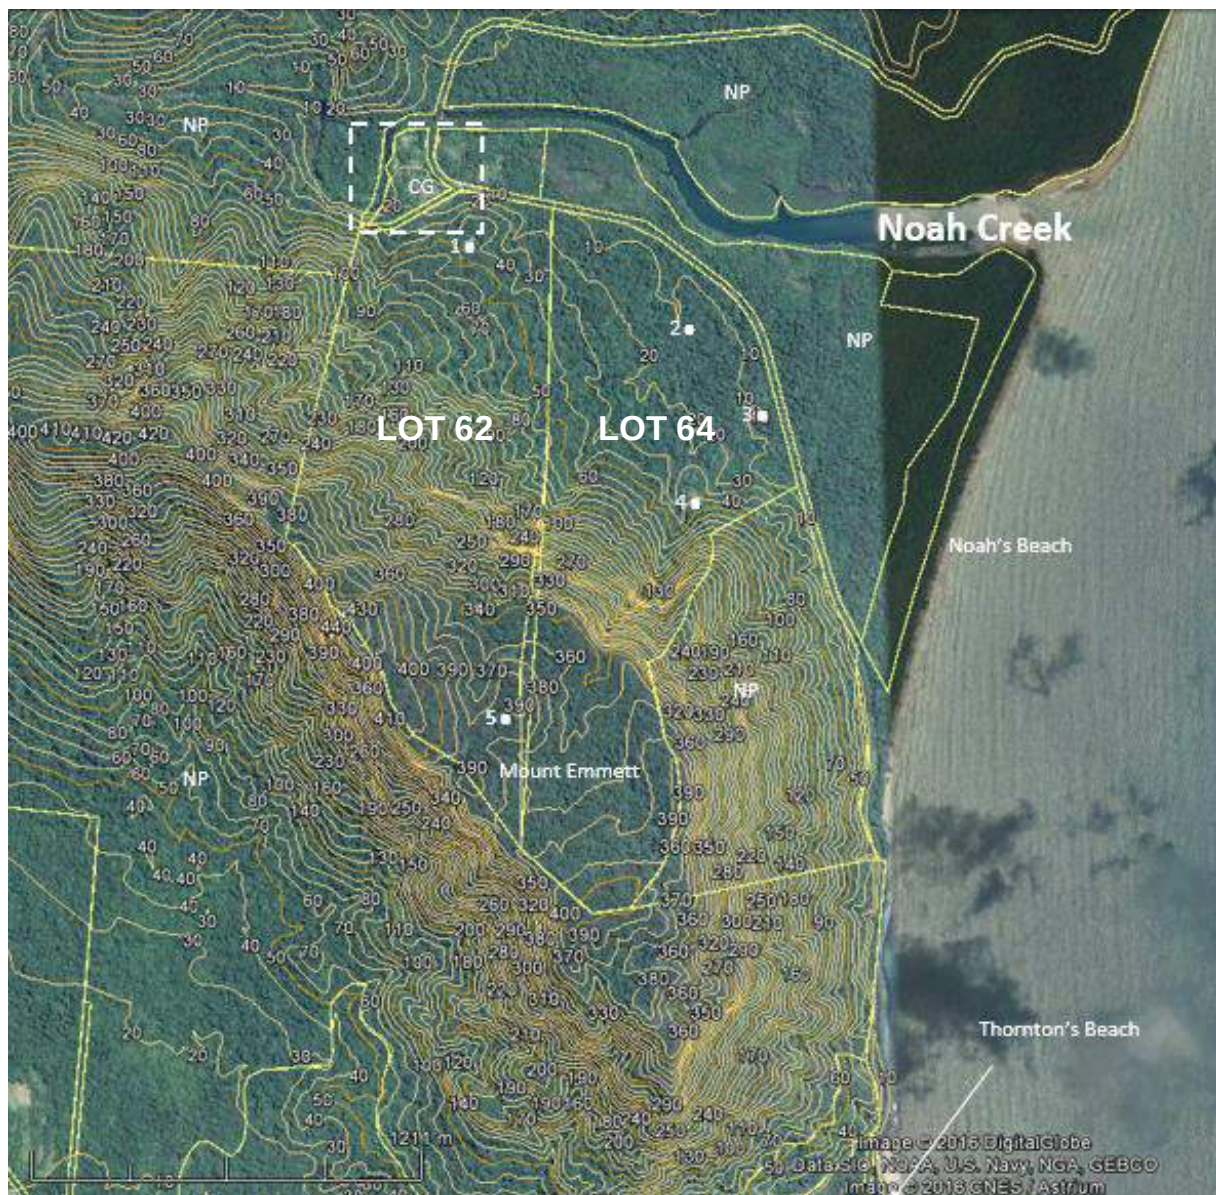
**Figure 1 – Contour Map of Noah Creek Land Division: Lot 62-64 Cape Tribulation Road; Remote Trail Camping Locations (1-5); For inset: see Figure 2 (Heweston, 2017)**

This report presents the findings of a geotechnical investigation carried out for proposed camp grounds and amenities to be located at 'Noah Creek', Lot 62 Cape Tribulation Road, Thornton Beach (Cape Tribulation) as illustrated in Figure 1.

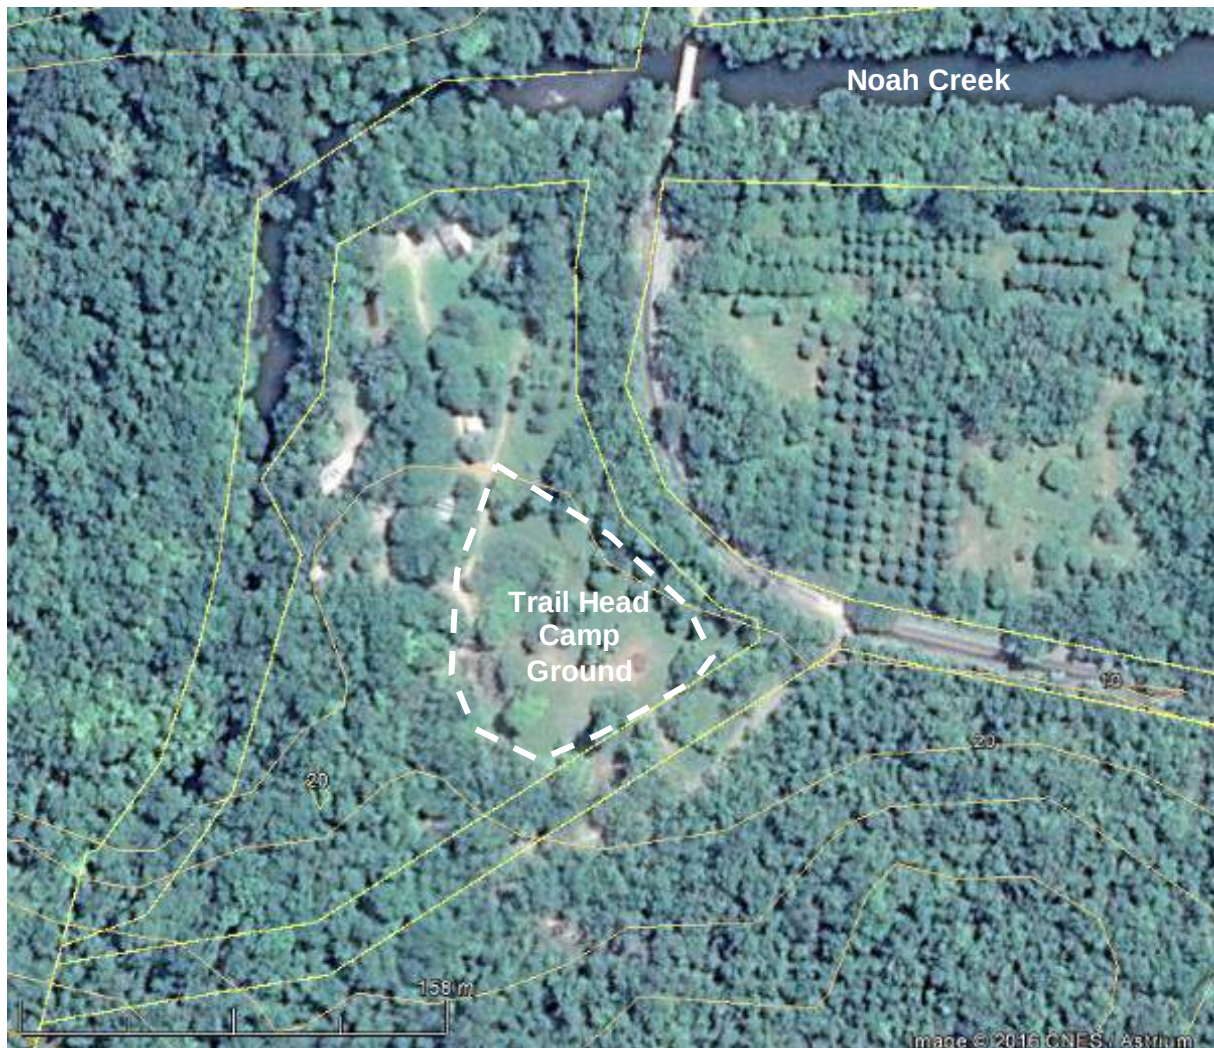
**Figure 2 – Location of Proposed Camp Ground (Heweston, 2017)**

It is understood the Trail Head Camp Ground development (location shown in Figure 2) shall include in the order of 20 light weight, single storey rooved-camping facilities and amenity blocks as outlined in the draft plan: Figure 3.

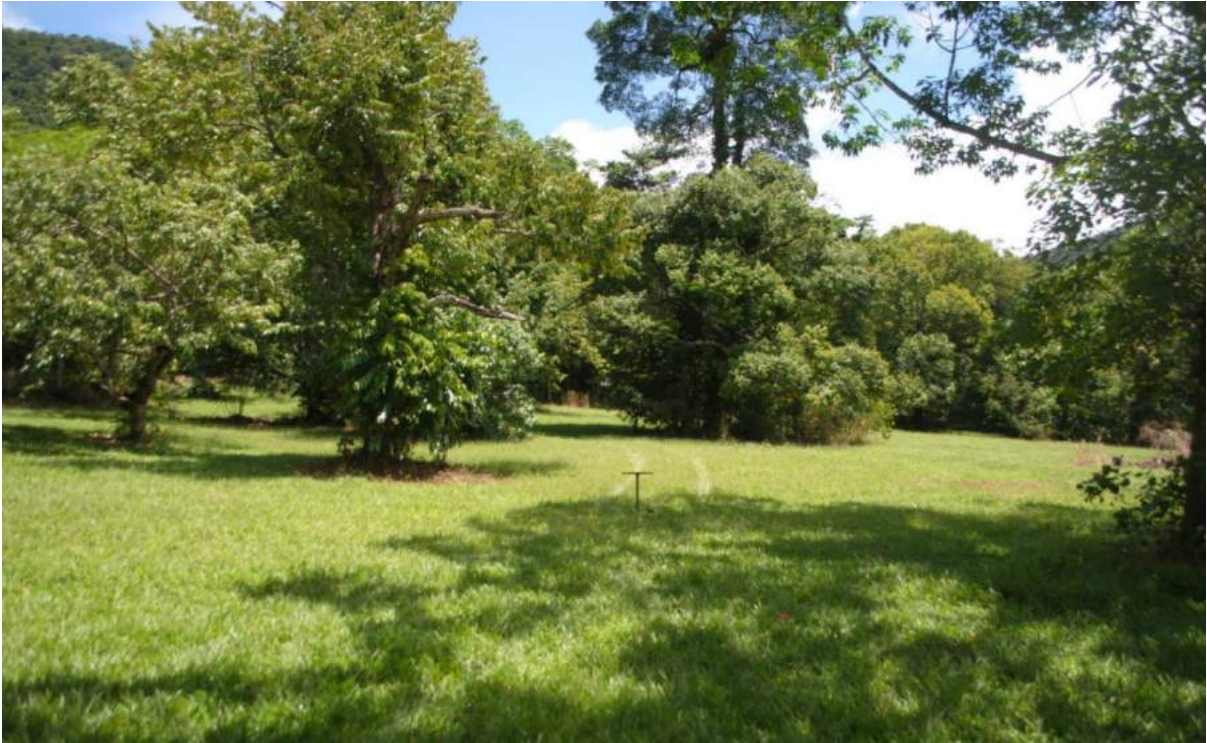
**Looking ~west from DCP1 toward DCP2 (AH1)**

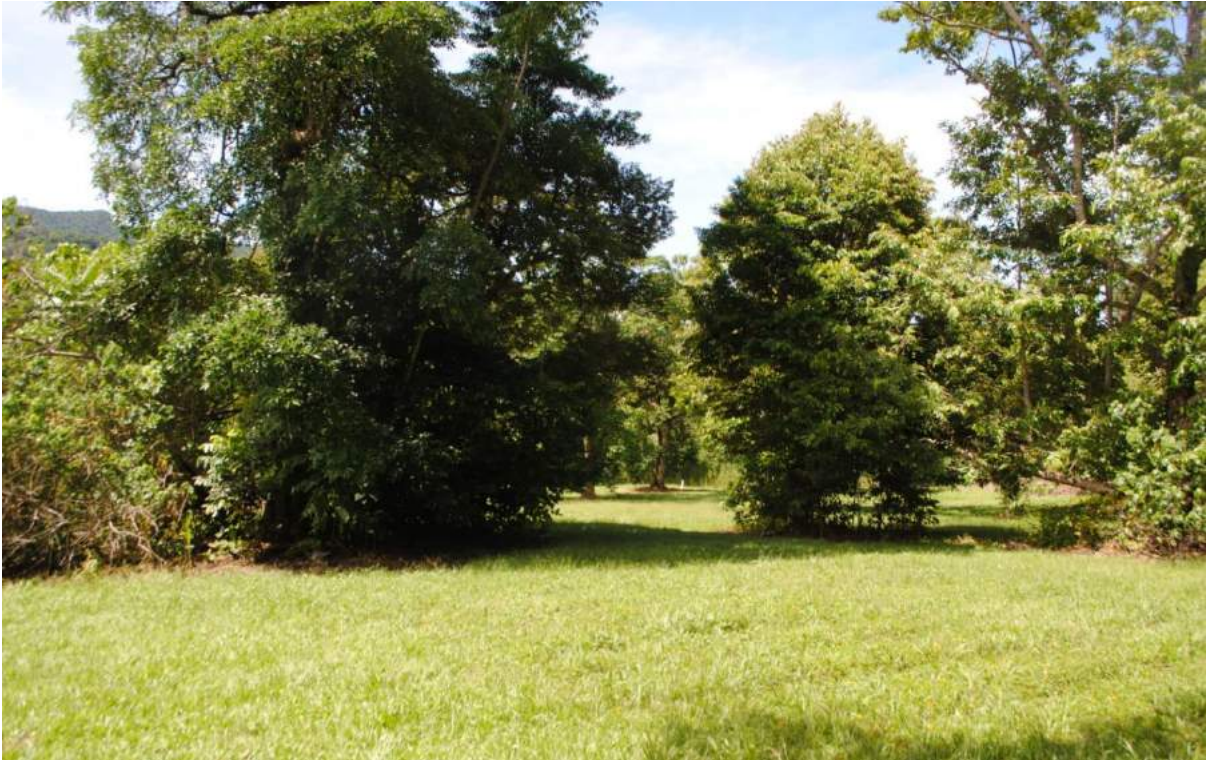
**Looking ~east from DCP5 (AH2) toward existing drill hole and DCP1**

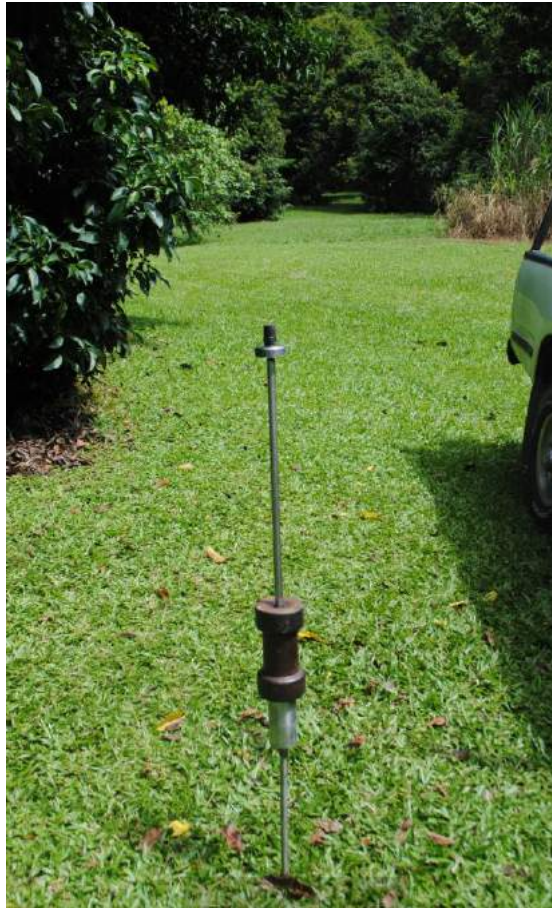
Looking ~south from DCP8 toward DCP5 (AH2)

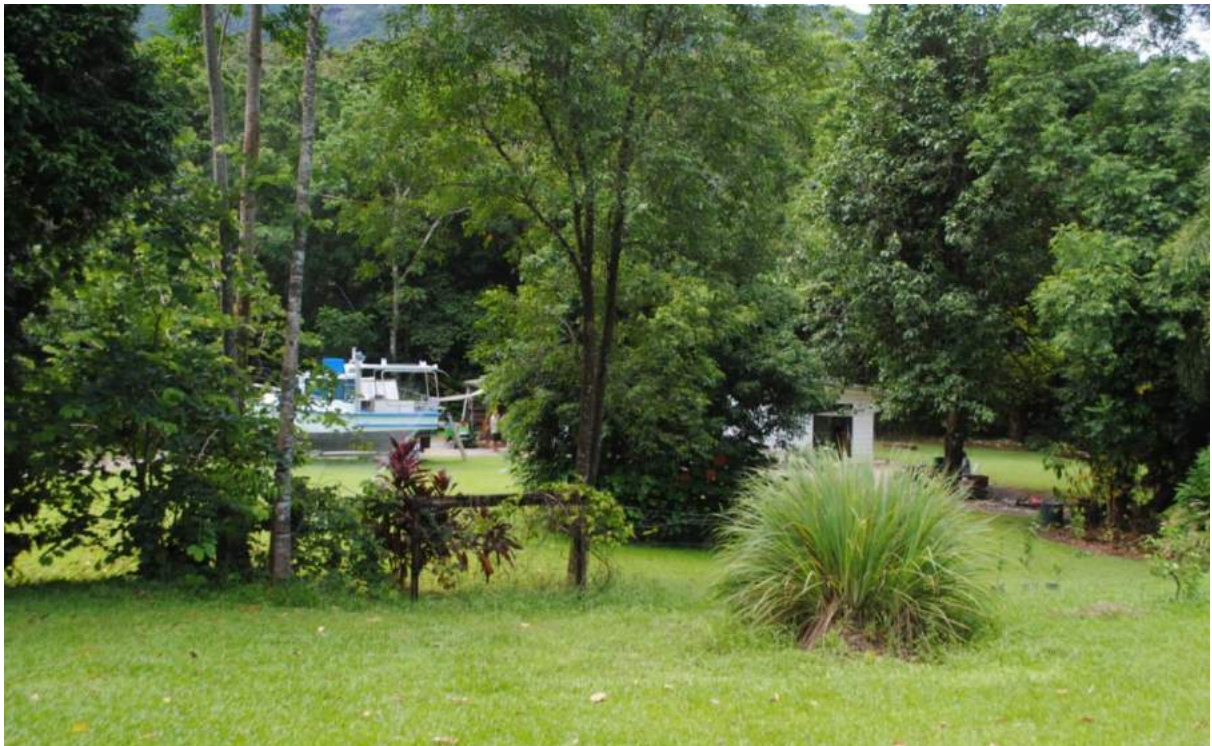
Looking ~north from DCP10
