Our ref: Mossman Gorge Subdivision  
File ref: 6960

**MOSSMAN GORGE COMMUNITY  
STAGE 1A COLLATION AND CAPACITY PHASE OUTCOMES**

Commentary on Each Service/infrastructure Element

Capacity, alignments and general compliance of the infrastructure for the roads and intersections within the community have been assessed with the results presented in **Attachment 3**. The results include tabulated audit findings and sketches of key elements assessed.

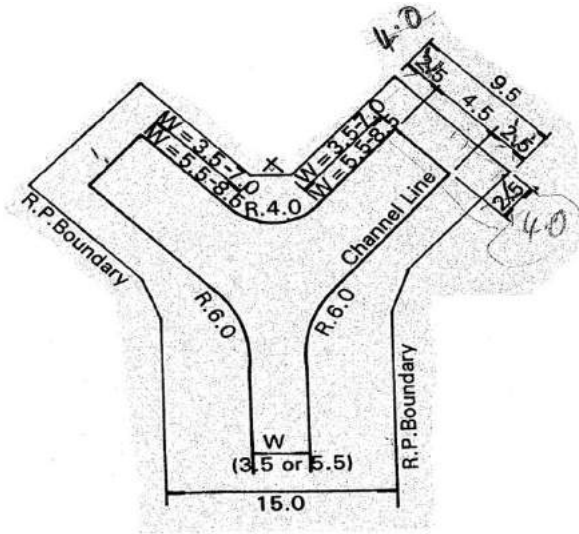
QLD ST's FIGURE 2.12m

Requirements: D1.1 Access Place Reserve Width - 14.5m      Seal Width - 5.5m Verge Width - 4.5m      Design Speed - 30km/h Lighting P4 Min R9.0 on Kerb Returns Design Vehicle - Single Unit/Truck  T - Heads not permitted under FNQROC Provision for on street parking in turning head
--

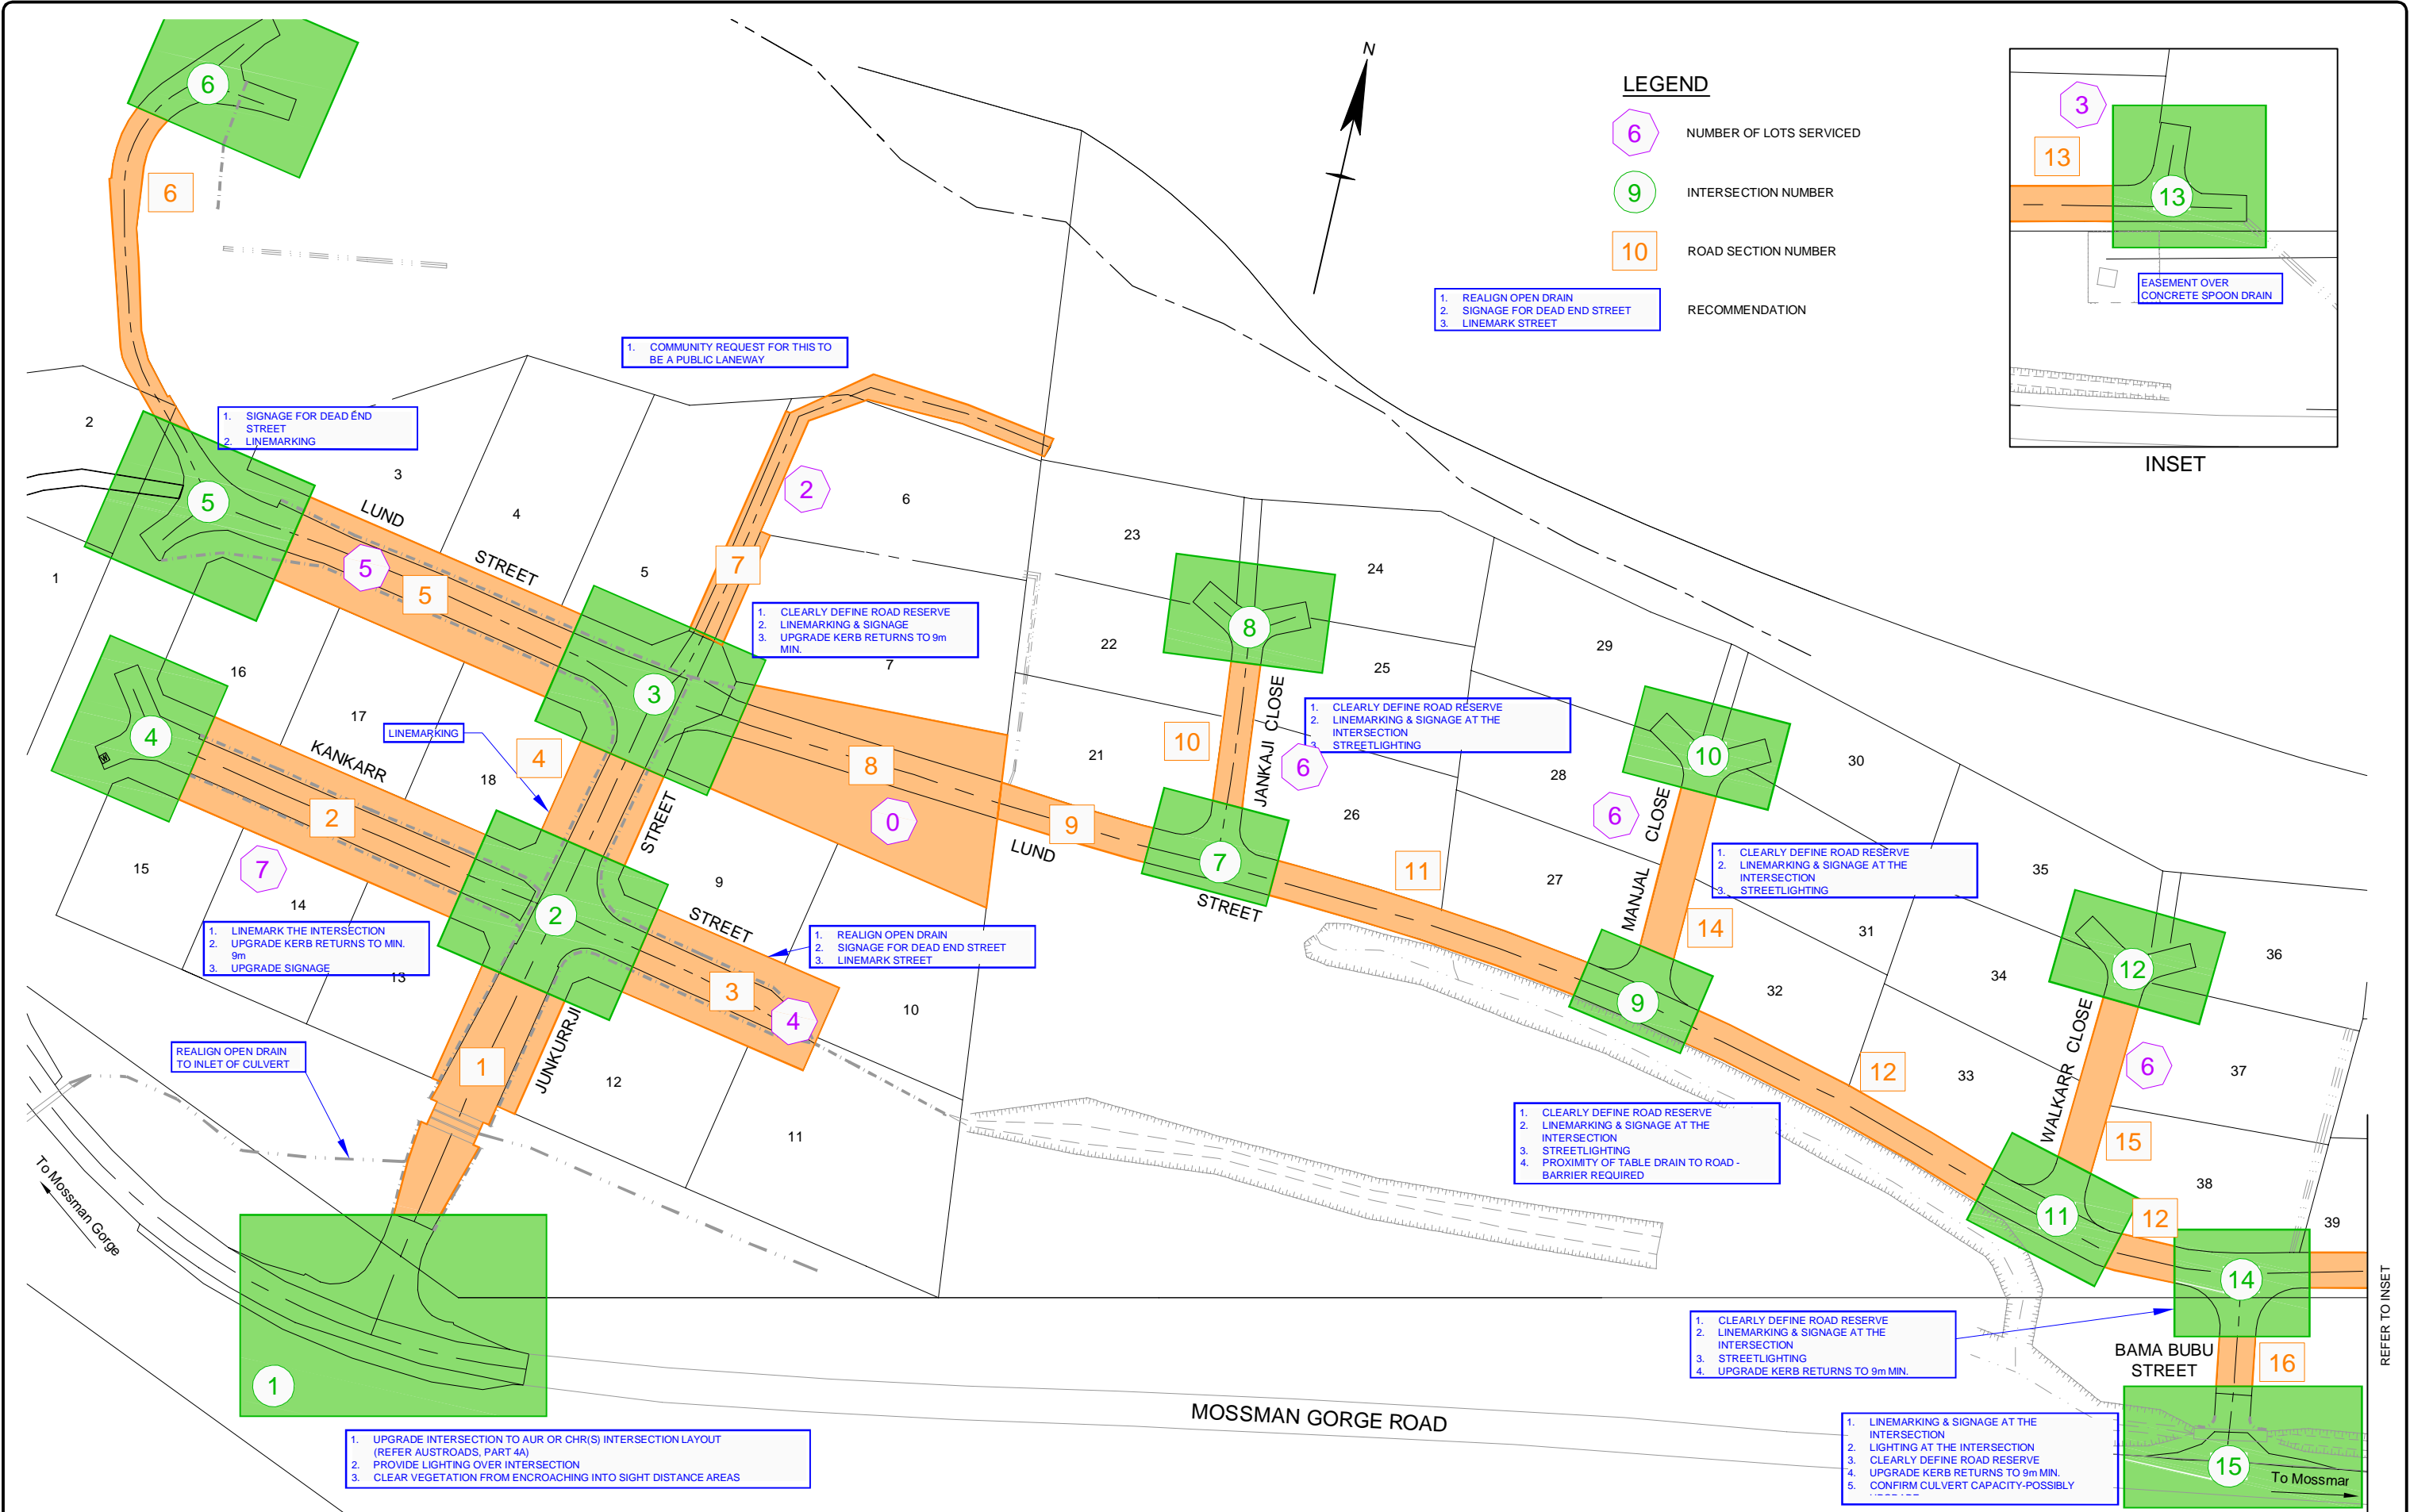
File: G:\Synergy\Projects\12069901 Mossman Gorge Subdivision\Drawings\SKETCH 6990-003a.dwg  
Printed: 30 March 2012, 10:39 AM

Description	Reserve Width (m)	Verge Width (m)	Seal Width (m)	Kerb Returns (m)	Linemarking / Signage	Geometry	Sight Distance	Drainage	Notes	Recommendation	References
Intersection No.1 (Mossman Gorge Road & Junkurrji St)	40	-	5.5m - MGR 7m Junkurrji St	7	None; Minimal signage	2m widening with 16m tapers	Requires 30-36m; intersection non-compliant due to vegetation	Layback K&C back to culvert on Junkurrji St	Verges heavily vegetated impacting sight distance;	Consider: Upgrading intersection to AUR or CHR(S) Increase kerb returns to R10 Provision of lighting over intersection; Clear vegetation as minimum so sight distance complies.	Austrads Pt 4A: Pg 40; Pt 3: Pg106
Road Section No.1 (Junkurrji St)	15	1.5 - 3.5	7 - 10	-	None	Alignment not central to reserve	-	Poor drainage at cross culvert due to existing fig tree and poorly aligned open drain	Verge widths constrained for service alignments	Minor earthworks to realign open drain on LHS to drain to inlet of culvert;	FNQROC Table D1.1 Std Dwg S1005

Description	Reserve Width (m)	Verge Width (m)	Seal Width (m)	Kerb Returns (m)	Linemarking / Signage	Geometry	Sight Distance	Drainage	Notes	Recommendation	References
Intersection No.11 & T-Head No.12 & Road Section No.15 (Walkarr St)	No Reserve Defined	-	6	5	None	T-Head dimensions acceptable	-	Drainage outlets to 300Ø RCP into open drain.	Why an easement to the North?	Consider: Linemarking at the intersection; Lighting at the intersection; Clearly defined road reserve;	
Intersection No.14 (Lund St & Bama Bubu St)	No Reserve Defined	-	6	7	None	-	-			Consider: Linemarking at the intersection; Lighting at the intersection; Clearly defined road reserve; Upgrade kerb returns to design vehicle	
Intersection No.15 & Road Section No.16 (Mossman Gorge Rd & Bama Bubu St)	40	-	6	6.5	None		Acceptable (Intersection Clear)	Cross drainage culvert at intersection	Why is concrete slab behind culvert? Scour issues?	Consider: Linemarking at the intersection; Lighting at the intersection; Clearly defined road reserve; Culvert capacity and possible upgrade requirement Upgrade kerb returns to design vehicle.

- a) Both intersections on Mossman Gorge Road should be upgraded to comply with the standards. Specifically the kerb returns require enlarging, line marking and signage, clearing of vegetation within the sight distance clear zones and installation of lighting of the intersections. Consideration for an Auxiliary Right Turn Layout may also be appropriate.

- c) Intersection upgrades of all intersections on the Junkurri-Lund-Mossman Gorge to cater for the 12.5m garbage truck along this section of the network. The design vehicle for the balance of the road network has been assumed to be a car. It should be noted that the garbage pick-up service currently uses this route even though the geometry is substandard. The consequence is that trucks will be currently be utilising the majority of the intersection to negotiate the turns. It will ultimately be up to Council to decide on level of service and/or potential conflicts with current operating conditions at intersections.

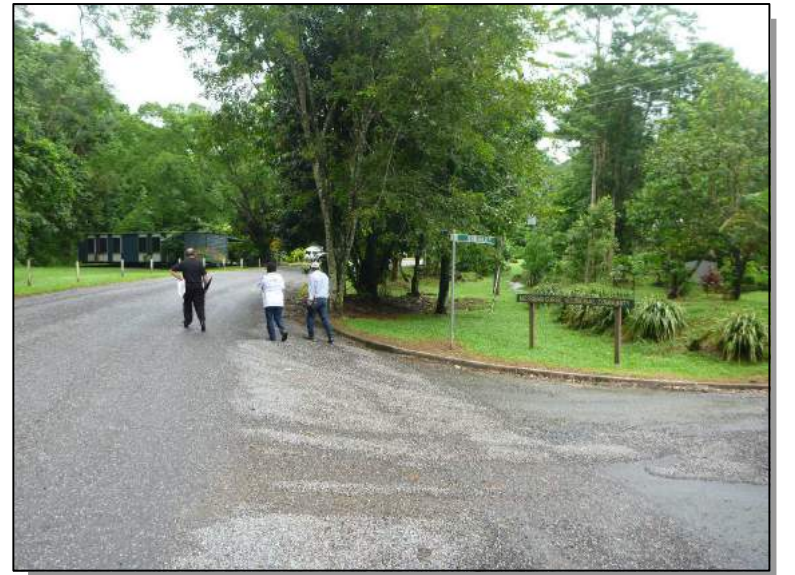
MOSSMAN GORGE ROAD LOOKING WEST

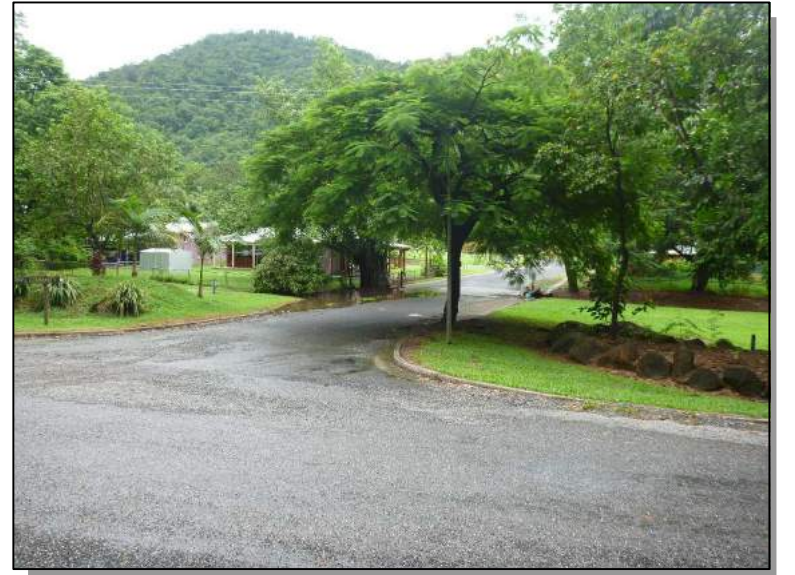
FROM MOSSMAN GORGE ROAD LOOKING ONTO JUNKURRJI STREET

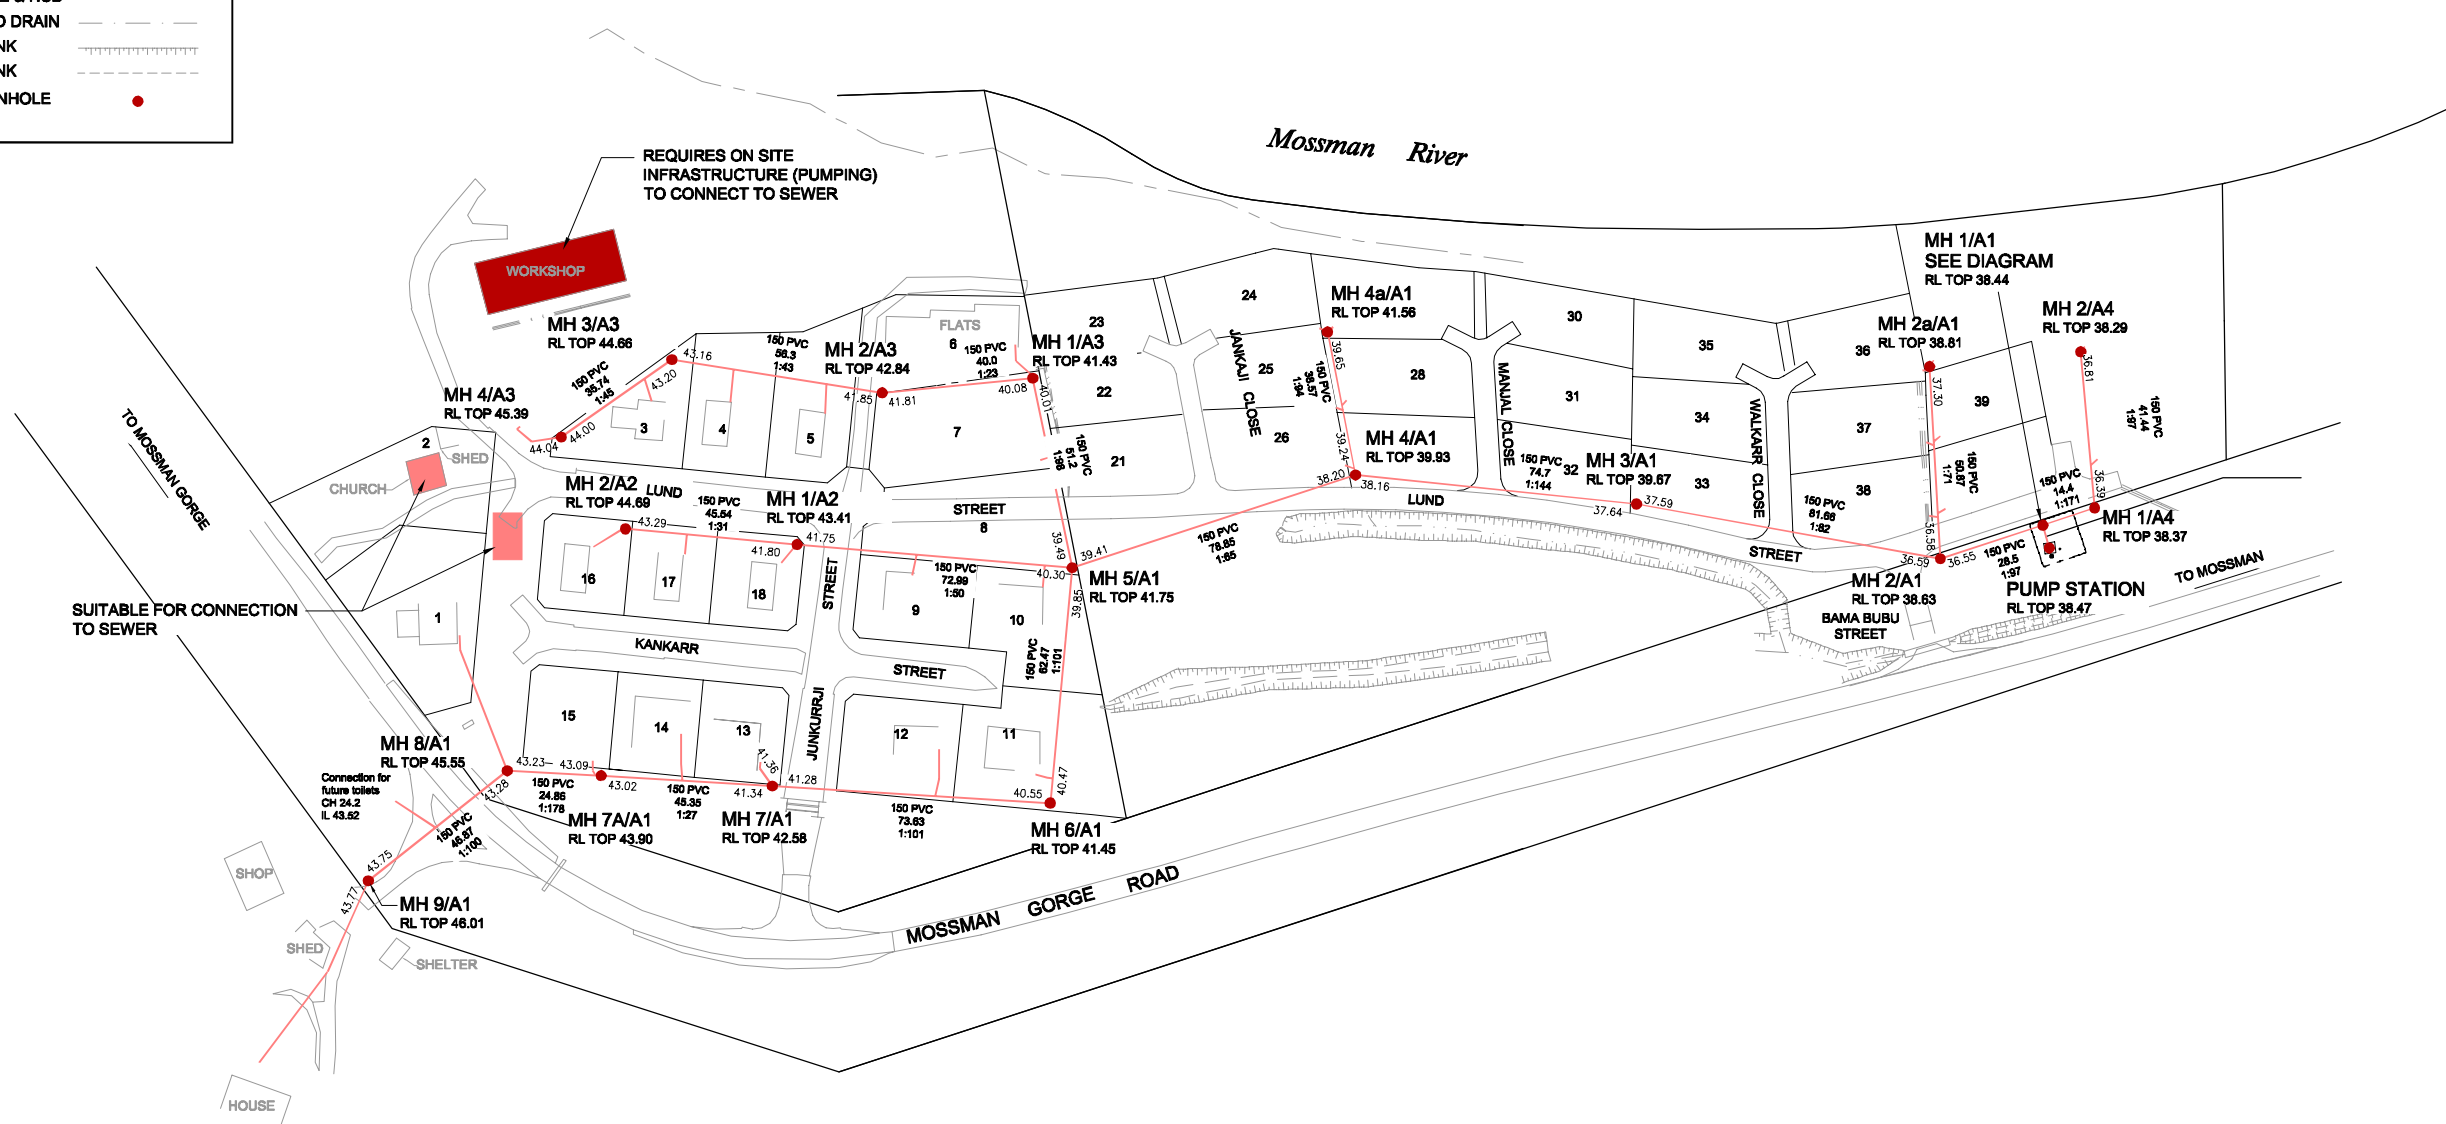
MH 7A/A1 to MH 7/A1	non-standard, offsets from fences	easement	adequate	nil	yes	adequate	nil	non-standard	nil	MH 7/A1 has HCB connecting in (non-standard)	Review of CCTV footage to determine if there's any infiltration	✓	nil
	MH 7/A1 to MH 6/A1	non-standard, offsets from fences	easement	adequate	nil	yes	adequate	nil	non-standard	nil	not shown on as-con data, unidentifiable	nil	✓	nil
	MH 6/A1 to MH 5/A1	non-standard, offsets from fences	easement	adequate	nil	yes	MH 5/A1 branch greater than 90° has drop of 44mm - less than standard. MH 5/A1 branch with acute angle has drop of 80mm.	Review of CCTV footage to determine if benching in manhole is sufficient.	non-standard	nil	not shown on as-con data, unidentifiable	nil	✓	nil
	MH 5/A1 to MH 4/A1	non-standard, offsets from fences	easement	adequate	nil	yes	adequate	nil	non-standard	nil	not shown on as-con data, unidentifiable	nil	✓	nil
	MH 4/A1 to MH 3/A1	non-standard, offsets from fences	easement	adequate	nil	yes	adequate	nil	non-standard	nil	not shown on as-con data, unidentifiable	nil	✓	nil

MH 1/A2 to MH 5/A1	non-standard, offsets from fences	easement	adequate	nil	yes	adequate	nil	non-standard	nil	MH 1/A2 has HCB connecting in (non-standard)	Review of CCTV footage to determine if there's any infiltration	✓	nil
A3	MH 4/A3 to MH 3/A3	non-standard, offsets from fences	easement	adequate	nil	yes	adequate	nil	non-standard	nil	not shown on as-con data, unidentifiable	nil	✓	nil
	MH 3/A3 to MH 2/A3	non-standard, offsets from fences	easement	adequate	nil	yes	adequate	nil	non-standard	nil	not shown on as-con data, unidentifiable	nil	✓	nil
	MH 2/A3 to MH 1/A3	non-standard, offsets from fences	easement	adequate	nil	yes	adequate	nil	non-standard	nil	MH 1/A3 has HCB connecting in (non-standard)	Review of CCTV footage to determine if there's any infiltration	✓	nil
	MH 1/A3 to MH 5/A1	non-standard, offsets from fences	easement	adequate	nil	yes	adequate	nil	non-standard	nil	unidentifiable	nil	✓	nil

A4	MH 2/A4 to MH 1/A4	non-standard, offsets from fences	easement	adequate	nil	yes	adequate	nil	non-standard	nil	not shown on as-con data, unidentifiable	nil	✓	nil
	MH 1/A4 to MH 1/A1	non-standard, offsets from fences	easement	1:171 inadequate	pt	yes	adequate	nil	non-standard	nil	not shown on as-con data, unidentifiable		✓	nil
Pump Station														
Finding		Recommendation												
located in Mossman Gorge Road reserve, infrastructure already owned by CRC.		none required unless advised otherwise by CRC

The condition assessment phase proposes further investigations on the condition of the sewers. This includes CCTV footage and assessment of the system.

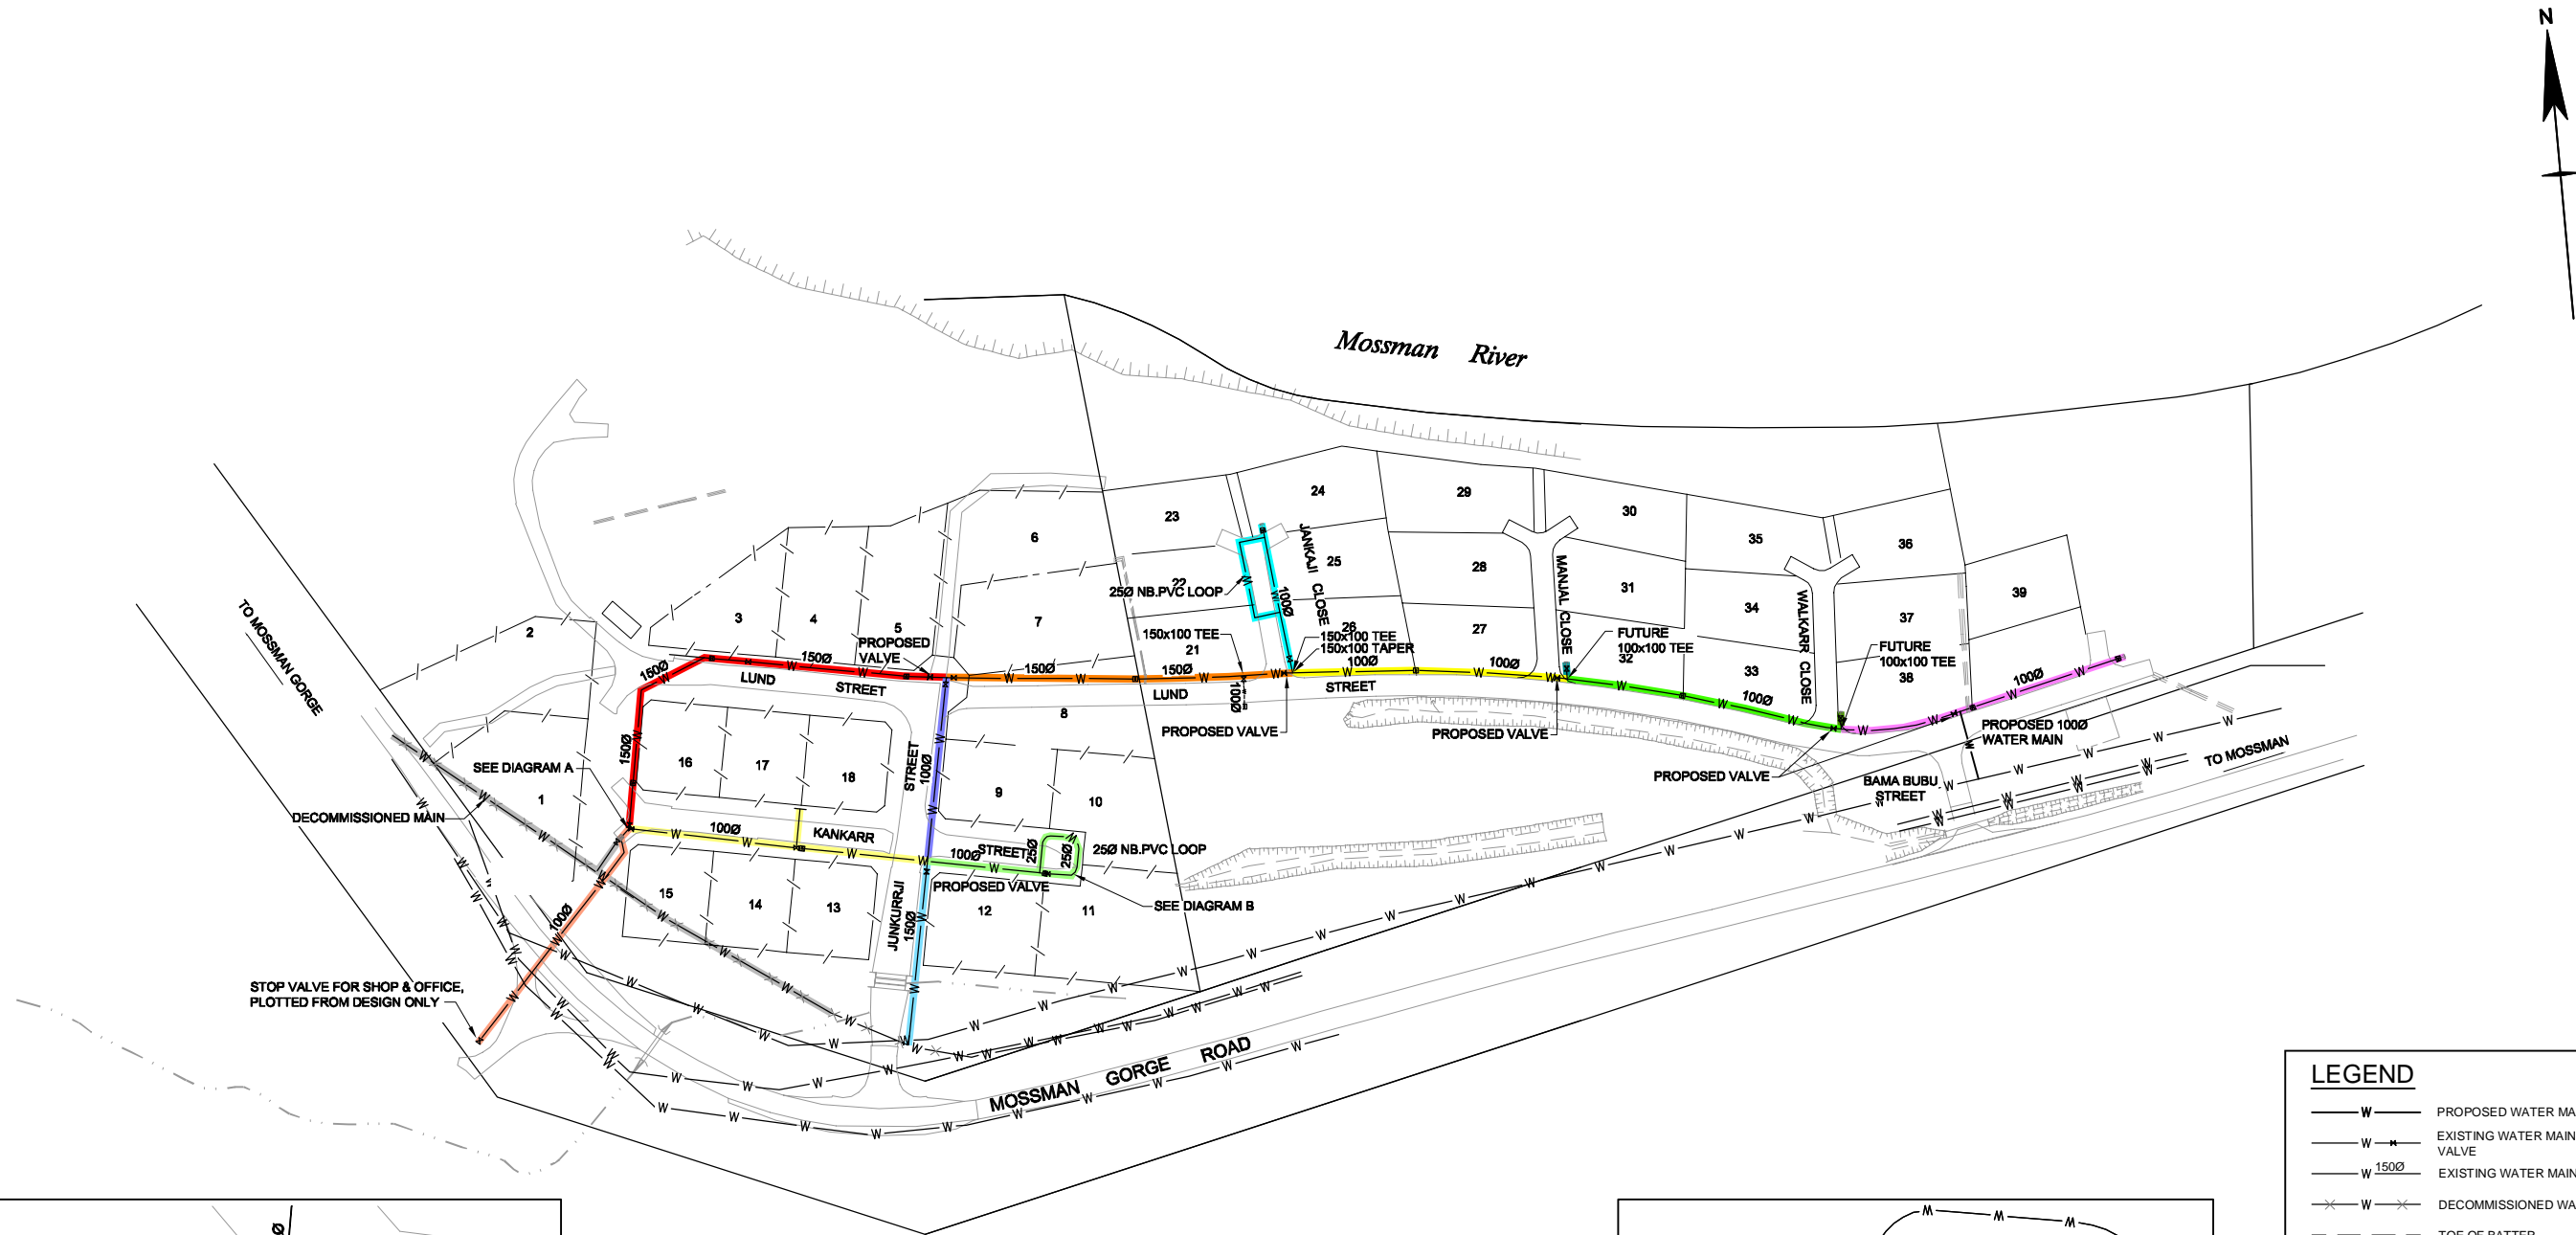
Ø25 PVC loop	assumed pipe type would be PVC based on age of infrastructure.	not specified		adequate	nil	adequate	nil
Junkurrji St (north)	Ø100 type unspecified	assumed pipe type would be PVC based on age of infrastructure.	non-standard		nil	nil	adequate	nil
Junkurrji St (south)	Ø150 type PVC( not shown on as-con). Based on information from B&M previous project knowledge.	pot hole to confirm exact location.	not specified			nil	adequate	nil
Lund St (west)	Ø150 type unspecified	assumed pipe type would be PVC based on age of infrastructure.	non-standard		adequate	nil	inadequate	additional valve to be installed at tee on Ø150 main so Lund St (east) can be serviced.
Lund St (east)	Ø100 type unspecified	assumed pipe type would be PVC based on age of infrastructure.	non-standard		adequate	nil	inadequate	new Ø100 main connected to existing to allow for more sufficient system
Lund St (a)	Ø150 type unspecified	assumed pipe type would be PVC based on age of infrastructure.	non-standard		adequate	nil	inadequate	additional valve to be installed at tee on Ø150 main so Lund St (a) can be isolated.

Ø100 road crossing type unspecified	assumed pipe type would be PVC based on age of infrastructure.	non-standard		adequate	nil	adequate	nil
Lund St (b)	Ø100 type unspecified	assumed pipe type would be PVC based on age of infrastructure.	non-standard		adequate	nil	inadequate	additional valve to be installed at tee on Ø150 main so Lund St (b) can be isolated.
Lund St (c)	Ø100 type unspecified	assumed pipe type would be PVC based on age of infrastructure.	non-standard		adequate	nil	inadequate	additional valve to be installed at tee on Ø150 main so Lund St (c) can be isolated.
Road stub 1	Ø100 type unspecified	assumed pipe type would be PVC based on age of infrastructure.	non-standard		adequate	nil	adequate	nil
	Ø25 PVC loop	assumed pipe type would be PVC based on age of infrastructure.	non-standard		adequate	nil	adequate	nil
Road stub 2	Ø100 stub for future connection type unspecified	assumed pipe type would be PVC based on age of infrastructure.	non-standard		nil	nil	nil	nil

Road stub 3	Ø100 stub for future connection type unspecified	assumed pipe type would be PVC based on age of infrastructure.	non-standard		nil	nil	nil	nil

Location of valves and hydrants appear to be generally consistent with the design guidelines. However, there may be some additional valves considered to improve the operation and maintenance of the Network. By constructing new valves at the locations shown will allow for sections of pipe to be isolated more sufficiently.

Council should also consider a second connection to the system at the eastern end of the community, (currently the need for metering has a single point of supply to the community). The proposed new 100mm diameter eastern connection in Bama Bubu Street has been shown to allow for a loop main.

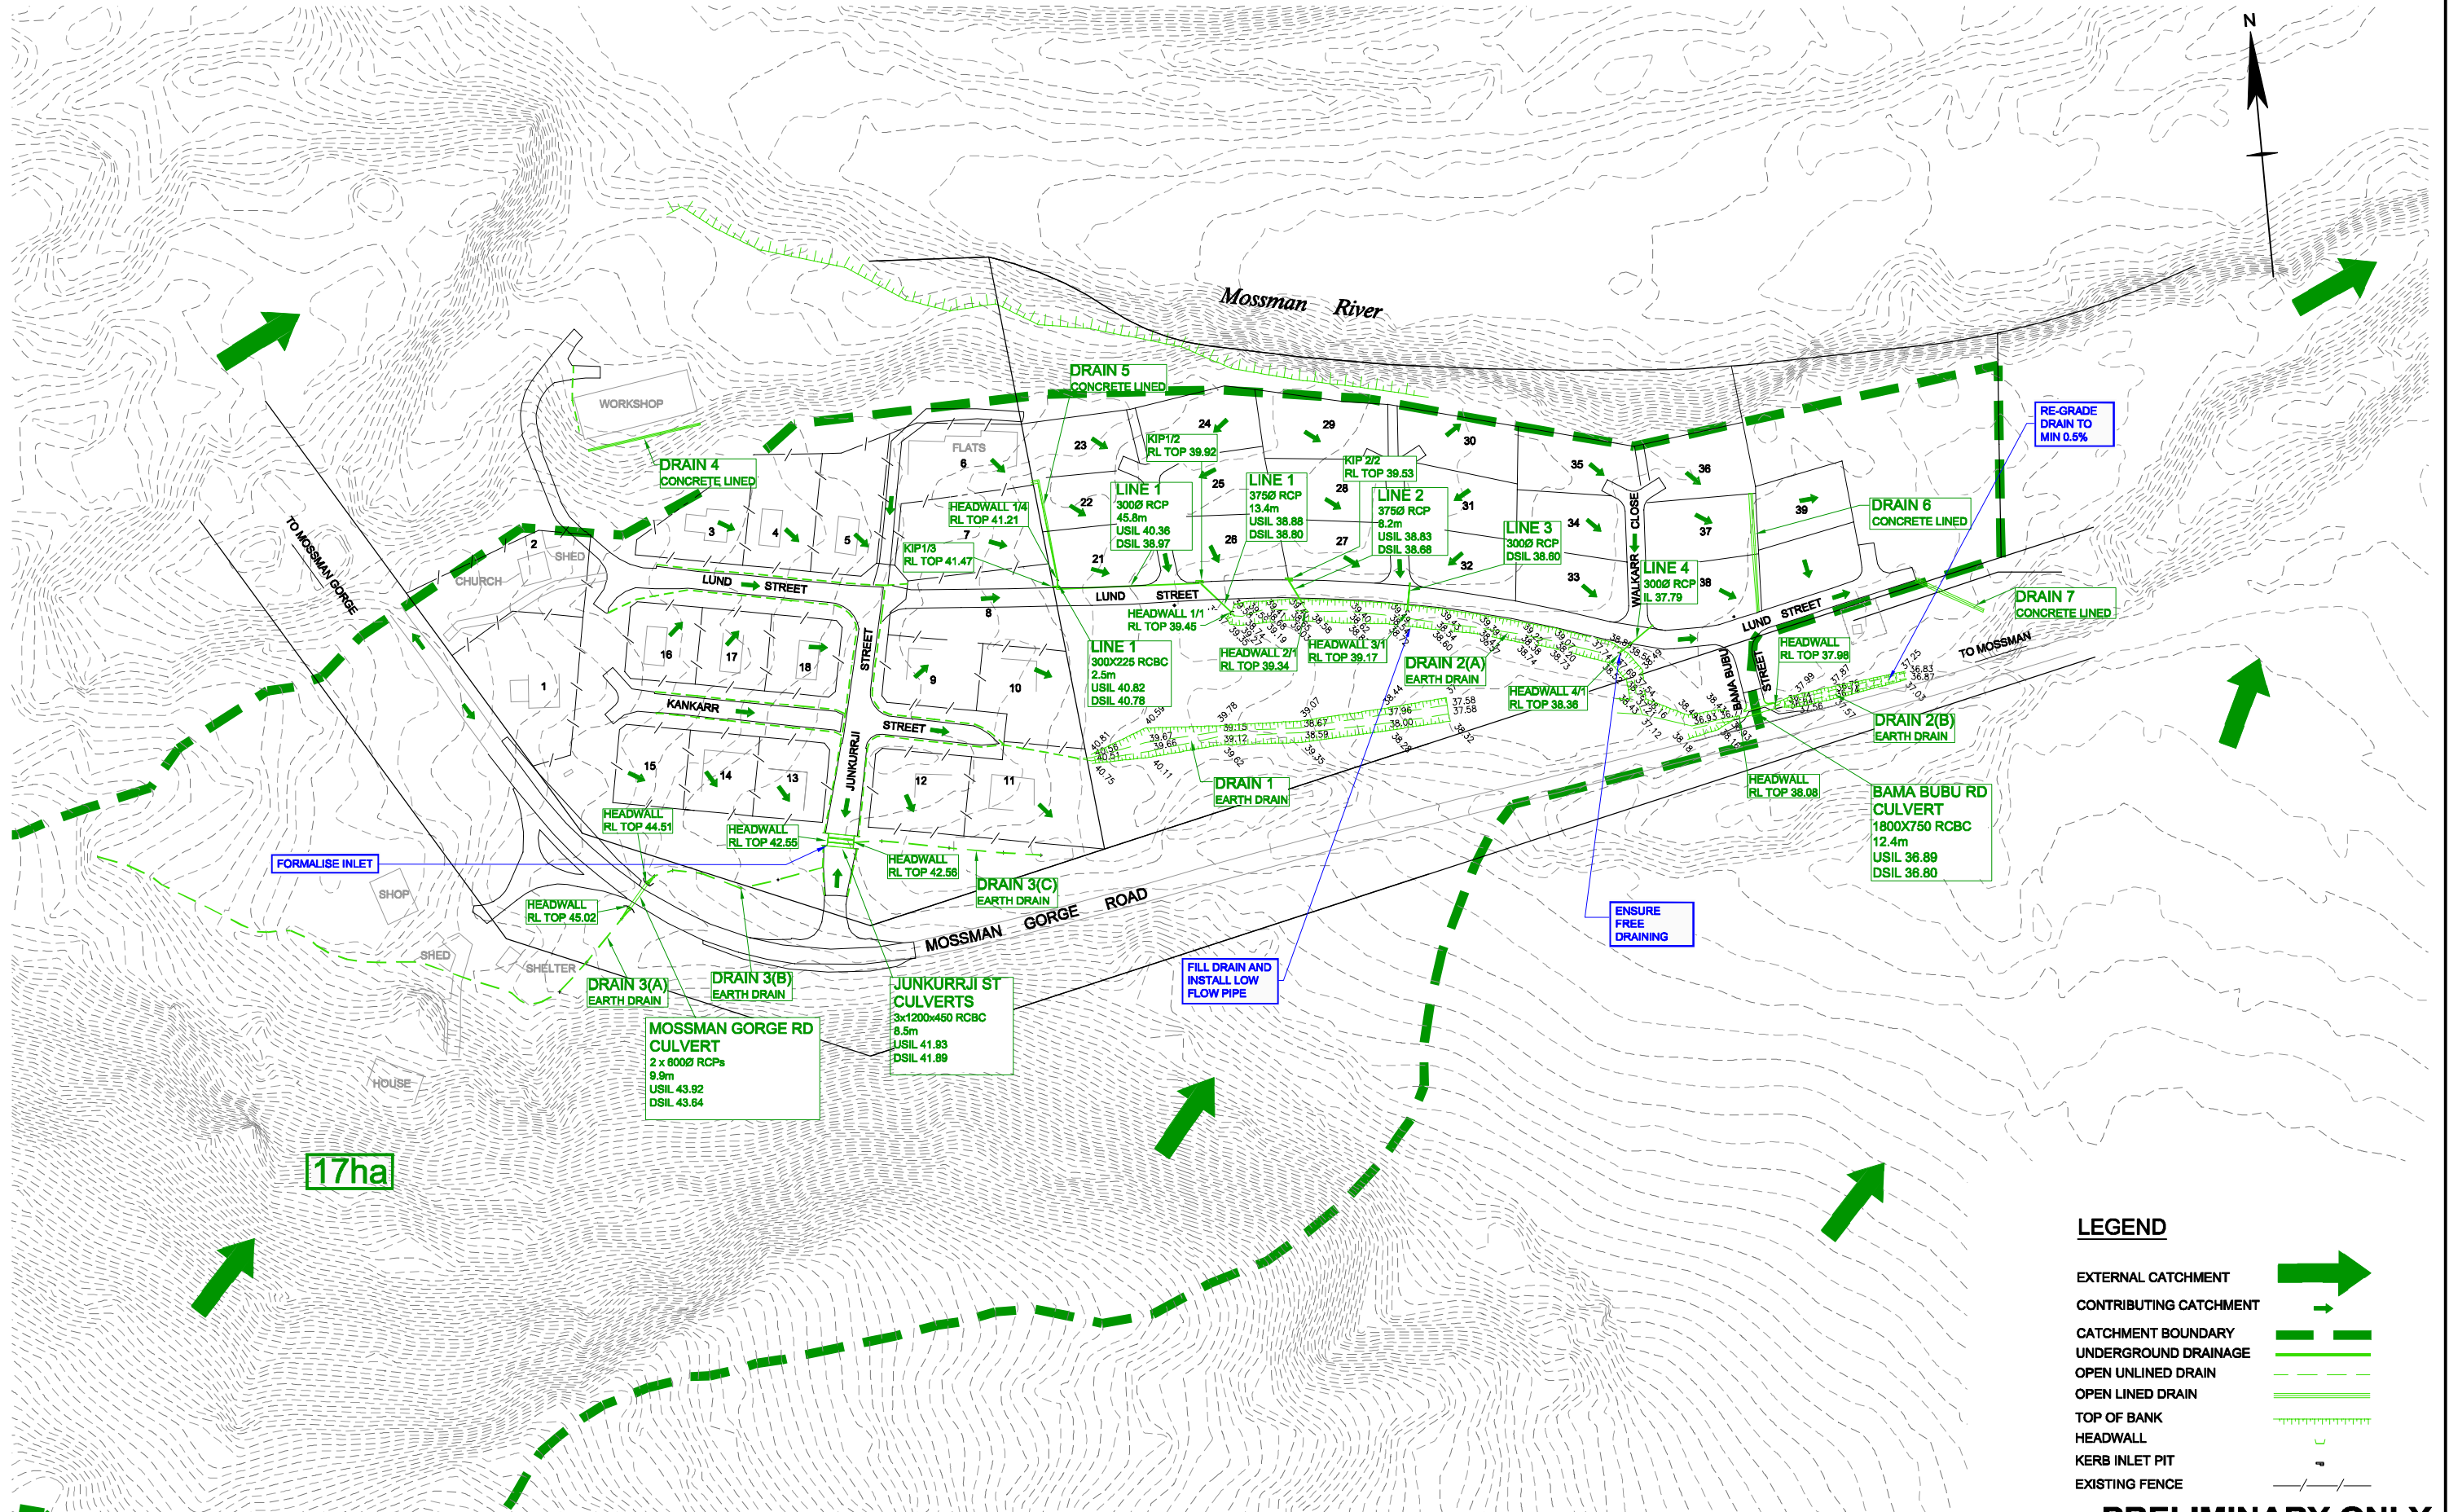
File: G:\Synergy\Projects\1206990 Mossman Gorge Subdivision\Drawings\Sketch 6990-006.dwg  
Printed: 30 March 2012, 10:53 AM

It was noted that the large Fig tree adjacent the upstream headwall to Jankurji Street culvert was preventing the culvert from operating as designed. The stormwater flows were ponding upstream from the Fig tree and flows were directed onto the roadway.

The system had recently experienced and rainfall. There was no evidence of major capacity constraints on the system (other than the issues at the Fig tree as noted above).

- b) Minor earthworks to realign open lined drain on LHS of Junkurri St into the inlet of the cross culvert to prevent ponding at the existing Fig Tree. Additionally, consideration must be given to immediate removal of the Fig Tree based on future damage to the road pavement, kerb and channel and the integrity of the cross culvert.
