2018 Douglas Shire Council Planning Scheme Property Report

MURPHY STREET RESIDENCE
PROPOSED NEW RESIDENCE AT No 12 MURPHY STREET
ON LOT 113 (PTD2094)
FOR : KIM CULLEN & NEIL BIDDLE

Ecological Report

Geotechnical Report

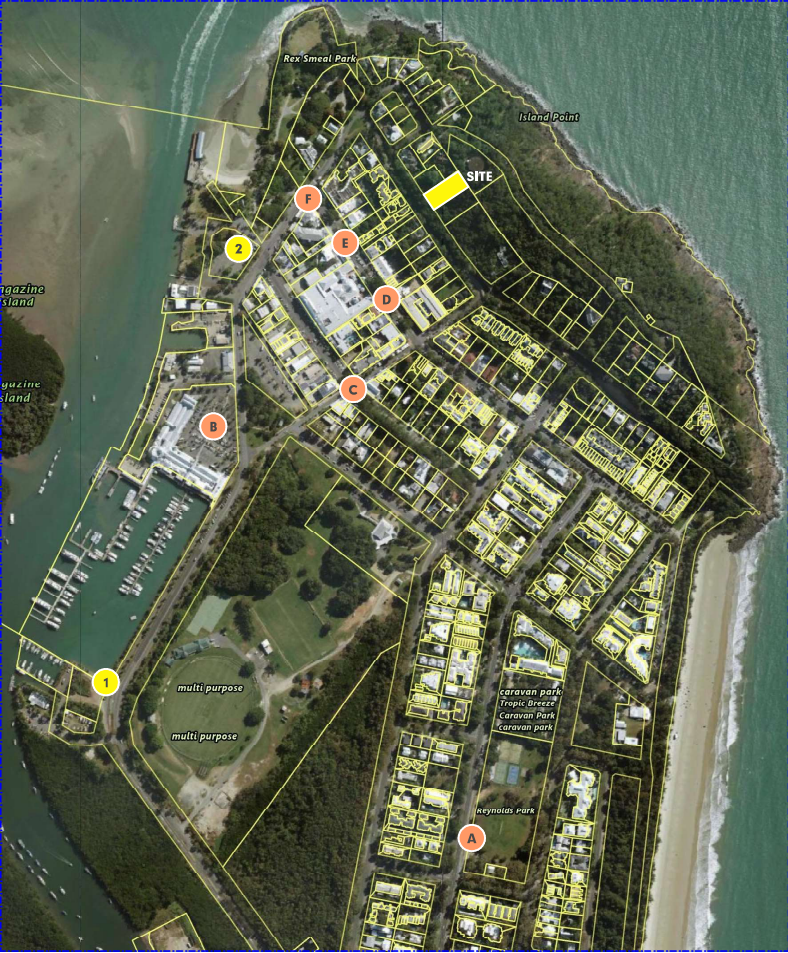
A PREDOMINANTLY OBSTRUCTED
VIEWS OF THE SITE FROM THE
PORT DOUGLAS TOWNSHIP

1 PRIMARY VISUAL IMPACT VIEWS
ALONG DICKSON INLET
REFER PHOTOMONTAGES
