**Response to Information Request**

**Development Application: MCUI3171/2019**

**Optus reference: B8857 Cape Tribulation**

**PRELIMINARY ACID SULFATE SOIL INVESTIGATION FOR SITE NO: B8857-Q  
CAPE TRIBULATION ROAD, CAPE TRIBULATION QLD 4873**

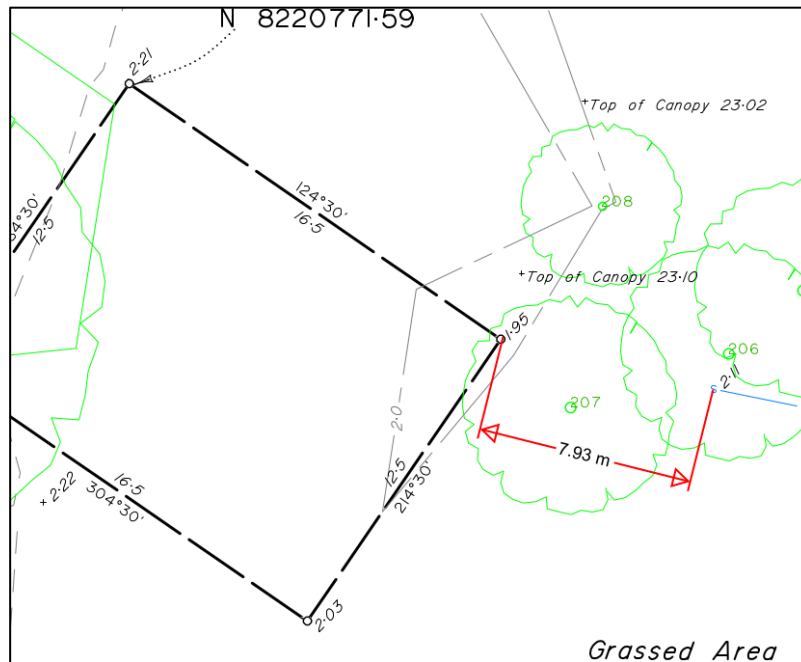
The site has been surveyed with reference to the existing on-site effluent system. The survey plan attached shows the extent the system. The below image shows the distance from the associated sprinklers, which have an approximate maximum reach of 5m. The proposed site does not interfere with the existing system.

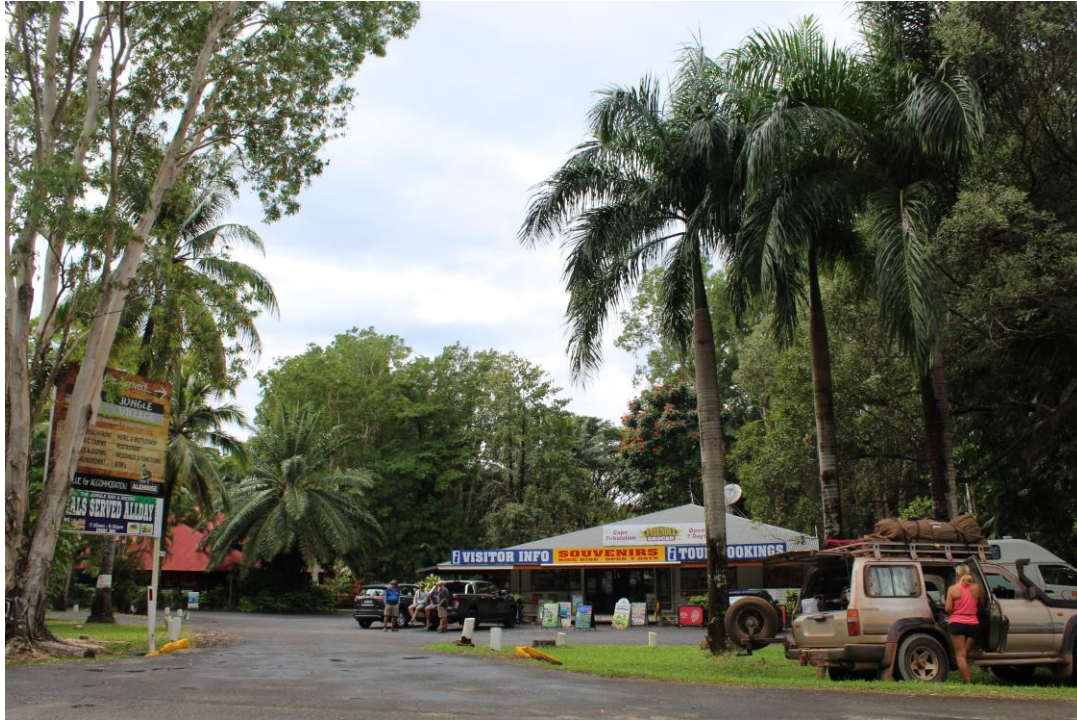
Image 1 – photo facing towards the tower location from Cape Tribulation Road

We note that council has concerns regarding the visual impact the proposed structure may have on the Cape Tribulation area. We note that as per the tree canopy measurements recorded on the attached site survey, the existing tree canopy surrounding the facility is between 22 and 32 meters in height. We also note that the proposed tower is located around 235m back from this roadway and the existing properties in the cape tribulation township. As such, we believe that the proposed tower will have a very minimal visual impact onto the Cape Tribulation township, as much of the facility will be obstructed by this existing vegetation.

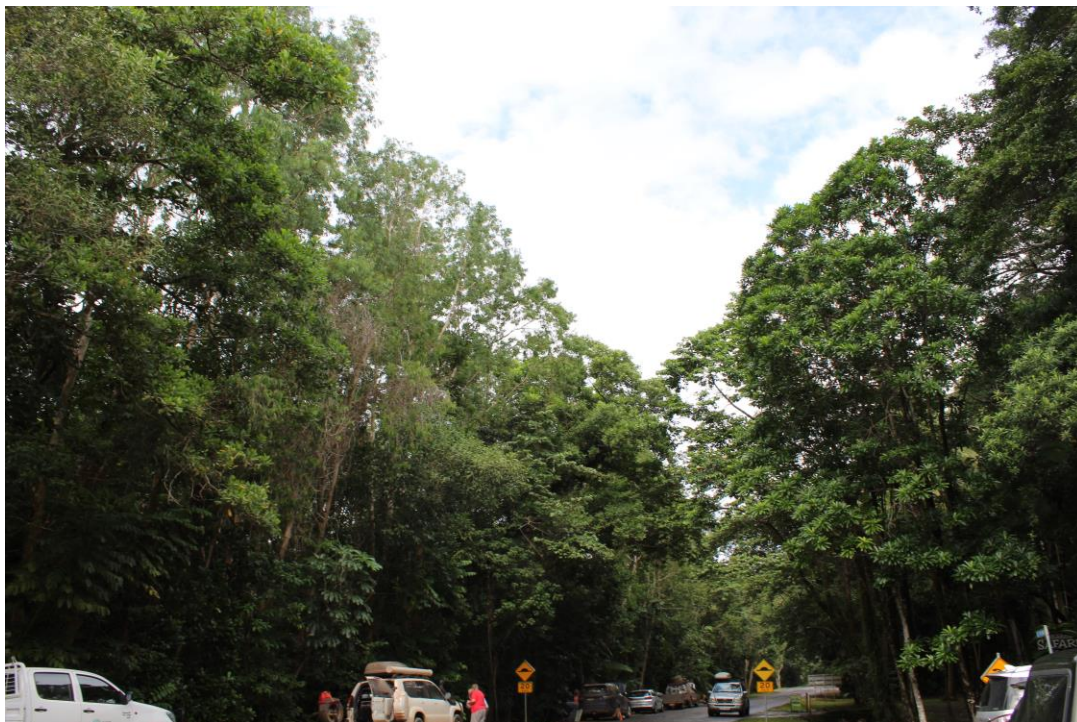
Image 2 – photo of the existing trees along Cape Tribulation Road

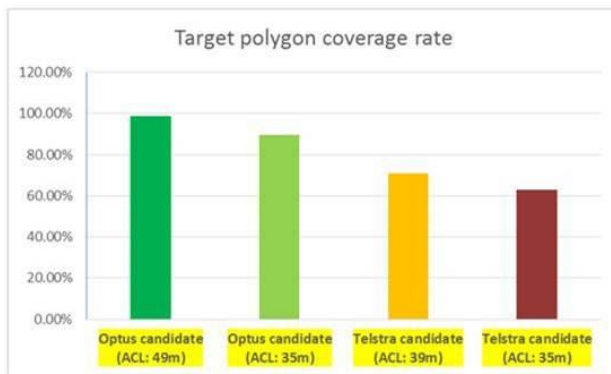
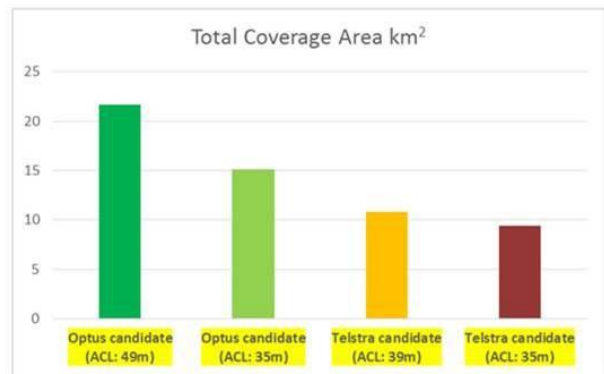
The table and graphs shown below demonstrate predicted radio performance levels at varying heights at both the proposed Optus location and the proposed Telstra location.

Note that predictions between 34-36m would show negligible differences and are not modelled.

The predictions demonstrate a material difference in radio performance for Optus between the two sites. This is the primary reason that the Optus location is strongly preferred by Optus.

Target polygon coverage rate	Total Coverage Area km <sup>2</sup>
Optus candidate (ACL: 49m)	98.74%	21.64
Optus candidate (ACL: 35m)	89.54%	15.13
Telstra candidate (ACL: 39m)	70.82%	10.82
Telstra candidate (ACL: 35m)	63.02%	9.42

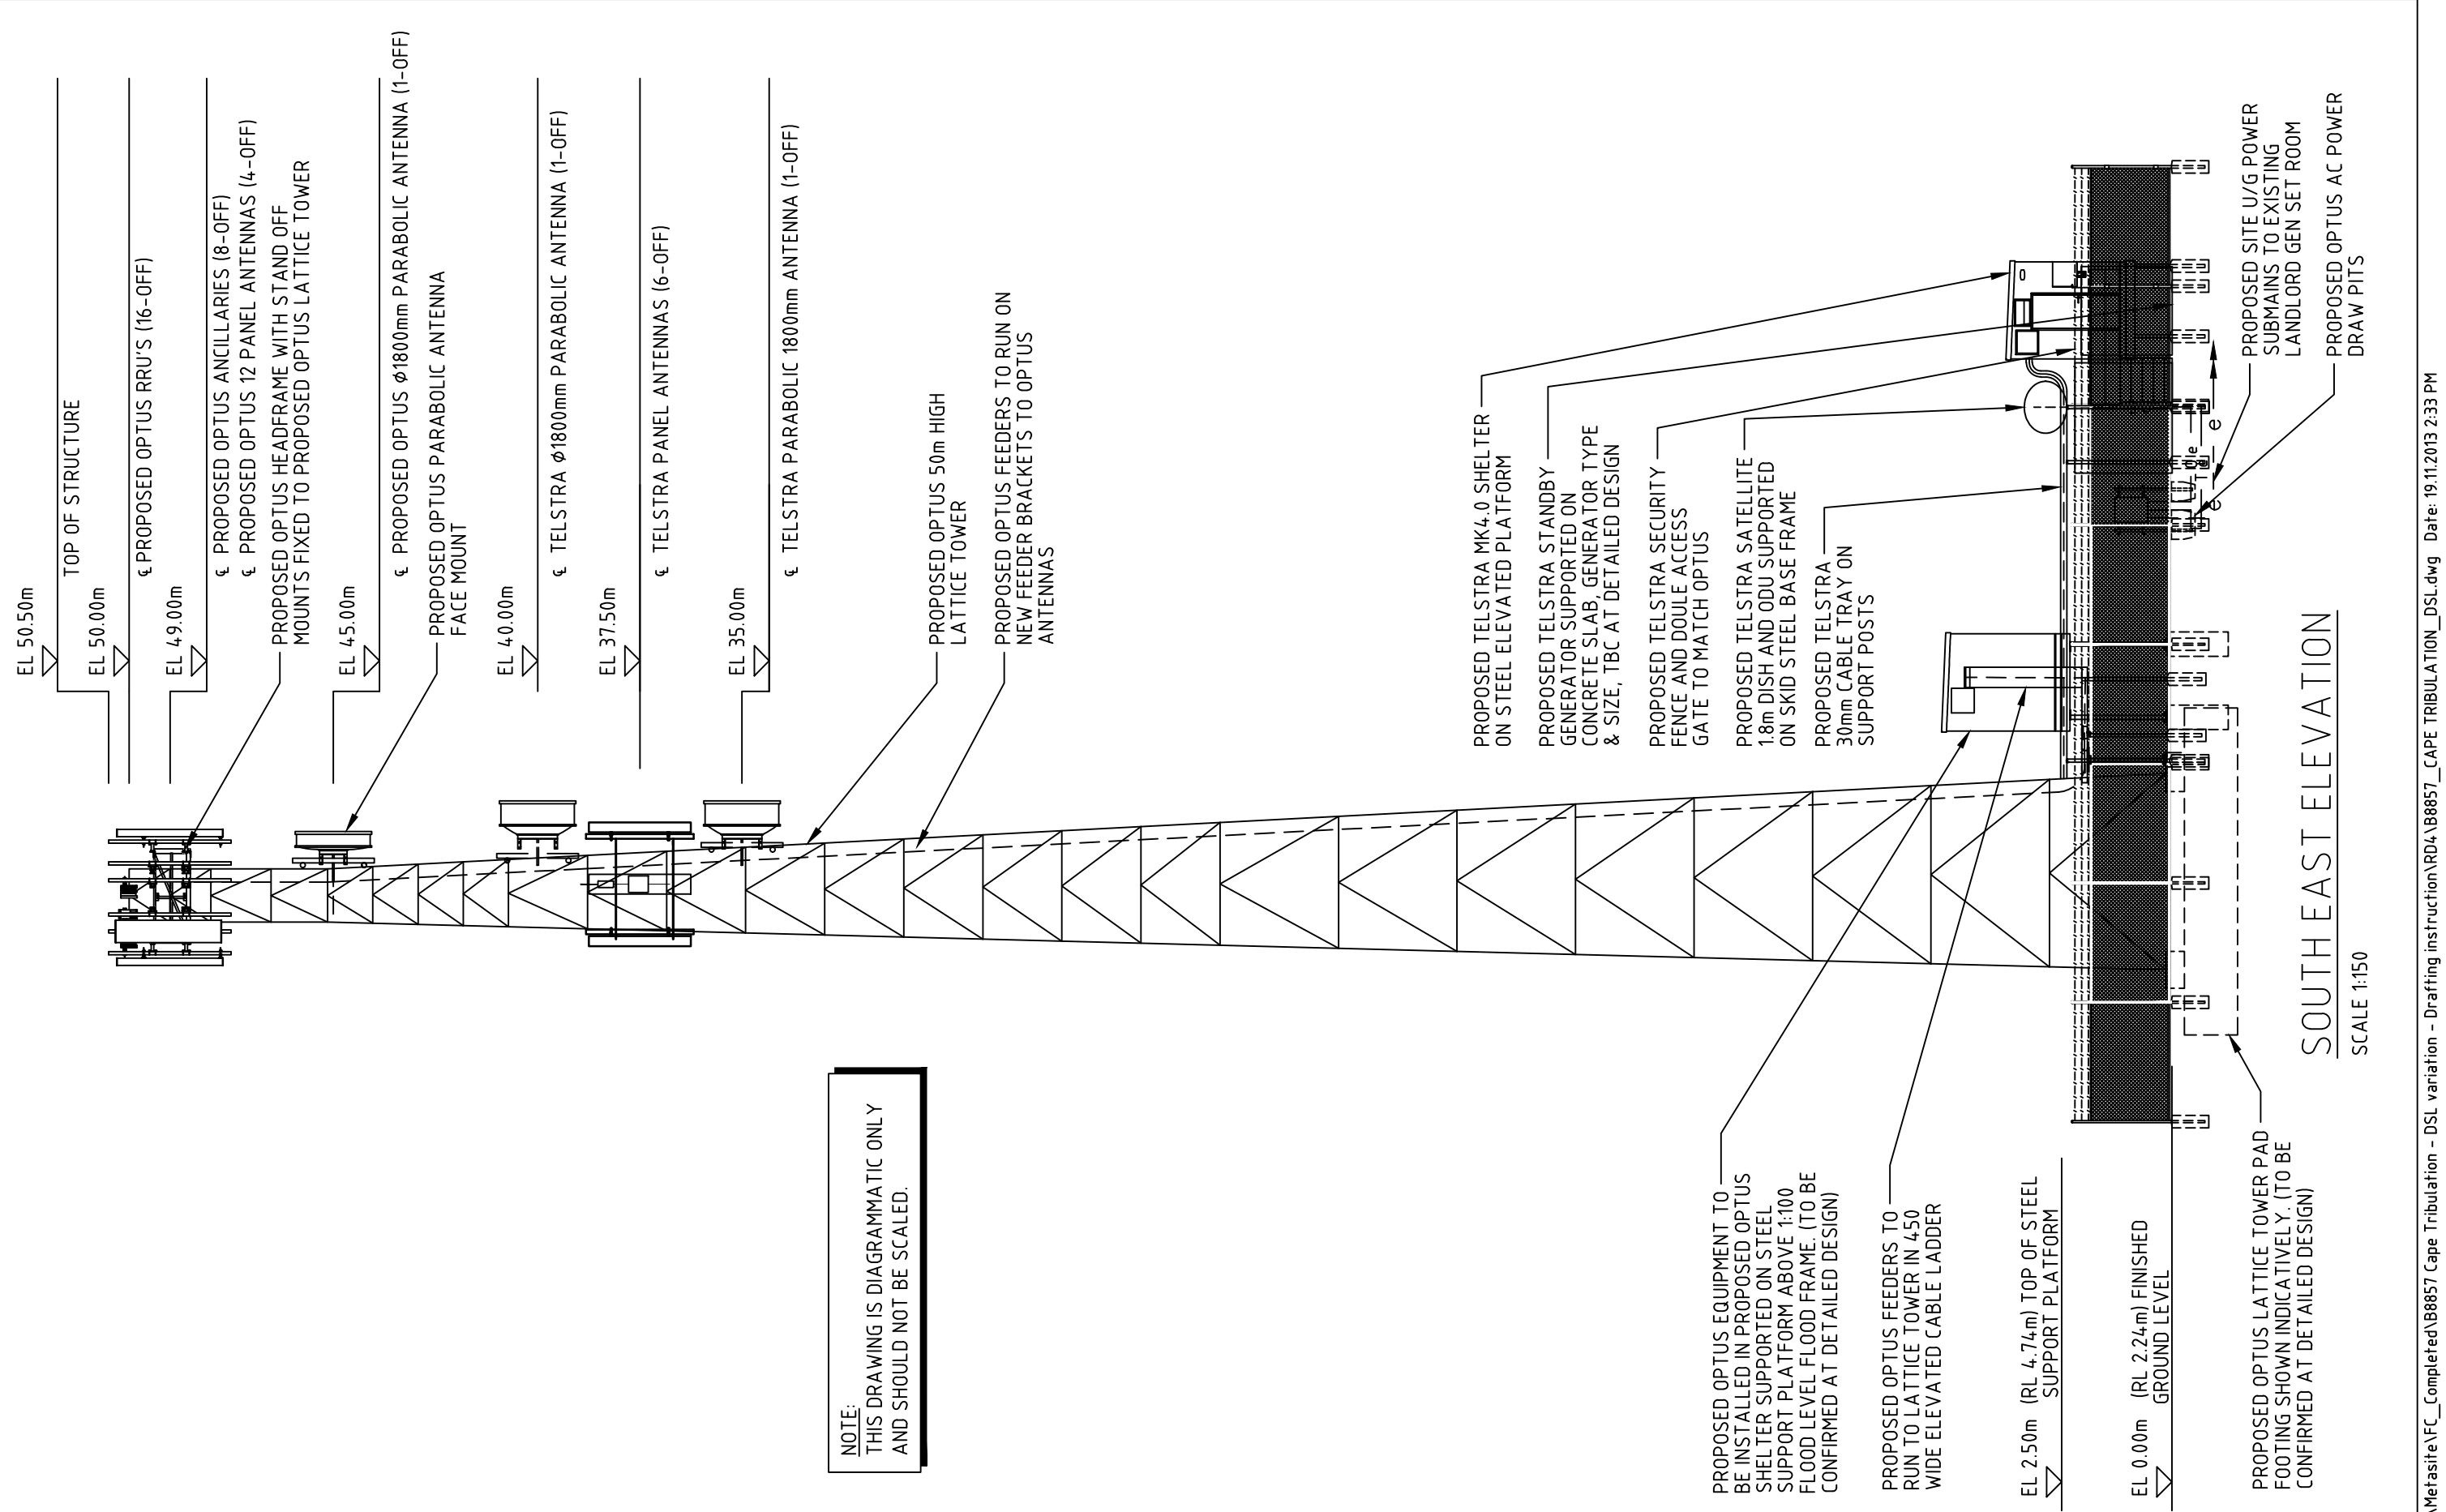
**SITE LAYOUT**  
SCALE 1:100

PROPOSED OPTUS EQUIPMENT TO BE INSTALLED IN PROPOSED OPTUS SHELTER SUPPORTED ON STEEL SUPPORT PLATFORM ABOVE 1:100 FLOOD LEVEL FLOOD FRAME. (TO BE CONFIRMED AT DETAILED DESIGN)
