**PORT DOUGLAS LAND DEVELOPMENTS PTY LTD**

**GEOTECHNICAL INVESTIGATION**

**PROPOSED PUMP STATION  
STAGE 1A & 1B PORT DOUGLAS ESTATE  
CAPTAIN COOK HIGHWAY, CRAIGLIE**

**REPORT NUMBER: GT19-242-001R REV 1**

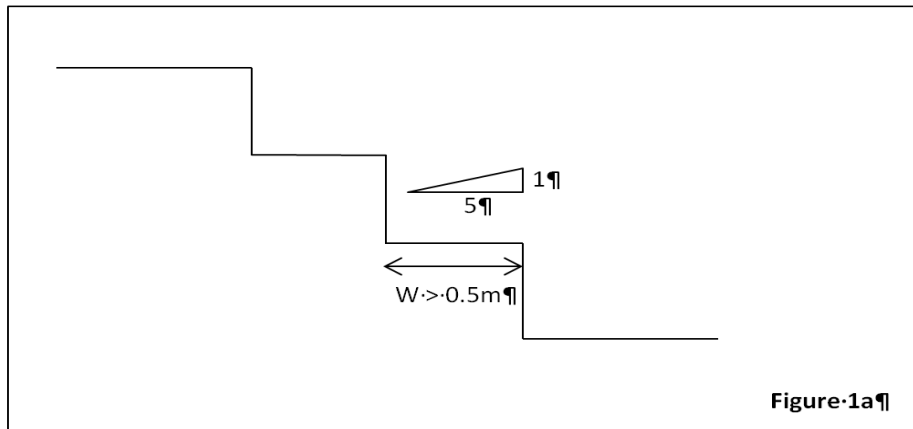
- Filling should be placed at least two (2) metres beyond the design profile and then trimmed to the design profile.
- Where unsuitable materials are to be excavated it is recommended that all excavated in-situ soils are removed from the site and approved select fill is placed and compacted in the excavation. The excavation should be benched to "key in" the select fill material and optimise compaction. The benches

should slope back at 1V:5H and be at least 0.5m wide, refer to Figure 1a below.

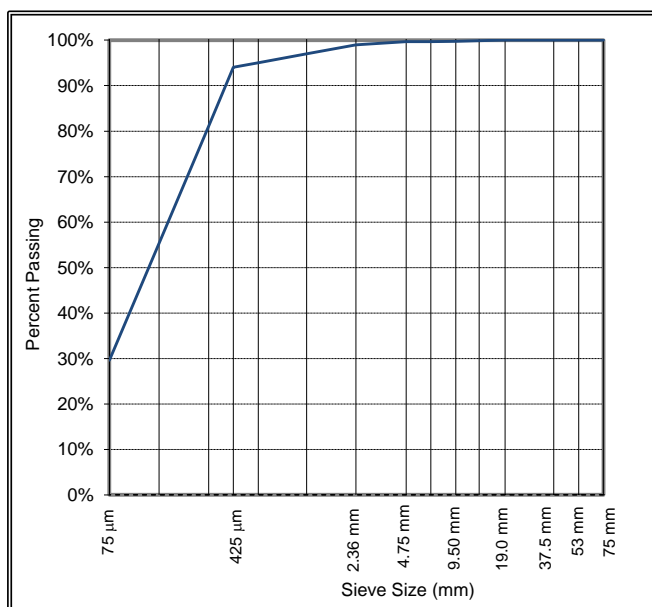
Particle Size Distribution			
Test Method AS1289.3.6.1			
A.S.	Specification		Result
	Specification	Result	Specification
Sieve Size	Minimum	% Passing	Maximum
75mm		100	
53mm		100	
37.5mm		100	
19.0mm		100	
9.5mm		100	
4.75mm		100	
2.36mm		99	
0.425mm		94	
0.075mm		30

Plasticity Tests	Test Method	Specification Minimum	Result	Specification Maximum
Air Dried - Dry Sieved				
Liquid Limit (%)	AS1289.3.1.2	Slippage in Cup, Liquid Limit could not be obtained.		
Plastic Limit (%)	AS1289.3.2.1		*	
Plasticity Index	AS1289.3.3.1		*	
Linear Shrinkage (%)	AS1289.3.4.1		*	
P.I. X % Passing 0.425mm				
L.S. X % Passing 0.425mm				
Ratio of % Passing (0.075 / 0.425)			0.31

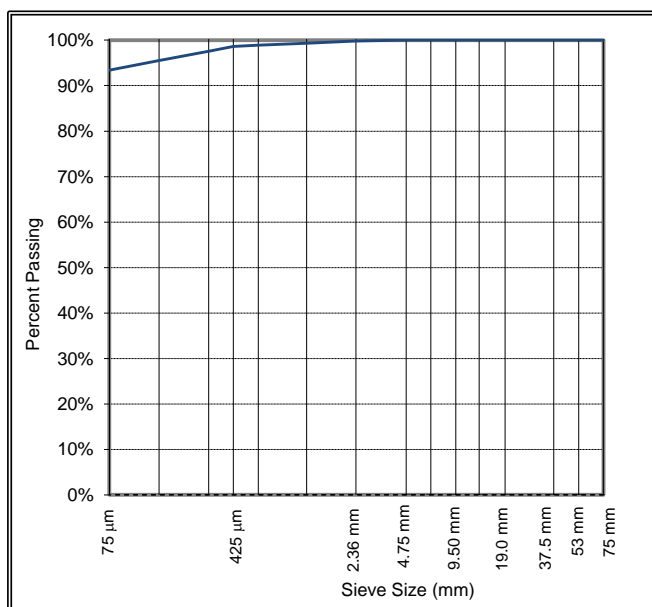
Particle Size Distribution			
Test Method AS1289.3.6.1			
A.S.	Specification		Result
	Specification	Result	Specification
Sieve Size	Minimum	% Passing	Maximum
75mm		100	
53mm		100	
37.5mm		100	
19.0mm		100	
9.5mm		100	
4.75mm		100	
2.36mm		100	
0.425mm		99	
0.075mm		93

Plasticity Tests	Test Method	Specification Minimum	Result	Specification Maximum
Air Dried - Dry Sieved				
Liquid Limit (%)	AS1289.3.1.2		42	
Plastic Limit (%)	AS1289.3.2.1		16	
Plasticity Index	AS1289.3.3.1		26	
Linear Shrinkage (%)	AS1289.3.4.1 *		13	
P.I. X % Passing 0.425mm			2565	
L.S. X % Passing 0.425mm			1282	
Ratio of % Passing (0.075 / 0.425)			0.95

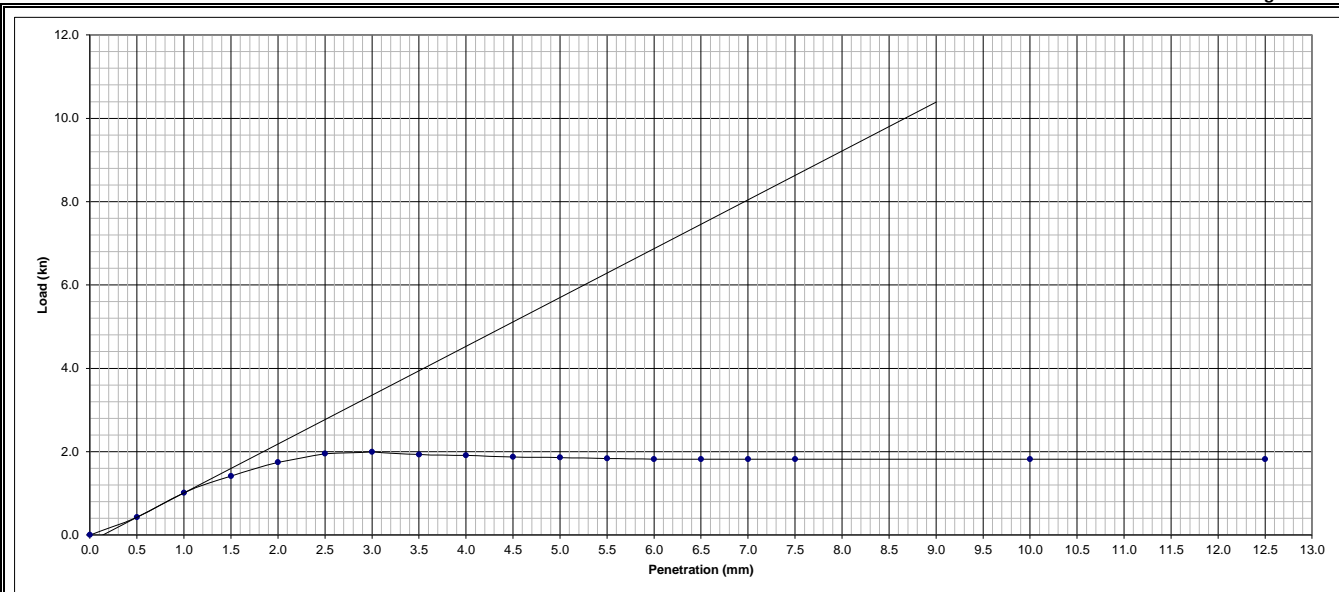
Maximum Dry Density - MDD (t/m³) :	1.818	Dry Density after Soak (t/m³) :	1.783
Optimum Moisture Content - OMC (%) :	13.5	Moisture Content after Soak (%) :	15.9
Compactive Effort :	Standard	Density Ratio after Soak (%) :	98
Nominated % Maximum Dry Density Compaction :	98	Hygroscopic Moisture Content (%) :	10.4
Nominated % Optimum Moisture Content Compaction :	100.0	Moisture Content (Top) after Penetration (%) :	16.8
Achieved Dry Density before Soak (t/m³) :	1.782	Optional Moisture Content (Remainder) after Penetration (%) :	16.2
Achieved Percentage of Maximum Dry Density (%) :	98	CBR 2.5mm (%) :	15
Achieved Moisture Content (%) :	13.5	CBR 5.0mm (%) :	9
Achieved Percentage of Optimum Moisture Content (%) :	100	CBR Value (%) :	15
Test Condition (Soaked/Unsoaked) / Soaking Period (Days) :	Soaked / 4	Minimum Specified CBR Value (%) :	-
Swell (%) / Surcharge (kg):	0.0 / 4.5	Oversize Material (%)

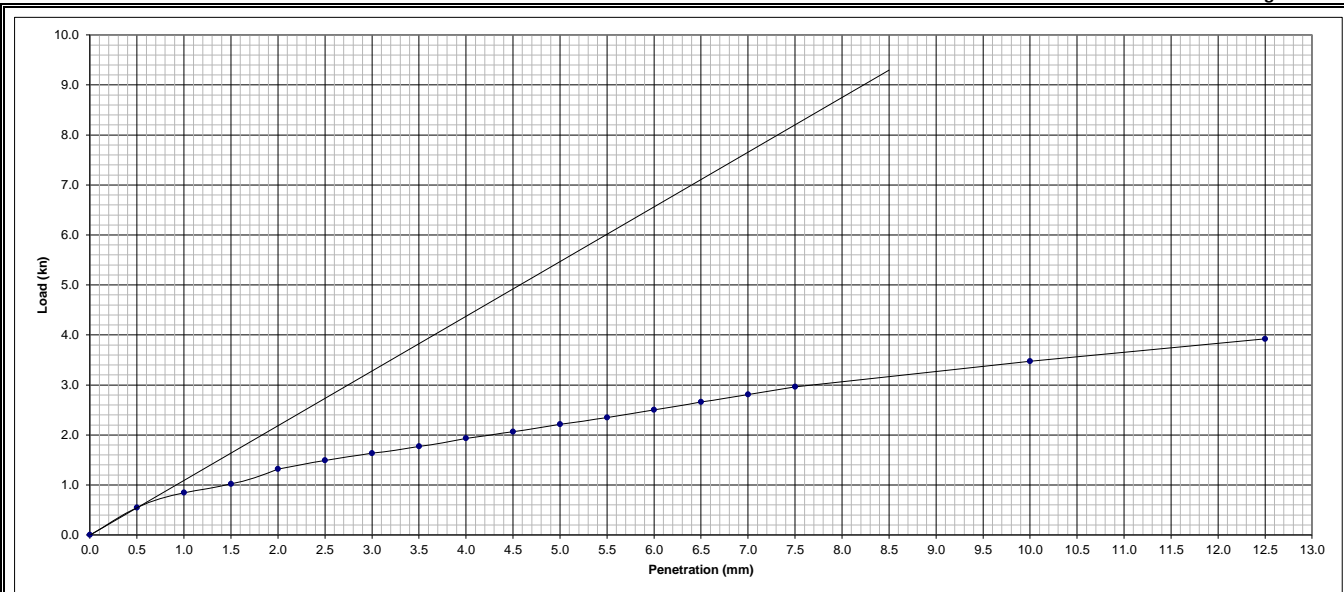
Maximum Dry Density - MDD (t/m³) :	1.796	Dry Density after Soak (t/m³) :	1.756
Optimum Moisture Content - OMC (%) :	15.3	Moisture Content after Soak (%) :	17.6
Compactive Effort :	Standard	Density Ratio after Soak (%) :	98
Nominated % Maximum Dry Density Compaction :	98	Hygroscopic Moisture Content (%) :	14.6
Nominated % Optimum Moisture Content Compaction :	100.0	Moisture Content (Top) after Penetration (%) :	17.7
Achieved Dry Density before Soak (t/m³) :	1.758	Optional Moisture Content (Remainder) after Penetration (%) :	17.0
Achieved Percentage of Maximum Dry Density (%) :	98	CBR 2.5mm (%) :	11
Achieved Moisture Content (%) :	15.4	CBR 5.0mm (%) :	11
Achieved Percentage of Optimum Moisture Content (%) :	101	CBR Value (%) :	11
Test Condition (Soaked/Unsoaked) / Soaking Period (Days) :	Soaked / 4	Minimum Specified CBR Value (%) :	-
Swell (%) / Surcharge (kg):	0.0 / 4.5	Oversize Material (%) :

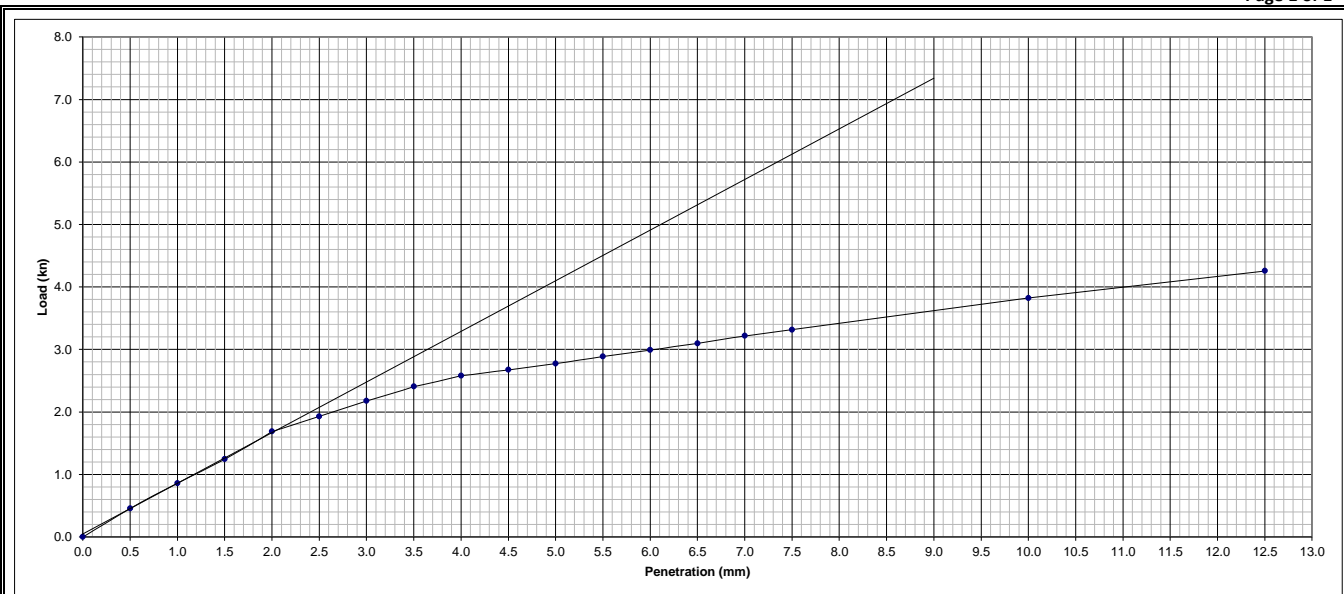
Maximum Dry Density - MDD (t/m³) :	1.867	Dry Density after Soak (t/m³) :	1.831
Optimum Moisture Content - OMC (%) :	14.2	Moisture Content after Soak (%) :	17.9
Compactive Effort :	Standard	Density Ratio after Soak (%) :	98
Nominated % Maximum Dry Density Compaction :	98	Hygroscopic Moisture Content (%) :	13.2
Nominated % Optimum Moisture Content Compaction :	100.0	Moisture Content (Top) after Penetration (%) :	18.3
Achieved Dry Density before Soak (t/m³) :	1.835	Optional Moisture Content (Remainder) after Penetration (%) :	16.4
Achieved Percentage of Maximum Dry Density (%) :	98	CBR 2.5mm (%) :	15
Achieved Moisture Content (%) :	13.9	CBR 5.0mm (%) :	14
Achieved Percentage of Optimum Moisture Content (%) :	98	CBR Value (%) :	15
Test Condition (Soaked/Unsoaked) / Soaking Period (Days) :	Soaked / 4	Minimum Specified CBR Value (%) :	-
Swell (%) / Surcharge (kg):	0.0 / 4.5	Oversize Material (%)	
Soil Description :	Refer Test Pit Log.

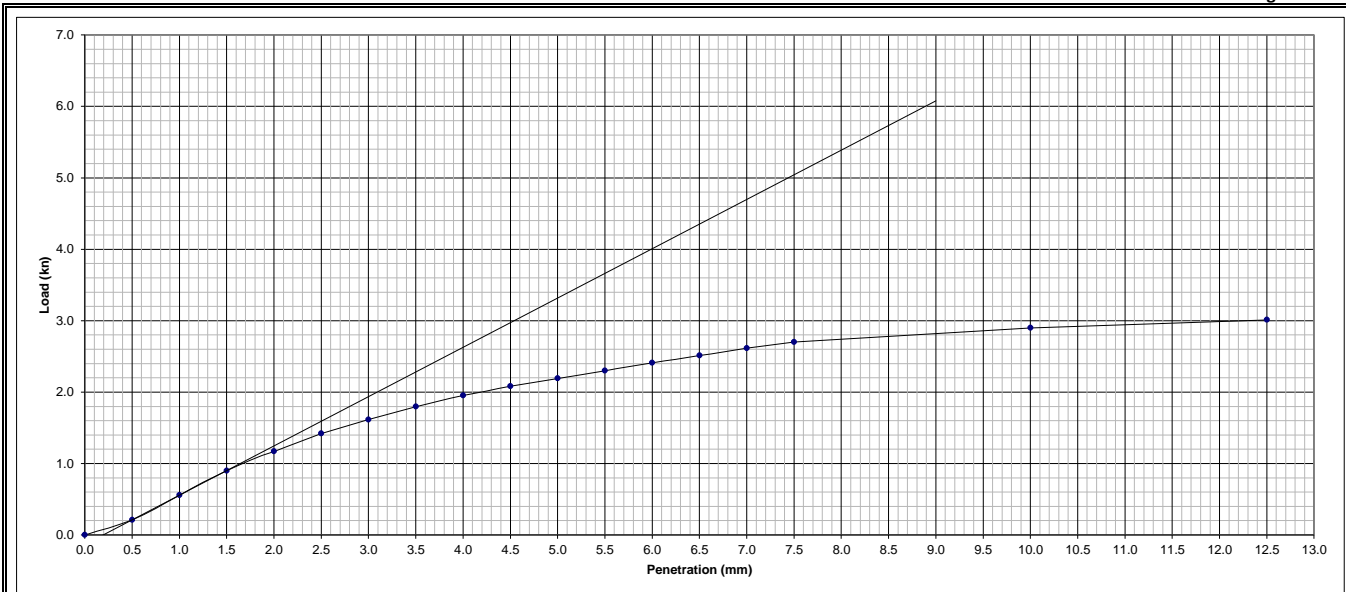
Maximum Dry Density - MDD (t/m³) :	1.831	Dry Density after Soak (t/m³) :	1.783
Optimum Moisture Content - OMC (%) :	11.7	Moisture Content after Soak (%) :	18.4
Compactive Effort :	Standard	Density Ratio after Soak (%) :	97
Nominated % Maximum Dry Density Compaction :	98	Hygroscopic Moisture Content (%) :	12.1
Nominated % Optimum Moisture Content Compaction :	100.0	Moisture Content (Top) after Penetration (%) :	15.7
Achieved Dry Density before Soak (t/m³) :	1.792	Optional Moisture Content (Remainder) after Penetration (%) :	16.5
Achieved Percentage of Maximum Dry Density (%) :	98	CBR 2.5mm (%) :	11
Achieved Moisture Content (%) :	12.2	CBR 5.0mm (%) :	11
Achieved Percentage of Optimum Moisture Content (%) :	104	CBR Value (%) :	11
Test Condition (Soaked/Unsoaked) / Soaking Period (Days) :	Soaked / 4	Minimum Specified CBR Value (%) :	-
Swell (%) / Surcharge (kg):	0.0 / 4.5	Over-size Material (%)	% Excluded

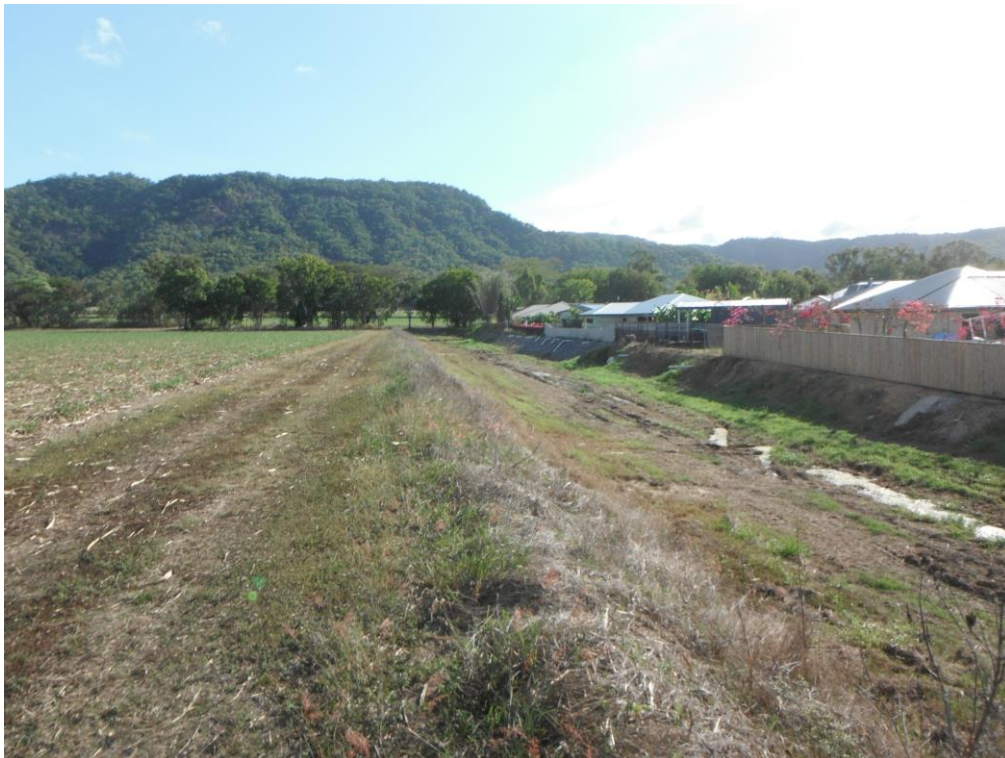
**PHOTO 3: Open Drain Along Northern Boundary**
