Response to Information Request Reconfiguring a Lot (One lot into nine lots and road) at 368-380 Port Douglas Road, Port Douglas (RP Lot 3RP729037) (ROL 2022_4962/1)

Attachment 1 - Amended Layout Plan ARO0188-SK05(1)

Tree Health and condition Report
Lot 3 Port Douglas road, Port Douglas.

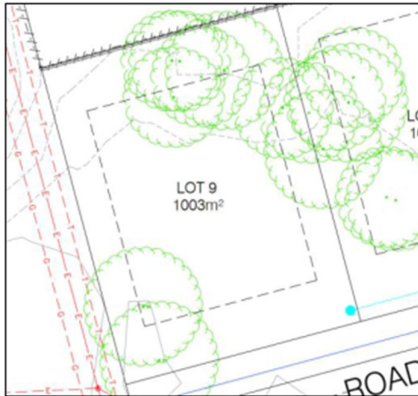
- 6. Please clarify the purpose of the rectangles drawn within each new lot.

Response: The rectangles show the minimum lot dimension as specified in the Douglas Shire Planning Scheme.

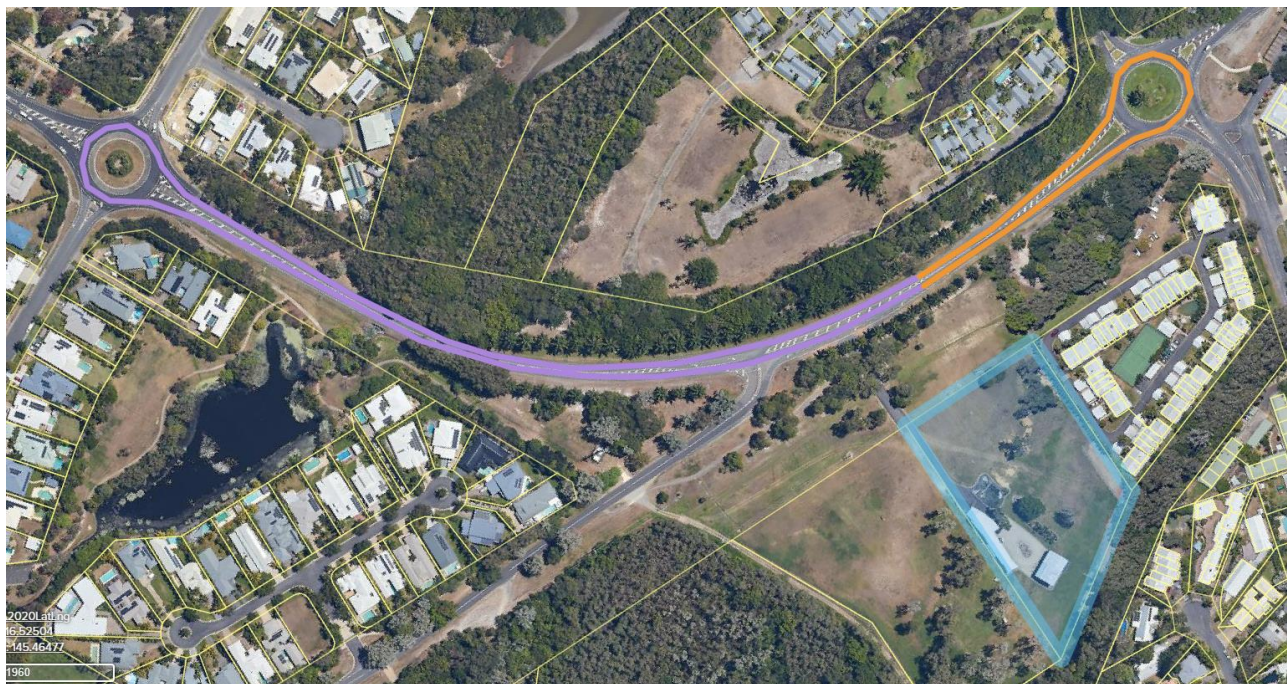
Figure 2 – Additional Travel Distance

The Purple line represents the additional travel of 1100m that a vehicle heading north will incur. The Orange line represents the additional travel of 440m that vehicle entering the site from the south will incur. Based on an average vehicle speed of 40km/hr, the additional travel time incurred associated with the left-in and left-out is 80 seconds and 40 seconds, respectively.

It is acknowledged that the left-in and left-out only movement will increase travel time for drivers wanting to travel in the opposite direction. Image 2, below shows the route required for vehicles travel in the opposite direction i.e. entering the development from the South and existing the development to the North.

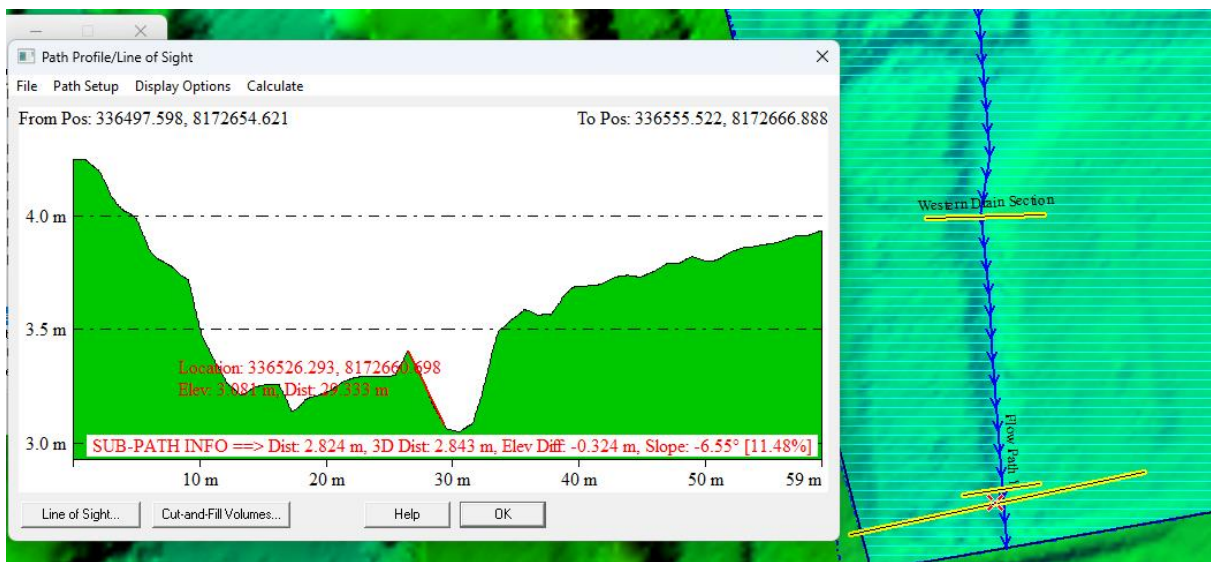
Representative Section 2

Adopt 10% slopes triangular channel with 600mm allowable depth

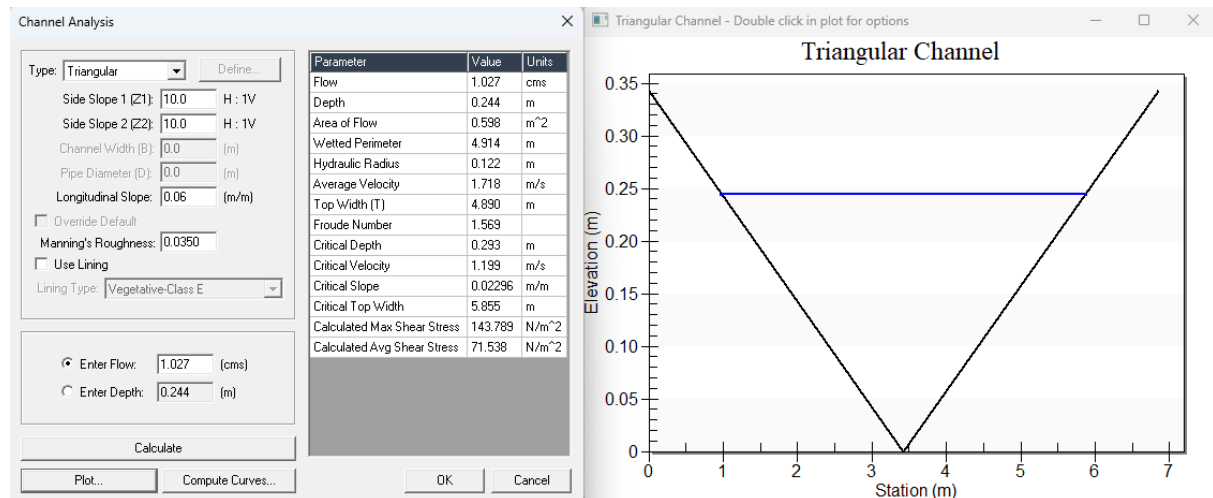
Predevelopment flow (1% AEP) (depth = 244mm)

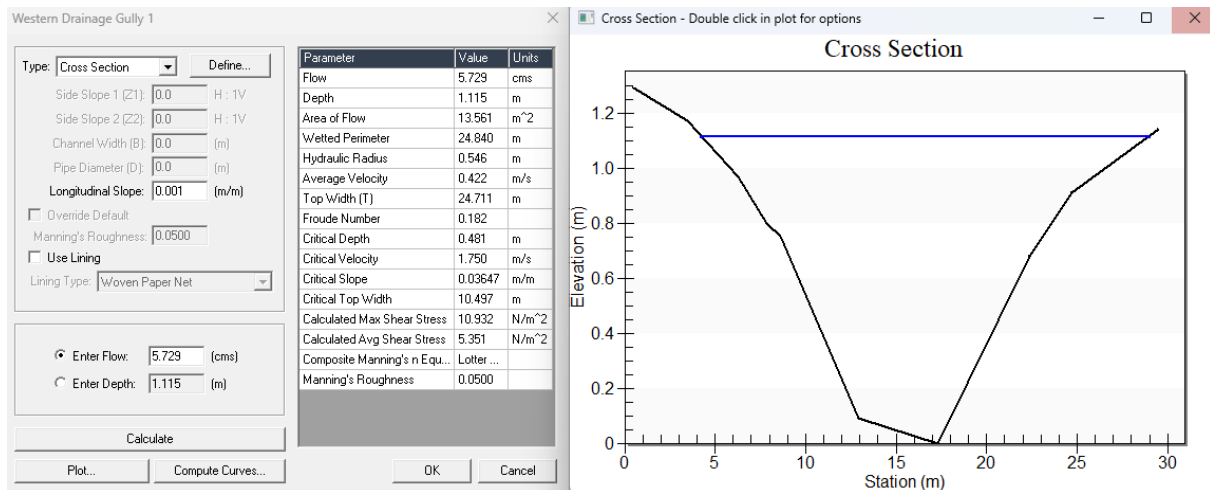
Eastern Drainage Gully Section 1 (1% AEP) Minimum Manning's Roughness $n = 0.05$ vegetated channel

Predevelopment flow (depth = 1.115m velocity = 0.422m/s)

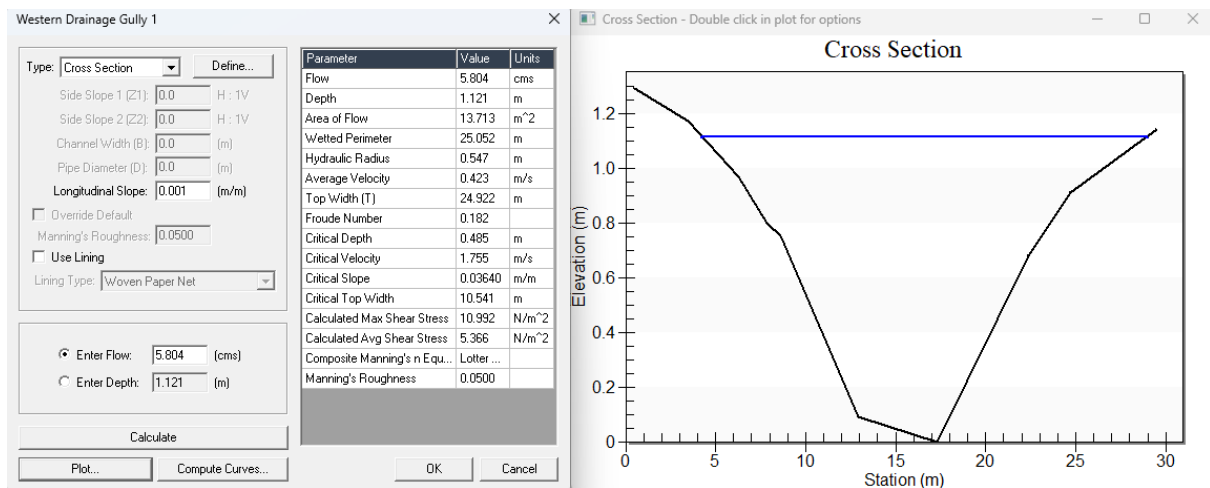
Post development flow (depth = 1.121m velocity = 0.423m/s)

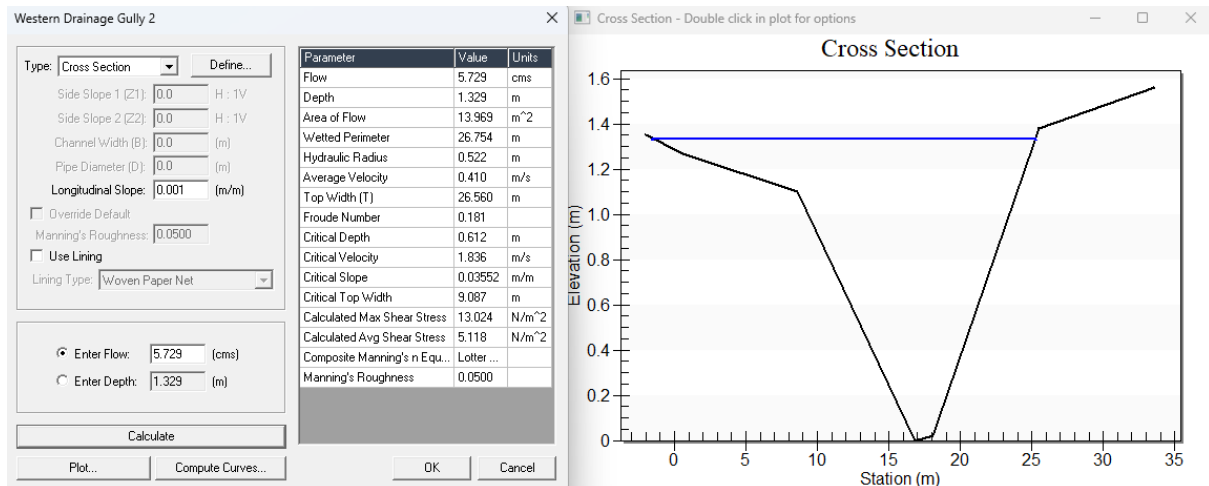
Eastern Drainage Gully Section 2 (1% AEP) Minimum Manning's Roughness $n = 0.05$ vegetated channel

Predevelopment flow (depth = 1.329m velocity = 0.410m/s)

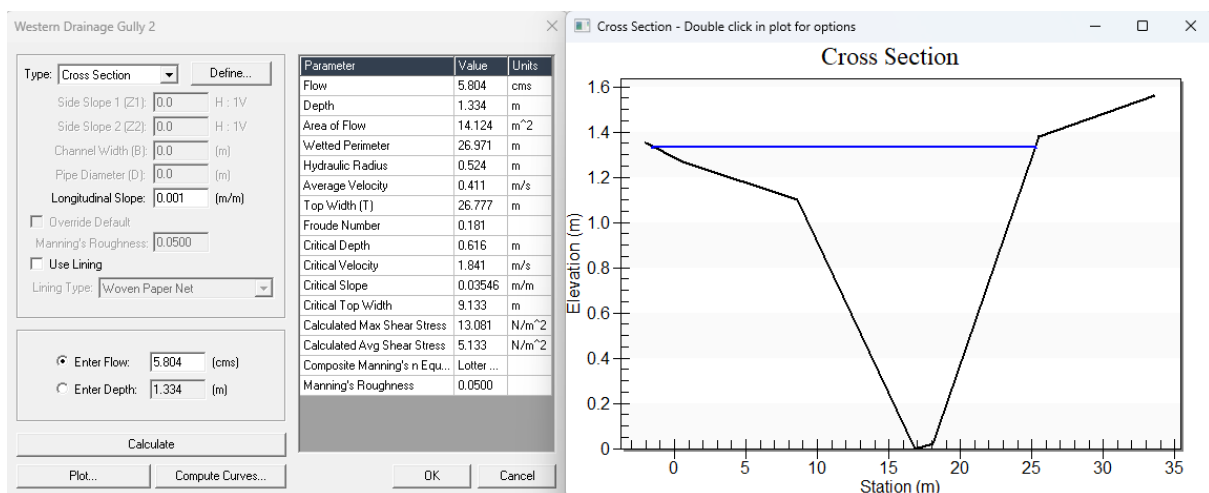
Post development flow (depth = 1.334m velocity = 0.411m/s)

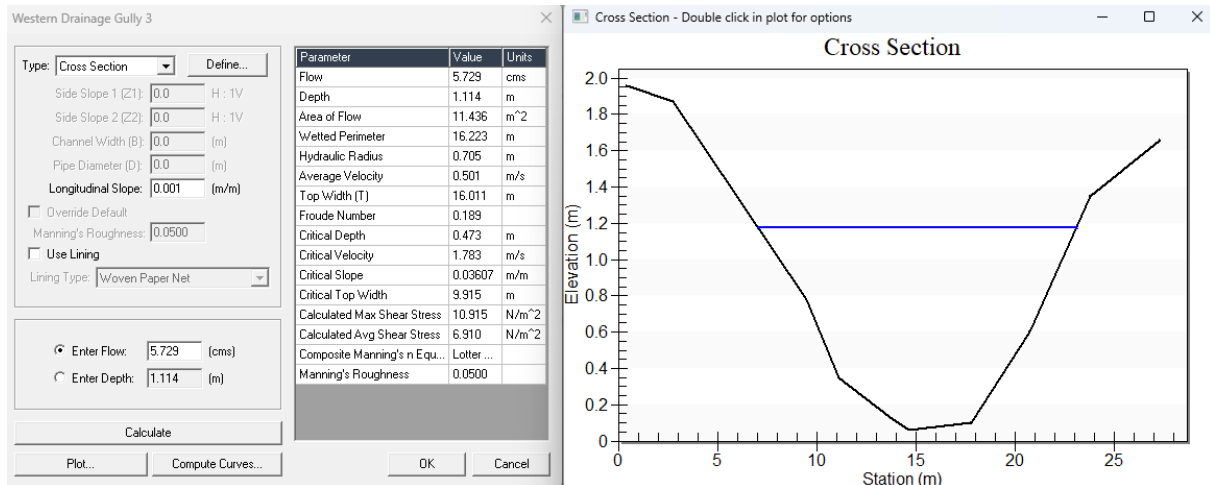
Eastern Drainage Gully Section 3 (1% AEP) Minimum Manning's Roughness $n = 0.05$ vegetated channel

Predevelopment flow (depth = 1.114m velocity = 0.501m/s)

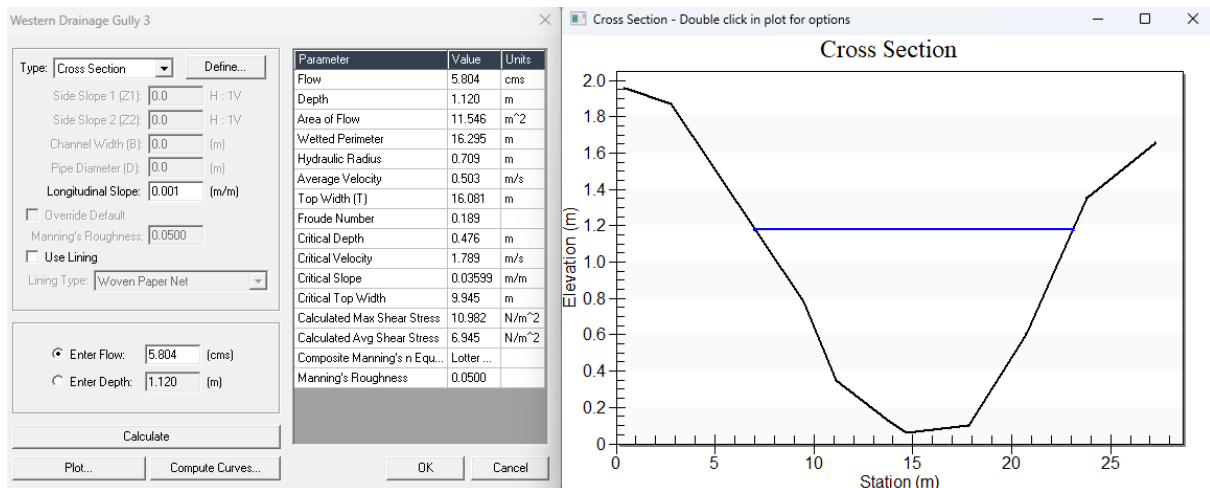
Post development flow (depth = 1.120m velocity = 0.503m/s)

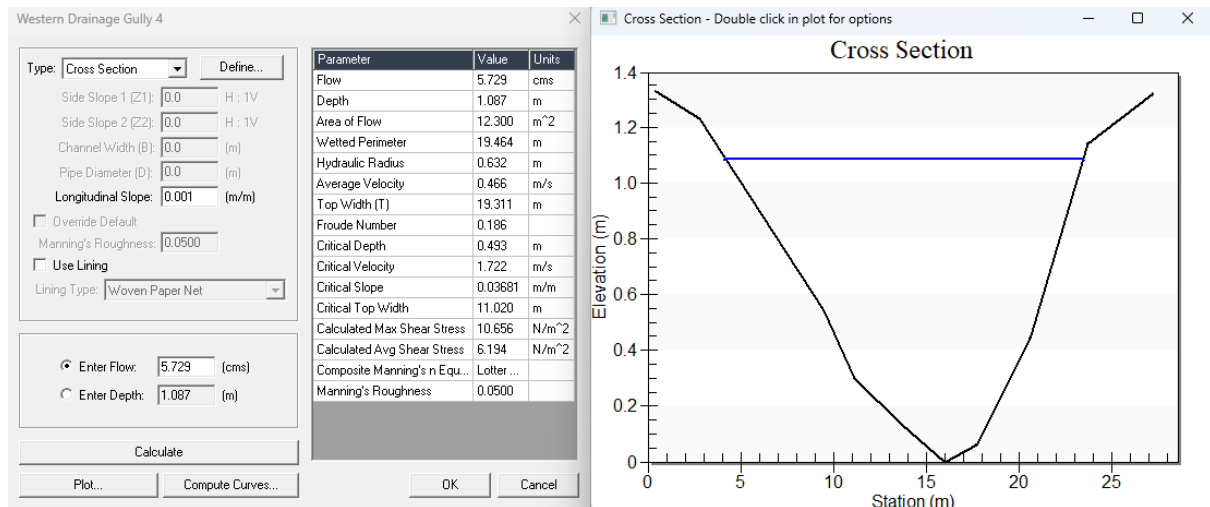
Eastern Drainage Gully Section 4 (1% AEP) Minimum Manning's Roughness $n = 0.05$ vegetated channel

Predevelopment flow (depth = 1.087m velocity = 0.632m/s)

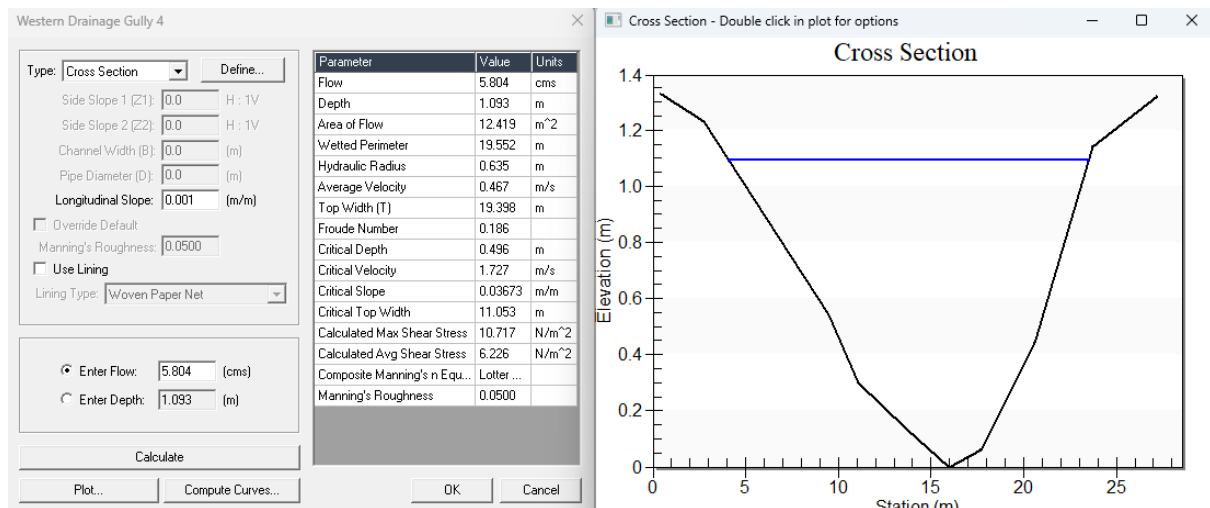
Post development flow (depth = 1.093m velocity = 0.635m/s)

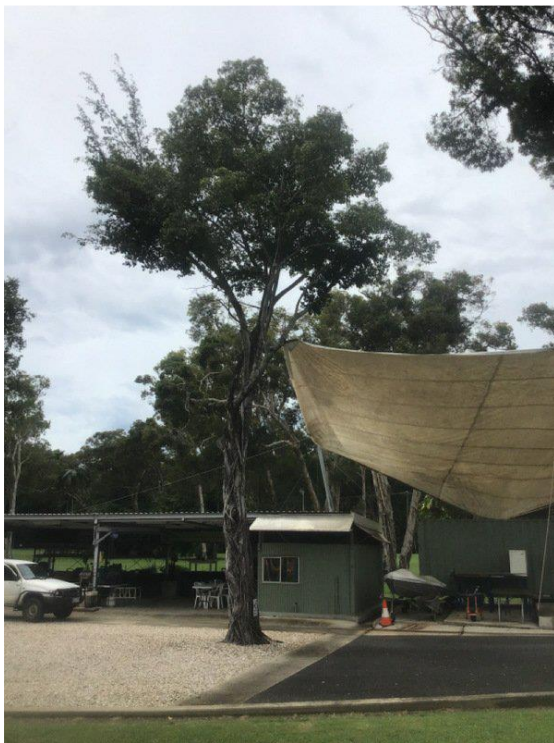
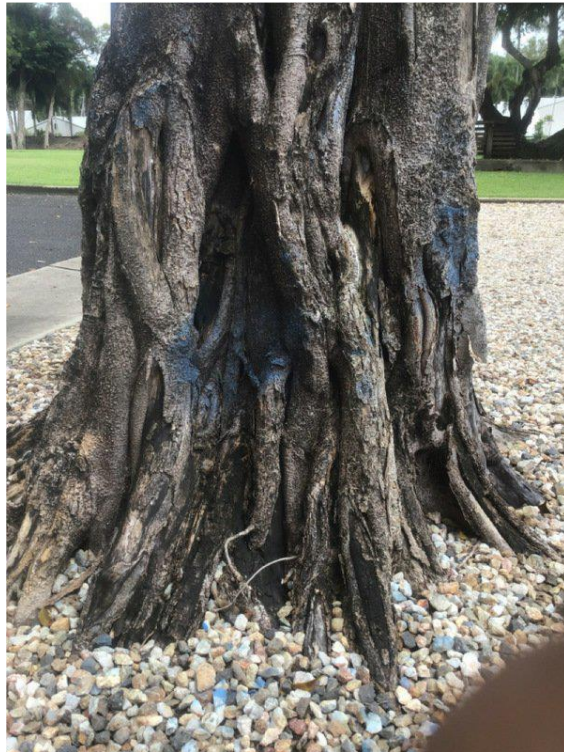
Tree has poor form with cavities at base extent of rot pockets unknown, would appear to be mechanical. Also, several wounds in upper crown with cambium die back.

Recommendations: Removal

Priority: High

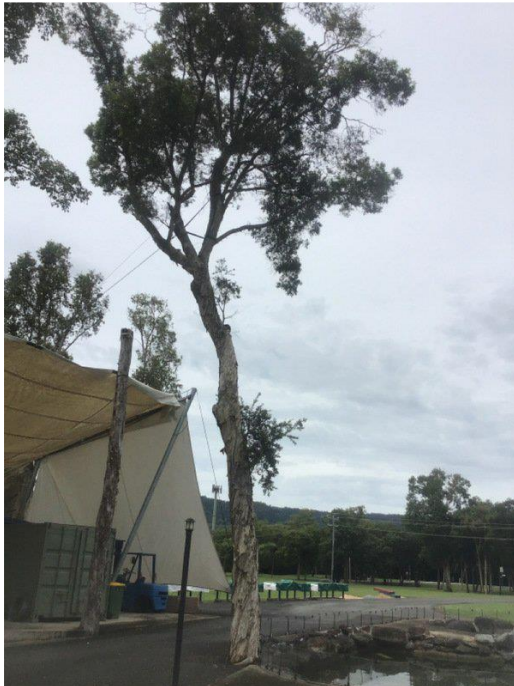
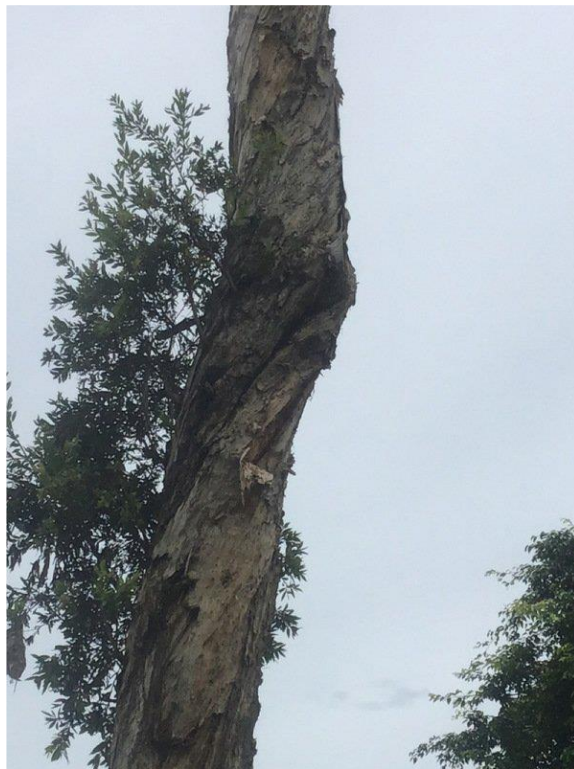
Species: Melaleuca leucadendra tree number 125

Condition: Poor

Comments: DBH 1.60m DRF 1.67m spread 6.10m height 9.23m
Poor form with improper pruning wounds from the past that have become cavity's which will be a concern in the future.

Recommendations: Removal

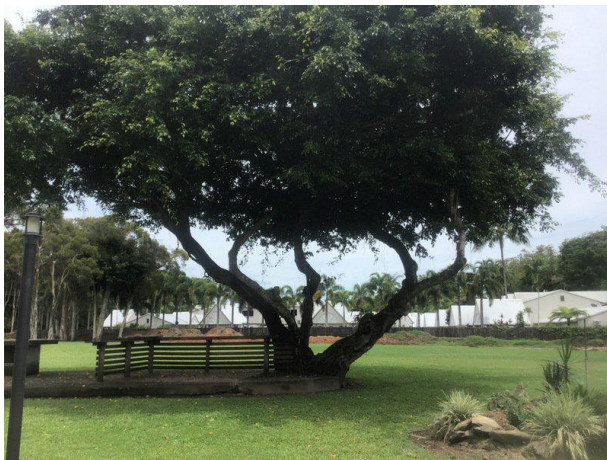
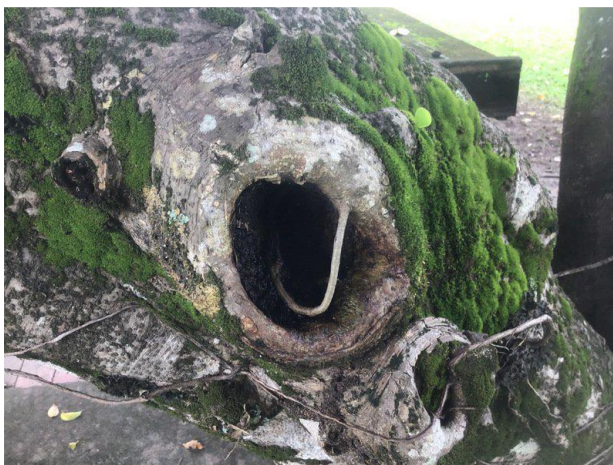
Species: Fig *Ficus virgata* tree number 126

Condition: Reasonable

Tree has noticeable rot pockets in old pruning wounds in lower and upper canopy, not a concern at this stage.

A good third of the tree is surrounded by cement to which the tree is impacting on. This will be a concern if cement is removed due to damage to tree roots and cause the tree to be structurally unsound for the tree has modified its roots and grown and established its root system to overcome the cement in the structural root zone.

The tree appears to be well maintained with regular crown reduction and crown lifting. If this regime is lapsed with more weighted limbs on extremities of the upper crown the wind shearing on the sail space will cause concerns with rot pockets throughout the crown therefore being structurally unsound.

Recommendations: Removal

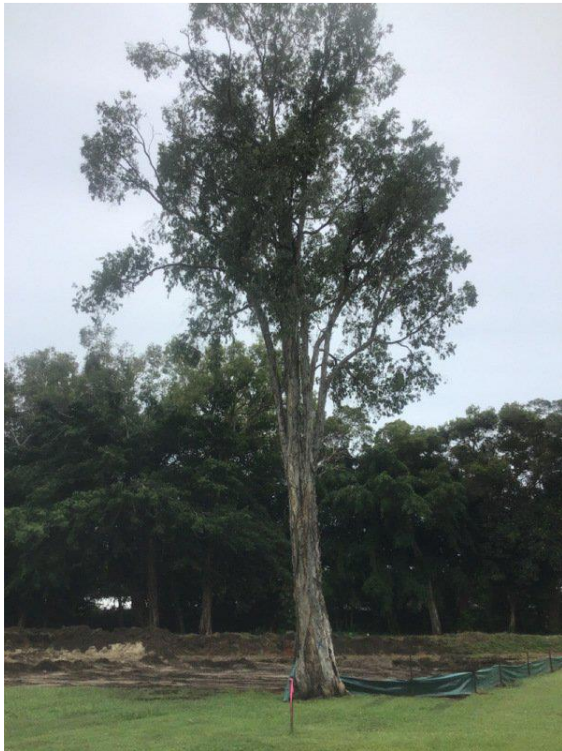
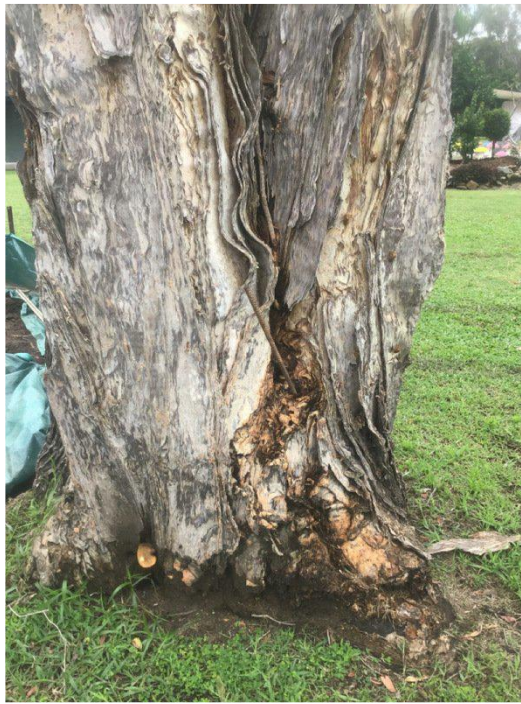
Species: Melaleuca leucadendra tree number 127

Condition: Poor

Fungus bracket also present at base suspect Russula Kalimna. Not aggressive but lives on dead wood which is an indication of a rot pocket at the base of this tree.

Recommendations: Removal

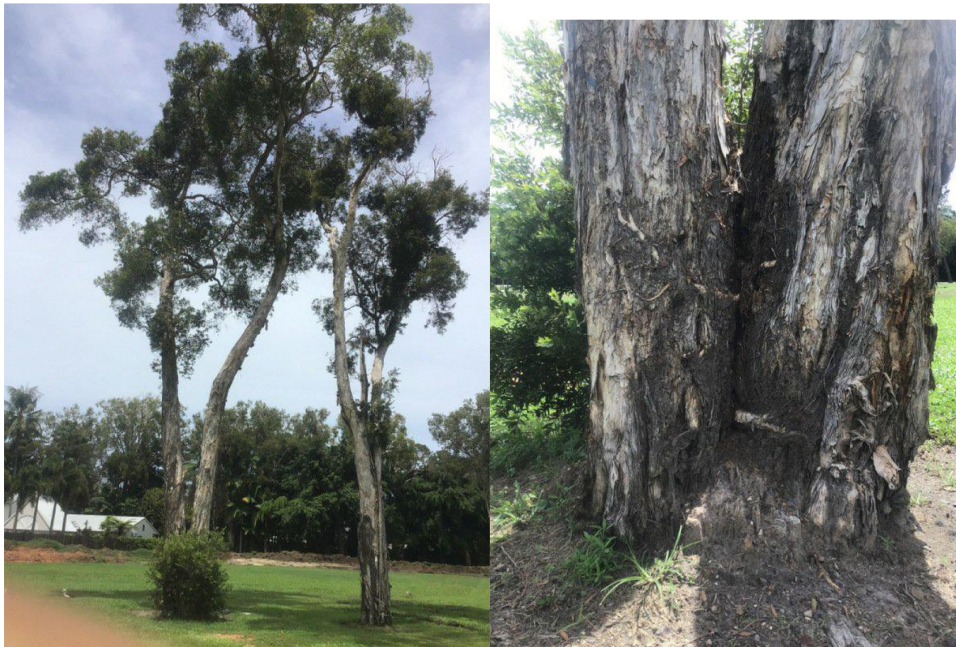
Species: Melaleuca leucadendra tree number 129

Condition: Poor

Comments: DBH 1.78m DRF 2.84m spread 5.90m height 11.20m
Bifurcation at base running up to 1m above ground level. Weak union prone to failure especially in bad weather, wind shear and weighted canopy support by poor architecture. High risk hazard in the future.
Upper crown has low vigour. This could be root disturbance or a root disorder from soil compaction.

Recommendations: Removal

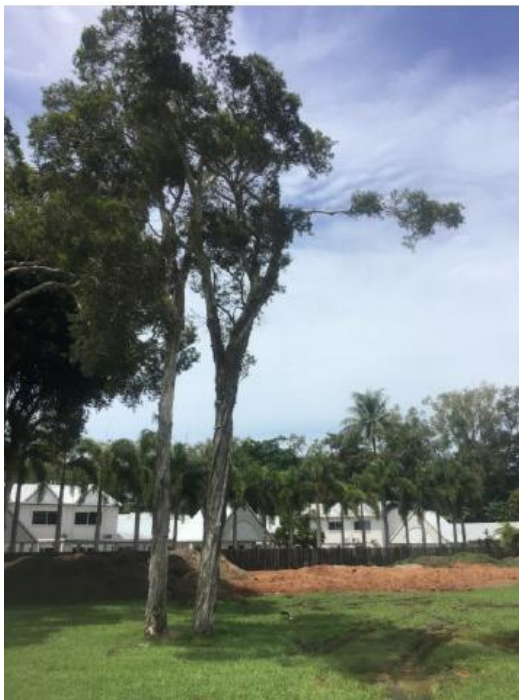
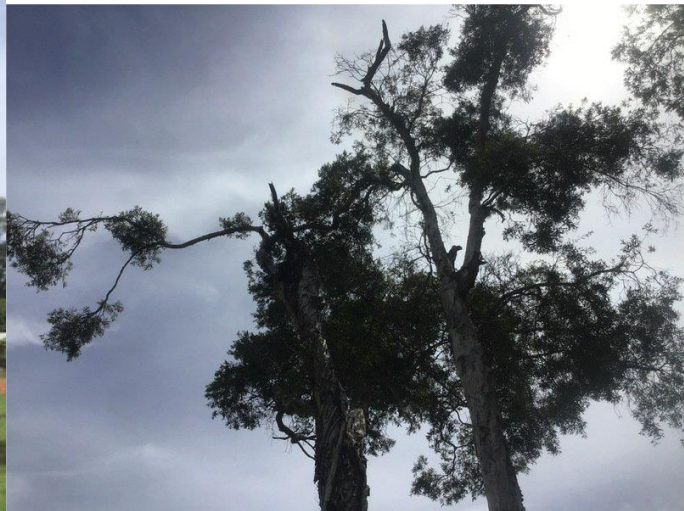
Species: Melaleuca leucadendra tree number 130 and tree 131.

Condition: Reasonable

Both trees have either had storm damage or are suffering from crown die back. Both main leaders have been removed significantly with large wounds as evidence.

Low in vigor in upper canopy with large diameter deadwood present. Indications of root damage or another form of root disorder.

Recommendations: Removal

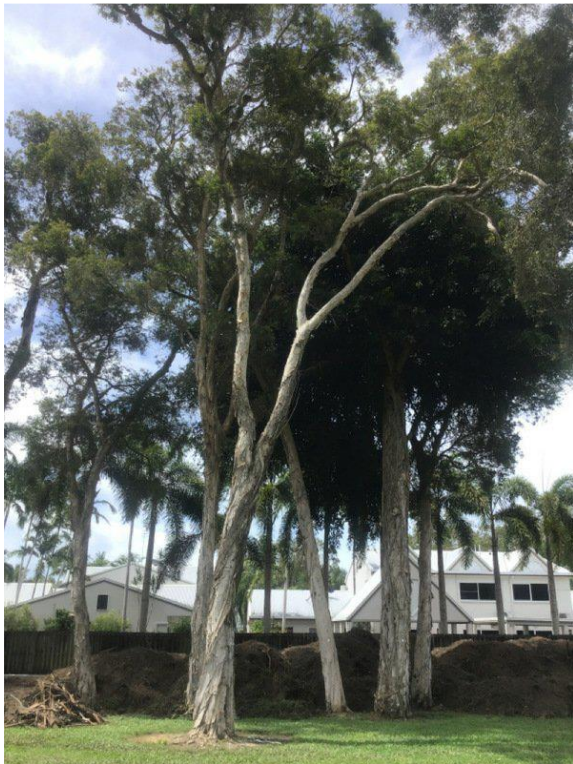
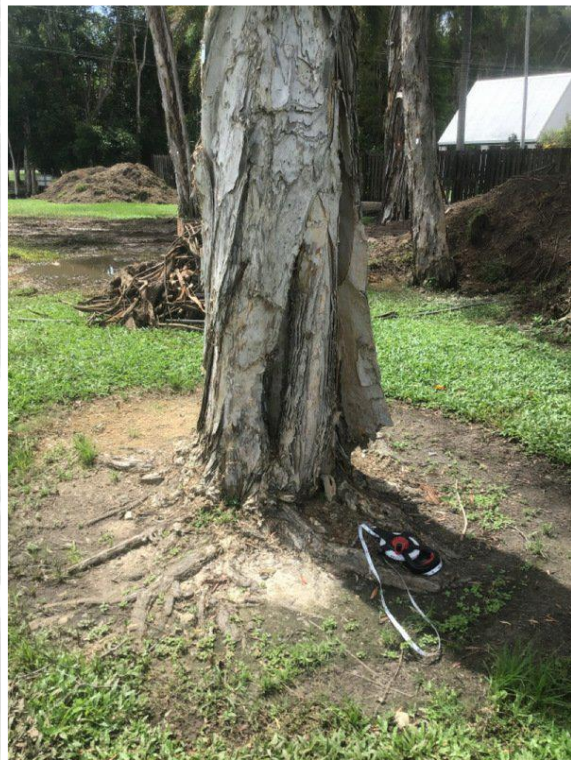
Species: Melaleuca leucadendra tree number 132

Condition: Poor

Comments: DBH 1.66m DRF 2.18m spread 8.70m height 10.87m
Large cavity at base 0.80m in length, 0.17m in width, knocked with sounding hammer and decay would be extensive, great sap wood around wound indicating wound repair is good but the extent of wound is too extensive for this tree to remain structurally sound.

Recommendations: Removal

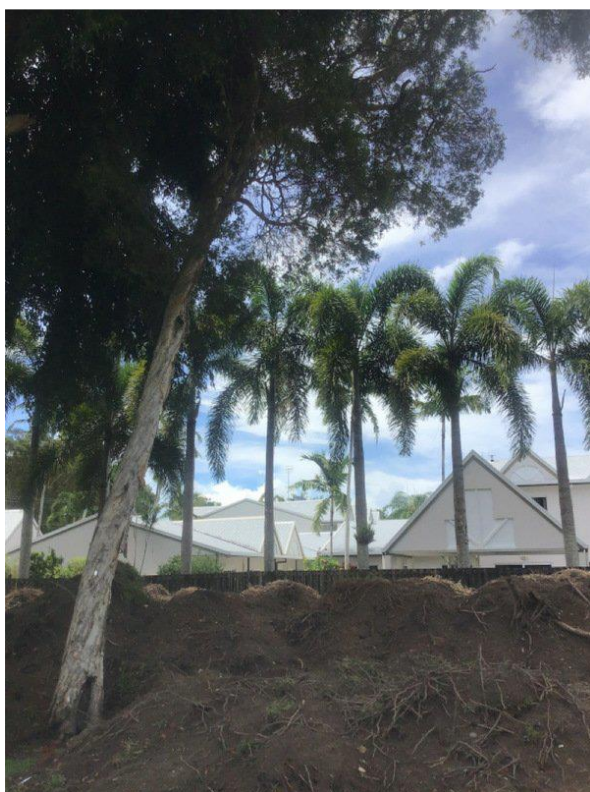
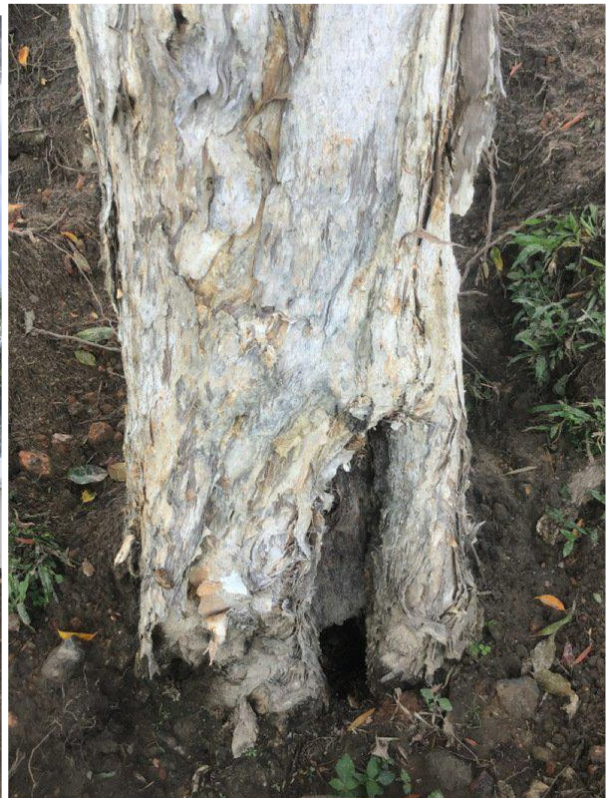
Species: Melaleuca leucadendra tree number 133

Condition: Poor

Recommendations: Removal

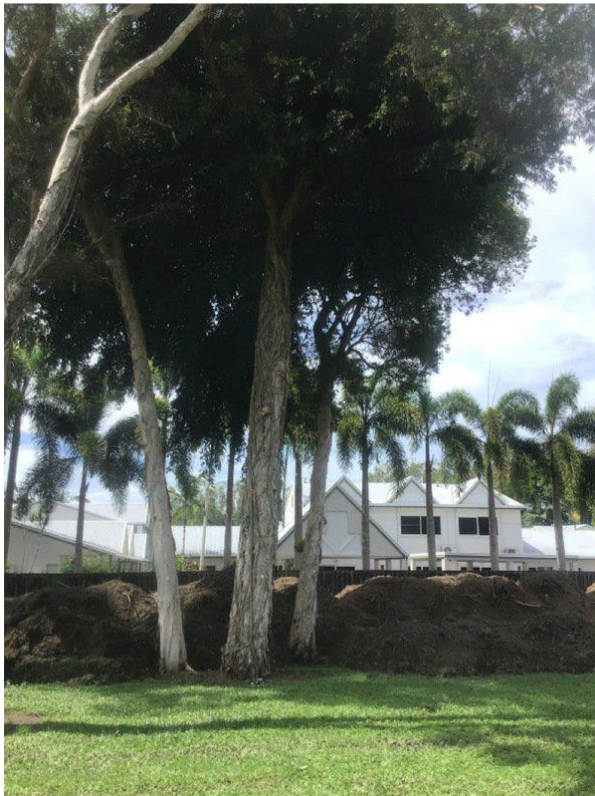
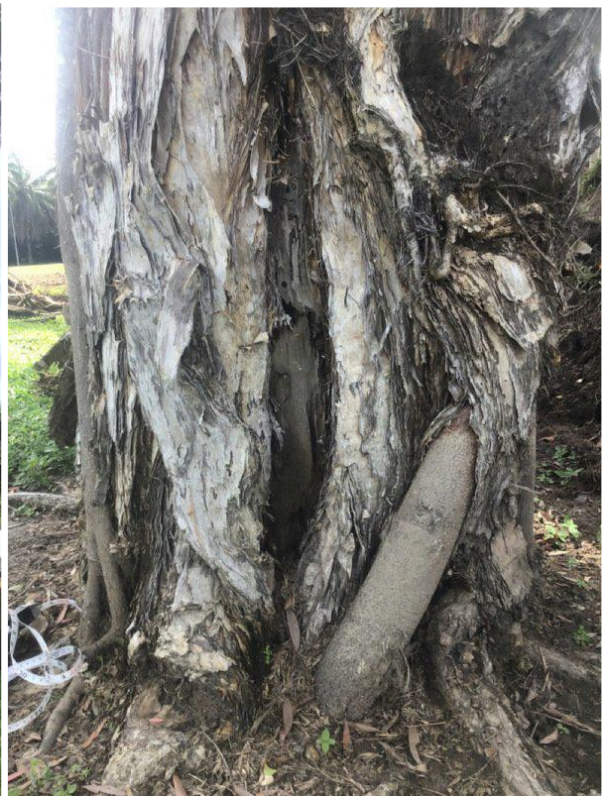
Species: Melaleuca leucadendra tree number 134

Condition: Poor

Recommendations: Removal

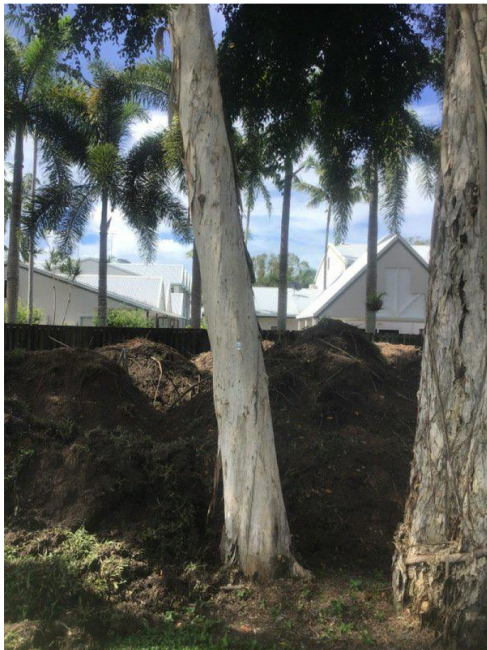
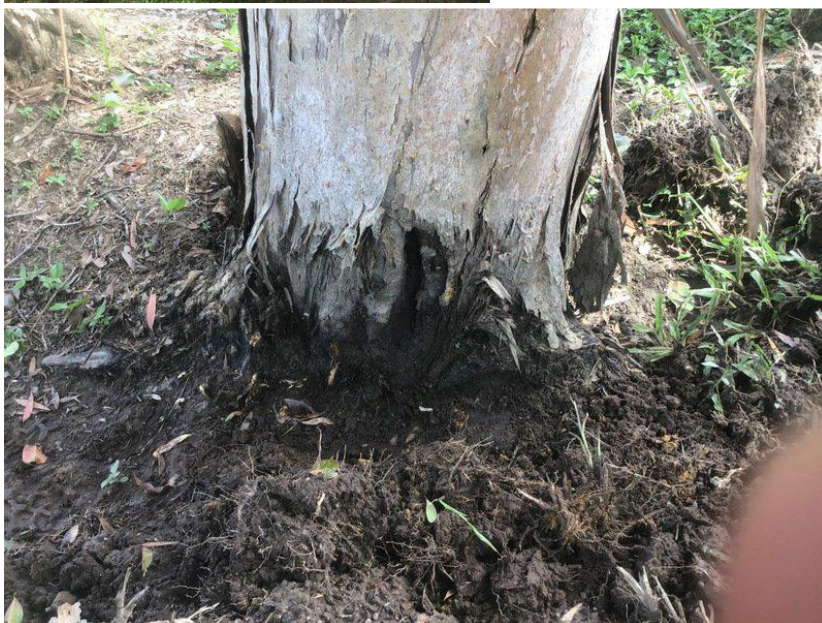
Species: Melaleuca leucadendra tree number 135

Condition: Poor

Recommendations: Removal

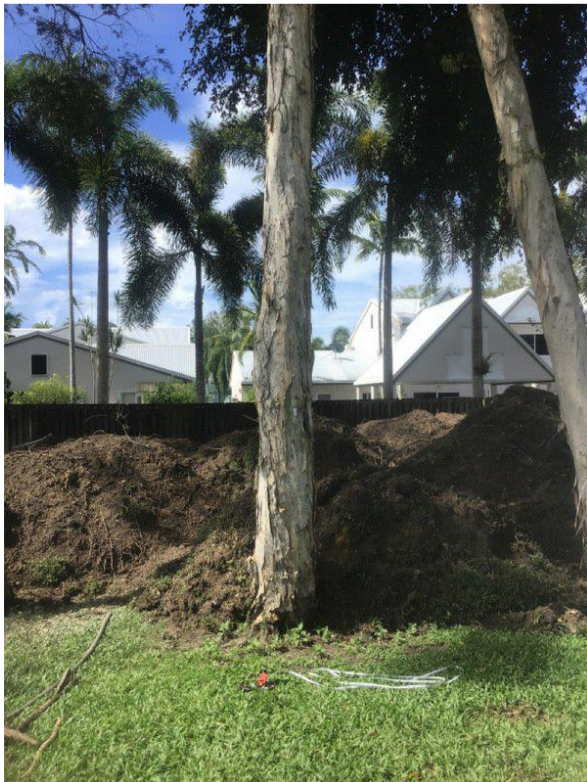
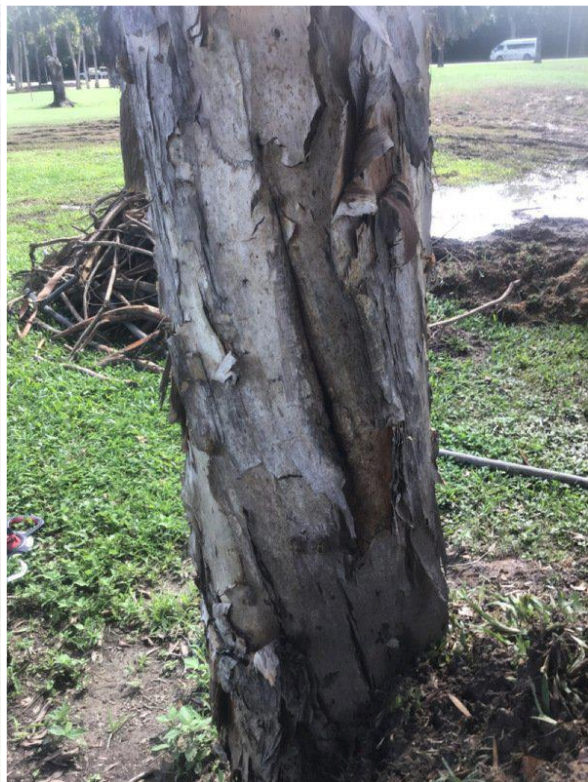
Species: Melaleuca leucadendra tree number 136

Condition: Poor

Recommendations: Removal

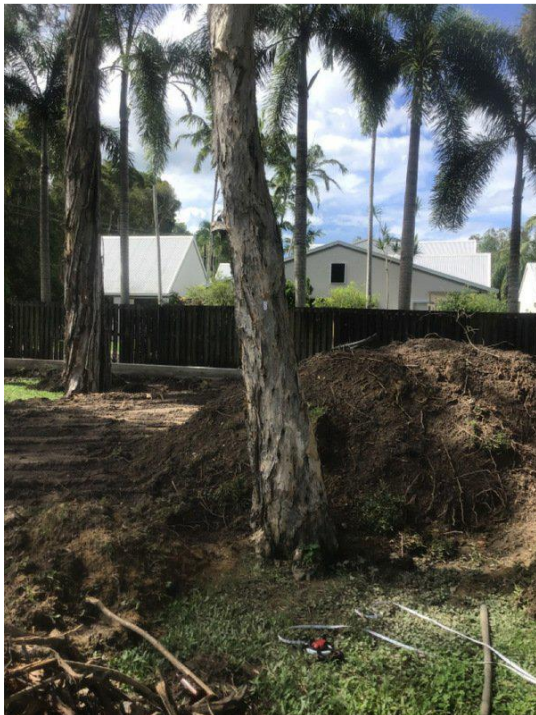
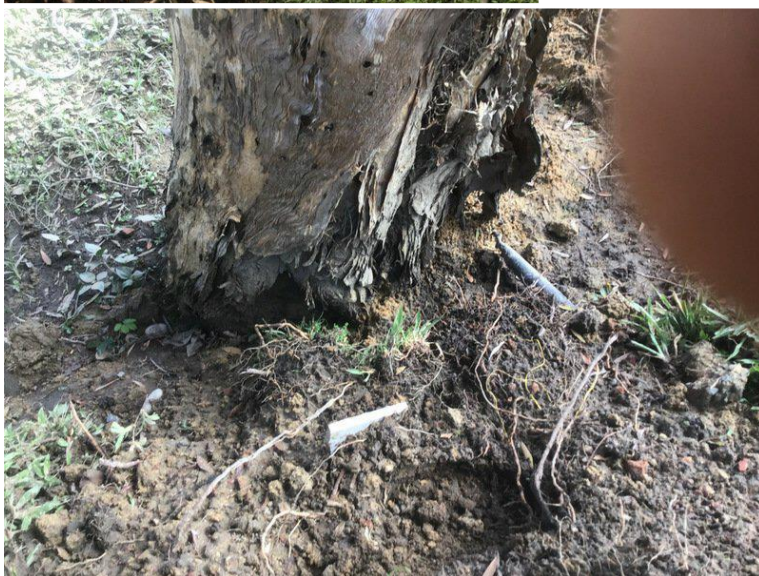
Species: Melaleuca leucadendra tree number 137

Recommendations: Removal

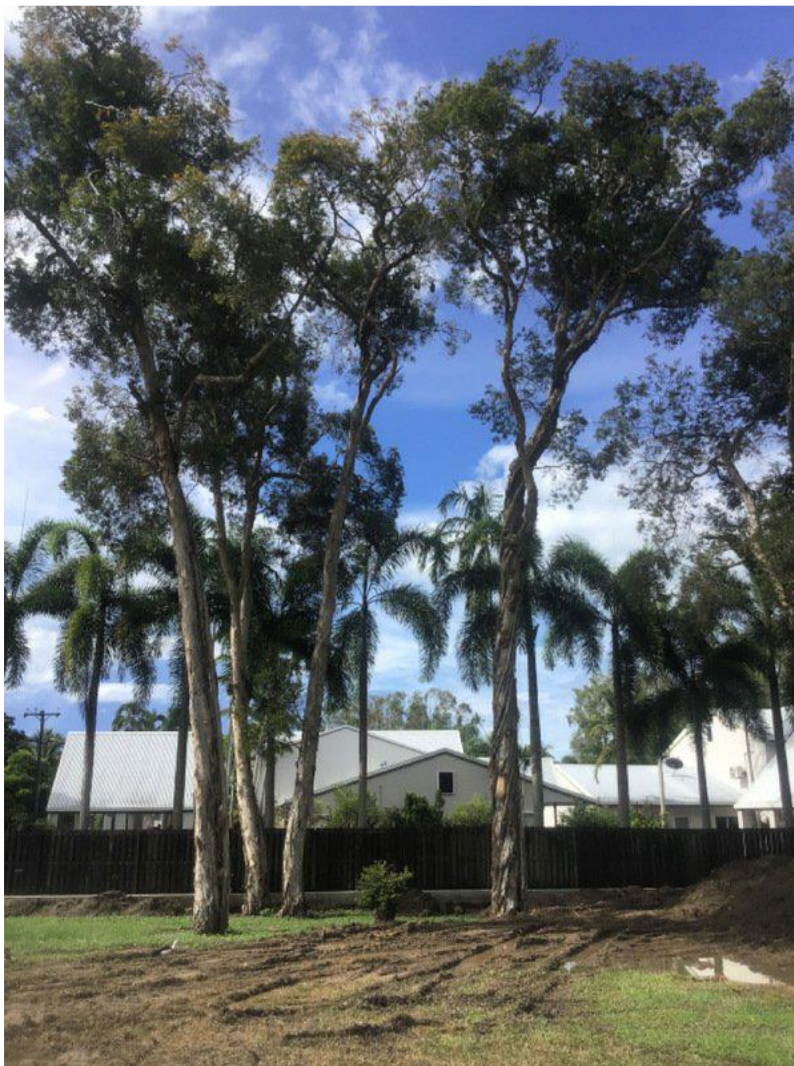
Species: Melaleuca leucadendra tree numbers 138-139-140,141.

Recommendations: Dead Wood, Crown lift, Rebalance, Crown Shape, Monitor
