5.11. OLD MOWBRAY RIVER BRIDGE REMOVAL

Attachment 1 - DRAFT- Level Two Structure Inspection Report (part) – Mowbray River Fishing Jetty

Level Two Structure Inspection Report

Structure ID:	188013	Bridge Name:	Mowbray River Fishing Jetty - 2 Span ti
Crossing:	Mowbray River	Road Number:	
Structure Type:	Jetty	Road Name:	Captain Cook Highway
Construction Type:	Girder	Owner:	Douglas Shire Council
Construction Material:	Timber	District:	Mowbray
Inspector:	Mark de Hayr	Local Authority:	DSC
Latitude:	-16.552986	Longitude:	145.481806
Inspection Date:	1/02/2016	Max Height (M)	3
Next Inspection Date:	1/02/2017	Width (M)	5.8
Total Length (M)	16.8	Bearing - AP1-AP2	West
Carriageway		Load Limit	
Footway		Status	Decommissioned
Chainage (Km)		From	To

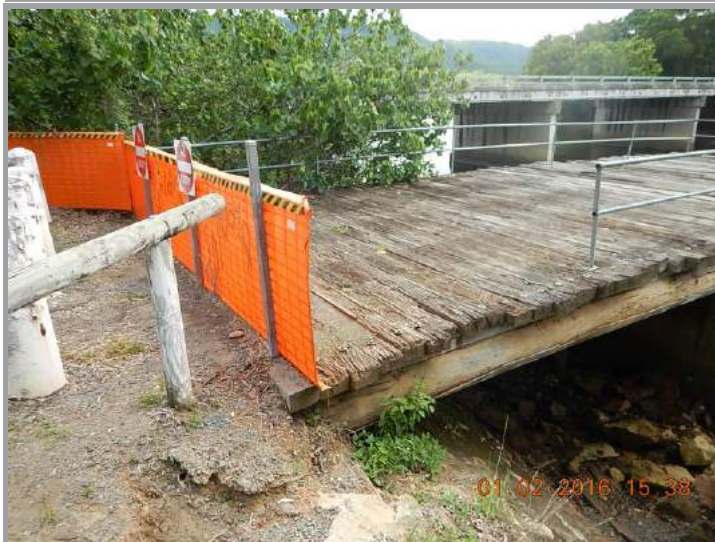
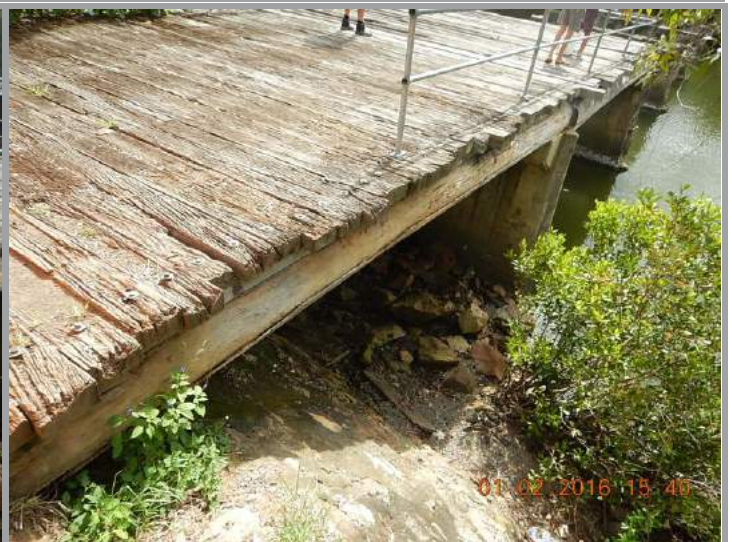
The Structure is in overall very poor condition. At the time of the inspection the structure was fenced off to restrict access. The deck was in very poor condition with some sections having collapsed into the river. The remainder of the deck shows signs of extreme rot and decay. There are Five Girders in each span. Four of the girders in Span One are in condition state Four due to extreme rot and decay. In Span Two, Girder Two has collapsed into the river and the remaining girders are in Condition State Four. Pier One and Two are comprised of cast in-situ Concrete Pier Walls. The Pier Walls have extensive spalling and sections of exposed reinforcement. The exposed reinforcement is severely corroded.

Recommendations: The structure should be closed immediately to all pedestrian traffic due to the possibility of catastrophic failure and the potential for personal injury. The superstructure should be removed so that it cannot fall onto members of the public. A Level Three inspection of this structure should be undertaken to determine if rectification of this structure is possible and/or cost effective.

Suggestions: Due to the degradation of the superstructure components (Deck Planks and Timber Girders) and the state of the Substructure Components (Pier Walls etc.). Rehabilitation of the structure in its current form would not be considered a cost effective option. If a Level Three investigation of the Substructure Components determined that they could be repaired in a cost effective manner. Then the option for replacing the existing superstructure with a alternative light weight construction may be possible.
