5.10. RISK ASSESSMENT DAINTREE RIVER FERRY PRECINCT

RISK ASSESSMENT REPORT - Daintree Ferry Precinct Douglas Shire Council	Document No.: QSG17-027	Version No.: 2A
Release Date: 10 April 2017	Ordinary Council Meeting - 26 April 2017	Page 18 of 33

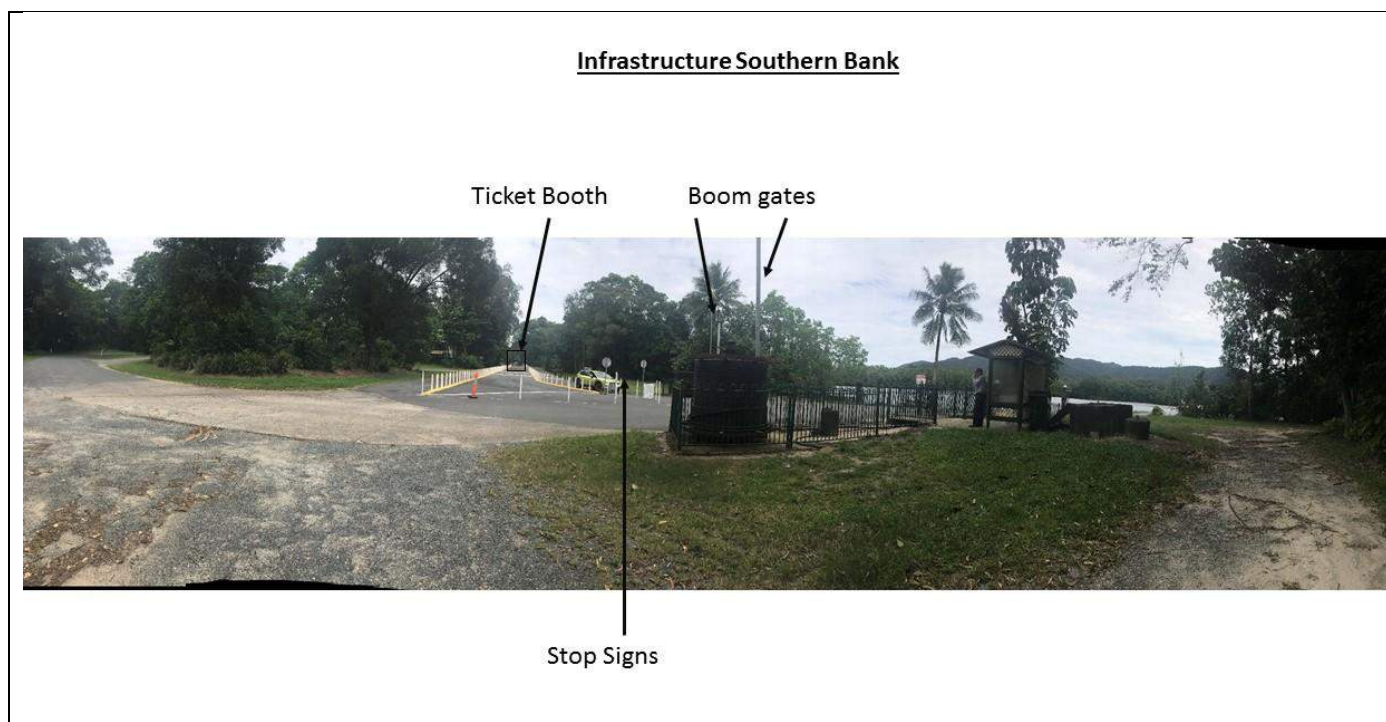
The following diagrams and discussion of issues increasing risk have been developed to provide the reader (particularly those with limited knowledge of the site) with a fundamental understanding of current infrastructure safety risks in simple language that is easily understood in simple terms. A detailed risk assessment associated with the boom gate operation supporting the recommendations detailed in Section 6 Executive Summary is included at ANNEX C.

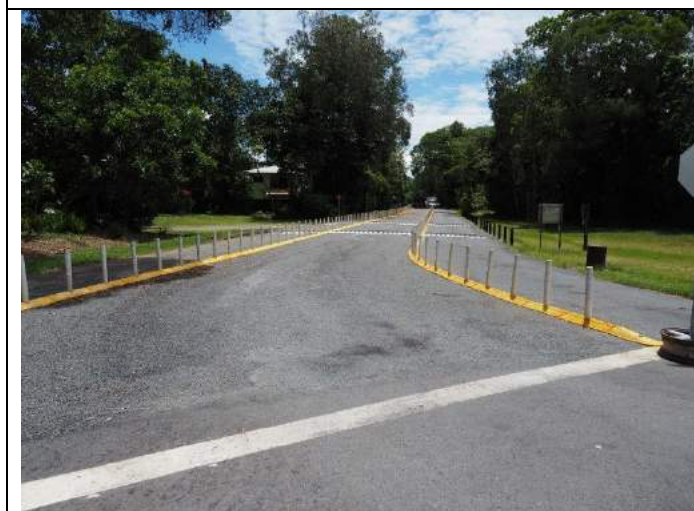
- Stop Sign is only administrative measure there is no physical control (barrier or boom gate) to control traffic movement prior to the arrival of the Ferry
- No controls in place to stop Human and Vehicle interaction
- No Staff present in this location to ensure compliance of vehicles.

Looking from the stop sign on Southern Bank up the entry road to the ticket booth

- In order to reduce the likelihood of unauthorised vehicles moving beyond the current STOP signs at times the vehicles are not under control of a competent traffic controller and thereby presenting unacceptable risk to the organisation's workers and others including pedestrians and the occupants of the vehicles, it is recommended that the land based boom gates be lowered after the ferry is loaded for each trip and before it disembarks from the land approach
- Due to the possible risks arising from the operation of the current boom gates consideration should be given to the installation of automated gates that can be controlled by the operator of the ferry (in conjunction with a competent traffic controller)
