5.6. BRIDGE RENEWAL PROGRAM - POLETTI'S BRIDGE

Level Two Structure Inspection Report

Structure ID:	8011	Name:	Poletti Road Bridge - 2 Span Timber brid
Crossing:	Saltwater Creek	Road Number:	
Structure Type:	Bridge	Road Name:	Poletti Road
Construction Type:	Girder	Owner:	Douglas Shire Council
Construction Material:	Timber	District:	Miallo
Inspector:	Mark de Hayr	Local Authority:	DSC
Latitude:	-16.407509	Longitude:	145.356155
Inspection Date:	4/06/2018	Max Height (M)	4.5
Next Inspection Date:	4/06/2019	Width (M)	4.5
Total Length (M)	18	Bearing - AP1-AP2	East
Carriageway		Load Limit	10
Footway	None	Status	Active
Chainage (Km)		From	To

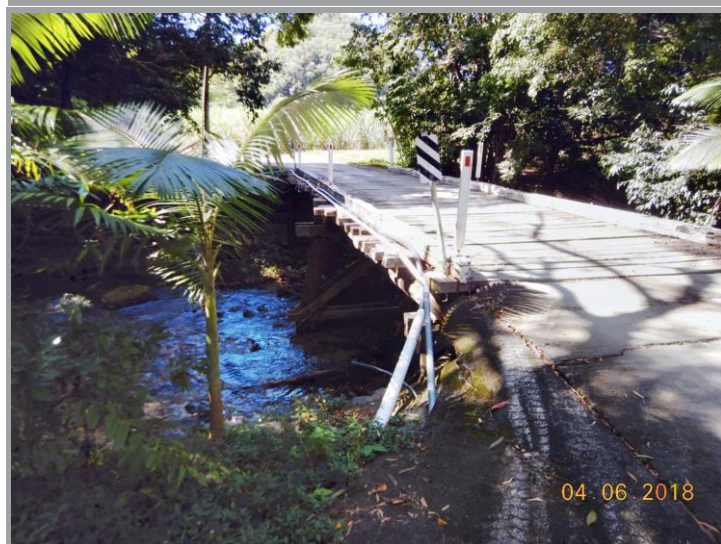
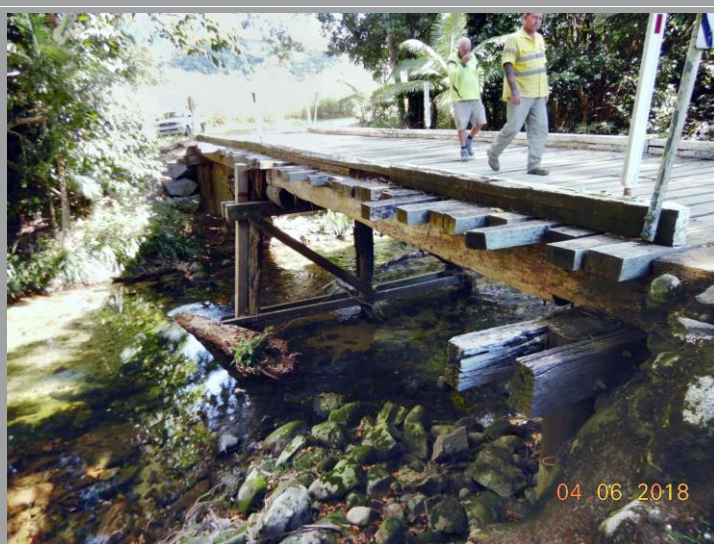
Two Span Timber Girder Bridge crossing Saltwater Creek on Poletti's Road. Approach One is deemed to be Western Side and is Give Way controlled. Structure is currently Load Limited to 10t.

Bridge is in Overall Poor Condition. The Snipes/notching have been incorrectly applied in most girders and could be rectified through anti split treatments. Pile Two has been previously Spliced at mid height. Pile Three in Pier is completely rotted through and the load is expected to be currently only be supported through the bracing timber. The Wale in Face Two in the pier (at Pile 3) has split resulting in no support. Piles 1 and 2 in Abutment Two are in CS3 from dill testing but have been elevated to CS4 due to loss of section from surface rot from being in contact with the concrete abutment sheeting. The distributors have missing/insufficient fixings. A "Fender Pile" has been installed by Council on the RHS of Pier One - This is not considered to be significantly adding to the Structural Capacity of the structure.

RECOMMENDATIONS: As per the Timber Bridge Inspection Manual - Pile Two has previously been Spliced and Pile Three is in CS4 there is no option but to fully replace one or more of the Piles in the Pier or to replace / upgrade the existing structure. Piles One and Two in Abutment Two should be replaced.

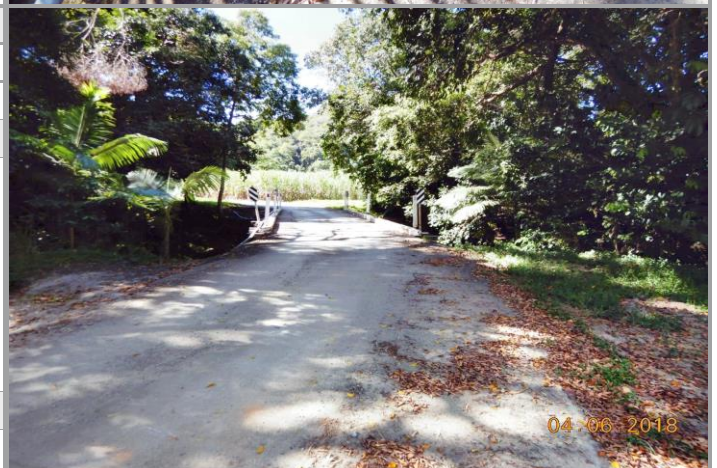
Transverse cracking in Approach One Bitumen Wearing Surface

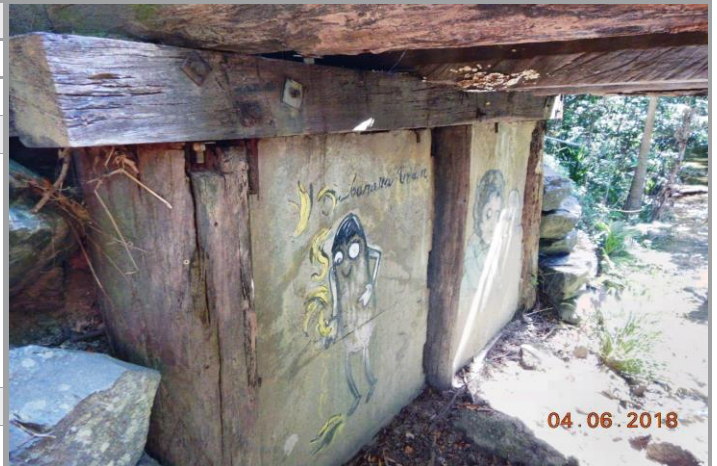
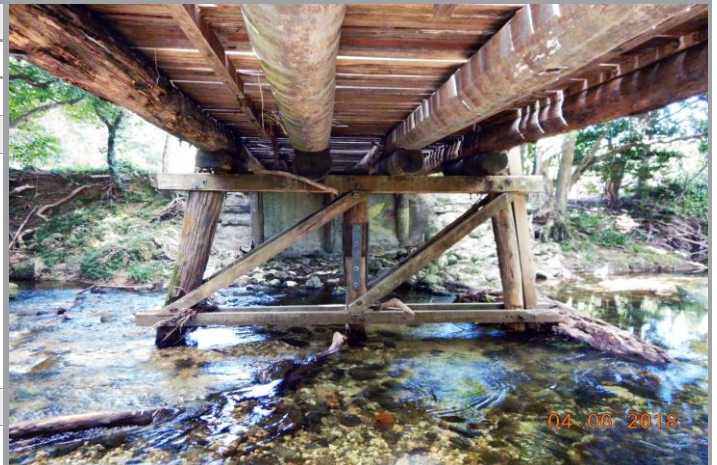
Pier One Face One

O	P1	COR	27T	2	4	Each	0	3	1	0	<input type="checkbox"/>	Corbel 2 is in CS4 due to over sniping, (CS2 by drill testing)
O	P1	H	54T	2	2	Each	0	2	0	0	<input type="checkbox"/>	280x180 hardwood headstocks are in fair condition [See Photo] - DSCN5949.JPG, DSCN5952.JPG

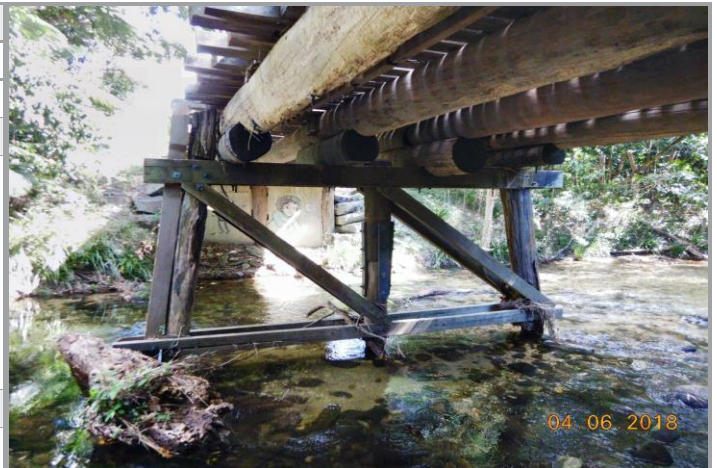
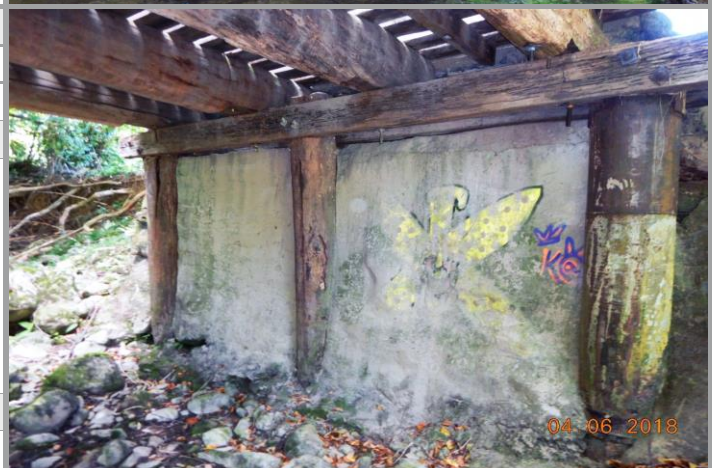
Abutment Two

O	A2	H	54T	2	2	Each	0	1	1	0	<input type="checkbox"/>	280x180 hardwood headstocks are in fair condition. Headstock One has 400x100mm section of rot at top of pile Two. "White Rot" is developing along the front face of Headstock One. [See Photo] - DSCN5955.JPG	
O	A2	P	56T	2	2	Each	0	0	0	2	<input type="checkbox"/>	Pile One has Full depth split to 1m from top of pile. Pile Two has doey (soft drilling) at top. Piles are rated CS3 by drill rating and have been elevated to CS4 due to loss of section due to surface rot at the base where 20% has deteriorated where it has been in contact with the concrete batter protection. Pile Two has Lichen growth. [See Photo] - DSCN5956.JPG, DSCN5954.JPG, DSCN5957.JPG	
O	A2	P	56S	2	1	Each	0	1	0	0	<input type="checkbox"/>	Concrete Filled Steel Pile is in Fair Condition - Abutment Pile #3

O	S2	G	22T	2	0	4	Replace Girders	<input type="checkbox"/>	<input checked="" type="checkbox"/>	<input checked="" type="checkbox"/>
O	A2	H	54T	2	1	0	Replace Headstock	<input type="checkbox"/>	<input checked="" type="checkbox"/>	<input checked="" type="checkbox"/>
O	A2	P	56T	2	0	2	Replace Pile	<input type="checkbox"/>	<input checked="" type="checkbox"/>	<input checked="" type="checkbox"/>

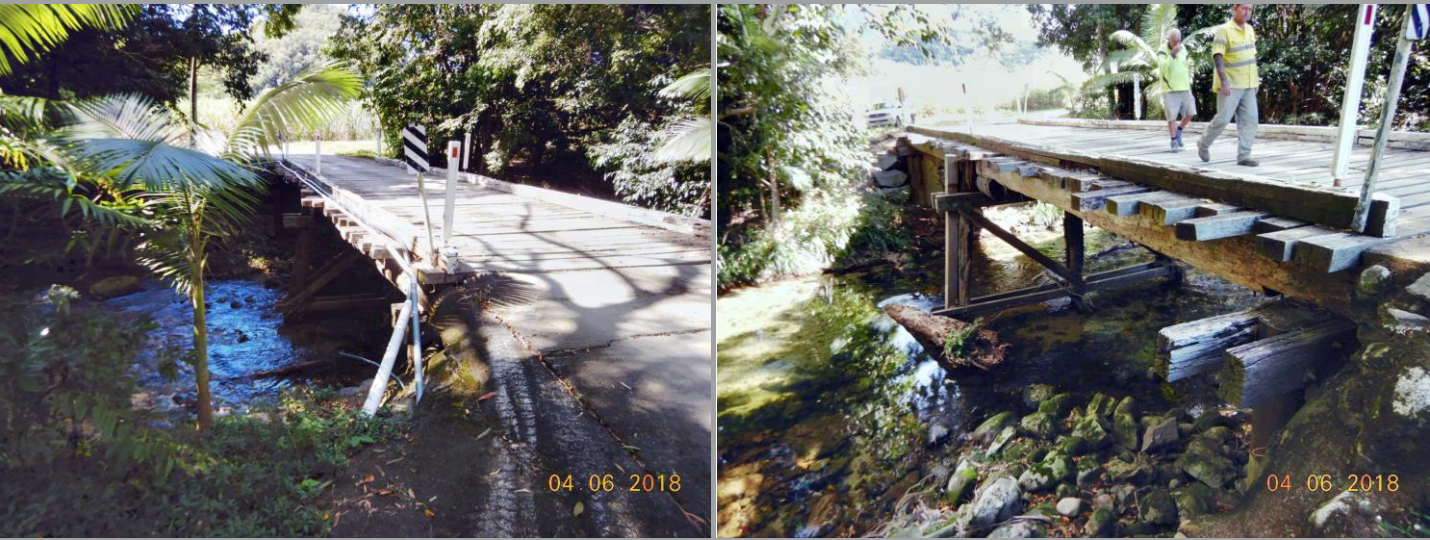
Bridge is in Overall Poor Condition. The Snipes/notching have been incorrectly applied in most girders and could be rectified through anti split treatments. Pile Two has been previously Spliced at mid height. Pile Three in Pier is completely rotted through and the load is expected to be currently only be supported through the bracing timber. The Wale in Face Two in the pier (at Pile 3) has split resulting in no support. Piles 1 and 2 in Abutment Two are in CS3 from dill testing but have been elevated to CS4 due to loss of section from surface rot from being in contact with the concrete abutment sheeting. The distributors have missing/insufficient fixings. A "Fender Pile" has been installed by Council on the RHS of Pier One - This is not considered to be significantly adding to the Structural Capacity of the structure.
