5.2. MINOR CHANGE APPLICATION TO MATERIAL CHANGE OF USE (MULTI-UNIT HOUSING) 14 MUDLO STREET

REPORT AUTHOR(S)	Daniel Lamond, Planning Officer
GENERAL MANAGER	Scott Hahne, Acting General Manager Operations
DEPARTMENT	Development Assessment and Coordination
PROPOSAL	Minor Change to Development Approval (Multi-unit housing)
APPLICANT	Luigi & Marianna Bonomi 27 Old Port Road PORT DOUGLAS QLD 4877
LOCATION OF SITE	14 Mudlo Street PORT DOUGLAS
PROPERTY	Lot 919 on PTD2092

Proposed is a minor change to condition 17 and 19 of development approval MCUC2385/2017 for a material change of use for multi-unit housing (3 units) at 14 Mudlo Street Port Douglas.

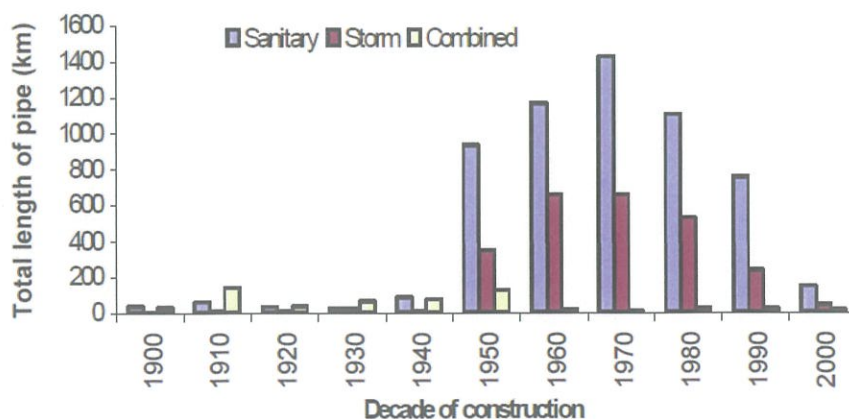
Figure 1. Typical age distribution of pipes in Australia

The quantity of installed sewer pipes has more or less followed the growth of the nation's population and the social demand to have a fully seweraged community. As such a relatively large proportion of the sewers were laid in the post war decades, meaning that the median age of the sewers is approximately 50 years.

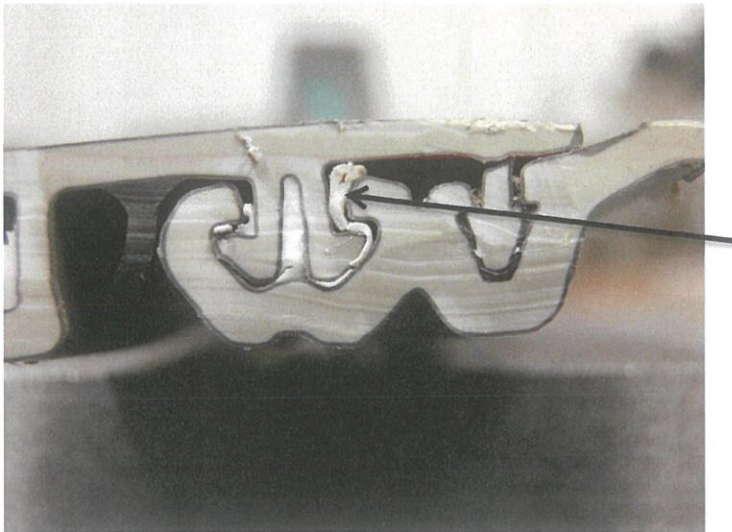
There were no junctions on the line in location 1. As such a pressure test was able to be performed (according to AS/NZS2032). The liner passed the test. There was no evidence of leakage via this test. For locations 2 and 3, the condition of the sealant in the spiral seam was analysed. In particular the quantity and properties of silicone were examined. As shown in the photograph below there is clear evidence that there has been no loss of sealant. Furthermore, the silicone removed from the lock has very similar properties (qualitatively) to new silicone. Furthermore, CCTV inspection showed no evidence of water or root ingress along the length of the liner.

Silicone sealant still present

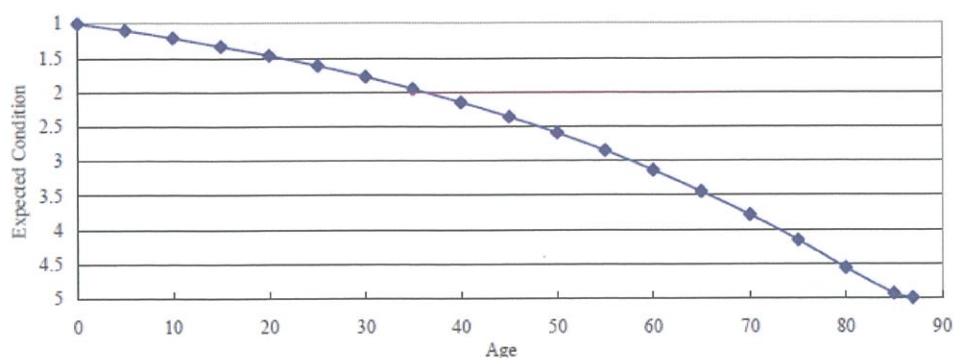
Figure 2: Model of Rate of 8" Concrete Pipe Deterioration (Park 2009)

This data alone tells us that there is no underlying deterioration of the product, unlike the host pipes. For example, if we were to select 25 year old concrete pipes we would be able to measure a reduction in the wall thickness due to erosion and/or gas attack. We know this would ultimately correlate to the data presented in the previous section concerning the service life of the pipe. Figure 2 published by Park (2009) shows a typical curve of concrete pipe deterioration. Clearly the deterioration process is continuous and is measurable quite early in the product's life.

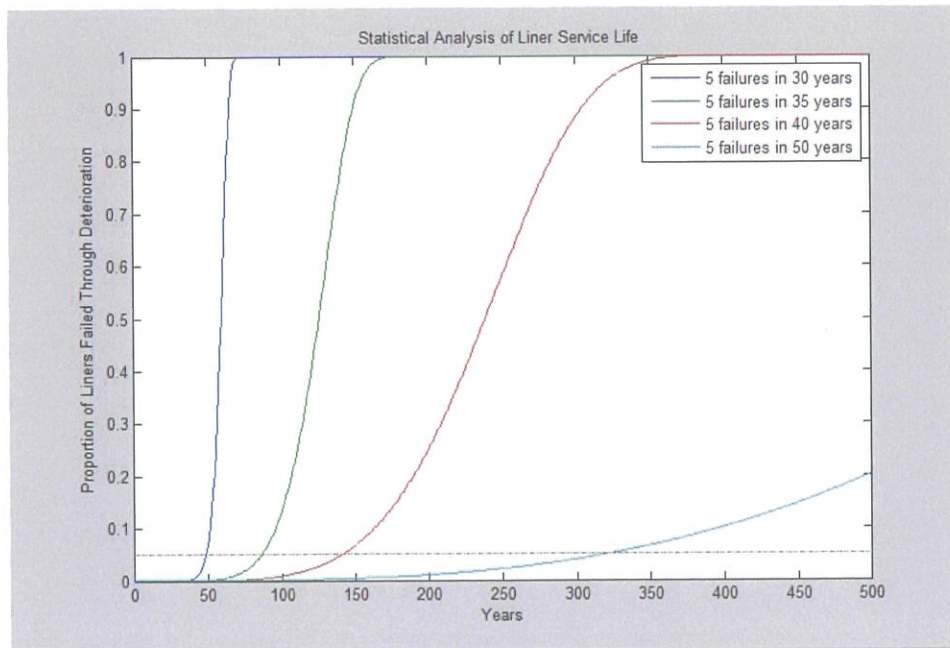
Figure 3: Graphical Representation of Life Curves Under Each Scenario

Using the Weibull Distribution Function model we can predict the maximum and actual service lives of the spiral liners. The results are shown in Table 1 and illustrated in Figure 3.

This approach allows us to see that as the number of years passes without any failures, the impact it has on the predicted service life increases rapidly. For example, if we have accumulated 5 failures by the time the liners have reached age 30 years the predicted actual service life would be 49 years. But if it takes 5 years longer to reach 5 failures the service life estimate increases to 86 years.

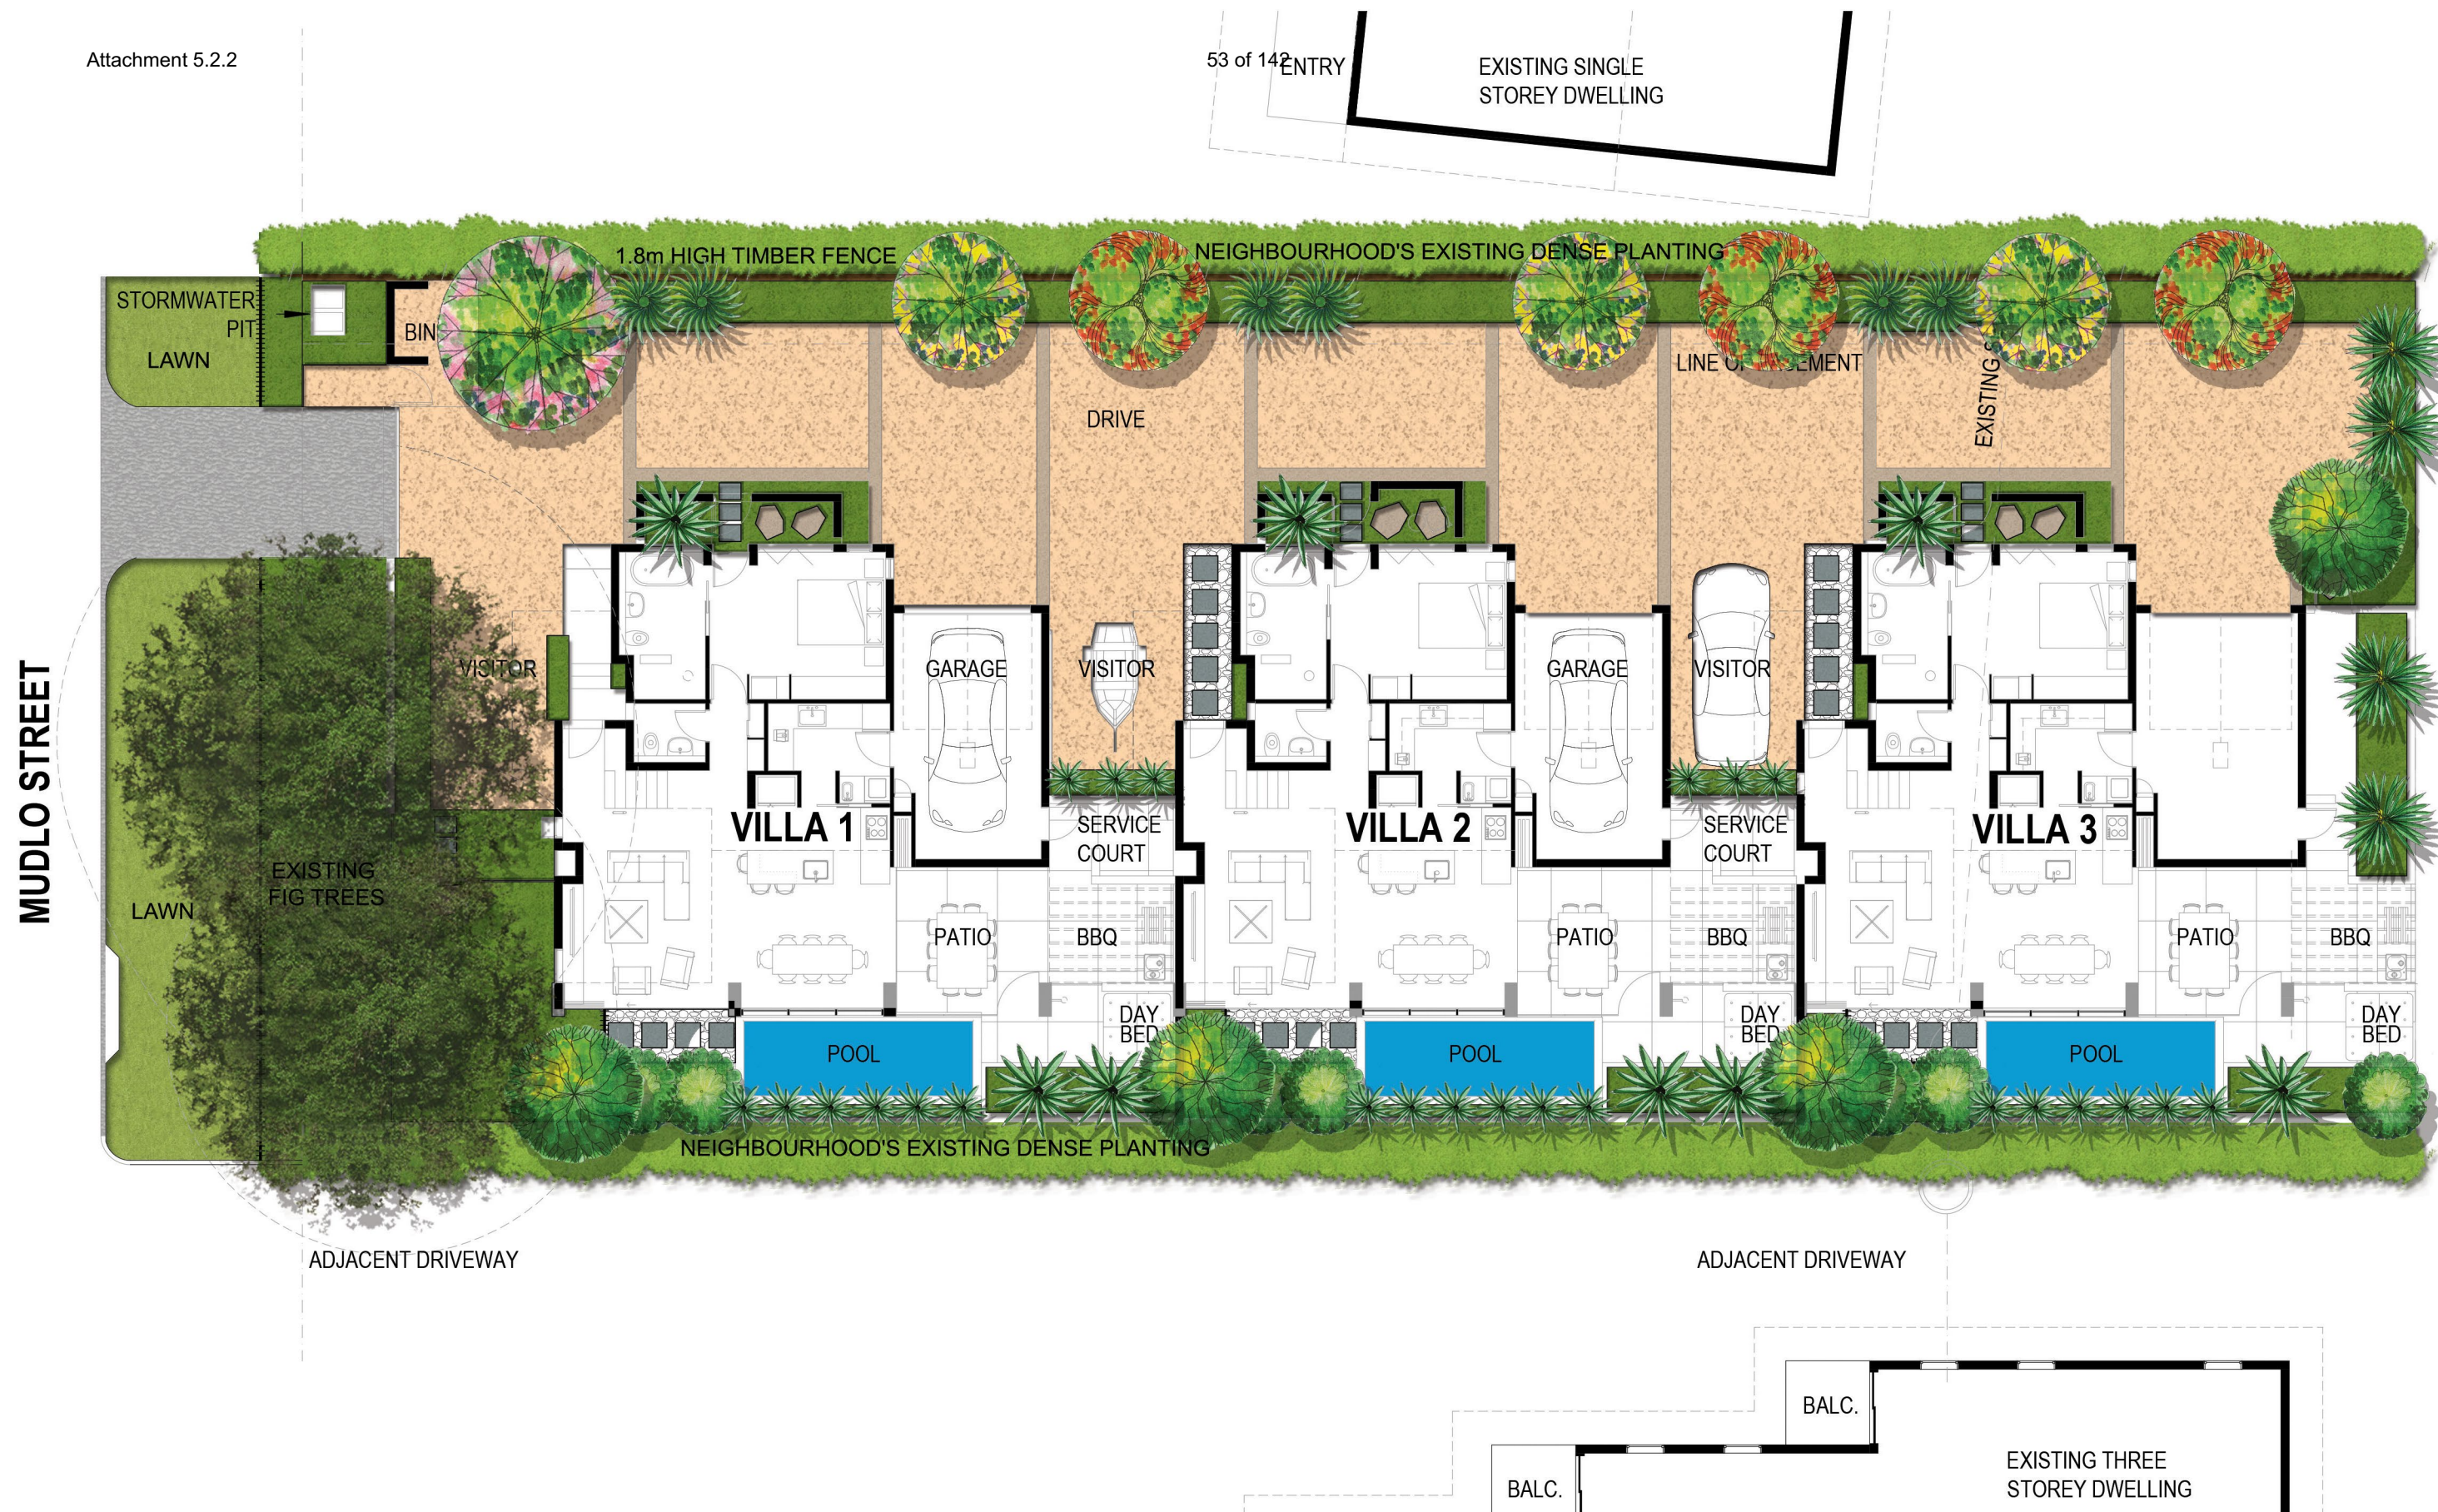
LANDSCAPE MASTER PLAN

FIG TREE VILLAS, 14 MUDLO STREET, PORT DOUGLAS

- 16. The site must be landscaped in accordance with the details included on the landscape plans prepared by Andrew Prowse Landscape Architect, Drawing No. LA-M.01, No. LA-P.01 and No. LA-S01. In the event the fig tree at the frontage of the site is required to be removed, a plan detailing the replacement landscaping must demonstrating deep planting of the setback area to the satisfaction of the Chief Executive Officer, prior to commencement of use or Survey Plan endorsement, whichever occurs first.**
