RE: Pool Resort, 19-37 St Crispins Avenue, Port Douglas

**LANDSCAPE REVIEW
FOR PROPOSED WESTERN SCREEN PLANTING, FOR
POOL RESORT.
19-37 St.Crispins Ave, Port Douglas.
12th June 2015.**

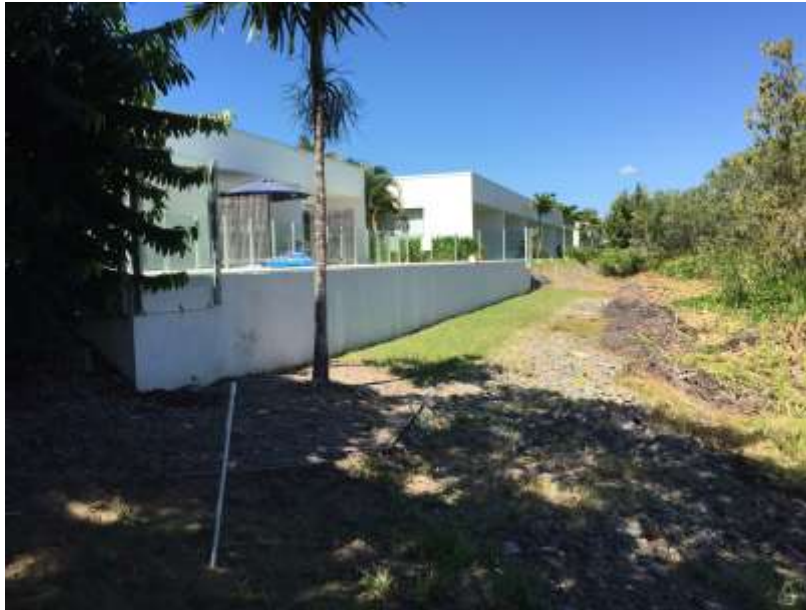
Figure 1 Apartments 1 to 4 with swimming pool to the west boundary.

On average the buildings (patios & pools) on the western boundary are located between two to three and a half meters off the boundary, and all front an existing open drainage line that is approximately six meters wide. This drainage area is irregularly maintained and has very marginal fall, only actually flowing in the Wet Season. (It may be better to developed it into a permanent wetland with a maintained fish population)

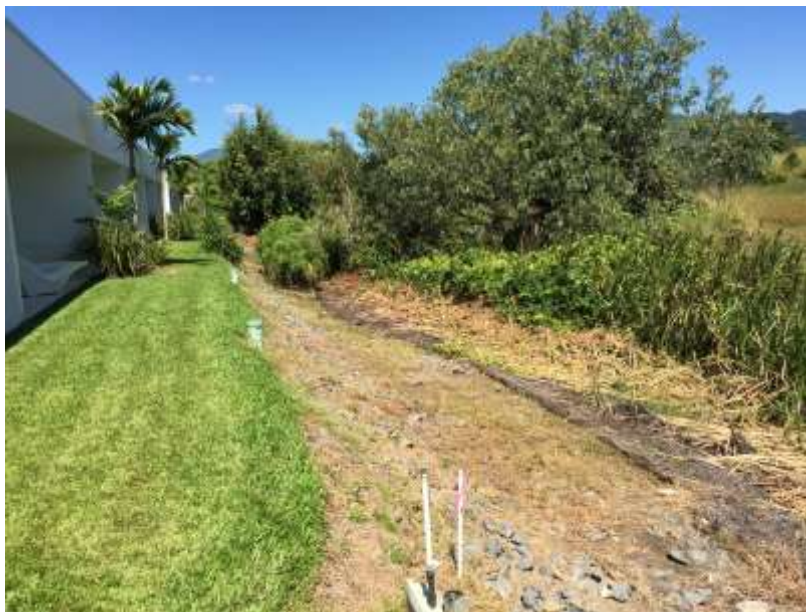
Figure 2 Apartments 5 to 10 showing the boundary peg at the bottom of photo with pink ribbon. Note the existing lawn, the slope with rock and drainage line on adjoining property. There is some additional vegetation such as wattle and melaleuca present

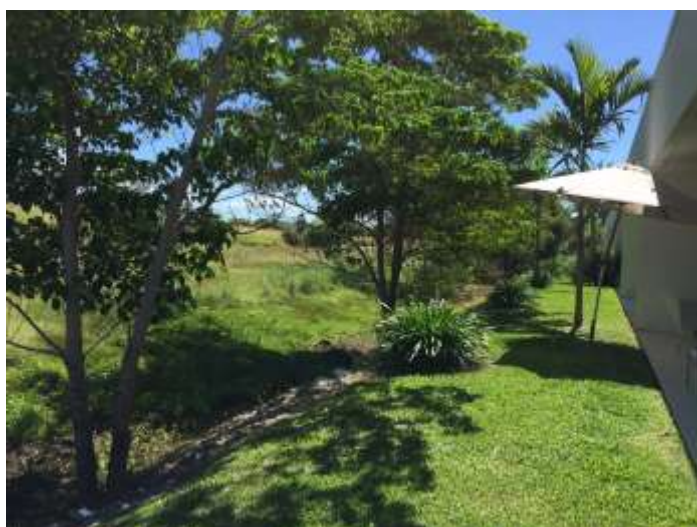
Figure 3 Apartments 16 looking back to apartment 11. Showing existing Bleeding heart trees on the neighbouring property and clumps of Spider Lily to the boundary.

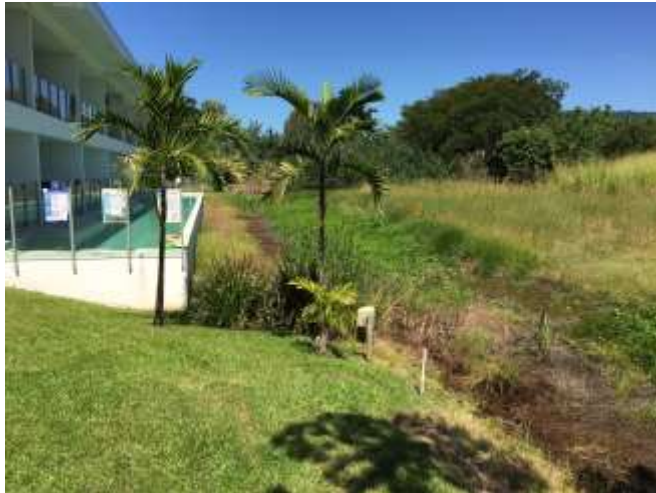
Figure 4 Apartments 17 to 27 on the south western edge of site. Note boundary peg in foreground and the permanently wet planting zone to the front of the pool.

The planting zones in front of the pools are at the soil water Table Level for a majority of the year and maybe inundated for extended periods during the Wet Season. For this reason there has been a species change to allow for the best chance of plant establishment. The selection of the understory planting in the southern “Bog” garden consist of native reeds that either exist naturally (*Typha domingensis*) or will cope in low oxygen soils (*Lepironia articulate*) but provide adequate screening height to the side of the pool. It is recommended that these plants be cut down annually in the Dry Season to prevent the area from “chocking” with debris in the Wet Season.
