RE: RESPONSE TO INFORMATION REQUEST – DEVELOPMENT APPLICATION FOR A MATERIAL CHANGE OF USE (DWELLING HOUSE, ANCILLARY SHED AND HOME BASED BUSINESS) OVER LAND AT 129 RYKERS ROAD, CAPE TRIBULATION, MORE FORMALLY DESCRIBED AS LOT 2 ON RP732553

CLIENT: K. Kasem ADDRESS: 129 Rykers Road Cape Tribulation QLD 4873

Potential Landslide Hazard Engineers Statement

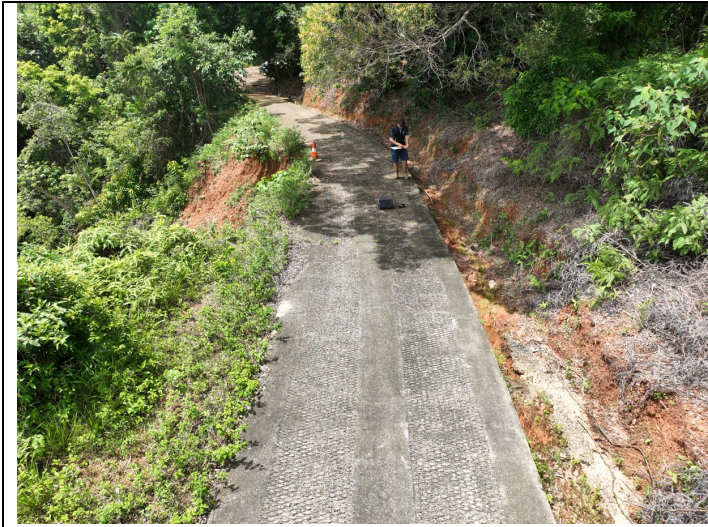
Photo 1:
20 metre section of driveway (715 metre long driveway) impacted by Cyclone Jasper exceeding 1 in 100 year water volumes, producing landslip which provides an opportunity to improve the driveway drainage.

The bungalows (under construction) are situated on a mountain ridge. A small 20 metre section of the approximate 715 metres access driveway has had a landslip to the downward side caused by severe tropical Cyclone Jasper in 2023. The cyclone crossed the coast 30km north at Wujal Wujal as a category 2 system then stalled as a tropical low-pressure system over the Cape York Peninsula for the next several days (Bureau of Meteorology, 2026). A major flood peak of 14.85 m was recorded at the Daintree Village on 18 December

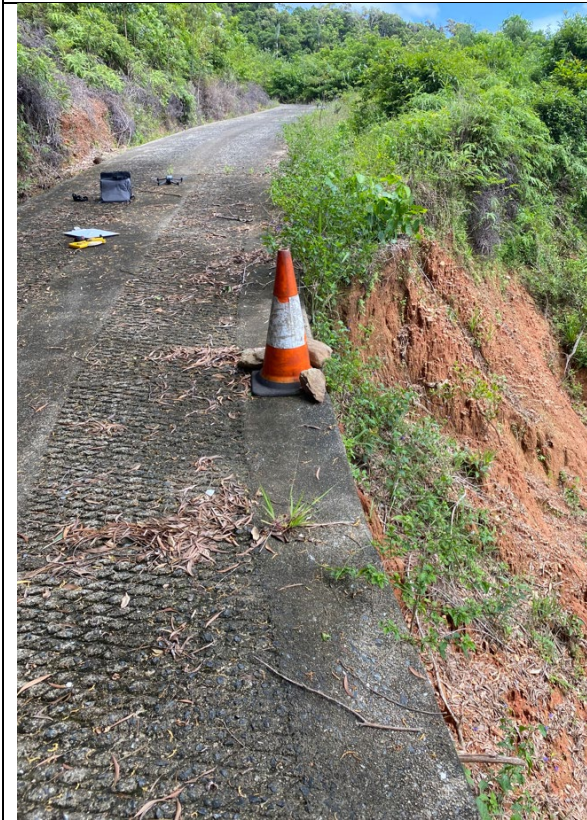
Photo 2: Close up view of photo 1.

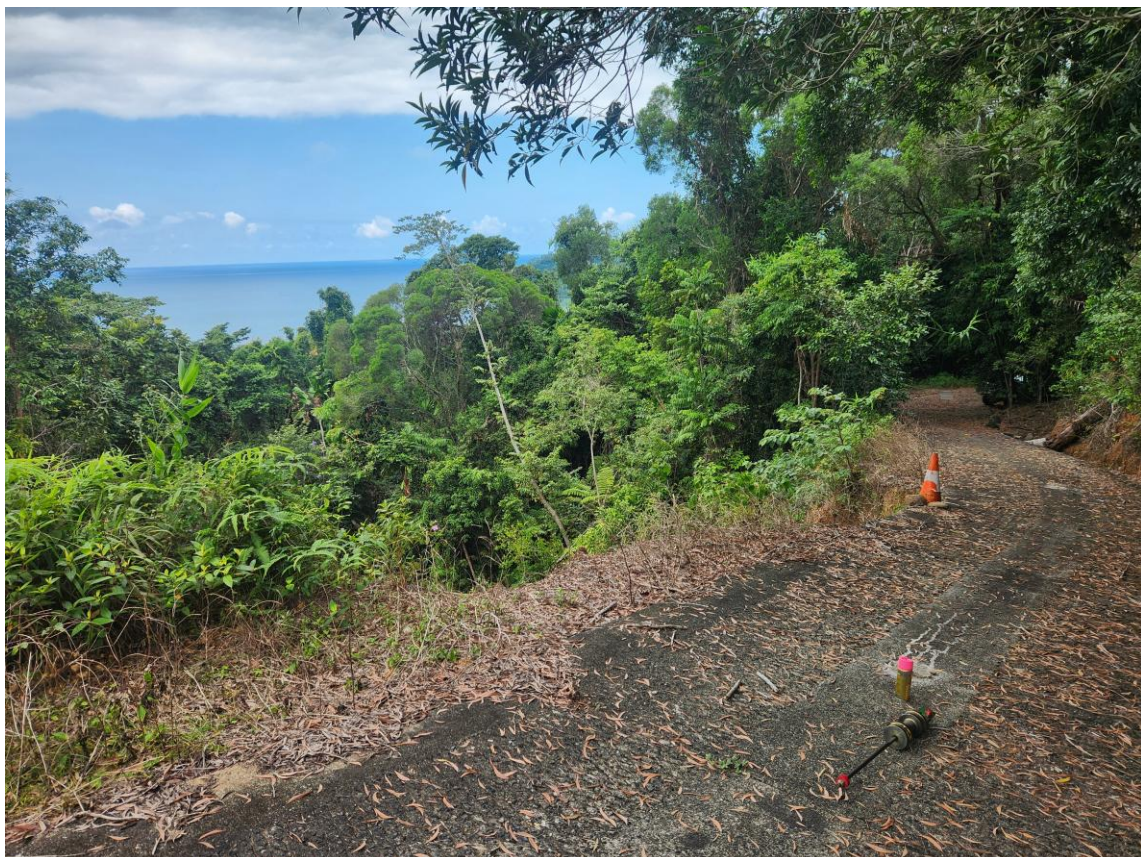
Site Testing at 129 Rykers Road, Cape Tribulation.

Twelve Dynamic Cone Penetrometer tests were performed at locations DCP1 through to DCP12 as shown on the site plan.

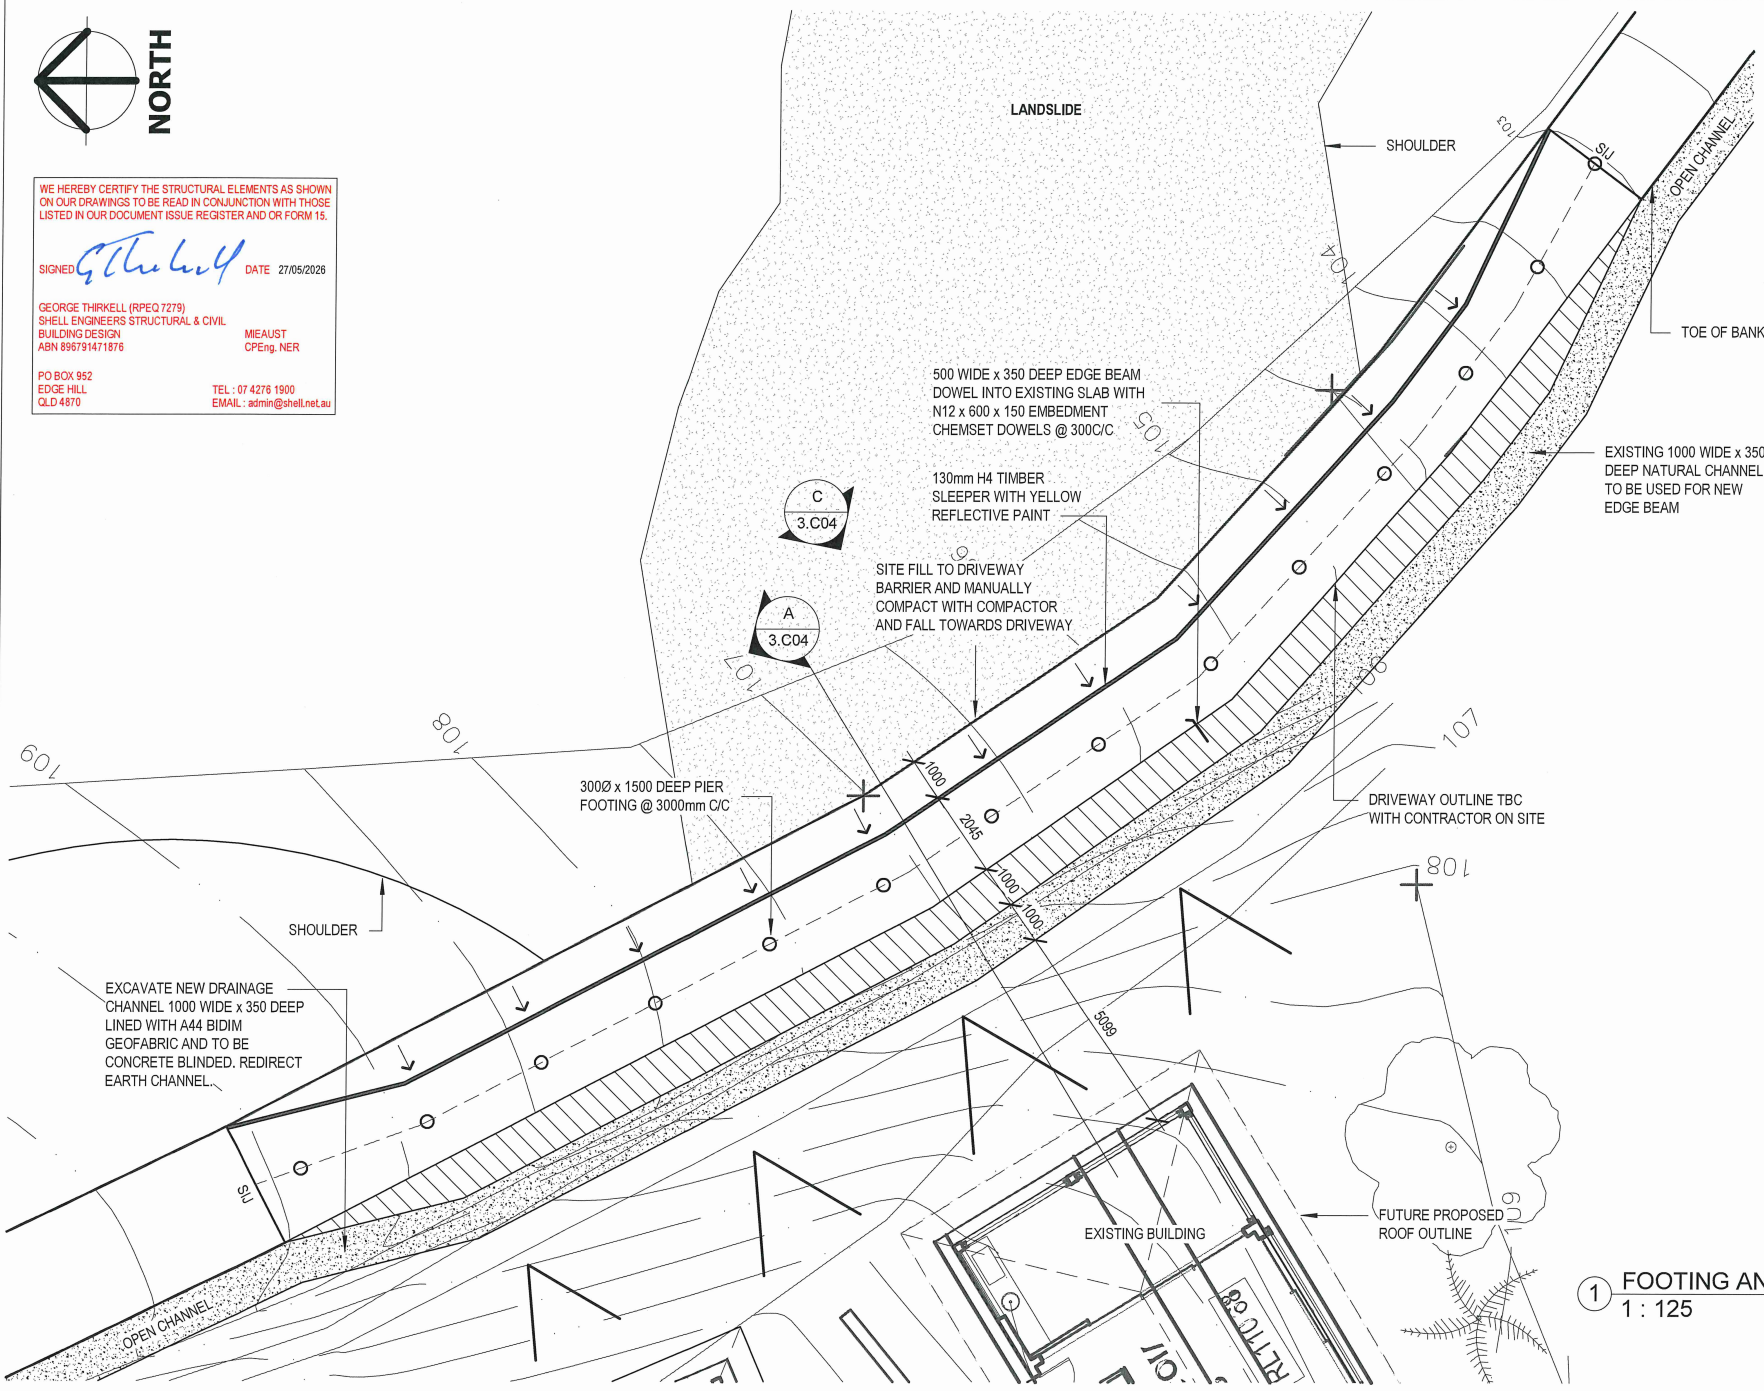
PROJECT
DRIVEWAY RECTIFICATION AT 129 RYKERS ROAD CAPE TRIBULATION QLD 4873
DRAWING TITLE
FOOTING AND SLAB PLAN

FOOTING NOTES

- REFER N-SERIES DRAWING NOTES FOR FULL SPECIFICATIONS & SOIL REPORT REFERENCE.
- CONCRETE SHALL BE N32 TO SPECIFICATIONS.
- INSPECTION OF EXCAVATION REQUIRED. ENGINEER TO CONFIRM DESIGN
- MINIMUM CLEAR COVER TO REINFORCEMENT:
