# REPORT Geotechnical Studies Port Douglas Wave Park

**Graben Pty Ltd** 19 Macrossen Street Port Douglas Qld 4877

Submitted by: Golder Associates Pty Ltd 216 Draper Street, Cairns 4870

20446551-001-R-Rev0

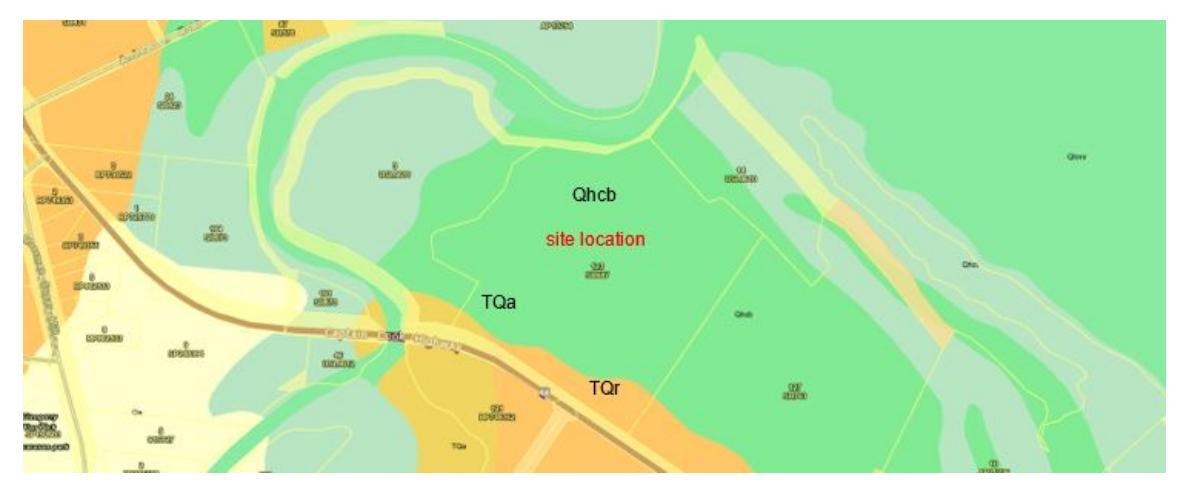
An excerpt of the regional geology map published electronically by the Queensland Department of Natural Resources and Mines (DNRM) is presented in Plate 1. The map indicates that the site is underlain by the following geological units:

- Qhcb Quaternary (Holocene) age deposits comprising sand ridges in the lower lying areas of the site;
- TQa Quaternary/Tertiary age high-level alluvial deposits comprising sand, silt, clay and minor gravel in the area along the Captain Cook Highway nearer the Mowbray River; and
- TQr Quaternary/Tertiary age colluvial and residual soil deposits (generally on older land surfaces) comprising clay, silt, sand, and gravel in the area along the Captain Cook Highway further away from the Mowbray River.

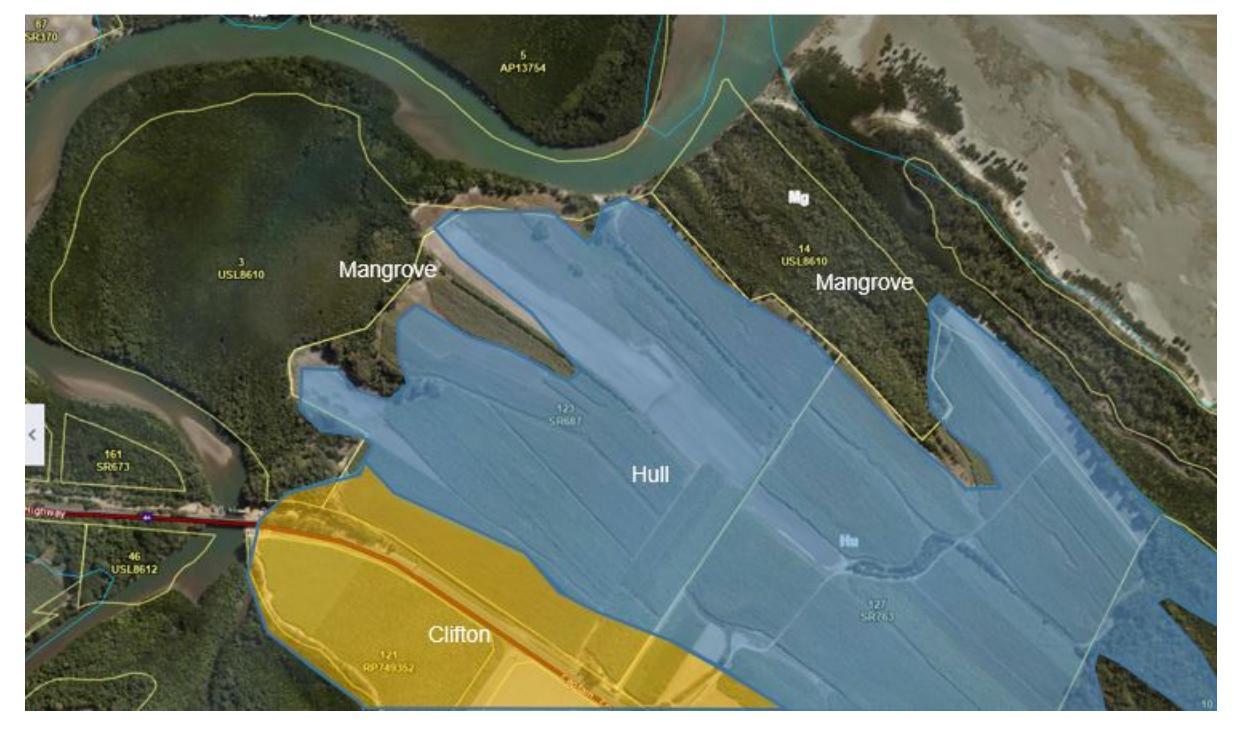
Plate 2 Soils Map

An excerpt from the soils map (1:50,000 scale on Queensland Globe) is shown on Plate 2. The map indicates the presence of Hull series soils over most of the site. Clifton series soils are present in the area along the Captain Cook Highway and Mangroves series soils are present in parts of the site near the north western and north eastern site boundaries.

Hull series soils are formed on sand ridges and are generally associated with acid sulfate soils below the water table. Mangrove soils are undifferentiated soils subject to tidal inundation and may be associated with acid sulfate soils. Clifton series soils are not typically associated with acid sulfate soils.

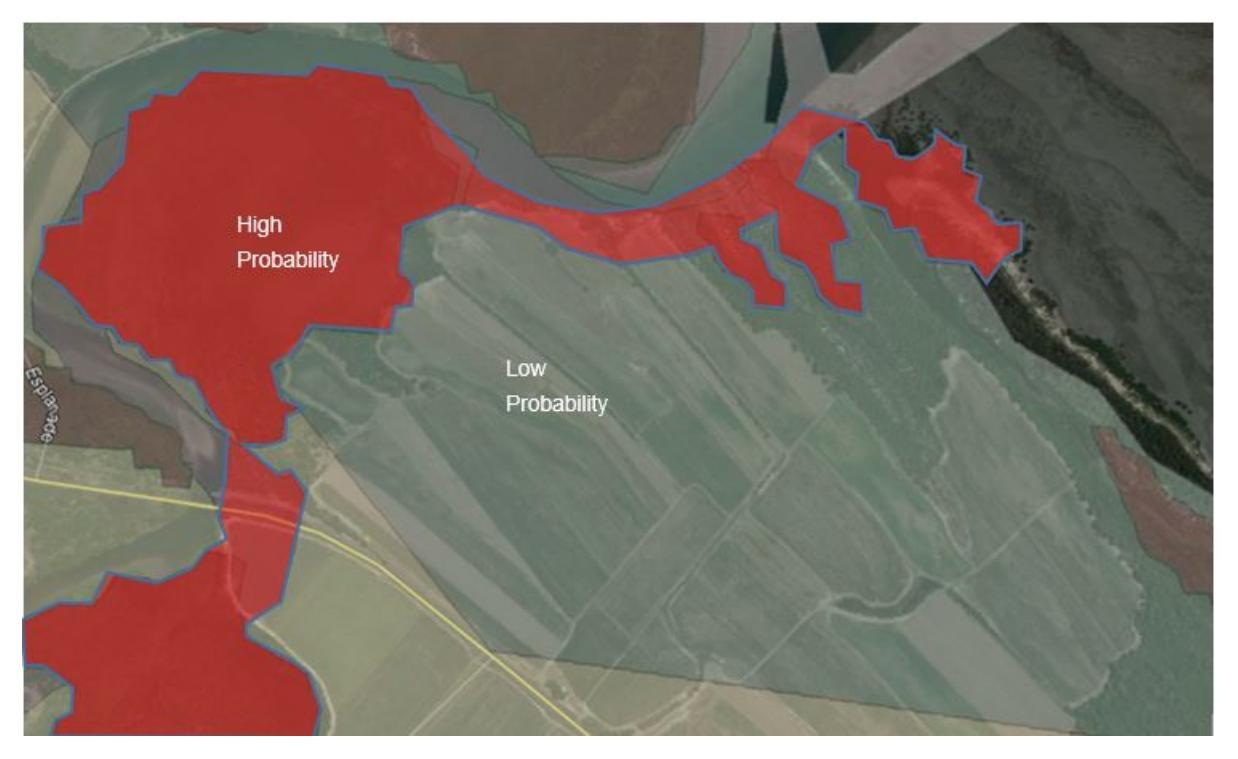
### Plate 3 ASS Risk Map

An excerpt from the ASRIS ASS risk map is shown on Plate 3. The map indicates a low probability of occurrence across most of the site. The map also indicates a high probability of ASS occurrence near parts of the north western and north eastern site boundaries.

ASS risk mapping generally indicated a low potential for ASS in the near surface soils across most of the site, however there is a high probability of encountering ASS in mangrove areas surrounding the site. The preliminary ASS investigation detected PASS in soil samples analysed below 0 m AHD at two locations. These locations are considered to be associated with surrounding mangroves and/or former drainage features and may not be representative of conditions under all site areas. Deposits of ASS may be present in deeper layers of soils below the investigated depth.

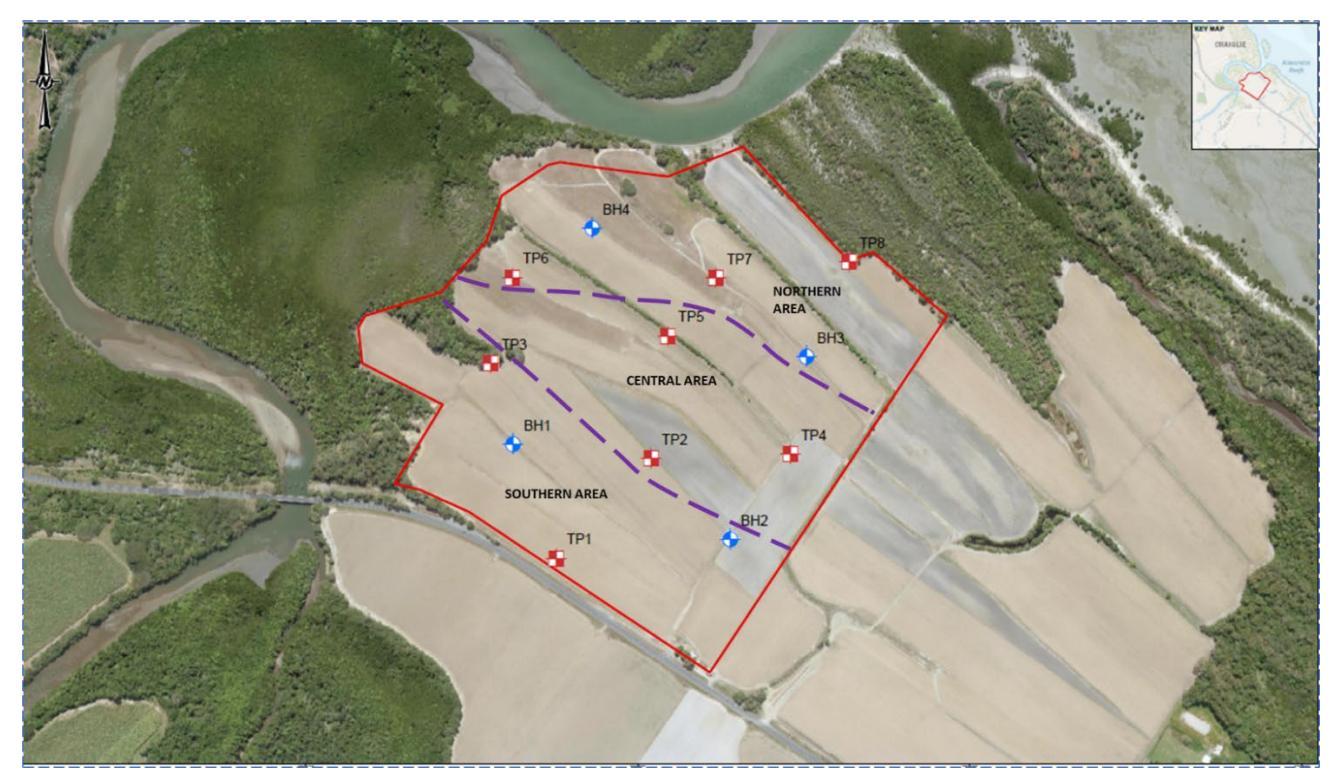
Plate 4: Site areas

For discussion purposes the site has been divided into three main areas (northern, central, southern) based on subsurface conditions encountered during the investigation. These areas are shown in Plate 4.

As outlined in Section1.0, the aims of the studies were to provide a broadscale assessment of near-surface ground and groundwater conditions across the site. On this basis the site has been divided into three main areas (northern, central, southern) based on subsurface conditions encountered during the investigation. The inferred extent of each area is shown in plan on Plate 4 in Section 4.2 and in cross section on Figure 2. Ground conditions encountered in each area are summarised as follows:

- Southern Area Predominantly stiff to hard clays to depths greater than about 4 m;
- Central Area Variable thickness of loose to dense sands to depths ranging to about 4 m, overlying stiff to hard clays; and
- Northern Area Predominantly loose to dense sands to depths greater than about 4 m.

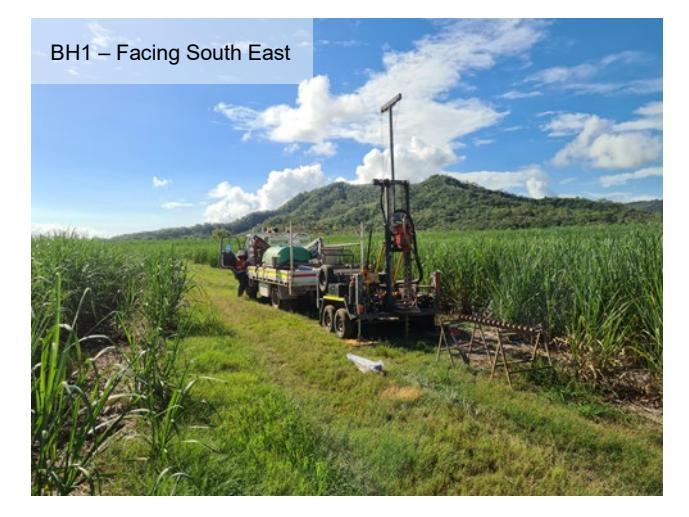
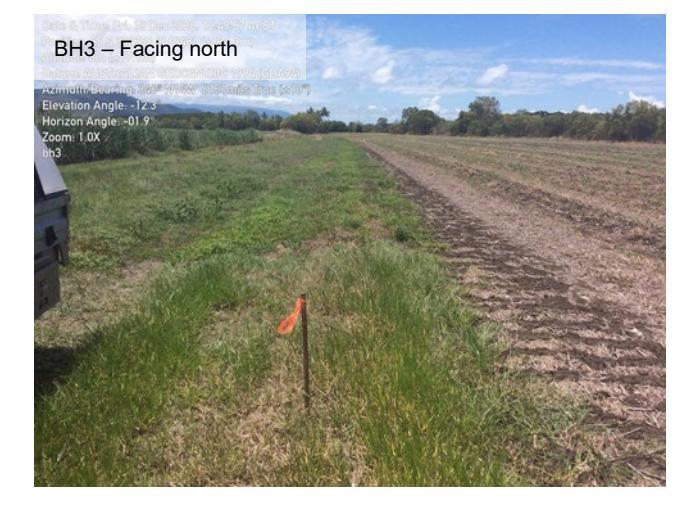
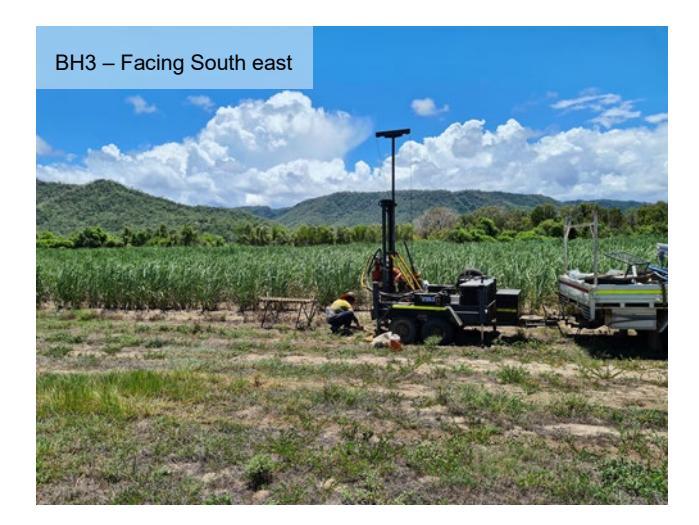
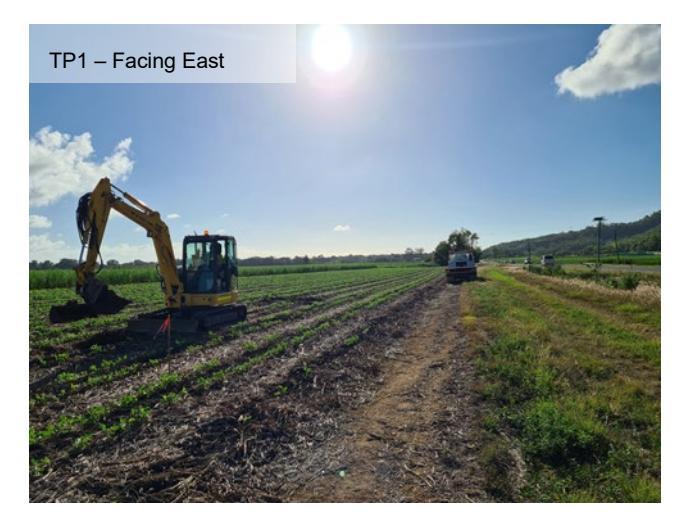
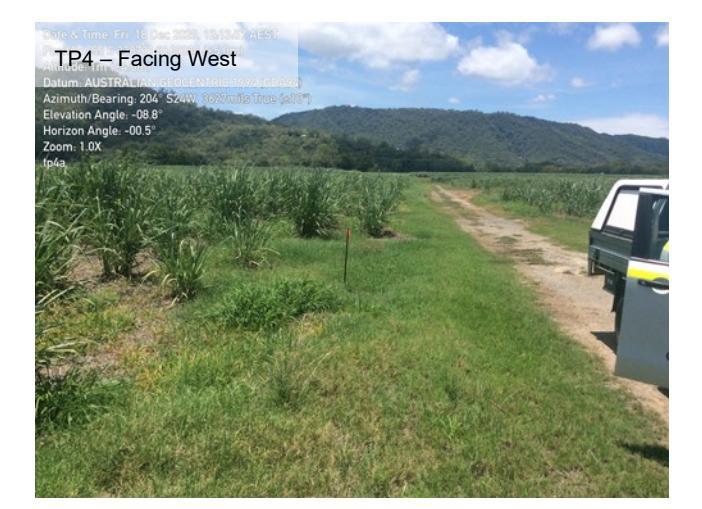
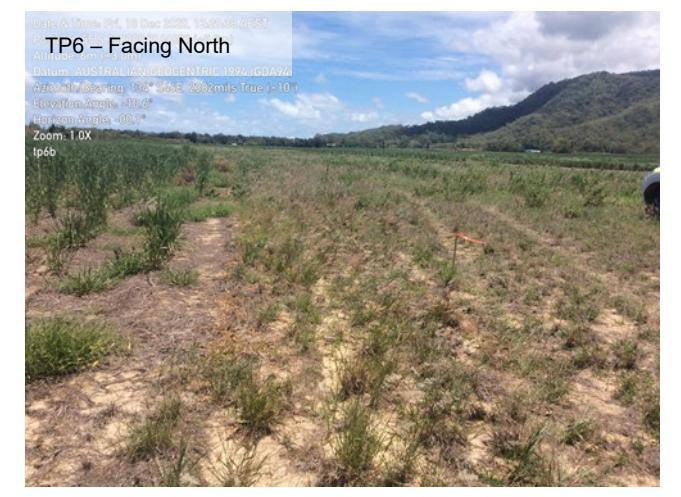
Plate 5: Selected photographs at time of investigation

At the time of the site investigation, most of the site was covered with sugar cane. The site gently grades north east towards the Mowbray River and the coast with surface elevations ranging from about RL ~6 m AHD (where the site adjoins the Captain Cook Highway) to RL ~1 m AHD (within creeks/ drains that cross the site typically in a north-west direction towards the Mowbray River). The site is bounded by vegetated land and the Mowbray River to the north east and north west; adjacent cane farms to the south east; and the Captain Cook Highway and cane farms to the south west.

Selected site photographs at the time of the site investigation are presented in Plate 5.

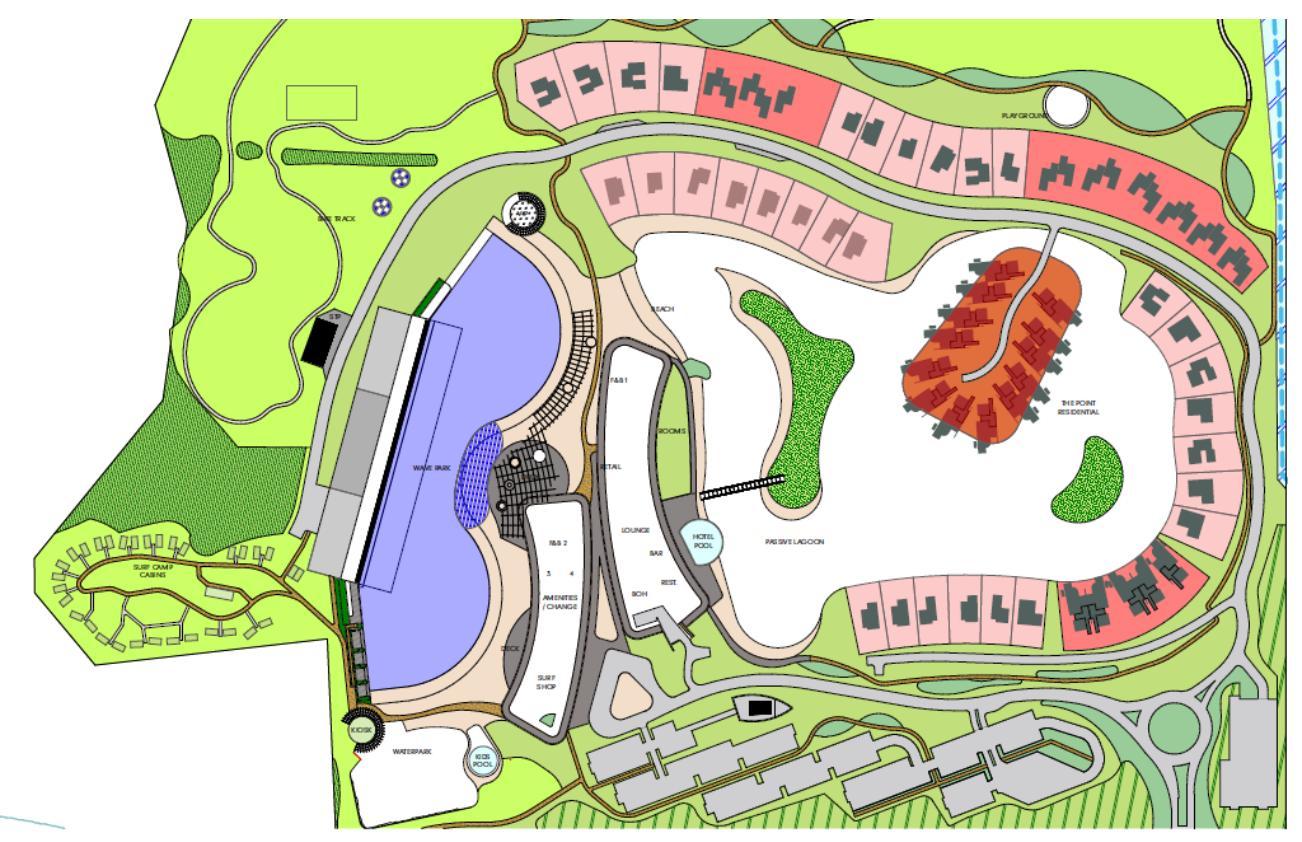
Plate 6: Schematic layout of proposed development

A copy of the schematic layout of the proposed development from a drawing provided by Hunt Design is presented in Plate 6.

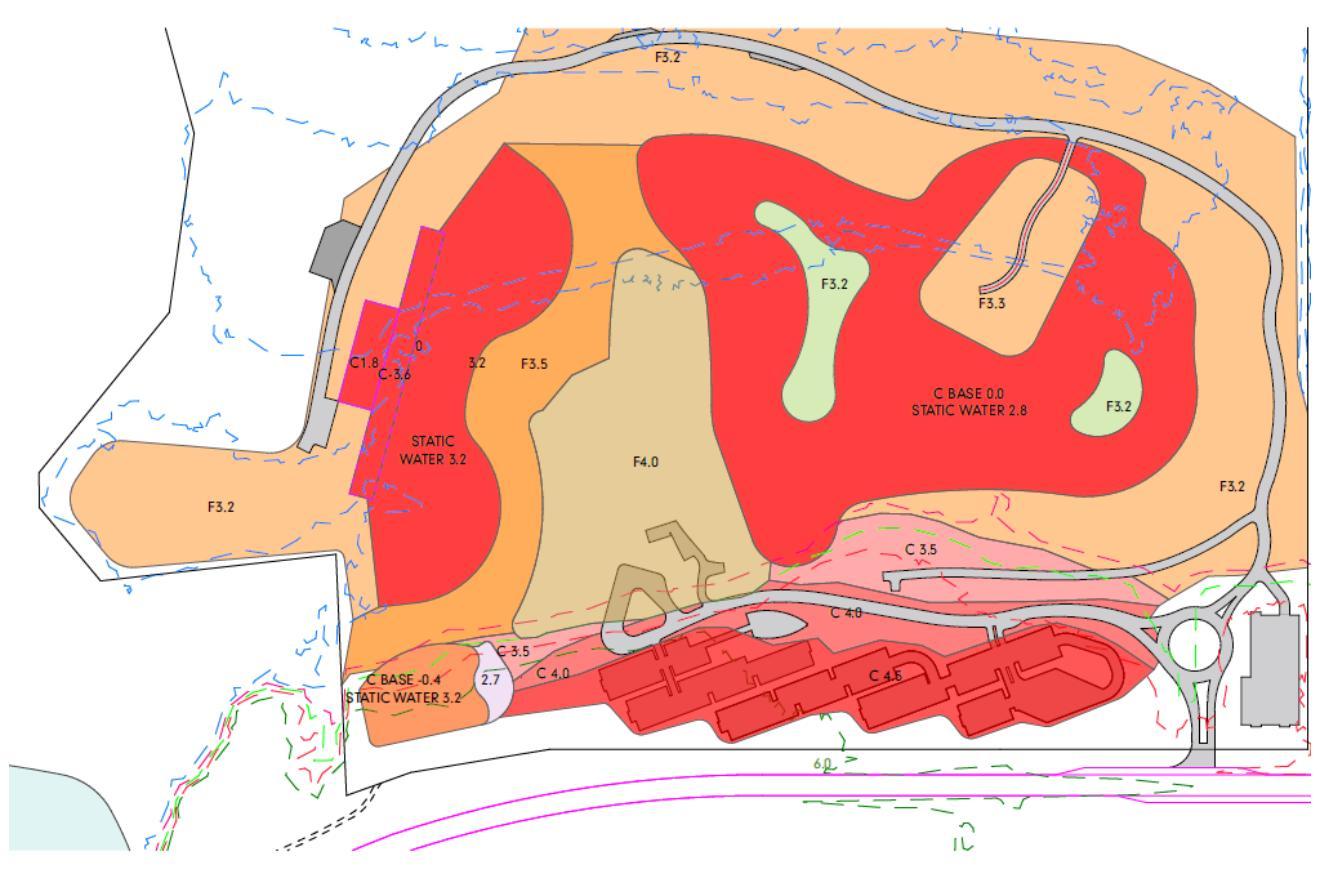
### Plate 7: Schematic layout of proposed cut and fill earthworks

A copy of the schematic layout of the proposed cut and fill earthworks from a drawing provided by Hunt Design is presented in Plate 7.

As outlined above fill materials won from excavations are expected comprise mainly clays in the Southern Area, variable amounts of clays and sands in the Central Area (with the amount of sand increasing towards the Northern Area), and mainly sands in the Northern Area. All of these materials are considered to be suitable for use as controlled (or engineered) fill, subject to appropriate moisture conditioning for compaction.

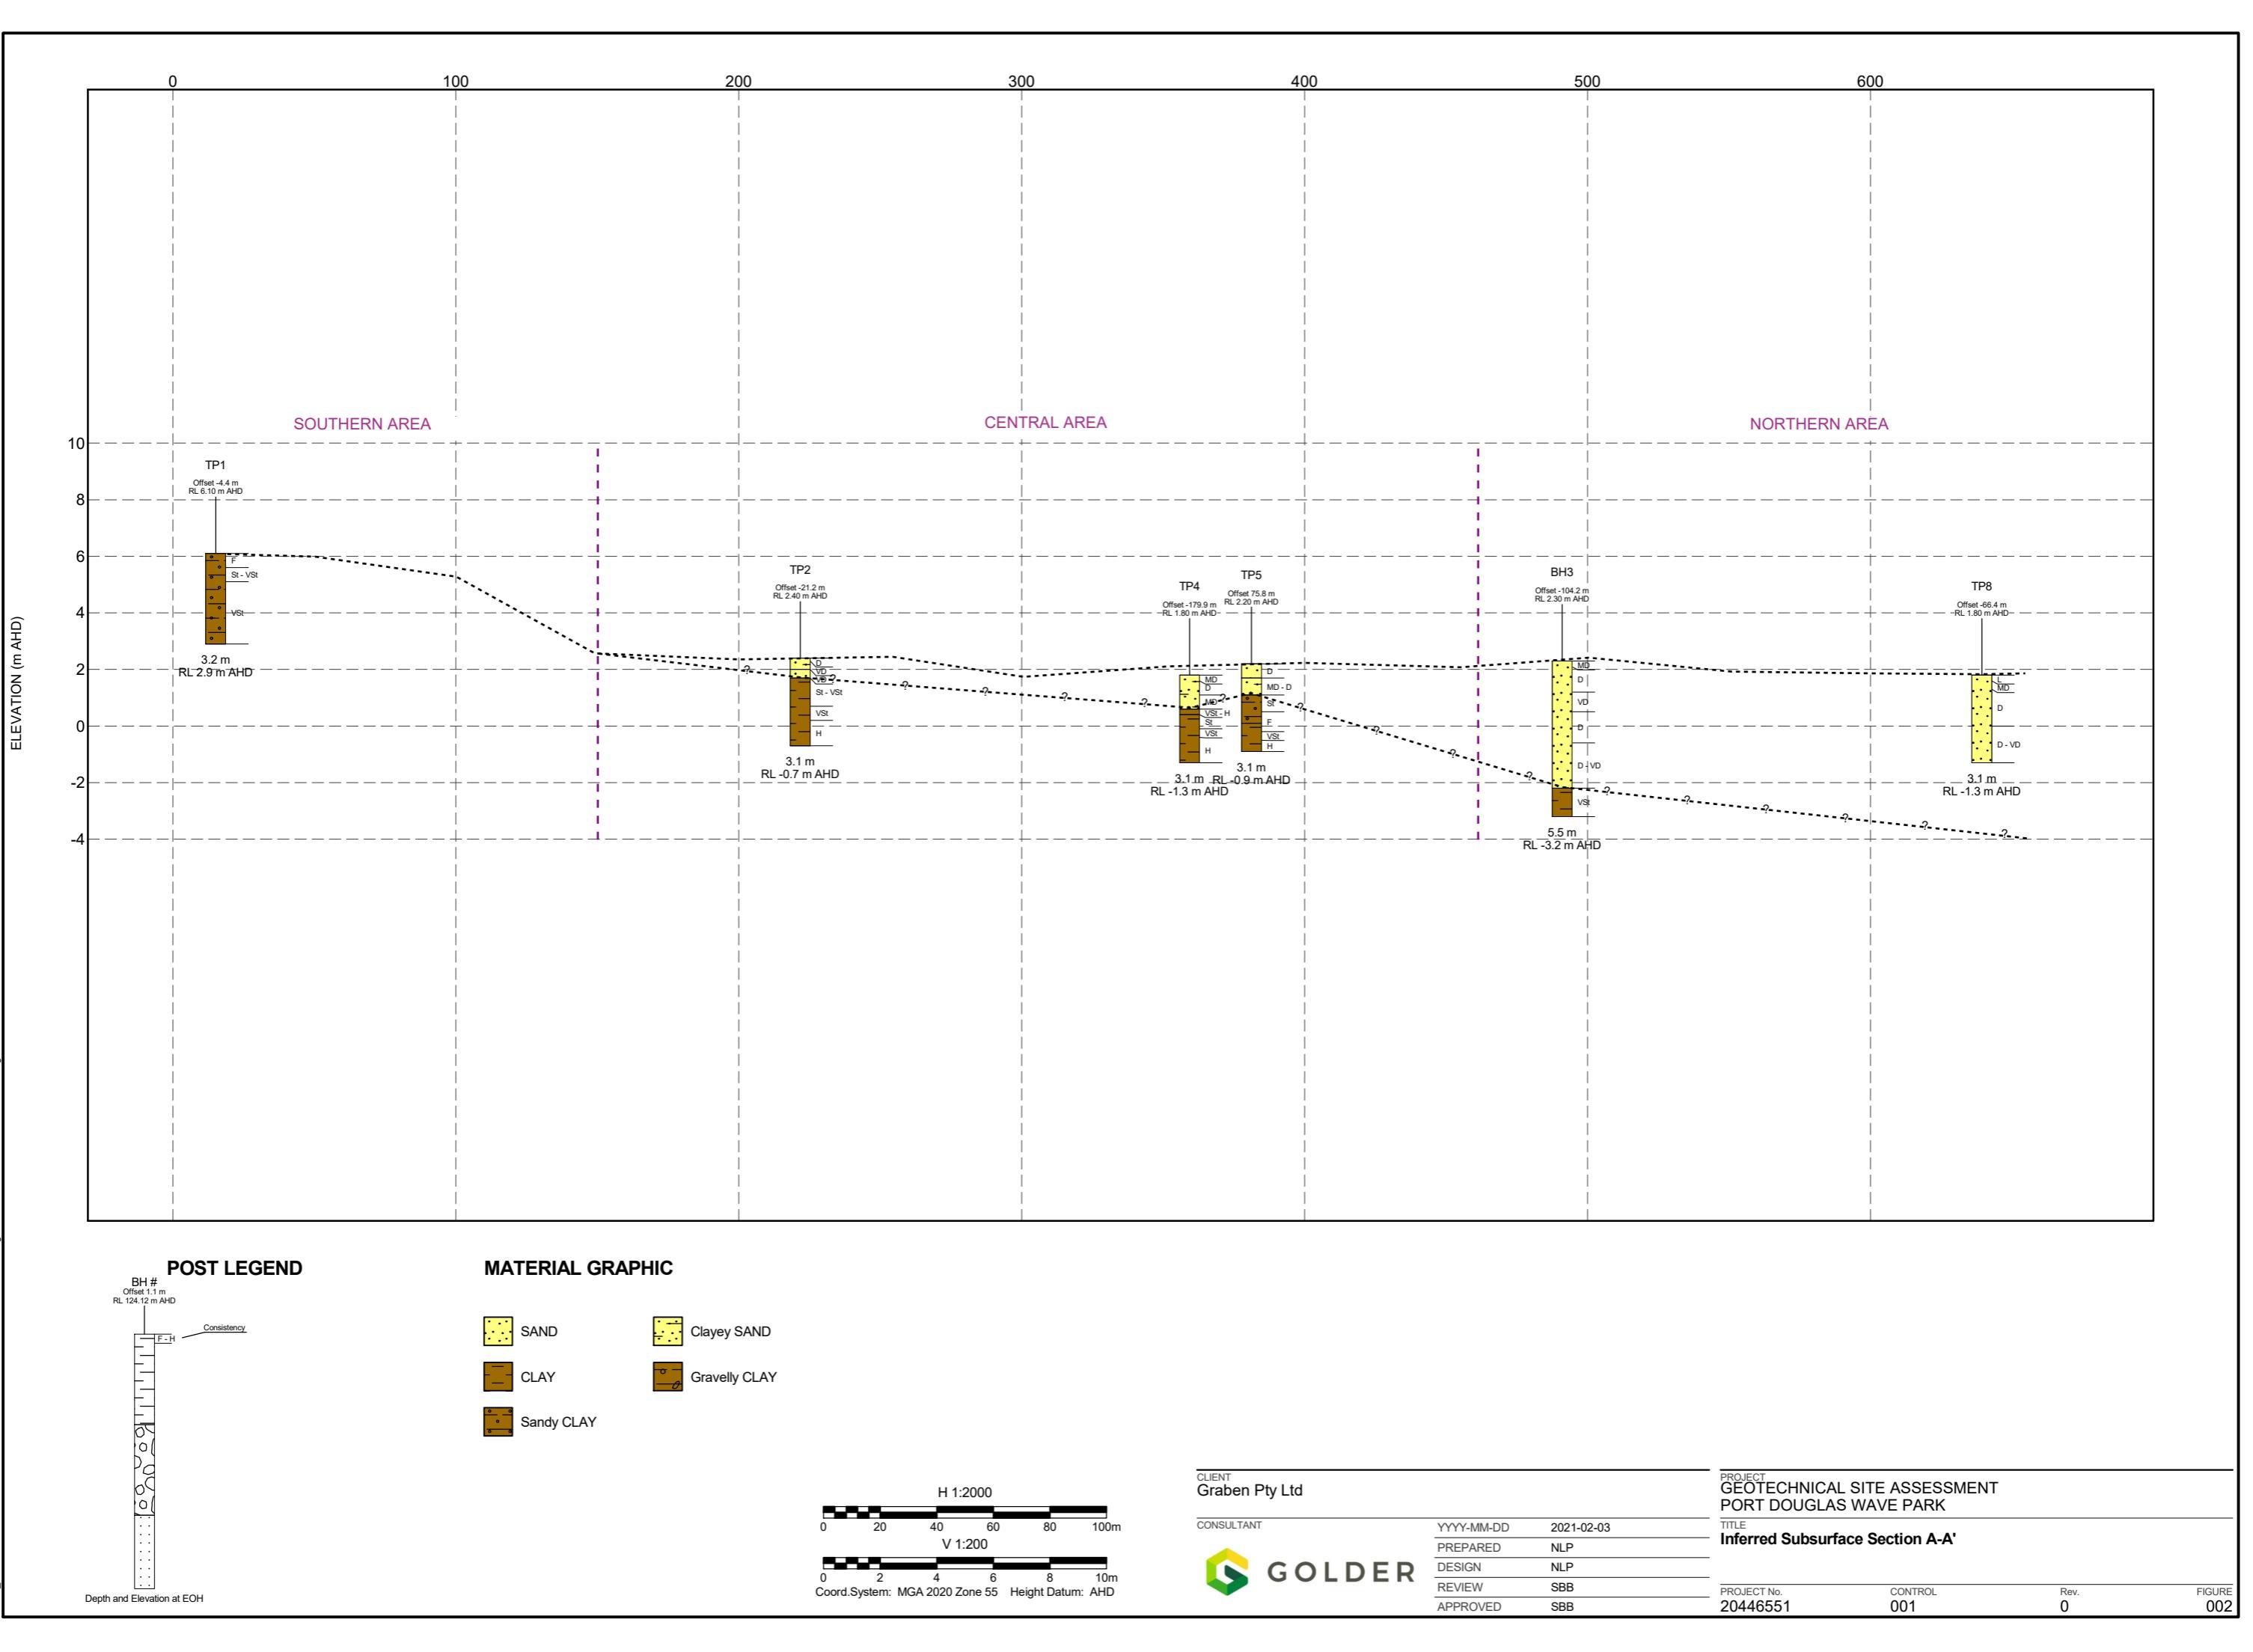
Figure 002 – Inferred Subsurface Section

Figure 002 presents a typical section through the site with inferred subsurface conditions.
