RE: RESPONSE TO INFORMATION REQUEST A MATERIAL CHANGE OF USE (DWELLING HOUSE) 34 MURPHY STREET, PORT DOUGLAS, MORE FORMALLY DESCRIBED AS LOT 126 ON SP144708

Amended Proposal Plan

Geotechnical Assessment

Proposed New Residence 34 Murphy Street Port Douglas QLD 4877

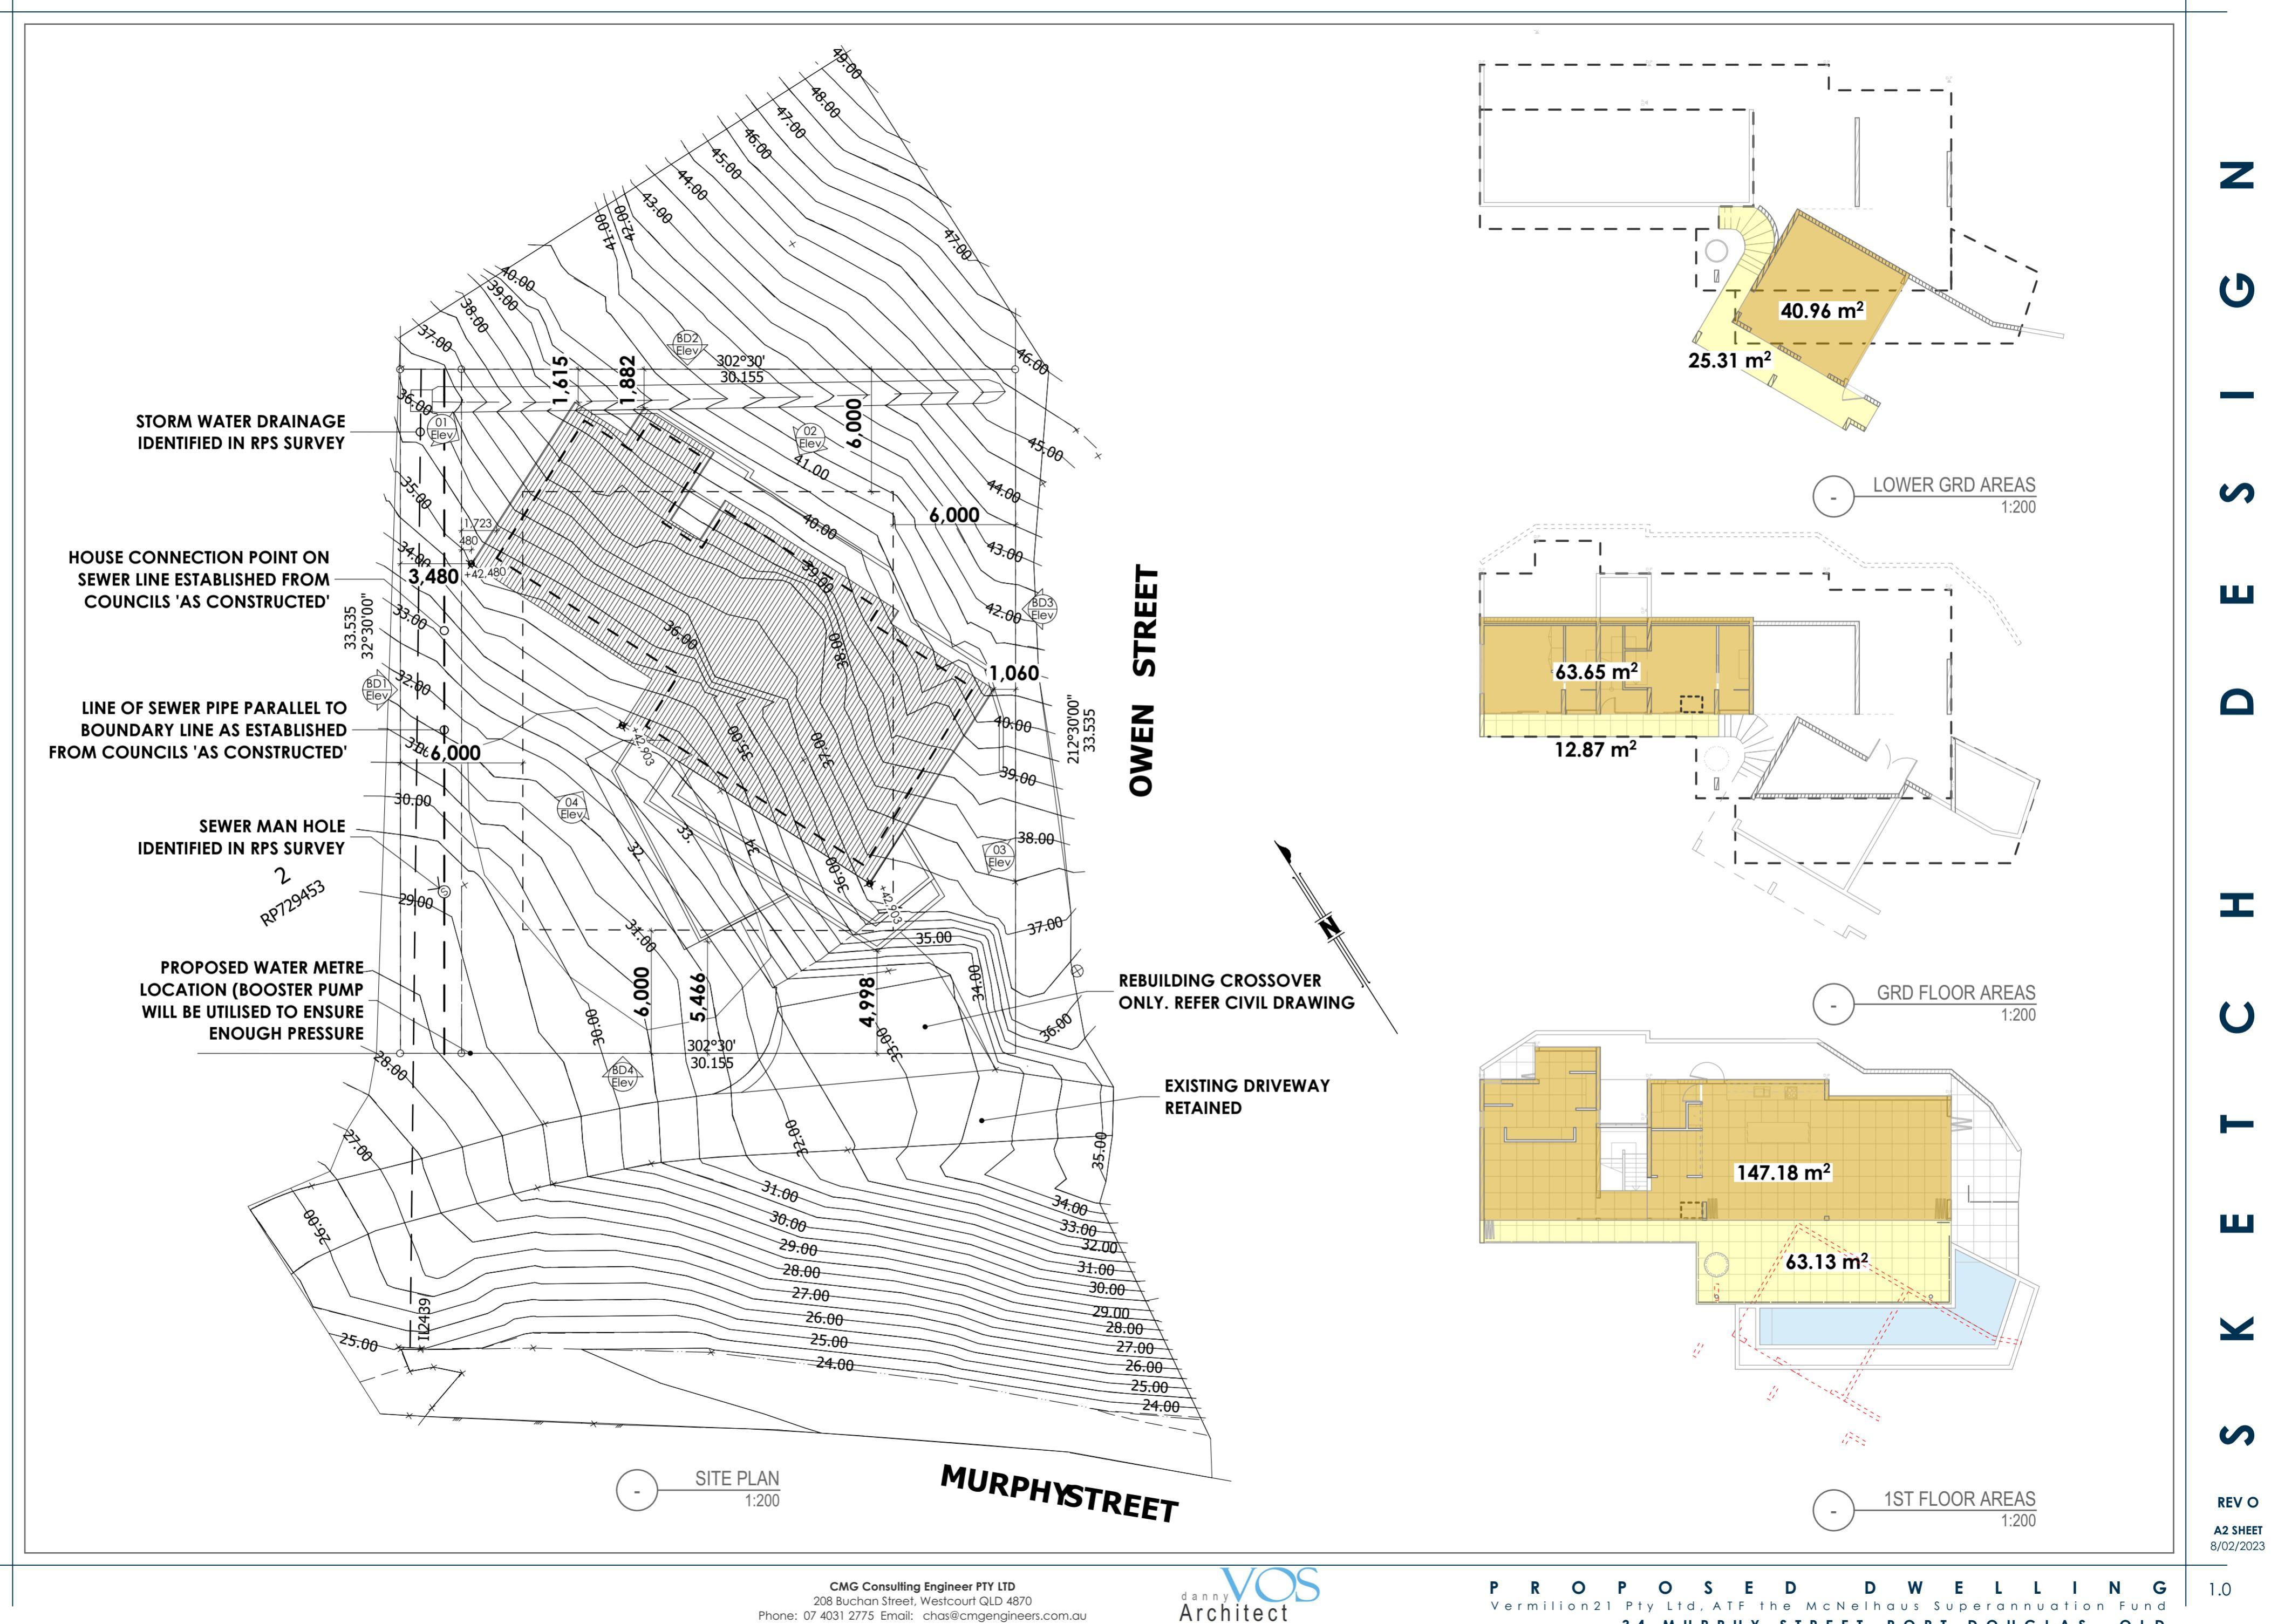
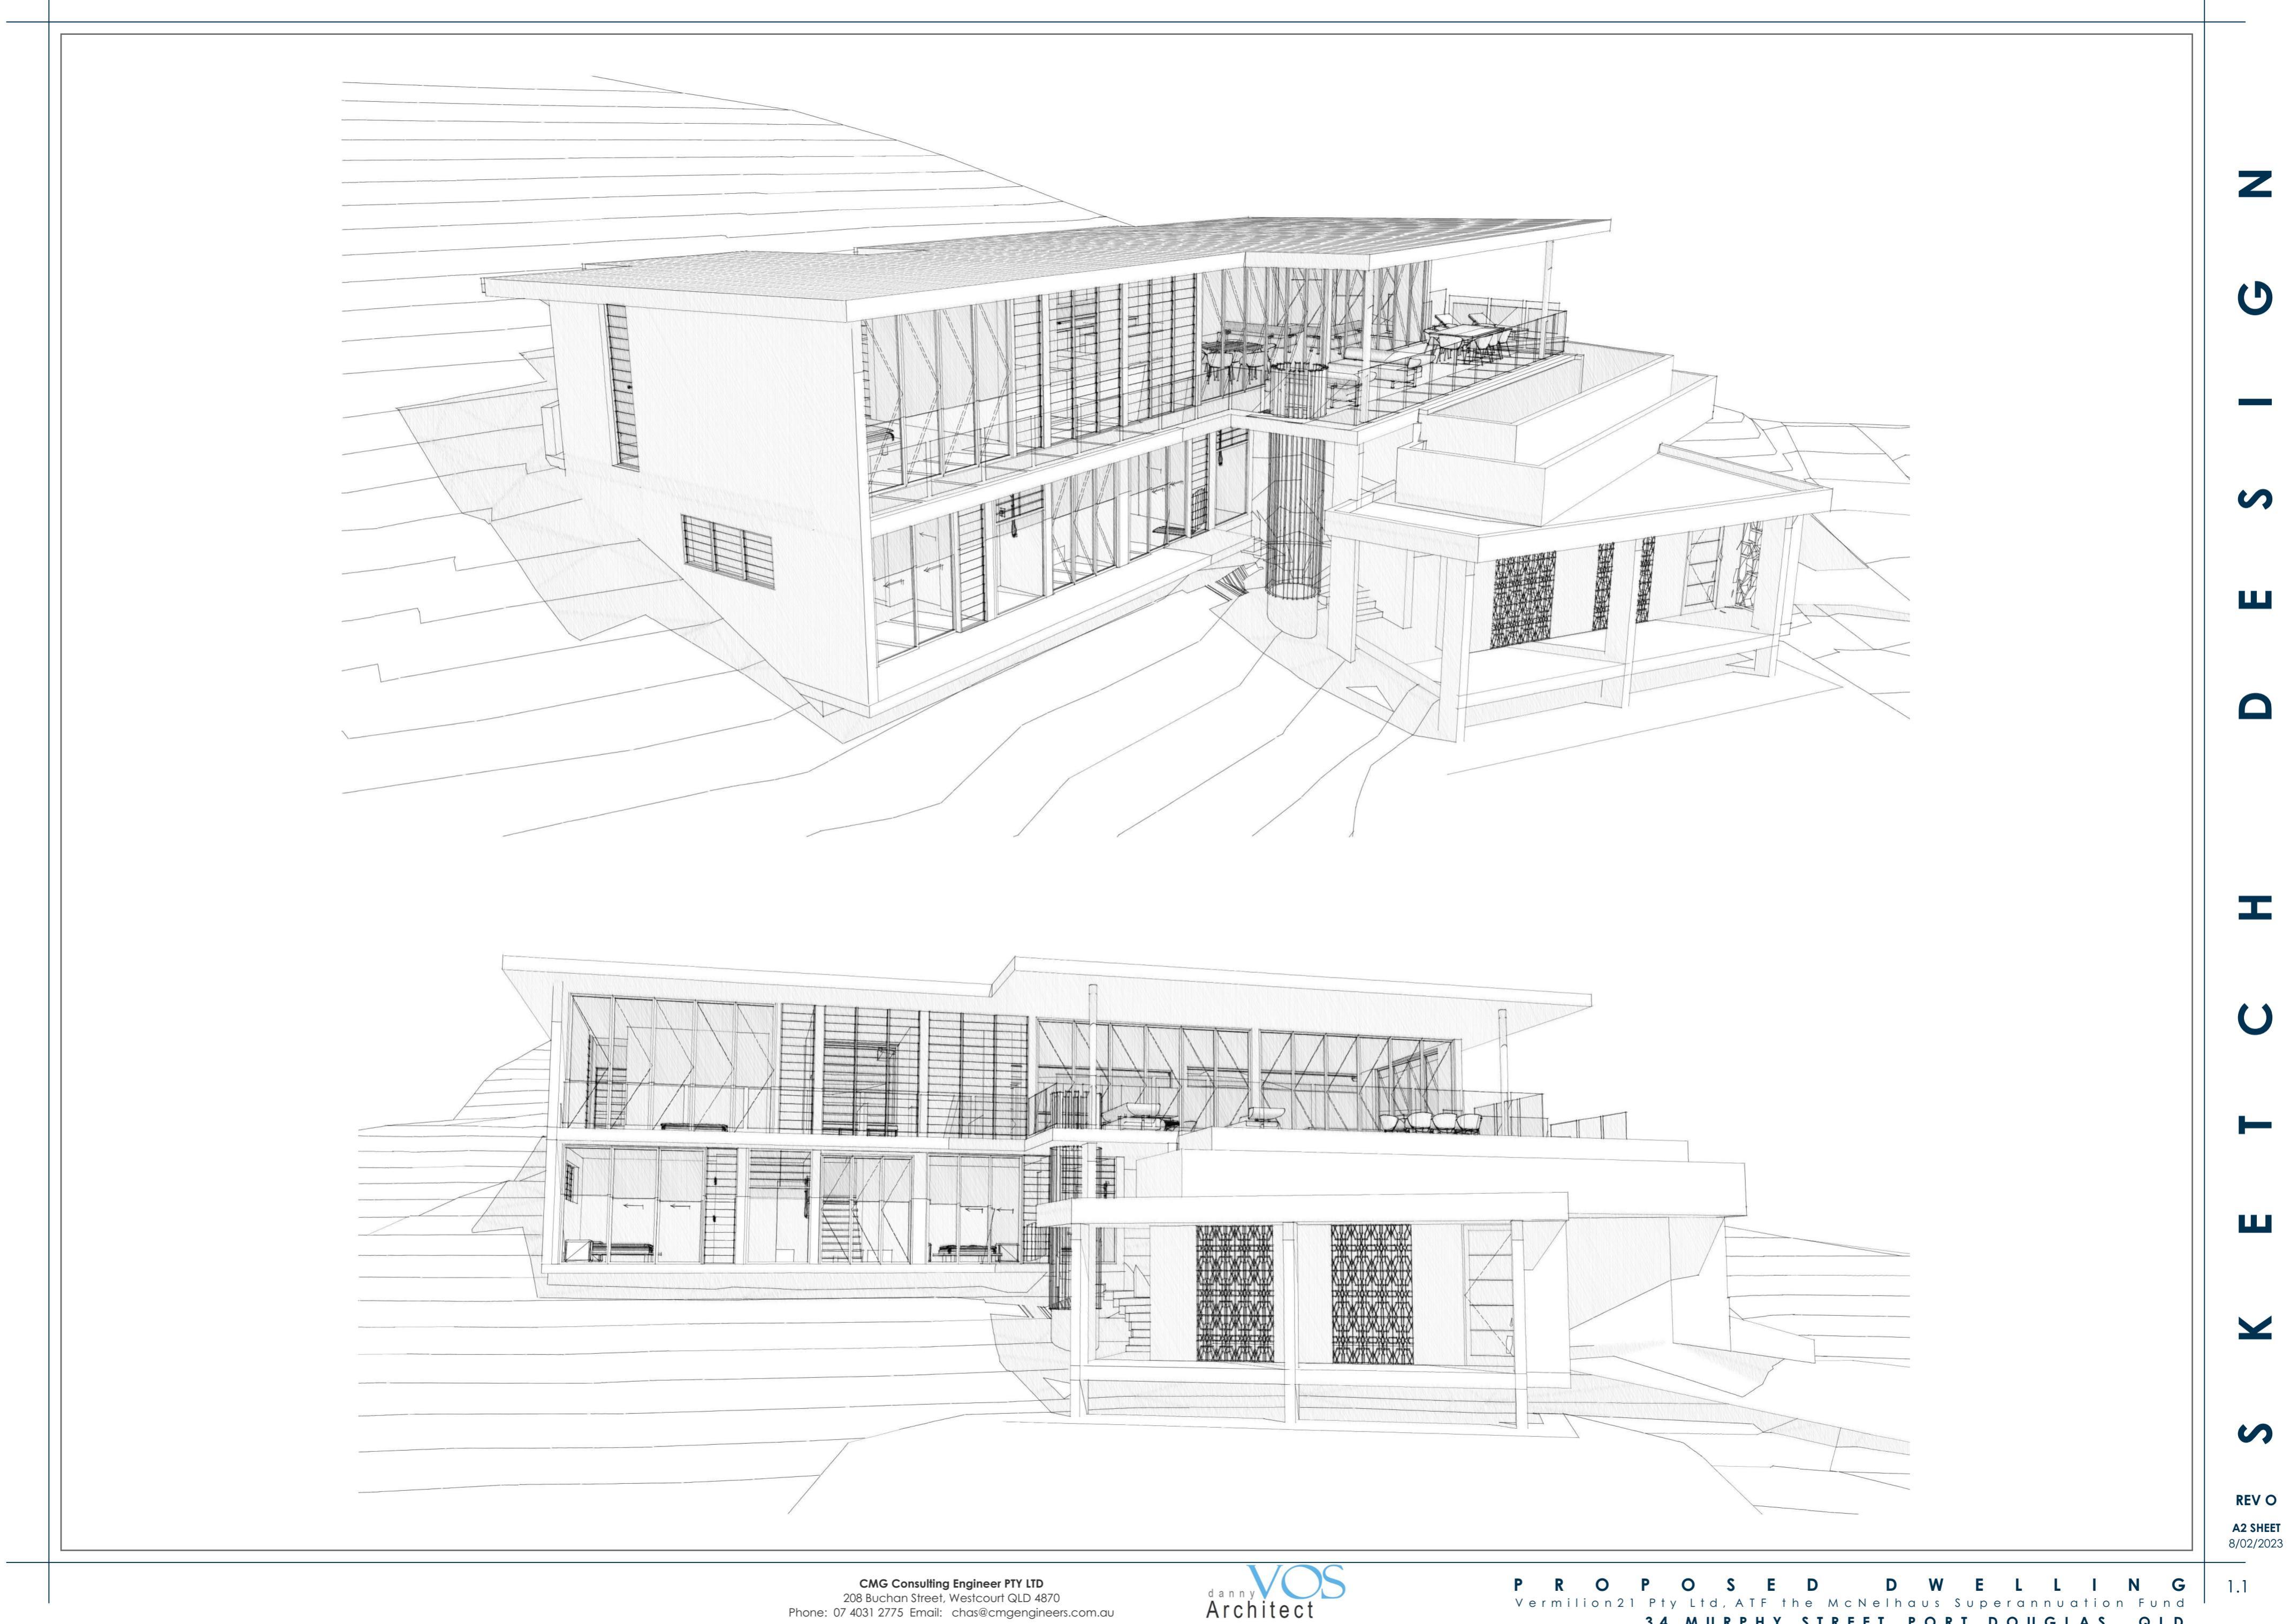
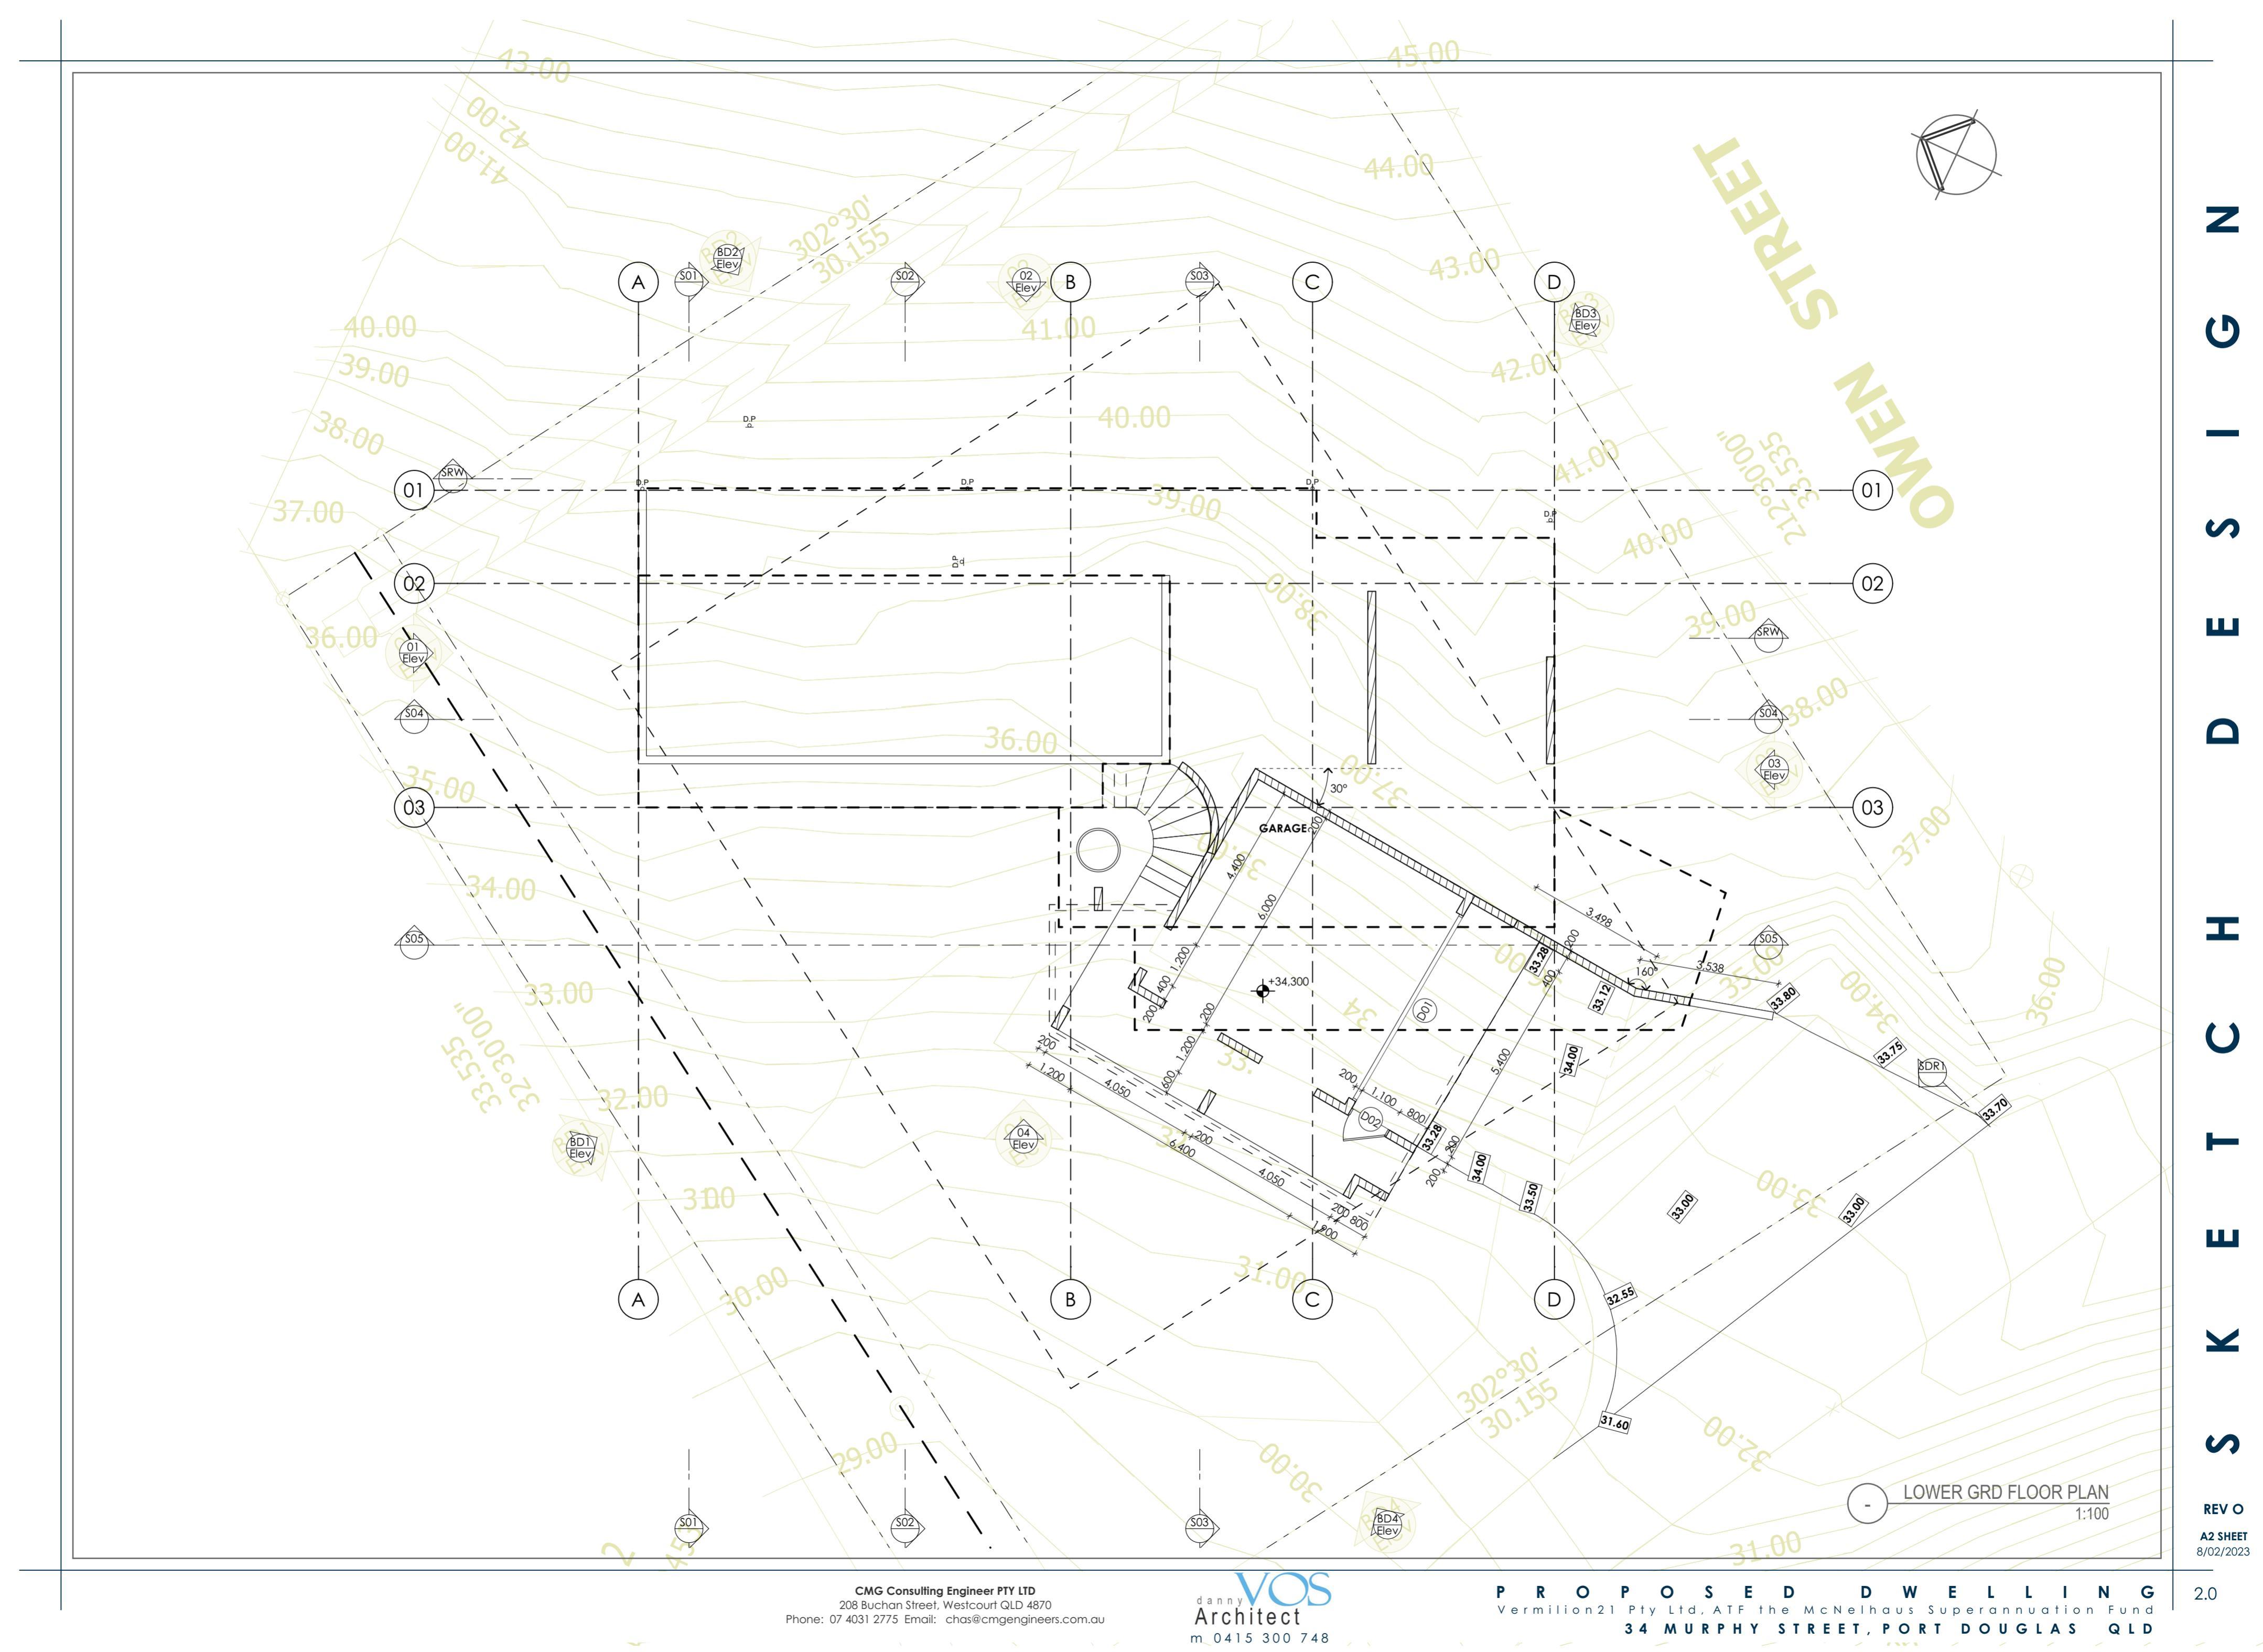
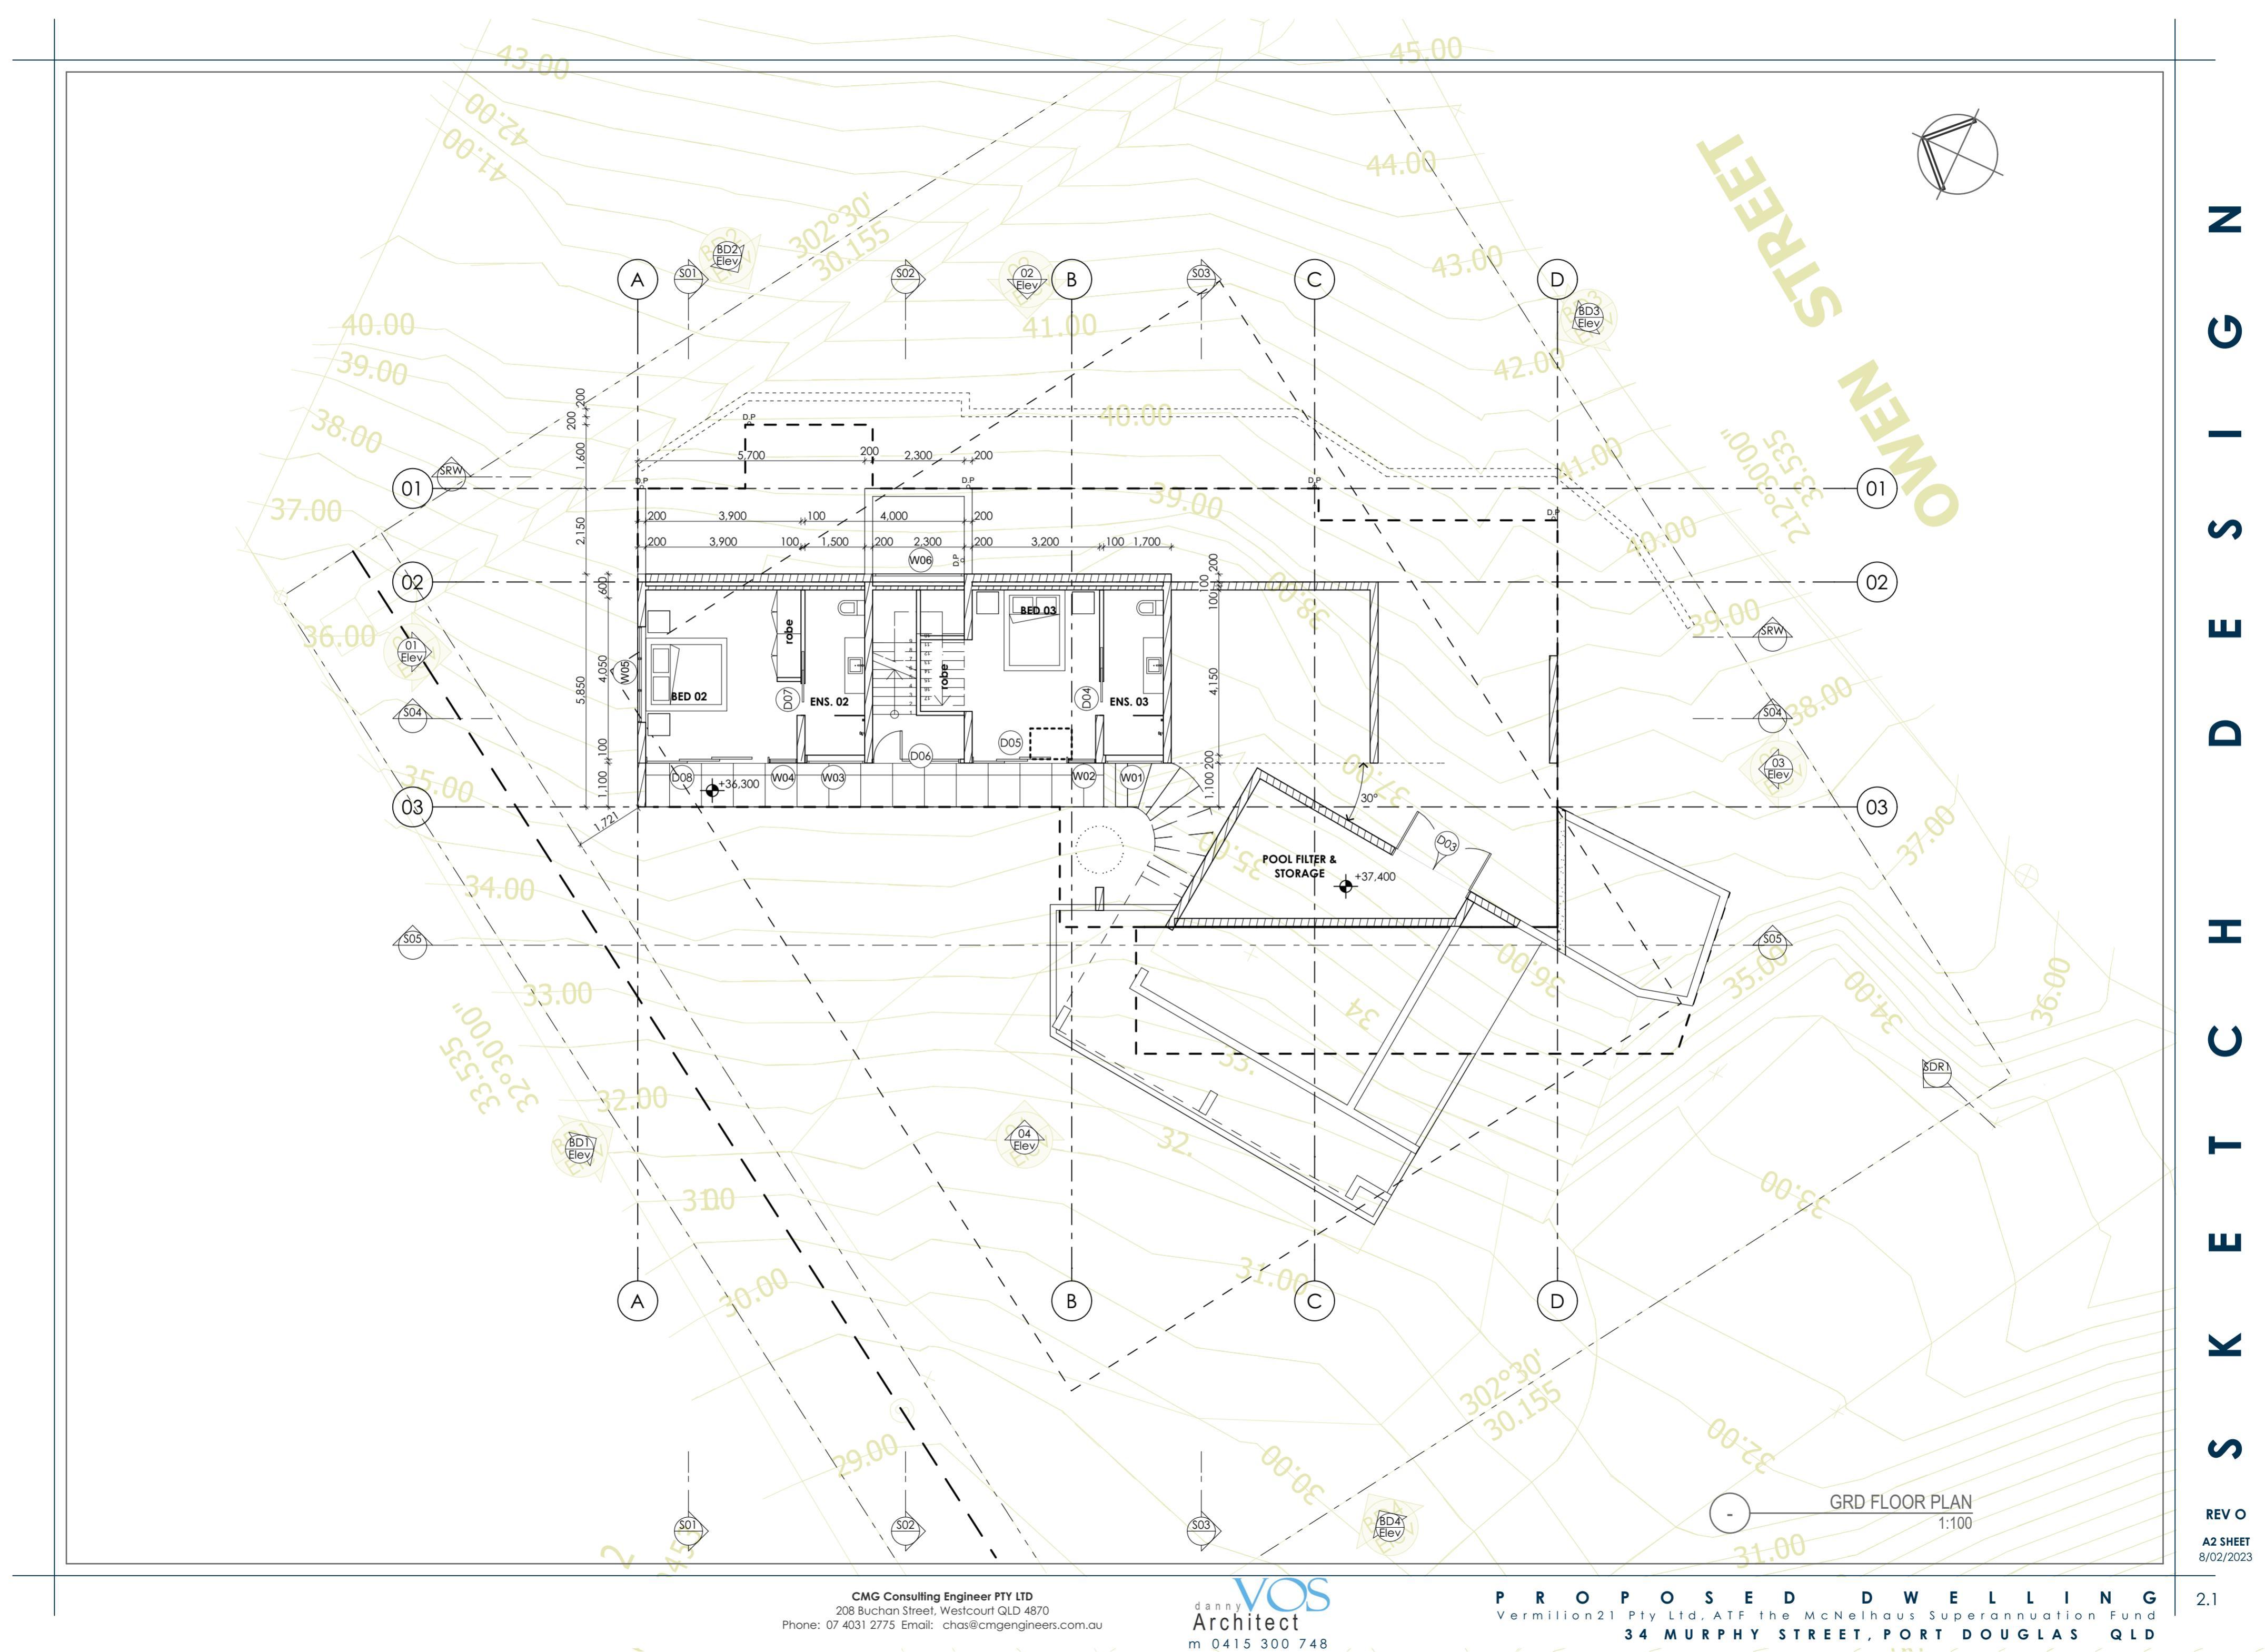
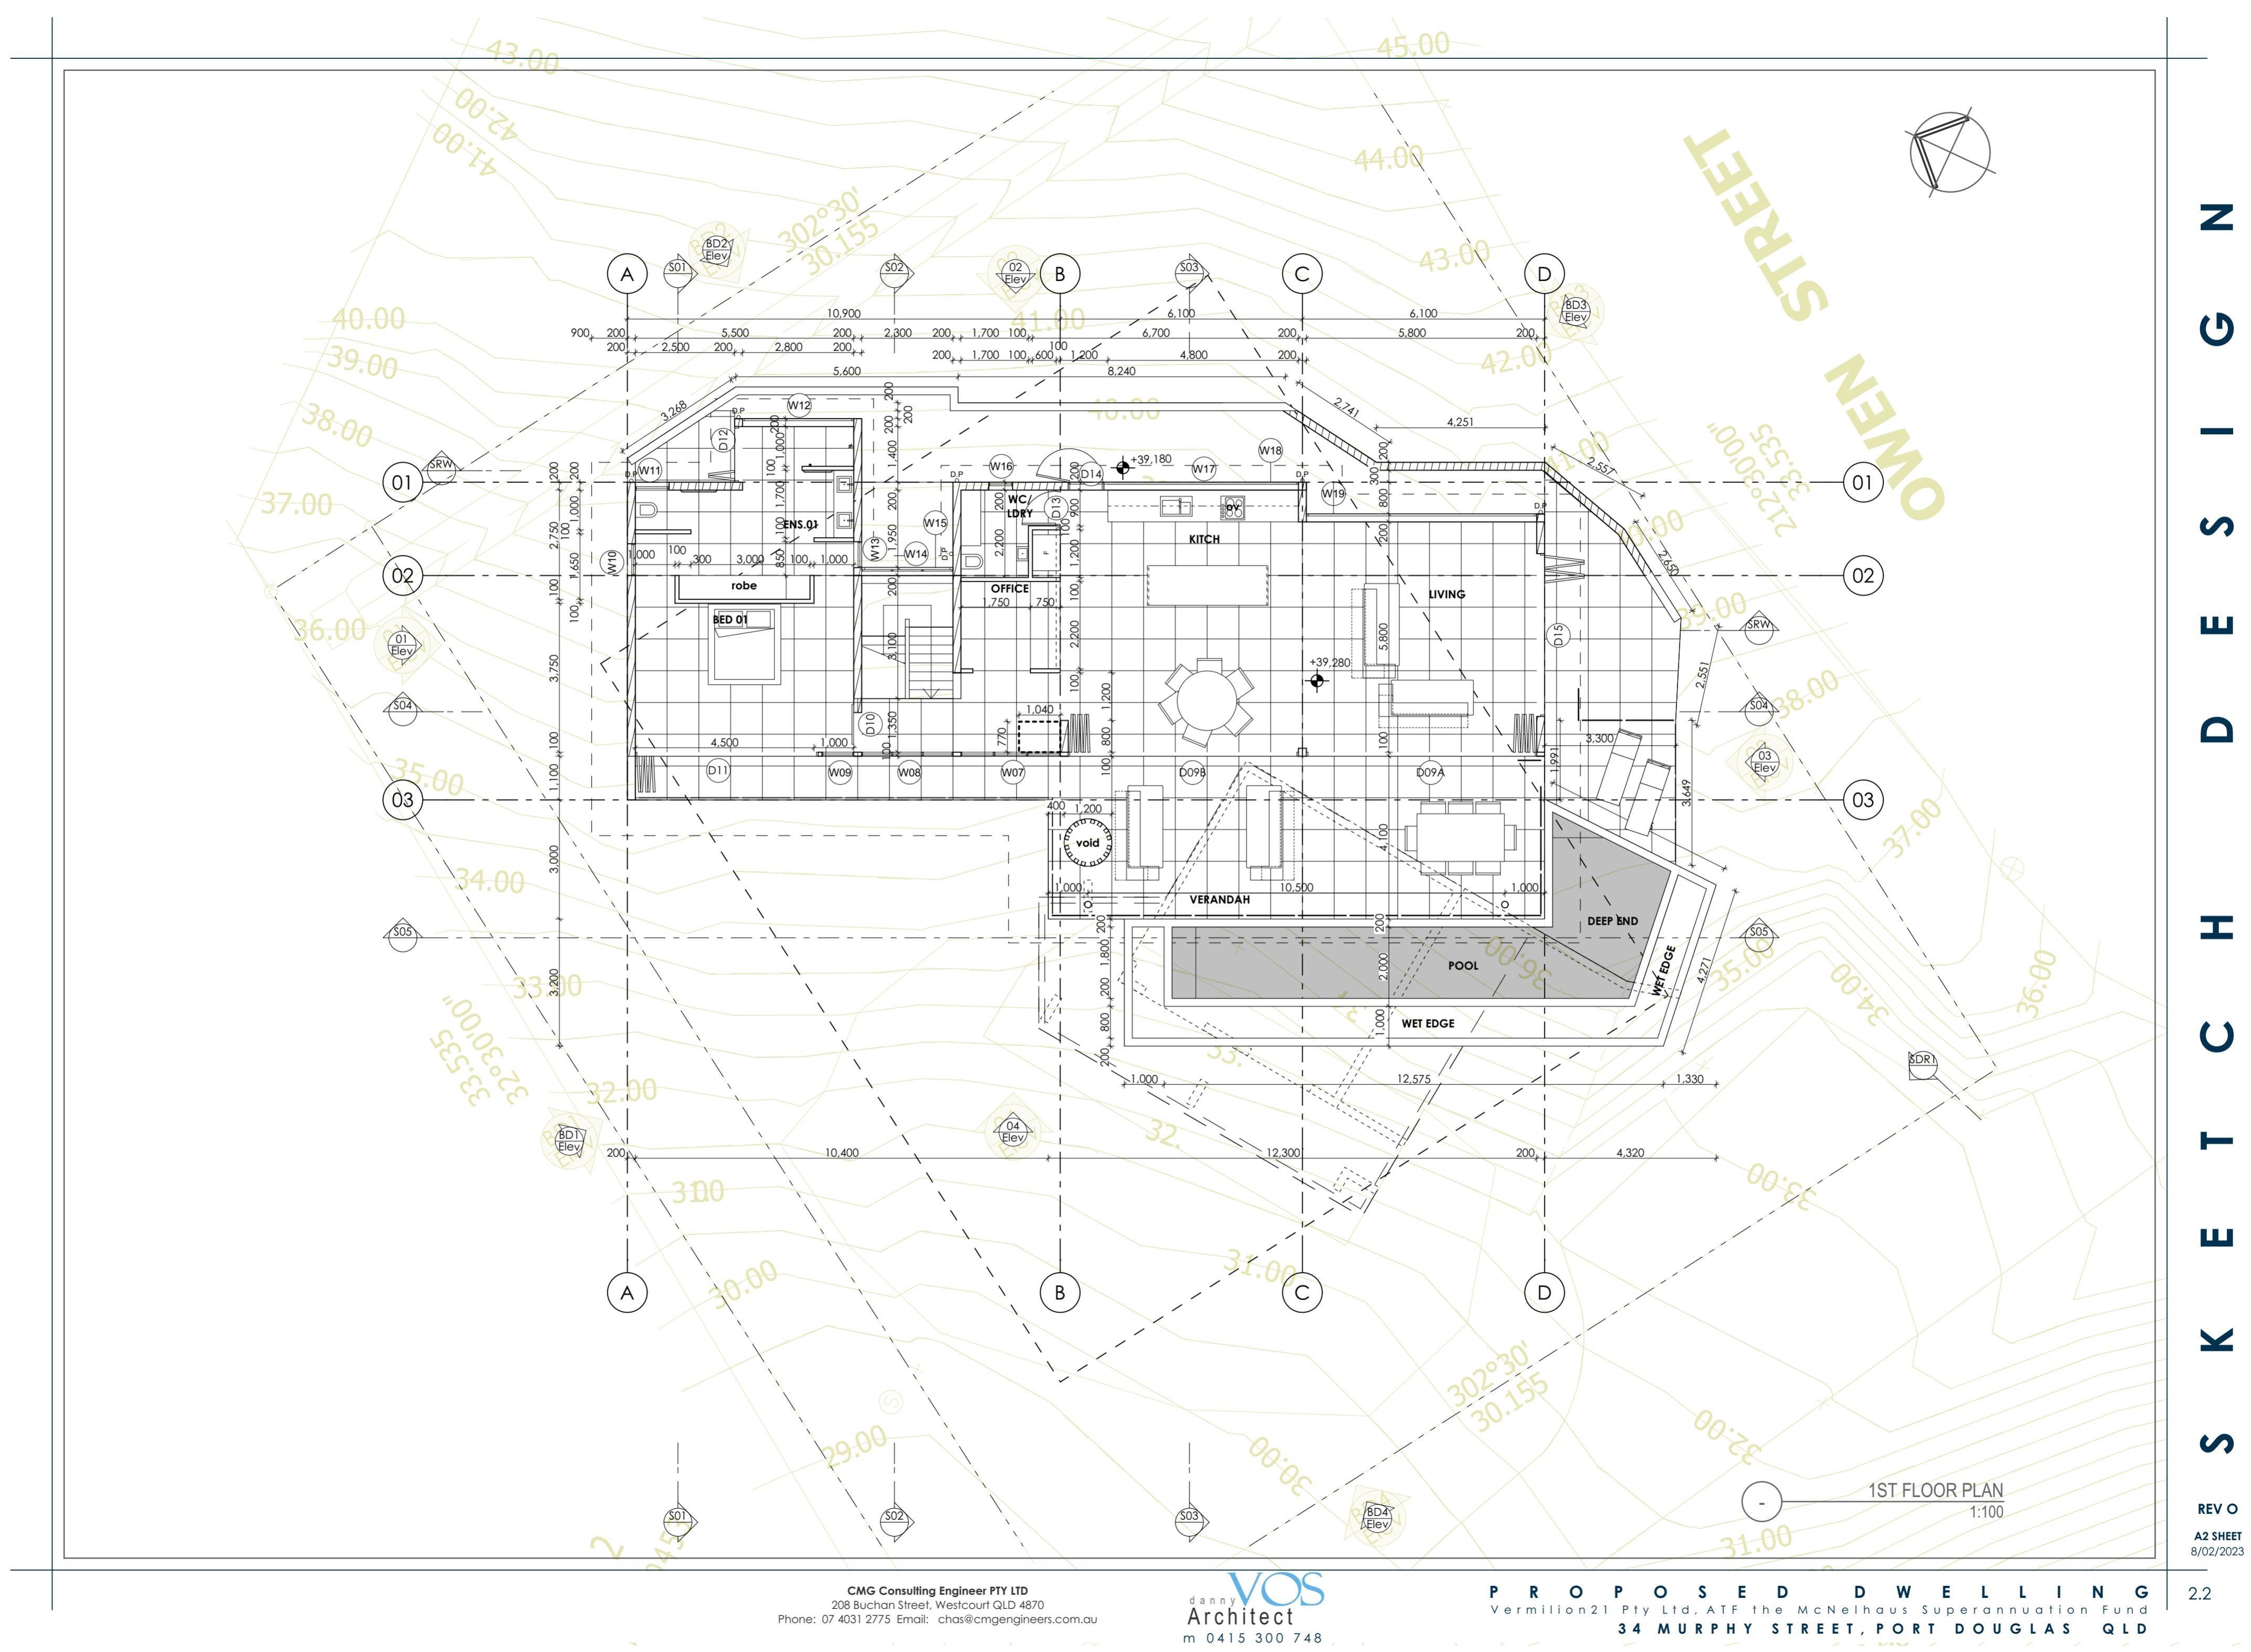
The Proposal Plan has been amended to show the location of the existing sewer main which runs parallel to the site north-western boundary. The alignment has been derived from Council's As Constructed Plans. It is shown on the Amended Proposal Plan that the corner of the building is located 1.723m, and the roof corner is 0.48m from the edge of the easement. This allows sufficient area for maintenance access if required.

The Amended Proposal Plan indicates the location of the proposed water meter in the lower western corner of the site. The Applicant has been in discussions with Mr. Peter White of Council, and it is understood that a separate application to Council will be required for a water connection which will be constructed by the Council Water Team. Until such time as a connection is extended to the property it is not possible to understand the water pressure at the site. It is acknowledged that a private booster may be required to achieve appropriate water pressure and it is suggested that this requirement is placed as a condition of approval.

The Amended Proposal Plan illustrates the 6m setback line from all boundaries. Justification for the proposed reduced boundary setbacks is included within the original Development Application.
