RE: RESPONSE TO INFORMATION REQUEST A MATERIAL CHANGE OF USE (DWELLING HOUSE) 34 MURPHY STREET, PORT DOUGLAS, MORE FORMALLY DESCRIBED AS LOT 126 ON SP144708

Amended Proposal Plan

Geotechnical Assessment

Proposed New Residence 34 Murphy Street Port Douglas QLD 4877

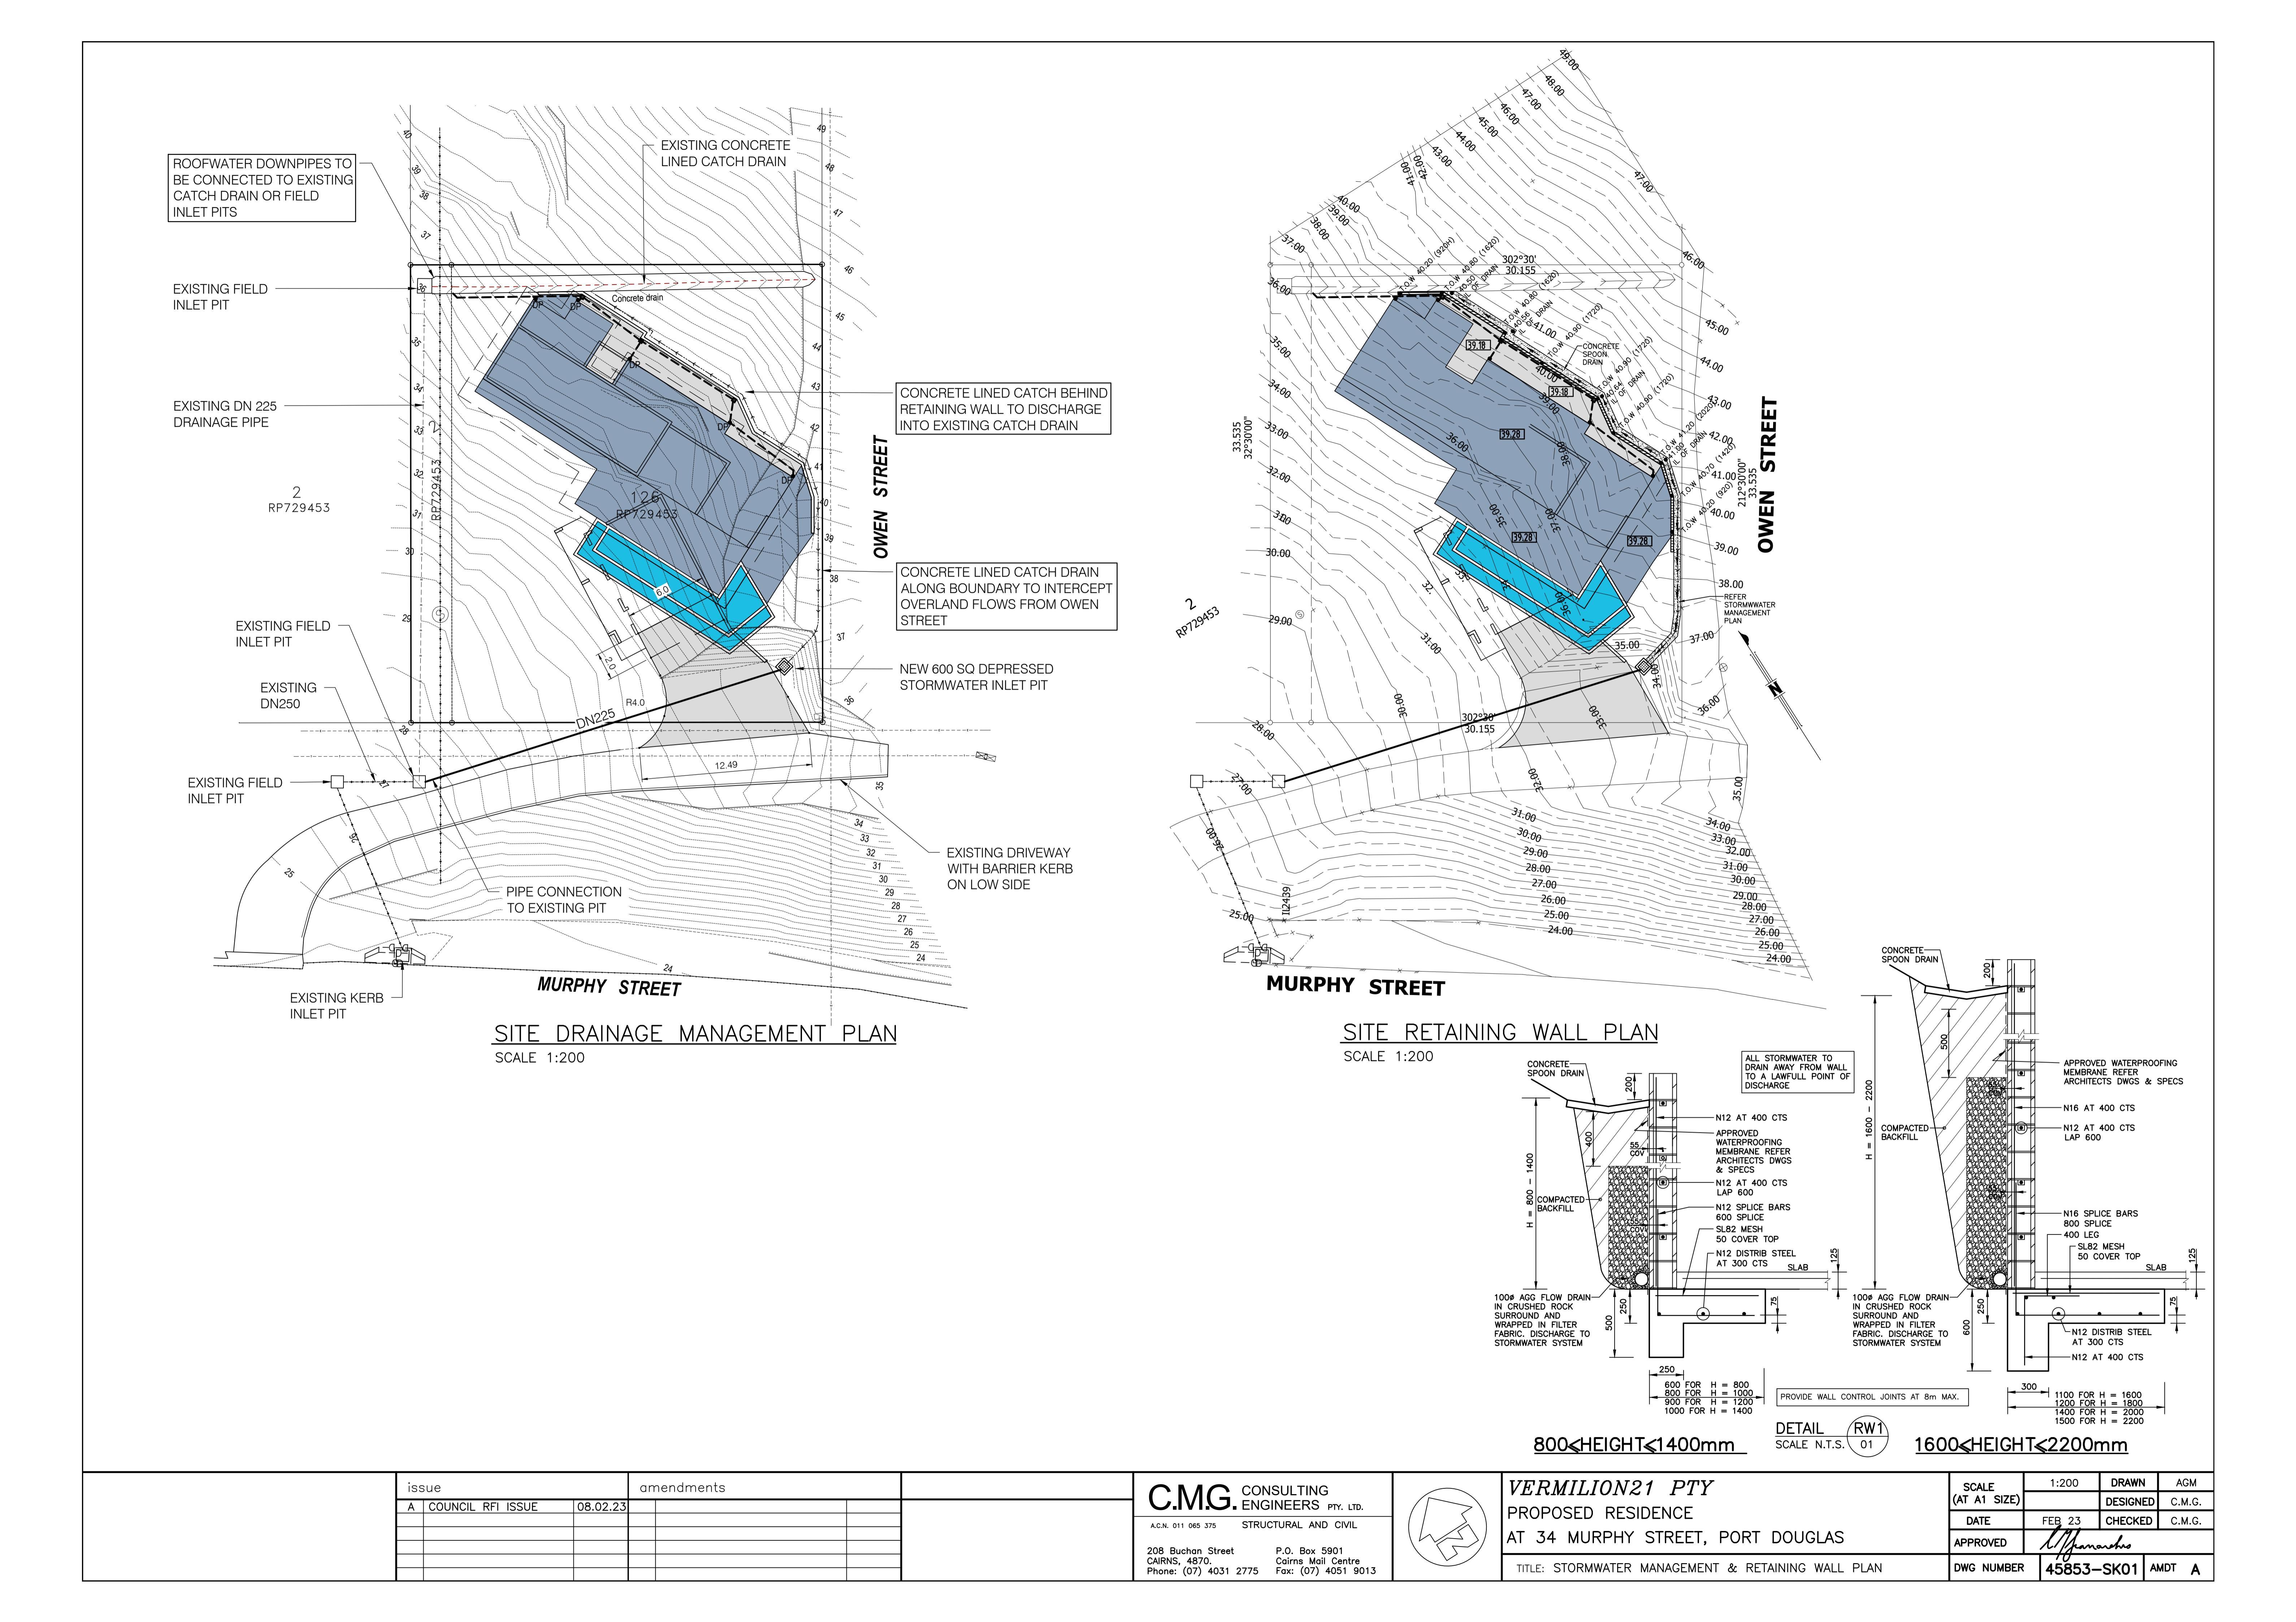
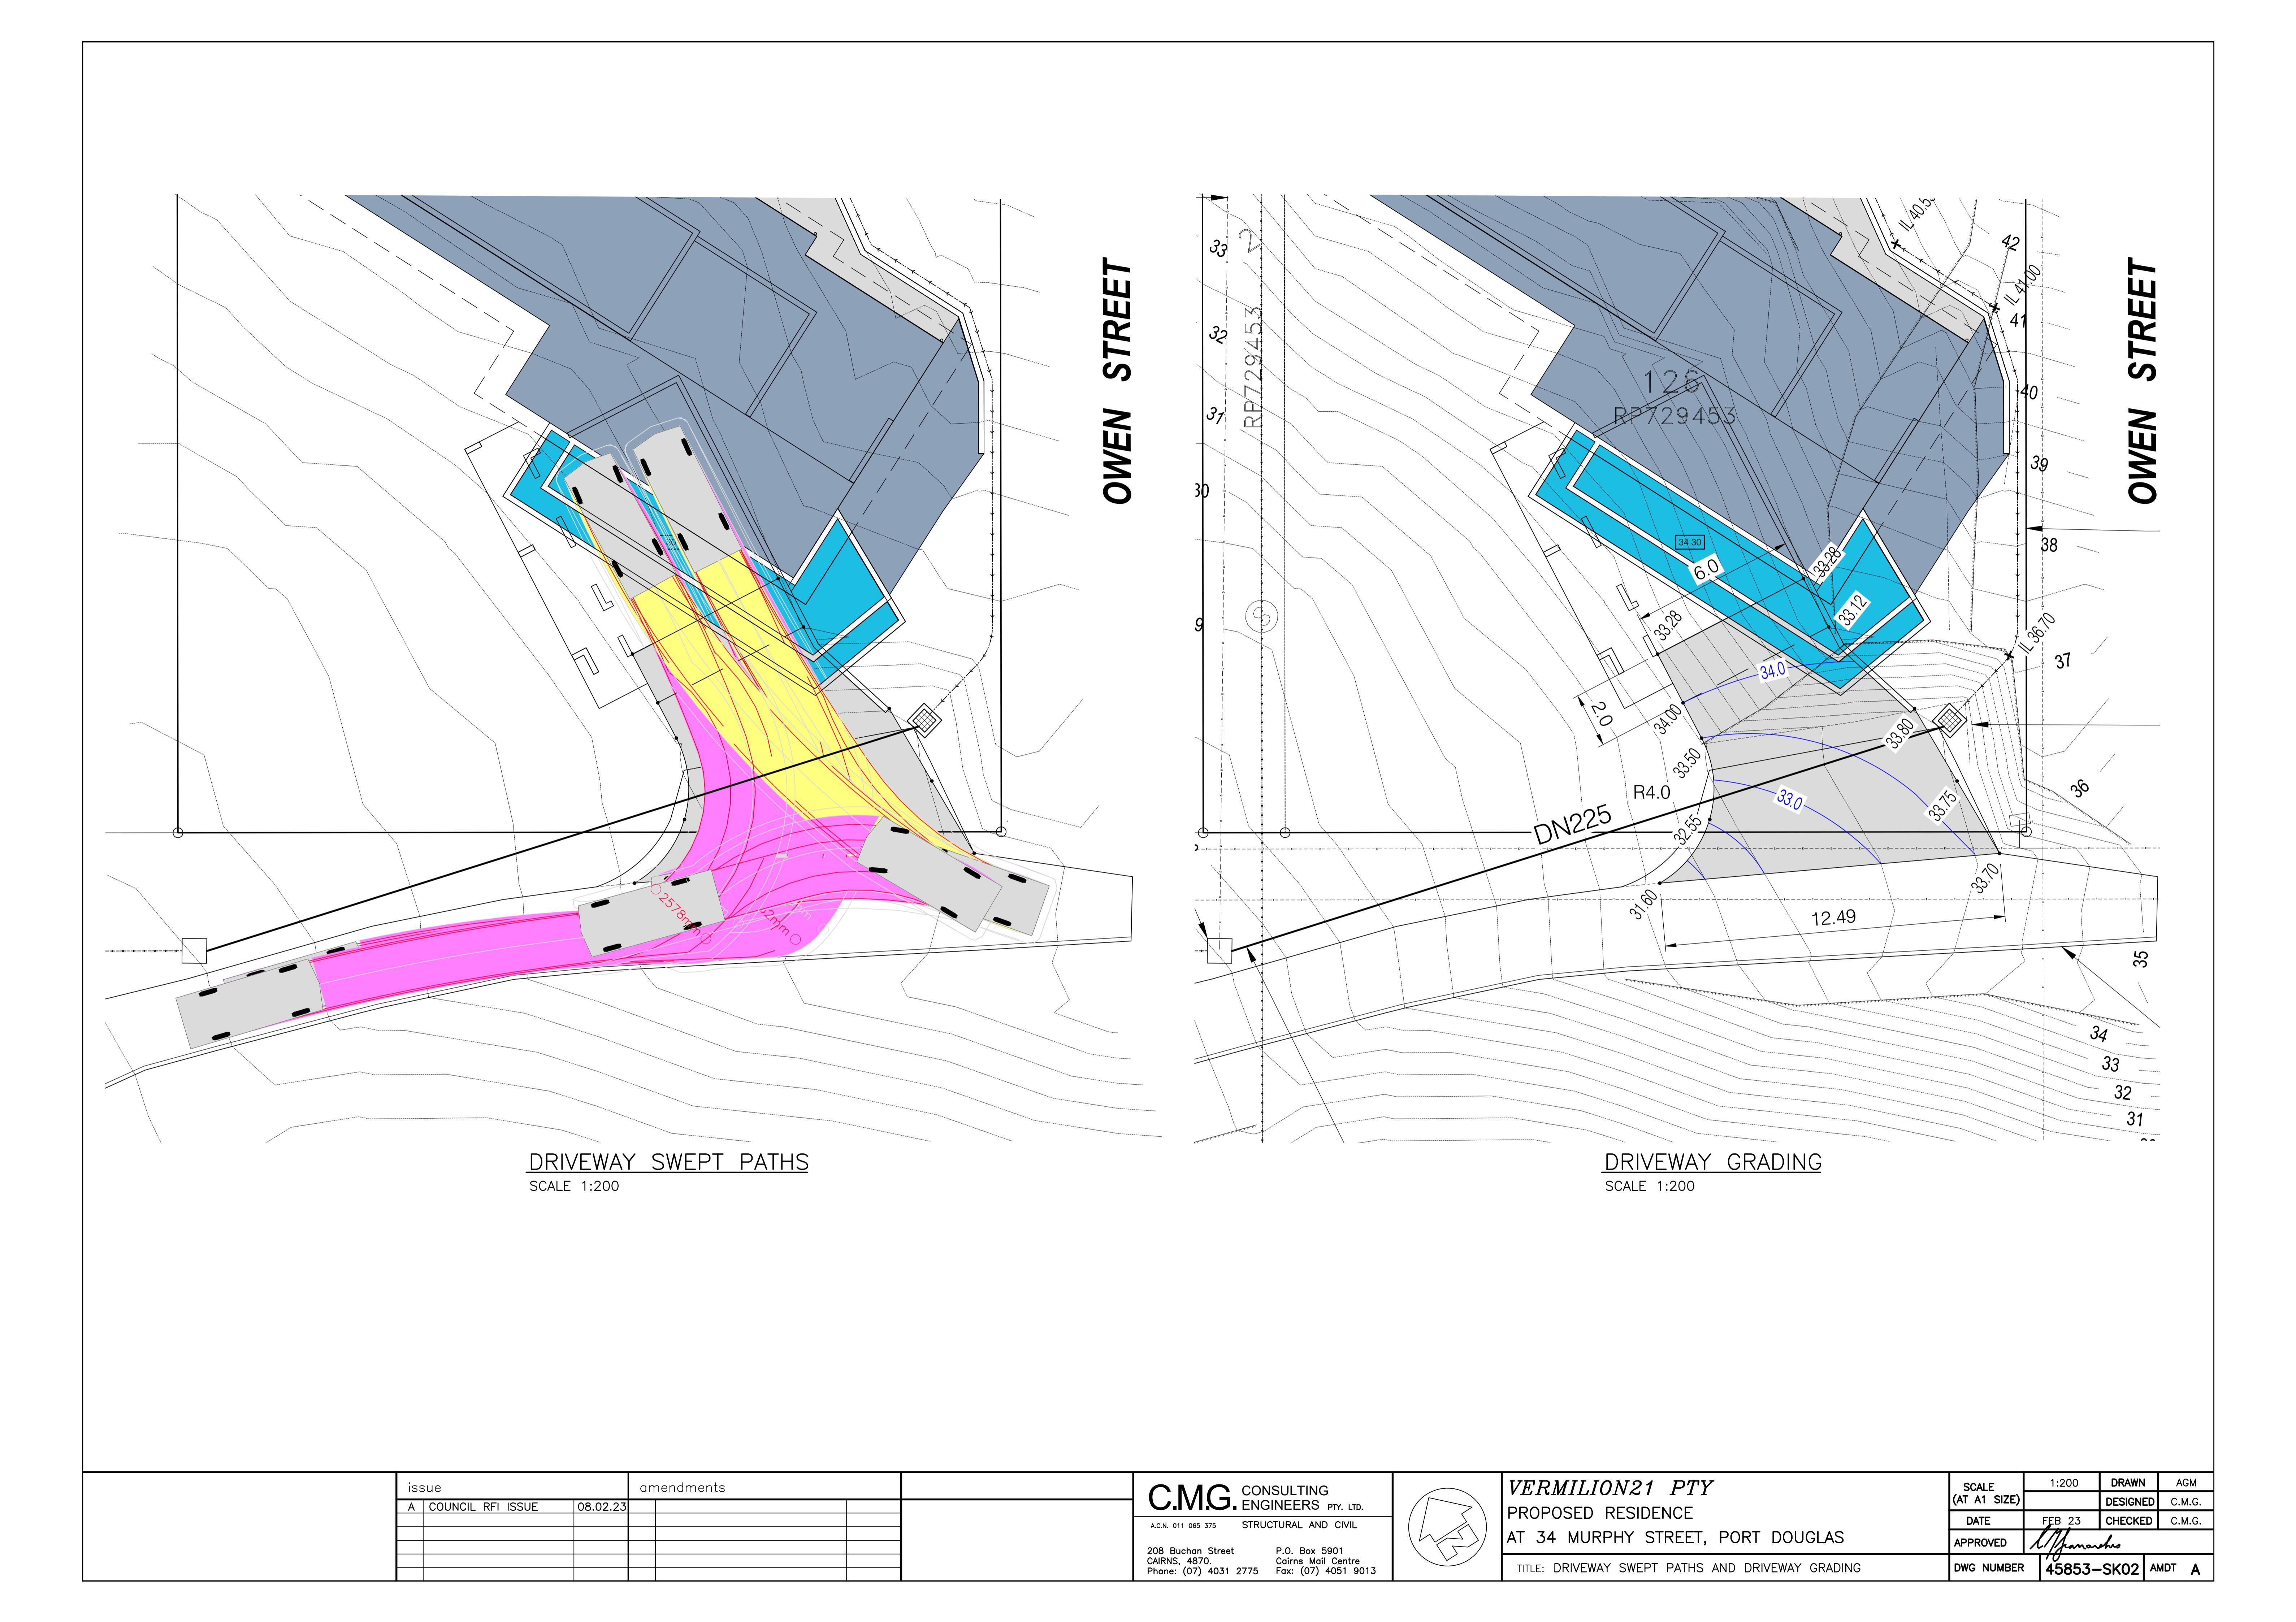
Stormwater Management, Retaining Wall Plan and Vehicle Circulation Plan

CMG Consulting Engineers has been engaged to develop a plan to manage the capture and discharge of stormwater across the site.

CMG Consulting Engineers has been engaged to develop a Site Retaining Wall Plan including Site Drainage.

Refer to Attachment B: Stormwater Management, Retaining Wall and Vehicle Circulation Plan and Attachment C: Geotechnical Assessment. This plan demonstrate vehicle swept paths driving in forward motion into the site and reversing out of the site onto Murphy Street and existing Murphy Street on the wider transport network in forward gear. The design is supported under the Geotechnical Assessment.

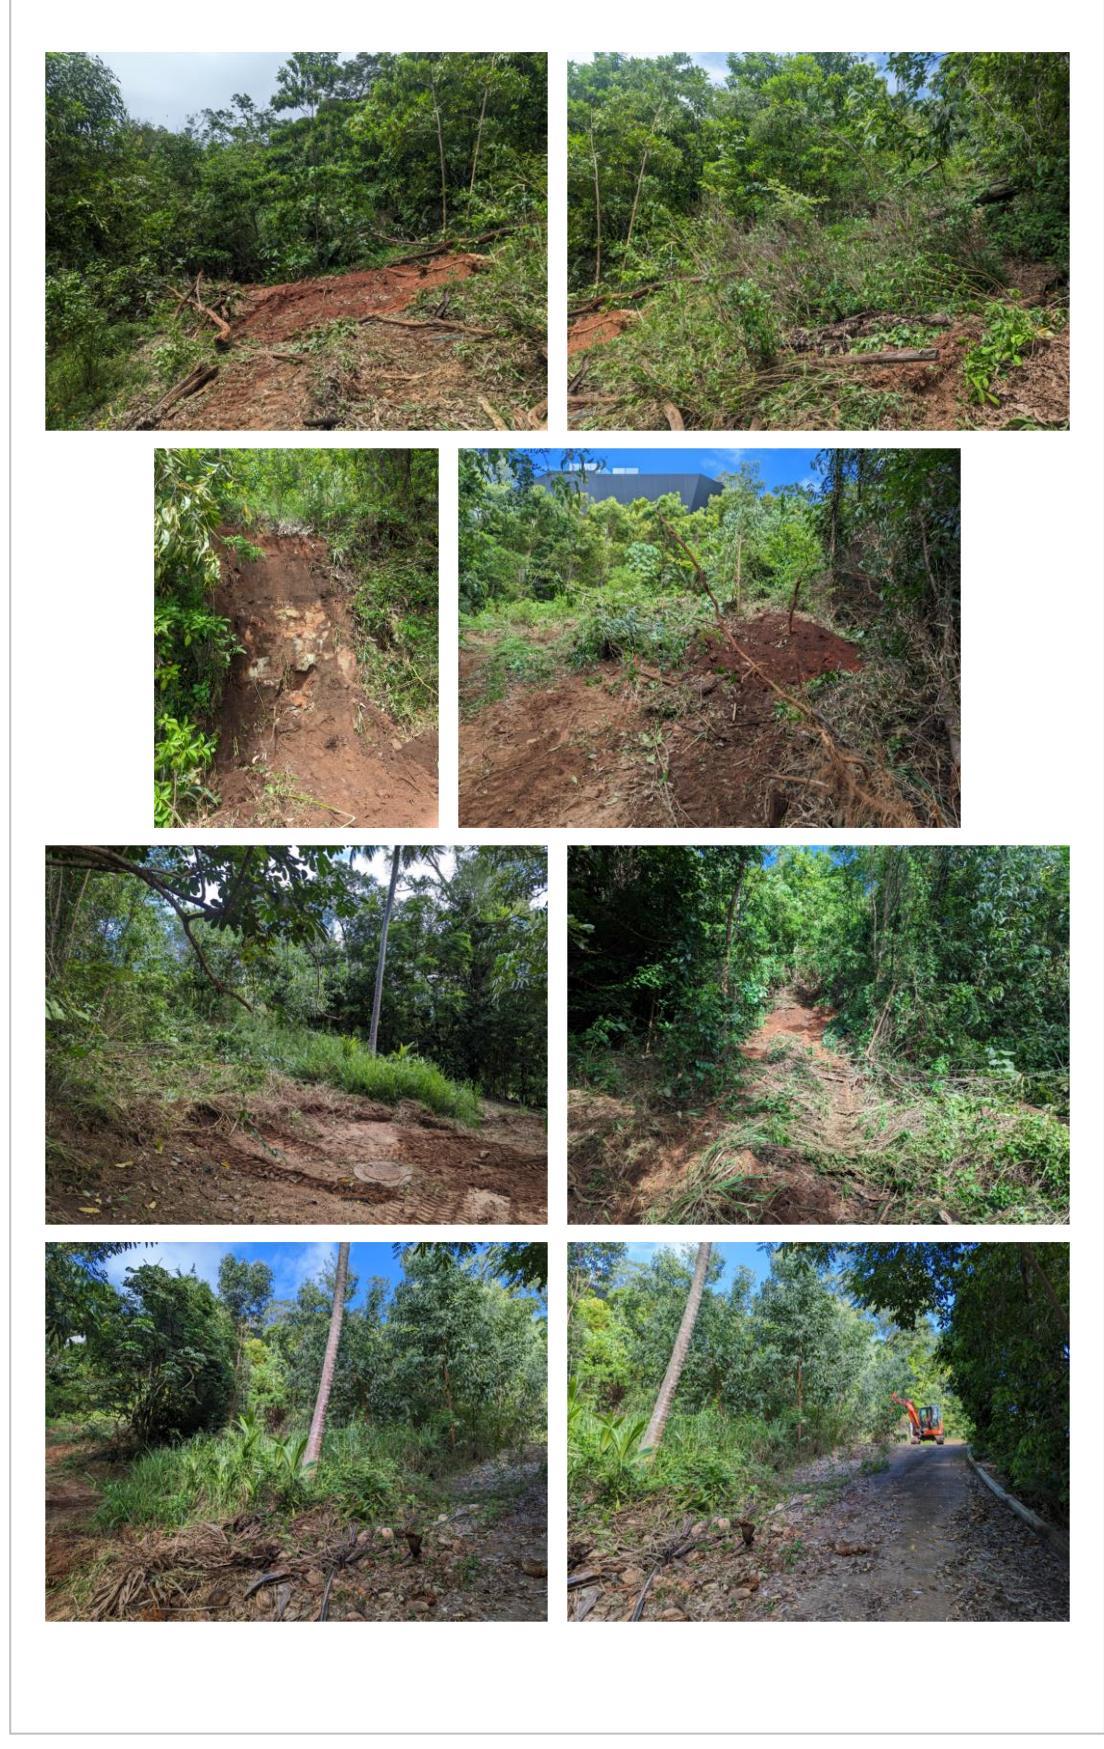
Figure 2: Site Photographs

The site is located at 34 Murphy Street, Port Douglas. The site is located to the north of Murphy Street and is bound to the north by a residential development, to the west by a gully and drainage path, and to the east by an undeveloped portion of the Owen Street easement. A concrete driveway extends along the southern boundary of the allotment which in turn is bound by a cut batter that extends down to Murphy Street.

The cut batter along Murphy Street is generally covered by thick vegetation in the area adjacent to the existing concrete driveway. The batter extends further to the east and increases in height with slope stability works carried out in the area to the south and southeast of the proposed residence.

The surface of the site generally slopes towards the southwest up to about 25° to 30° with locally steeper sections. A small rock wall is located in the central portion of the allotment. At the time of fieldwork, the site was generally covered by trees and various vegetation.

Some evidence of previous earthworks were observed at the site.

No signs of significant instability were noted in the walkover survey.

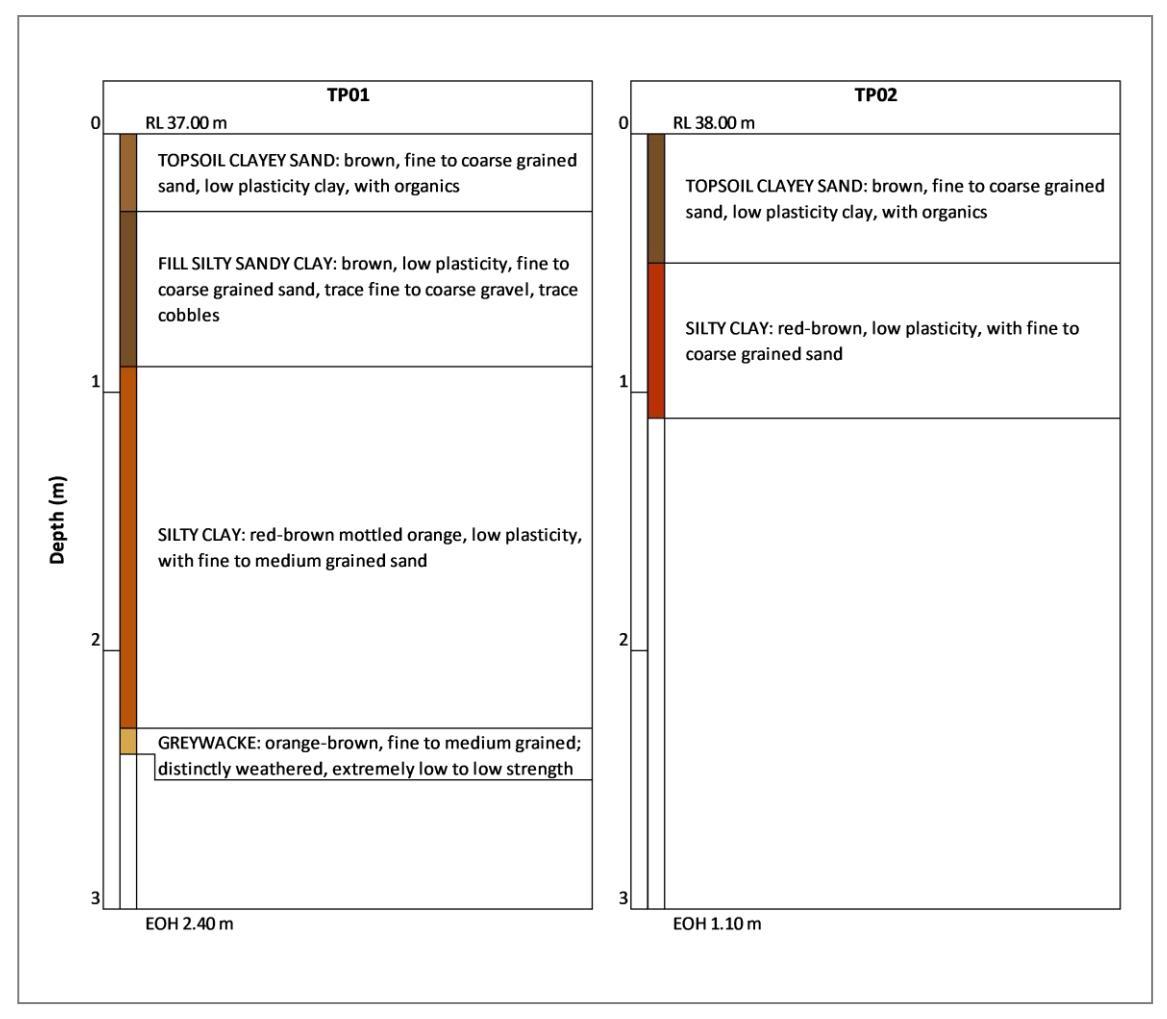
Figure 3: Summary of TP01 to TP02 Results

The subsurface conditions observed within the existing batters and excavated test pits (TP01 to TP03) generally comprised Firm to Stiff/Loose to Medium Dense Clay's/Sands to a depth of about 0.3 m to 0.9 m, over Very Stiff to Hard Silty CLAY to a depth of about 0.9 m to 2.3 m, over weathered greywacke rock of the Hodgkinson Formation. A layer of filling was observed between about 0.3 m to 0.9 m in TP01.

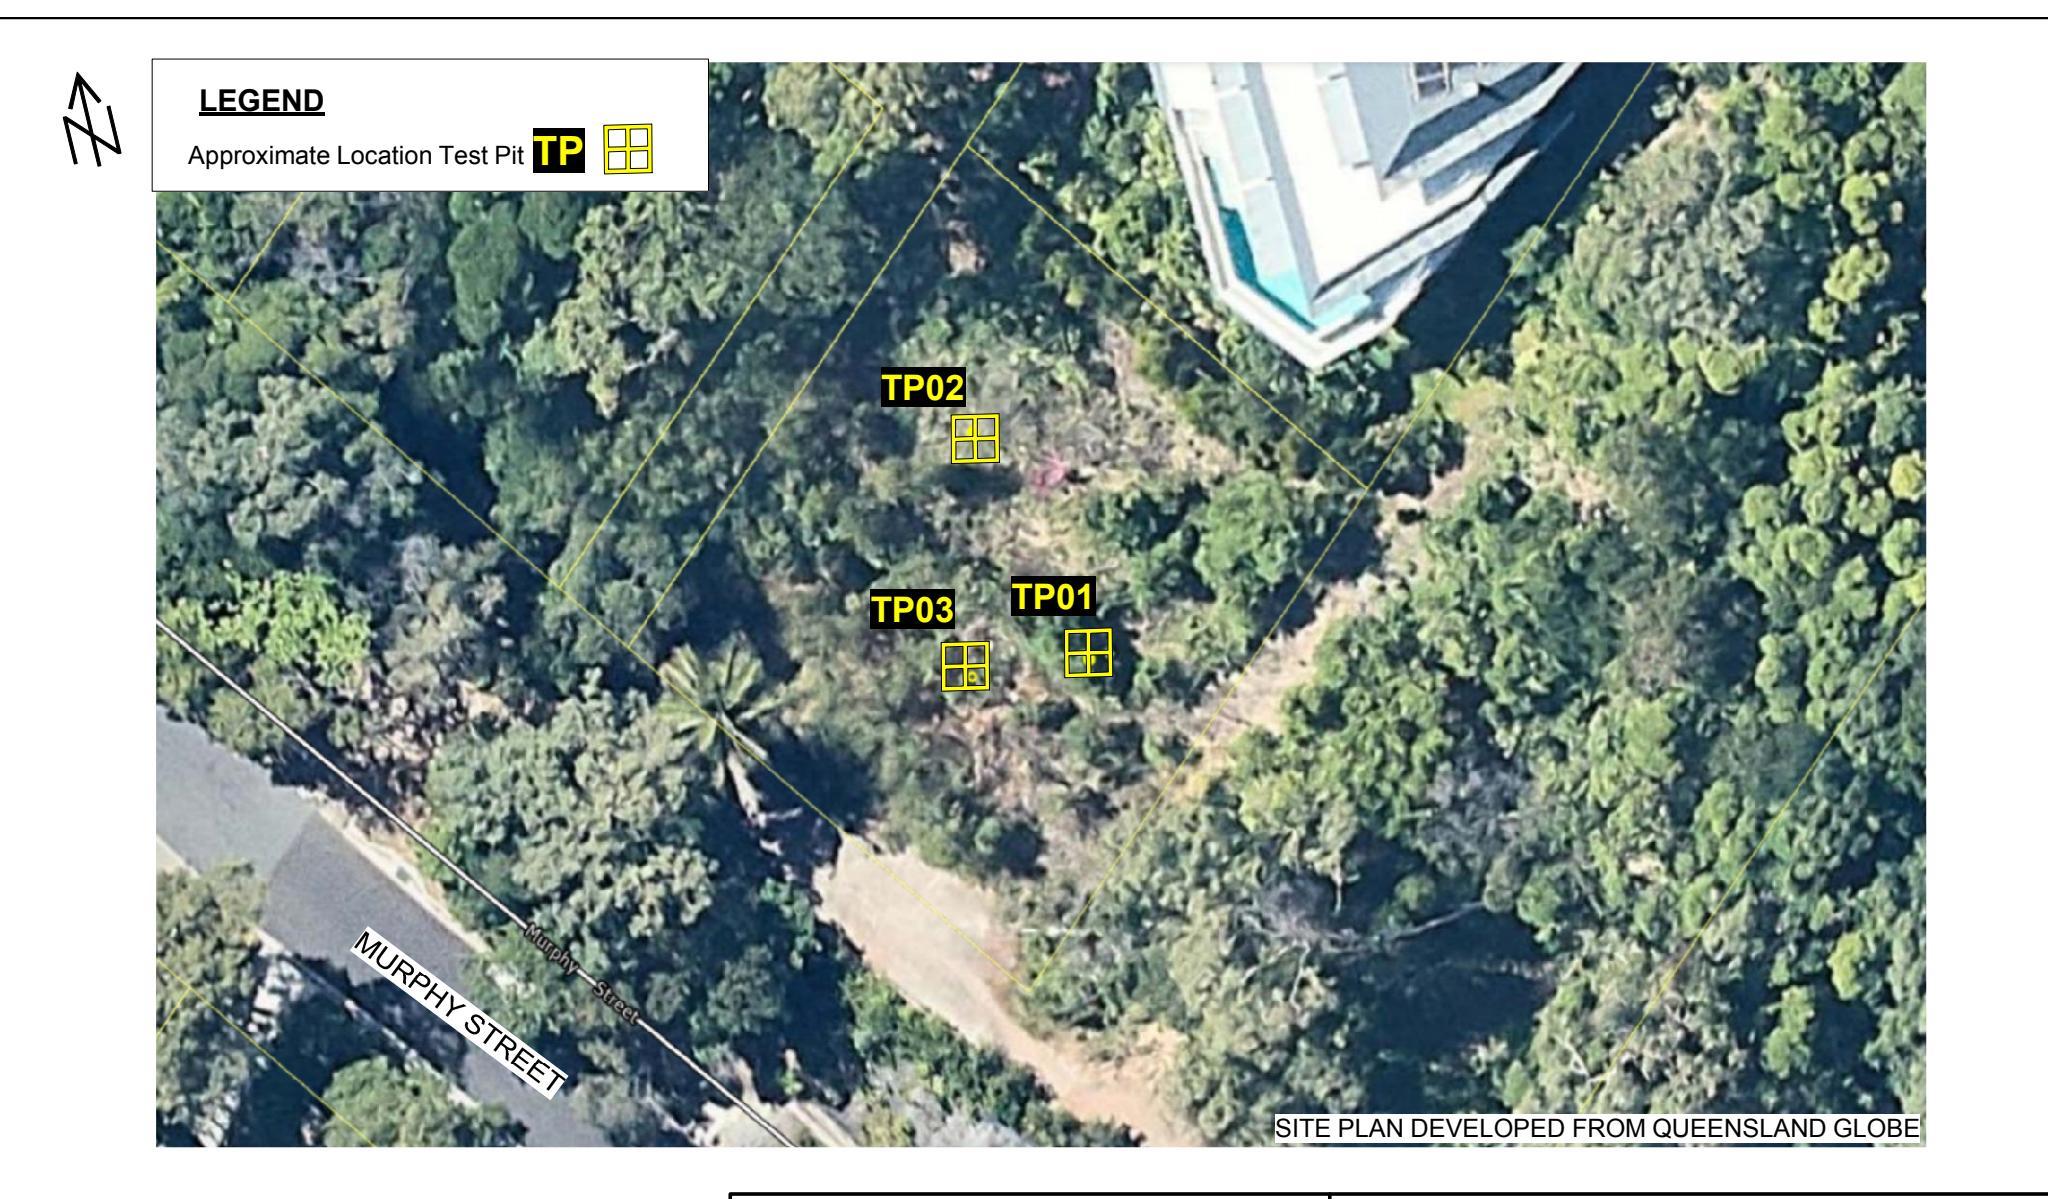
Client: VERMILION21	GEOTECHNICAL INVESTIGATION	
Drawn: DLH	34 MURPHY STREET, PORT DOUGLAS	
Scale: NTS	FIGURE 1 SITE PLAN	
Ref No: 22098AA-D-FIGURE1-V1

Fieldwork was carried out by an experienced field technician under the direction of a geotechnical engineer. The location of all testing is presented in Appendix A. The results of the fieldwork are presented in Appendix B. Site photographs are presented below in Figure 2.
