Cooya Beach

DRAFT FORESHORE MANAGEMENT PLAN

May 2021

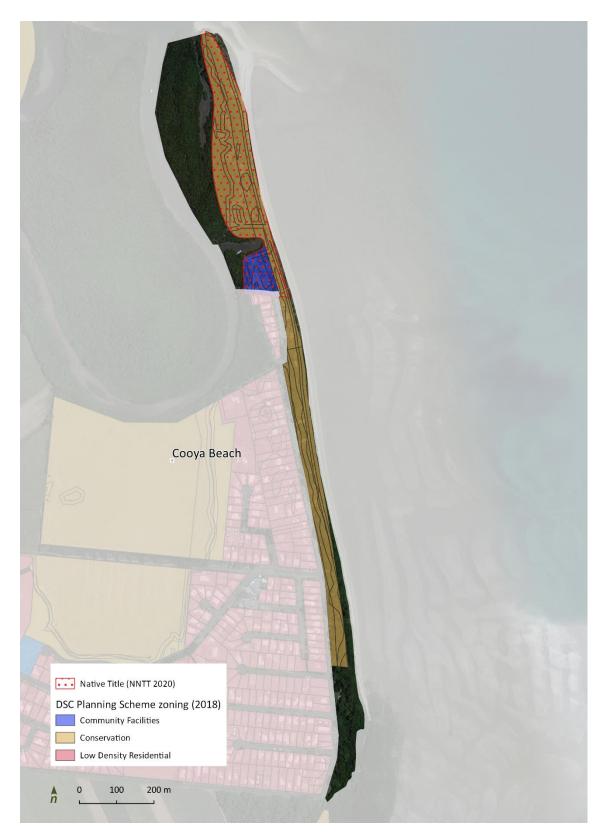
Figure 2. Douglas Shire Council Planning Scheme and Native Title land use zoning within the Cooya Beach foreshore area (DSC 2018a, NNTT 2020).

The DSC Planning Scheme (2018) has been used to understand the boundaries between different land uses (Figure 2) (DSC 2018a). At Cooya Beach, the primary land uses within or immediately adjacent to the foreshore area are conservation, community facilities and low density residential. These land uses have implications for the management of the foreshore area. Changes within these zones can have flow-on impacts to the foreshore area, including:

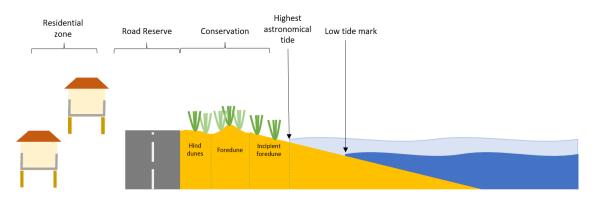
Figure 3. Graphic representation of the Cooya Beach foreshore management precinct.

The foreshore zone at Cooya Beach extends from the highest astronomical tide (HAT) line to the road reserve limit of the Conservation zone along the length of Bougainvillea St (Figure 3).

The foreshore area includes the dune system behind the beach, immediately landward of the HAT mark and is made up of the following three key sections (Figure 3):

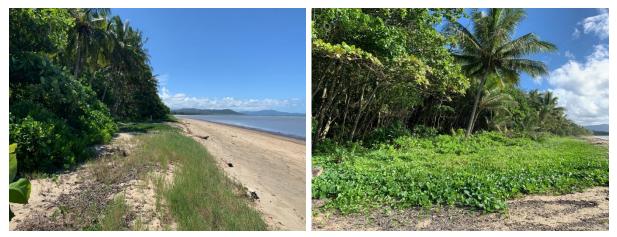
Healthy incipient foredune at Cooya Beach

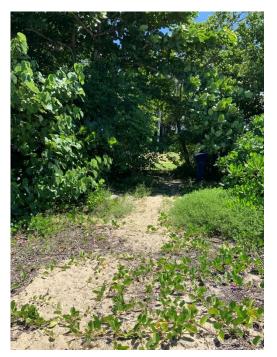
Vegetation clearing for access tracks.

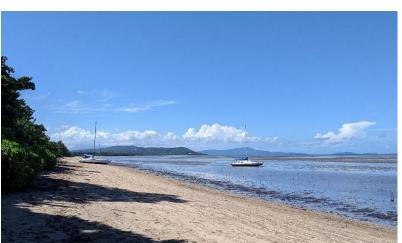
Boats moored off the Cooya Beach foreshore

vehicles to the beach at a number of locations along the foreshore. This also includes the construction of moorings by residents along the beach or boats tied to trees (as observed during site inspections) and vehicles accessing the beach via the Council access road through the Council conservation area. These activities have caused a disruption to the vegetation cover along the foreshore and have the potential to cause erosion and negatively impact essential wildlife habitats.

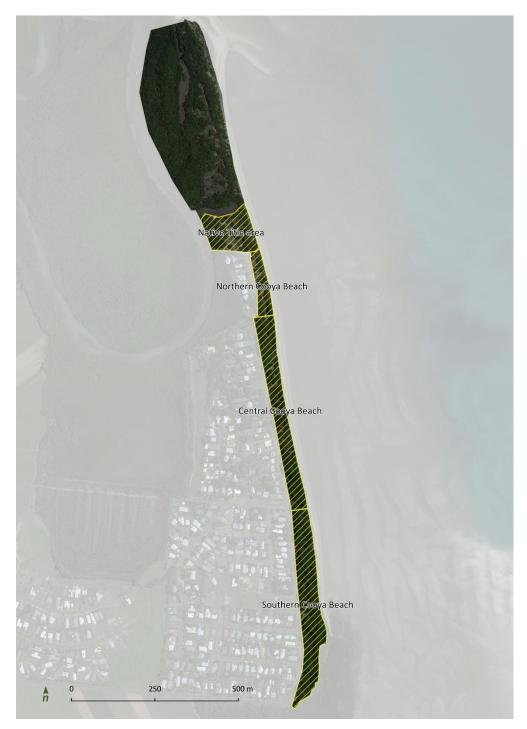
Figure 6. Cooya Beach foreshore management precincts.

The Cooya Beach foreshore zone has been divided into four management precincts. Management actions have been tailored to specific concerns and threats within each precinct. The four precincts are:

- Precinct 1 Native Title area
- Precinct 2 Northern Cooya Beach
- Precinct 3 Central Cooya Beach including Coconut Grove
- Precinct 4 Southern Cooya Beach

Precinct	Key foreshore threats and challenges			
<u>1 – Native Title area</u> Unpopulated precinct and falls under Native Title.	 Continue to allow cultural practices to occur in this precinct, including burning. Pedestrian and other access along foreshore within potential sensitive and vulnerable habitats, including turtle and shorebird nesting areas – access during nesting and hatching season may pose a threat to vulnerable species. Environmental weeds present – may impact the conservation value within the precinct. 			
<u>2 – Northern Cooya Beach</u> Includes land for conservation.	 Illegal clearing to create informal beach access tracks through the vegetation in the foreshore area – these activities may not meet the outcomes of the Conservation zone code, including biological diversity, ecological integrity and scenic amenity. Environmental weeds present – may impact the conservation value within the precinct.
