In relation to your query regarding the composition of sand on the site, I can confirm that the site contains regular sand and does not contain silica sand.

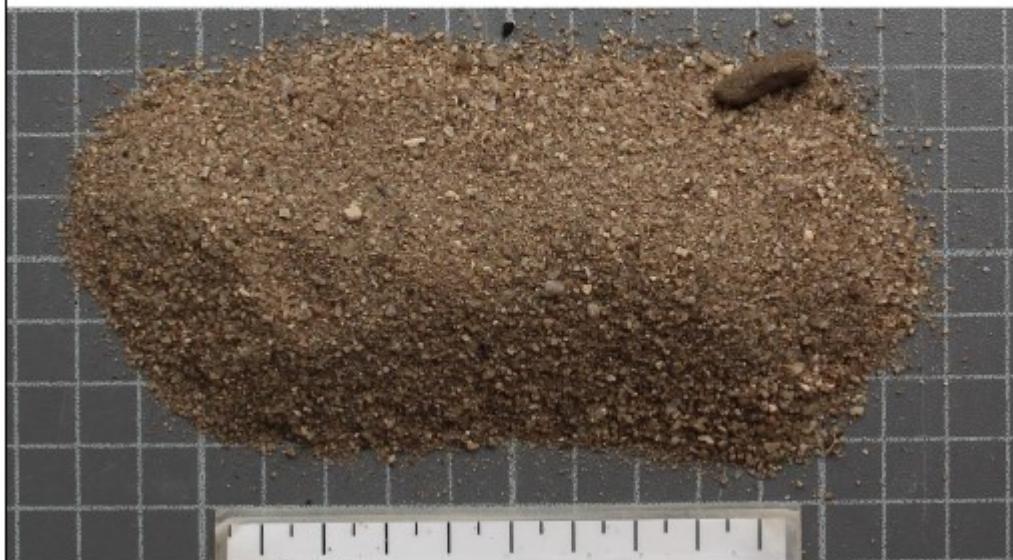
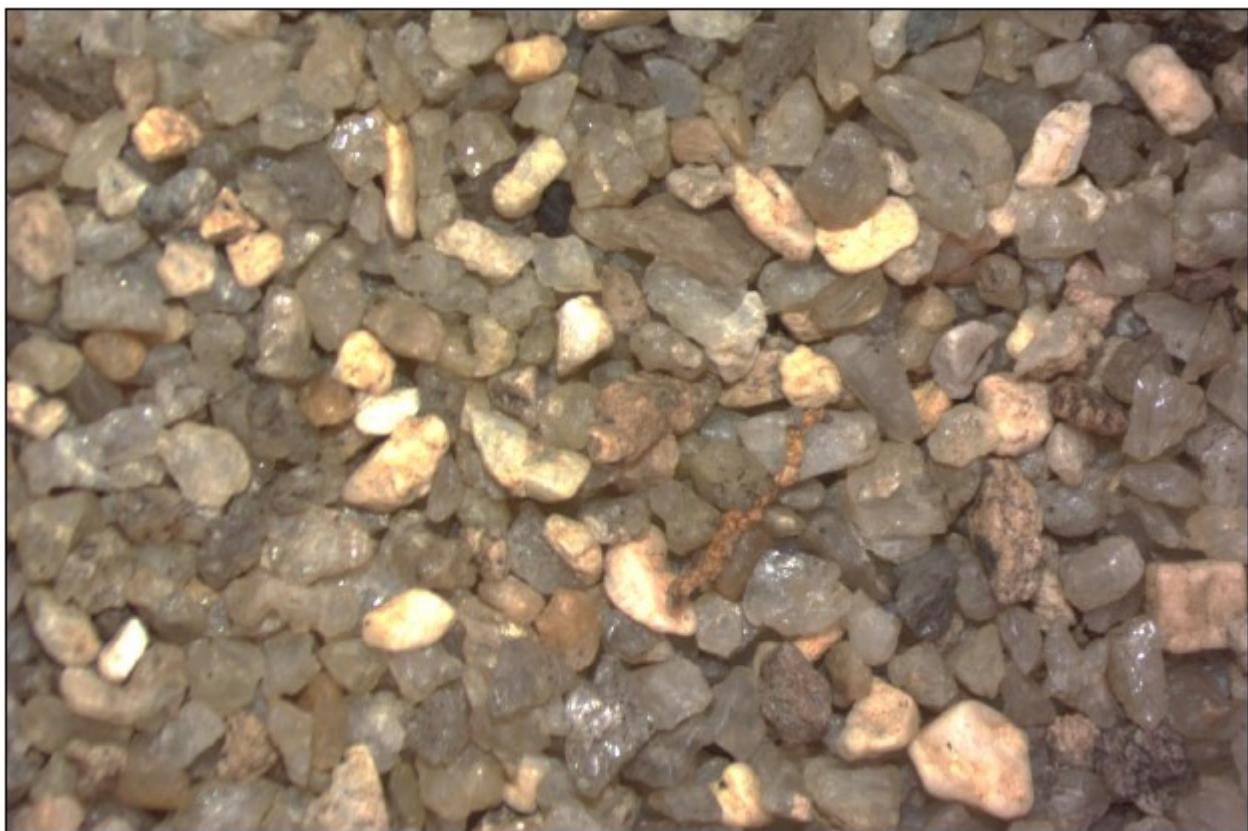
# G23100074

During initial investigations to determine whether sand within the site was suitable for use within concrete and in asphalt, the applicant conducted some preliminary investigations, including petrographic analysis. This analysis determined that samples taken consisted of dark yellowish-brown sand, comprised primarily of quartz and feldspar grains and minor lithic clasts. Grains were dominantly subangular to subrounded. Images of collected samples provided below.

The analysis concluded that the samples supplied were indicative of coarse medium to fine quartzofeldspathic and lithic sand. Dry sieving of samples indicated the following results:

Sieve Size	Wt % of sample
Coarse (>1.18 mm)	9.6%
Medium (>0.3 mm)	69.3%
Fine (>0.075 mm)	21.0%
Silt (<0.075 mm)	0.1%
