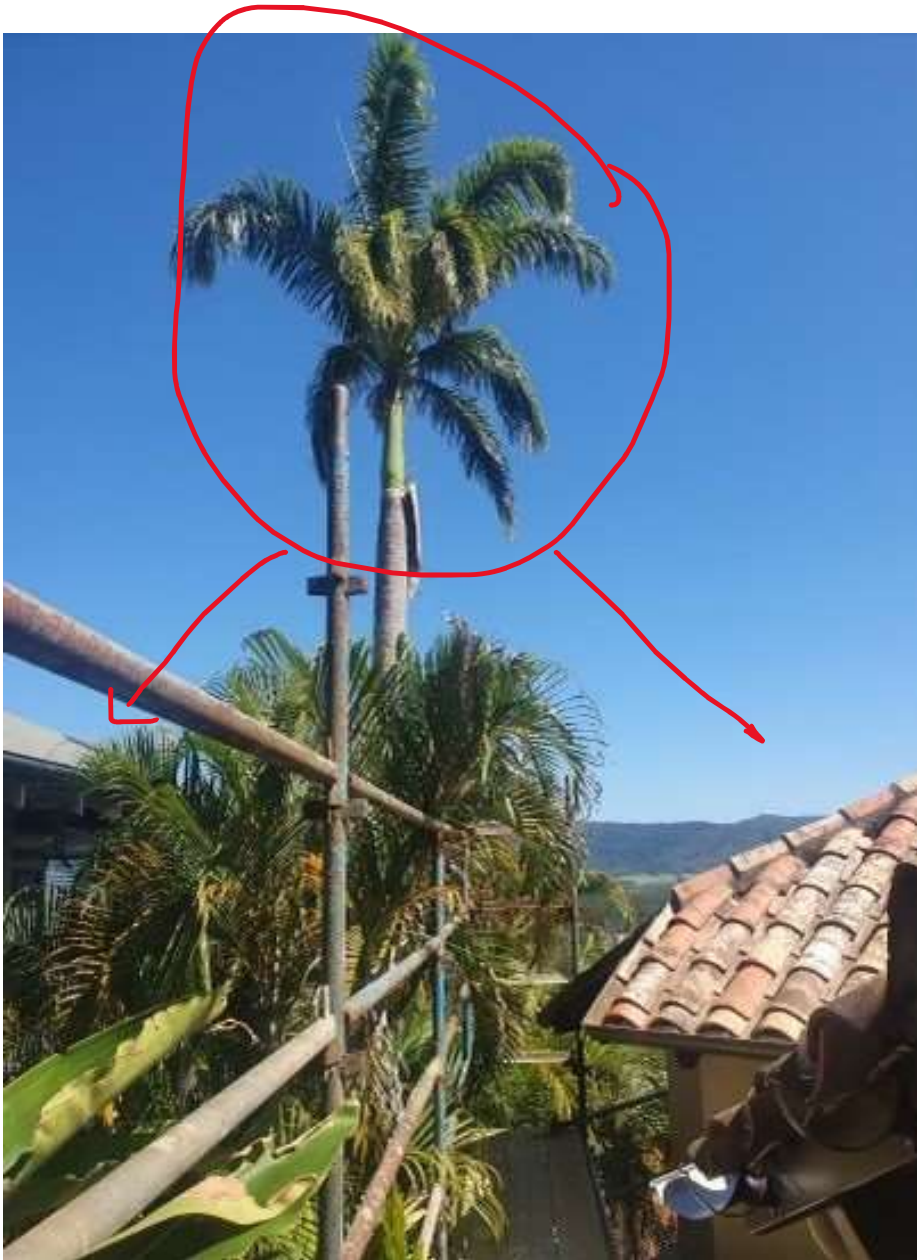
Photo 1 – Location of Queen Palm between 46 & 44 Island Point Road

Palm is closer than 3m to the building structure at 46 Island Point Rd and Palm Fronds fall to the roof of 44 Island Point Rd (weighing approximately 30-50kg each when they fall)

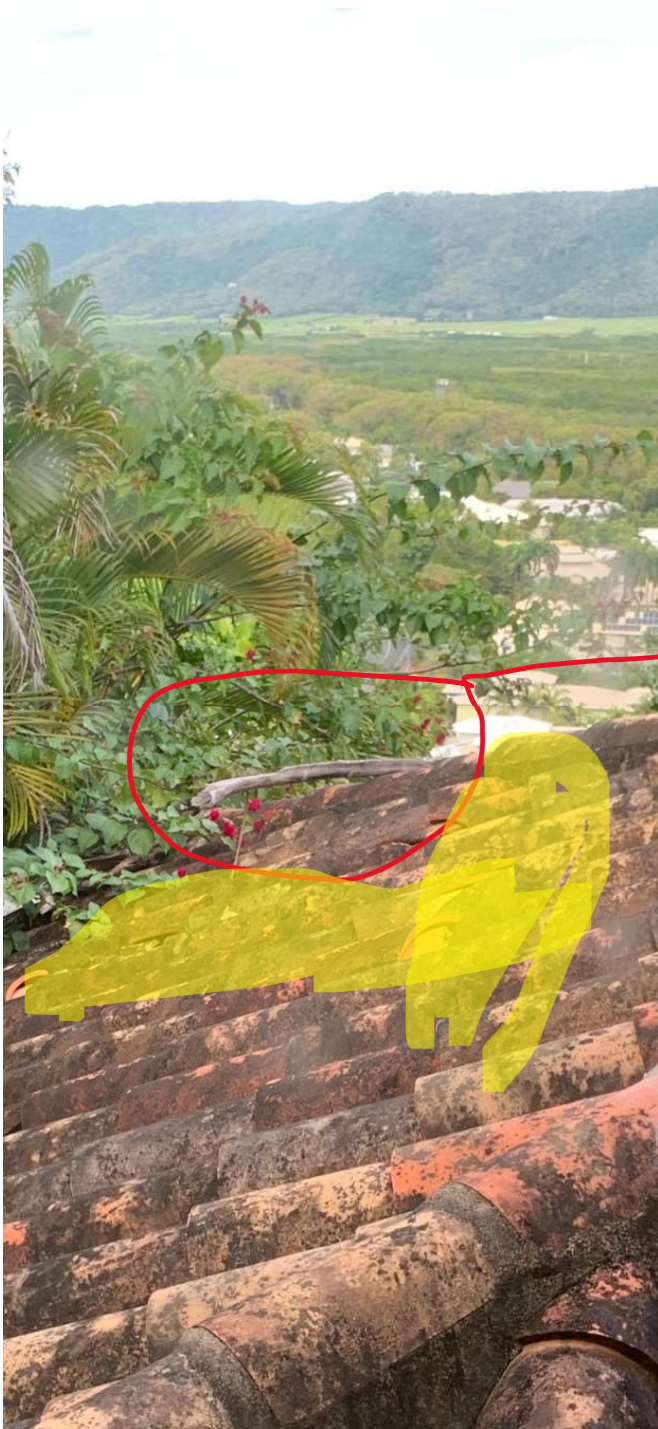
Photo 2 - 44 Island Point Road Roof tiles – Broken and evidence of Palm Frond landed on roof

Palm Frond from 46 Island Point Road Queen Palm

Broken Tiles from Queen Palm Frond

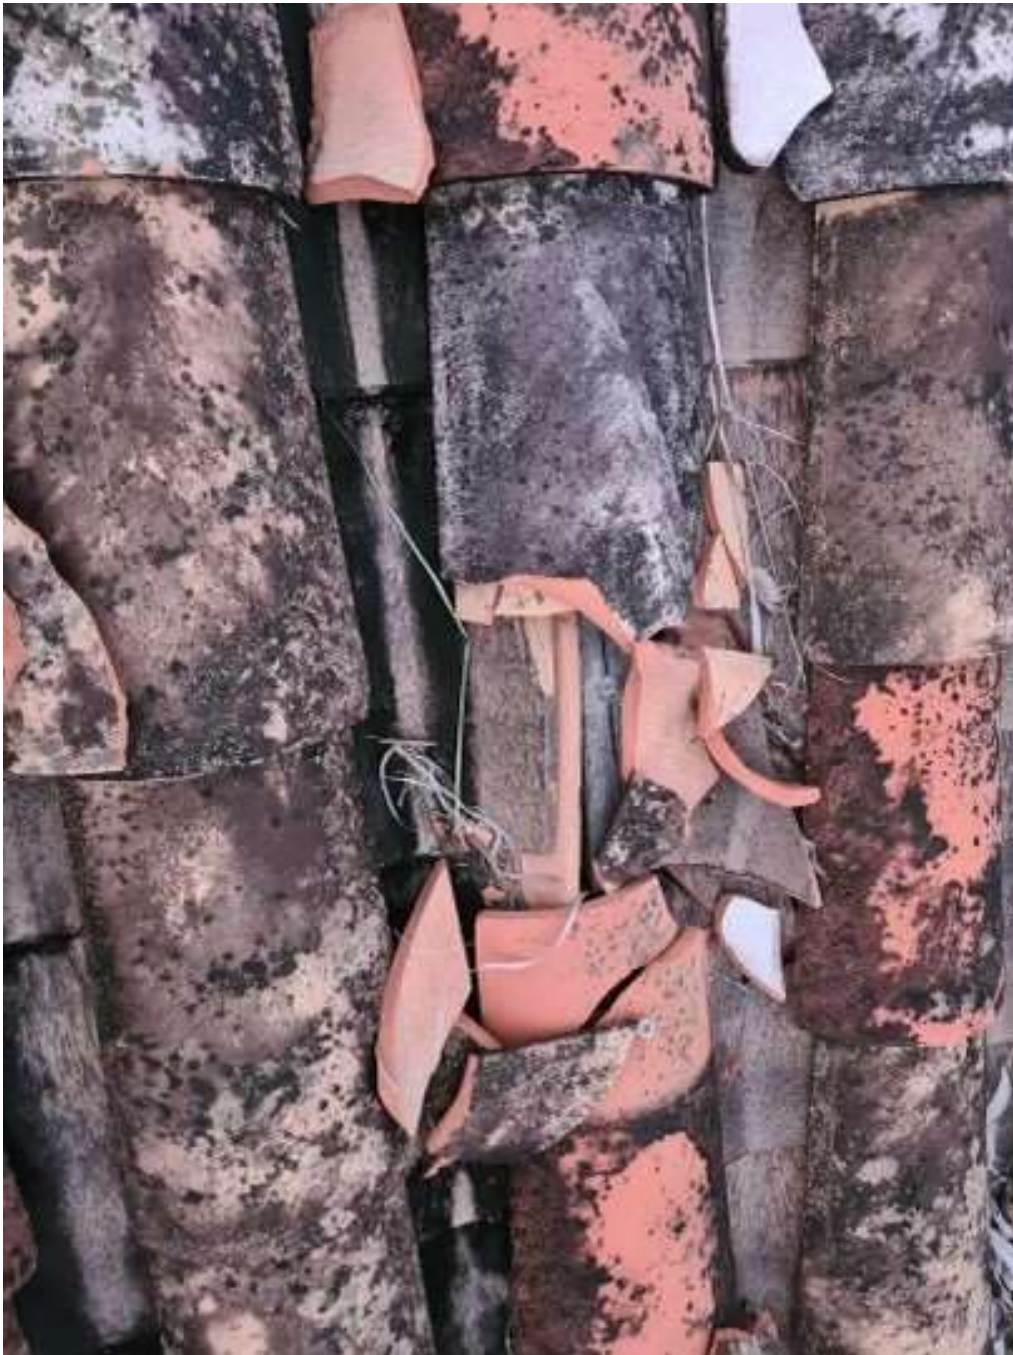
Photo 3 – 44 Island Point Road – Broken Roof Tiles from Queen Palm Fronds
